BARLAND'S FARM, MAGOR, GWENT: A ROMANO-CELTIC BOAT FIND

by Nigel Nayling and Sean McGrail

The last annual report contained an article on the ongoing work at the Europark development east of Llanwern steelworks (Lawler and Nayling 1993) and included a brief note on the finding of a late Roman timber and stone structure with an associated vessel. This paper reviews this piece of fieldwork and integrates results of ongoing post-excavation studies.

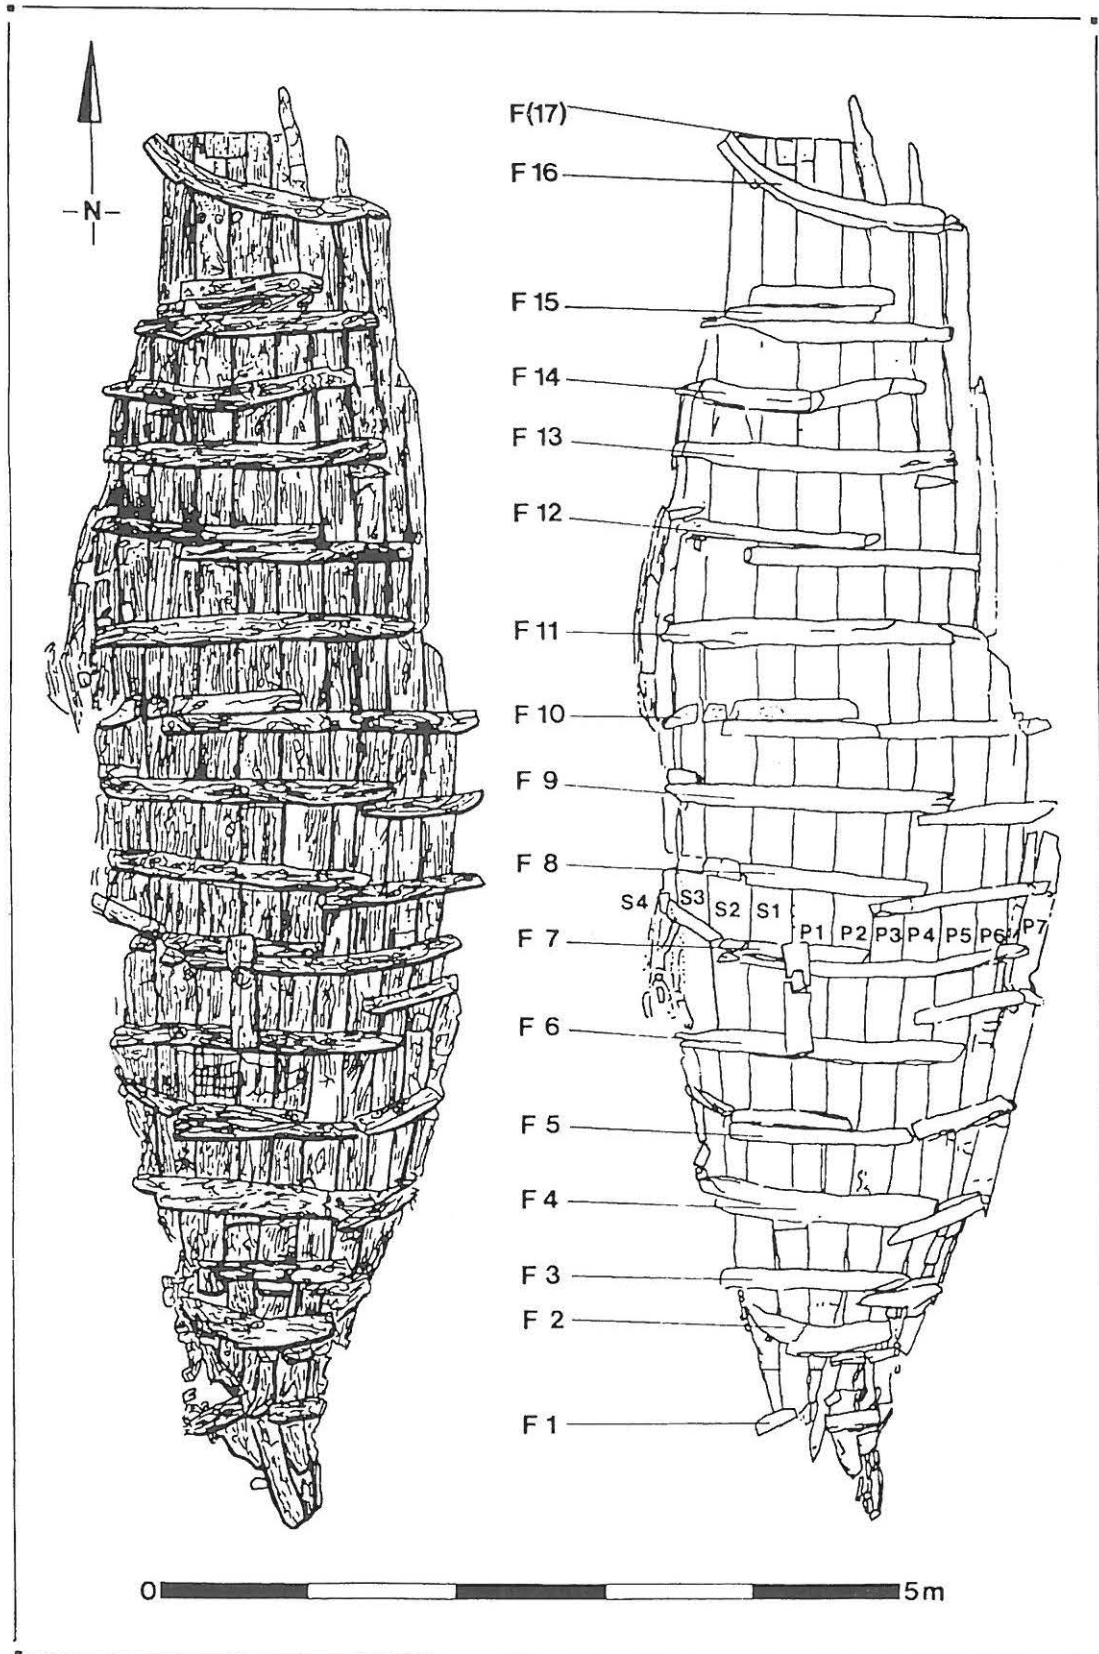
Figure 30 Barland's Farm, Magor: Plan of the vessel derived from photogrammetry and field drawings. Codes relate to the text.

The remains of this boat consist of: a bottom of four planks; one side of five strakes and one of three; one end post; sixteen sets of framing timbers and one inter-frame side timber; and a mast-step timber (Figure 30). All timbers examined so far are of oak (*Quercus* spp.). The position of the mast-step

The four bottom planks (P1,P2 ,S1, S2) are c.7 m long and, towards bow and stern alternately, they taper in

breadth along their length, as did their parent trees. These four planks, which are now some 35 to 65 mm. thick, were tangentially sawn. At each end of the inner bottom planks (P1 and S1) are rabbets into which the stem and stern posts were fastened.

The port side has five strakes surviving, each made up of at least two planks. The longest planks, c.4 to 5.5 m. in length, are in the central part of the boat, with shorter lengths butt-jointed near the ends. These butt joints, all underneath framing timbers, are staggered in adjacent strakes; on the port quarter, there is a horizontal spacing of c.0.50 m between a butt in the lowest side strake (P3) and that in the second side strake (P4), and a c.1.15 m. spacing between butts in P4 and P5.

Over the stem post/bottom junction there is a single floor timber (F4) extending from the fifth strake (P7) on the port side, across the bottom planking, to at least the second strake to starboard (S4). On the port side, adjacent to this floor timber and forward of it is an overlapping side timber extending from the second side strake (P4) to the fifth (P7). Forward of this frame are three single floor timbers, two of which (F2 and F3) also have adjacent, overlapping side timbers to port.

framing timbers. Four of these sets (F5, 7, 10, 12) consist of two adjacent asymmetric floor timbers running across the bottom planking and up to the fifth side strake (P7), the forward one of each pair going to port, the after one to starboard.

The other eight sets of framing timbers (F6,8,9,11,13,14,15,16) are single floor timbers extending from the second (P4) or third (P5) side strakes on the port side to, at least, the first side strake to starboard (S3). Three of these floor timbers (F8,9,13) have adjacent, overlapping side timbers forward of them on the port side, extending from the first (P3) or second (P4) side strake to the fifth (P7). One floor timber (F15) has two adjacent floor timbers aft of it, which extend from the first side strake to port (P3) across the bottom and probably to the equivalent strake to starboard. The remaining single floor timbers (F6,11,14,16) do not now have adjacent side timbers but future examination of the planking may reveal evidence for them. On the port side there is one inter-frame side timber between floor timbers F.6 and F.7, which extends from the second side strake (P4) to the fifth (P7).

On the middle line, between framing timbers F6 and F7, is a longitudinal timber, some 0.75 m in length, with a mast step cut into it, c.120 x 80 x 60 mm. The position of this step, some one-third of the overall length from the bow, is suitable either for a towing mast,

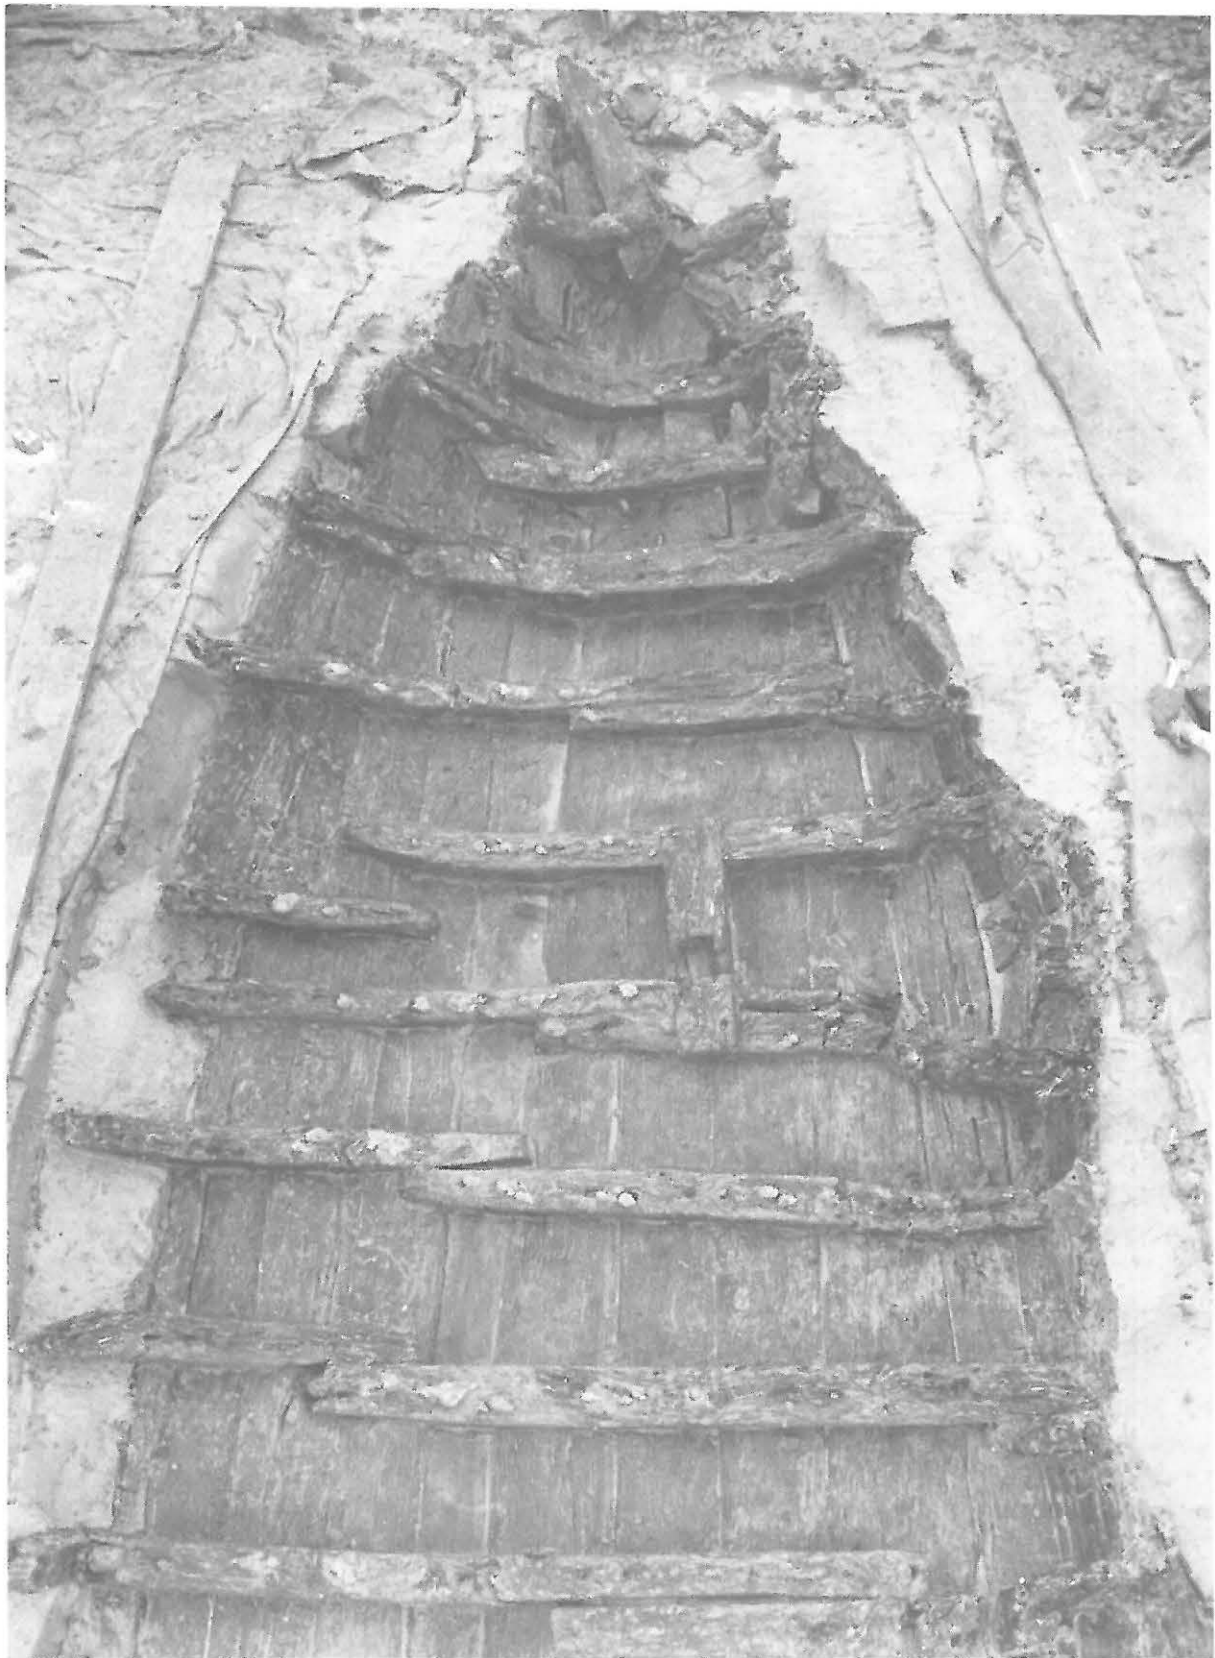
Figure 31. Barland's Farm, Magor: The Romano-Celtic boat. View to south (Photo: Glamorgan-Gwent Archaeological Trust).

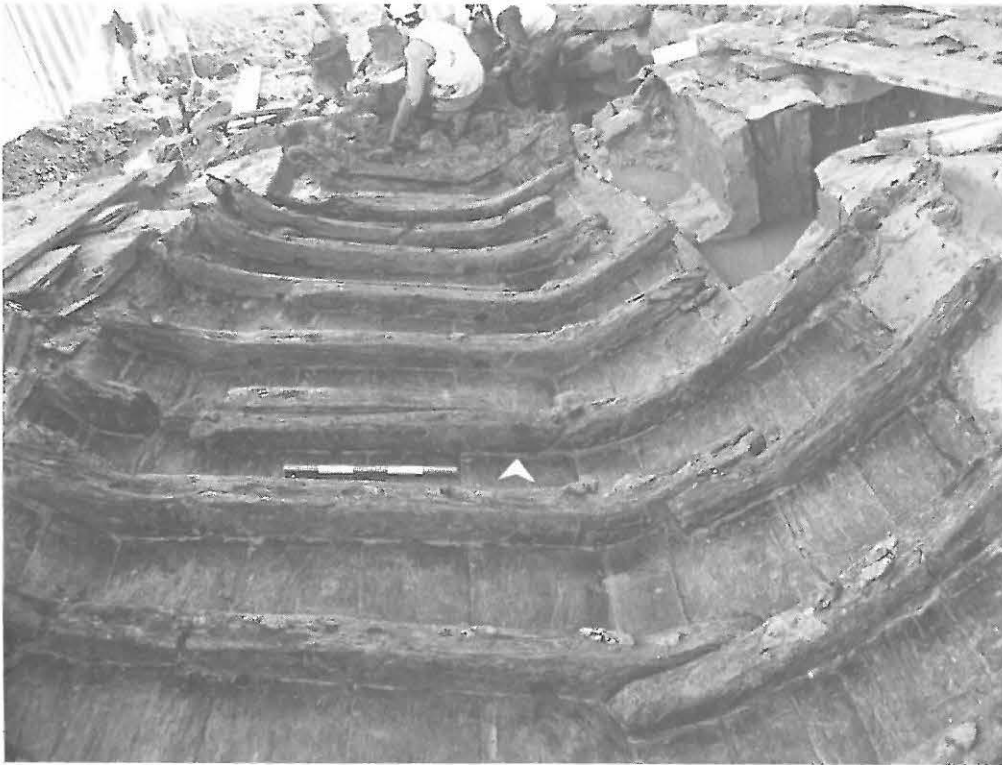
Figure 32. Barland's Farm, Magor: The Romano-Celtic boat under excavation. View to north (Photo: Glamorgan-Gwent Archaeological Trust).
