# THE EXCAVATION, RECOVERY AND PROVISIONAL ANALYSIS OF A MEDIEVAL WRECK FROM MAGOR PILL, GWENT LEVELS

by Nigel Nayling

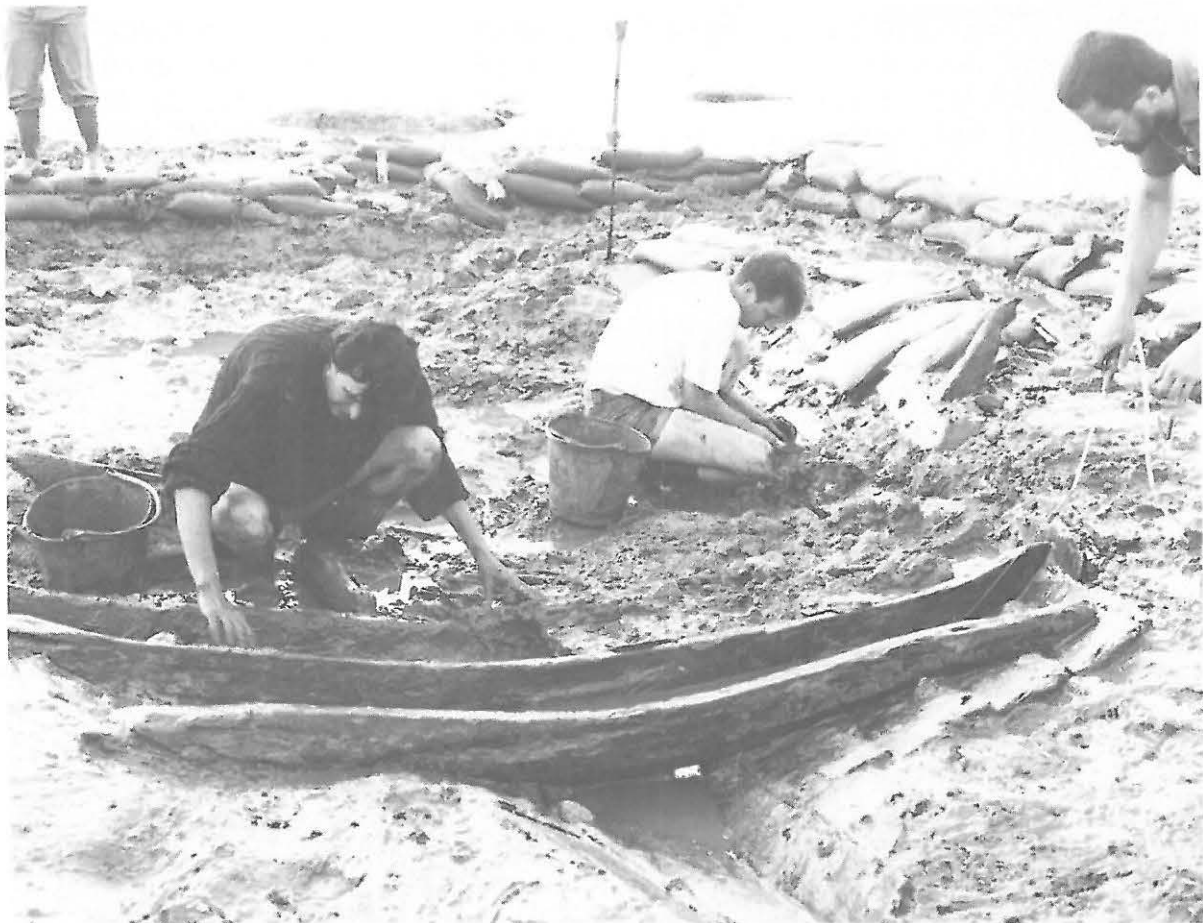
Figure 35. Magor Pill Wreck: During excavation.

During the winter, discussions with Cadw and potential receiving museums led to the National Museum of Wales indicating its interest in acquiring the vessel and Cadw agreeing to fund a phased programme of fieldwork to investigate the remains and examine the feasibility of lifting the vessel. Limited excavation in May 1995 confirmed the survival of up to 8m of a clinker-built vessel which appeared to have been truncated and disturbed, possibly by fluvial action following its deposition. Complete excavation followed in July (Figures 35 and 36), requiring the stratigraphic excavation

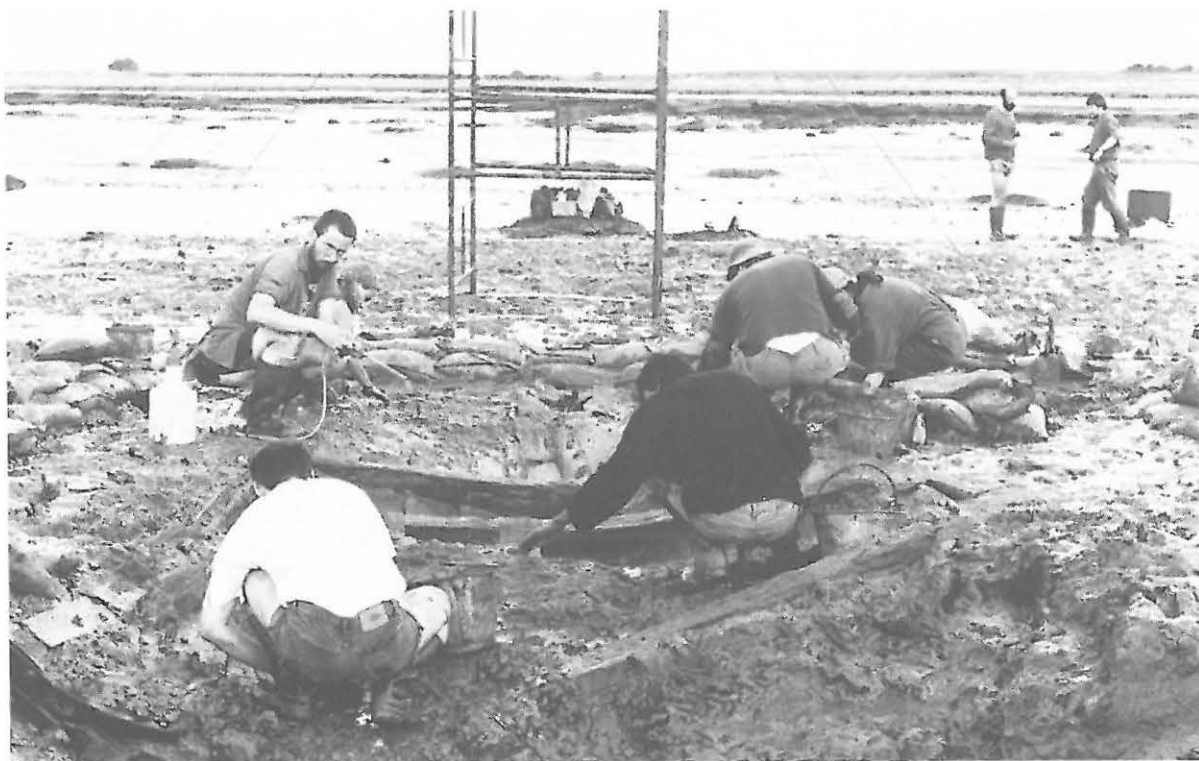
Figure 36. Magor Pill Wreck: Excavation and cleaning nears completion.

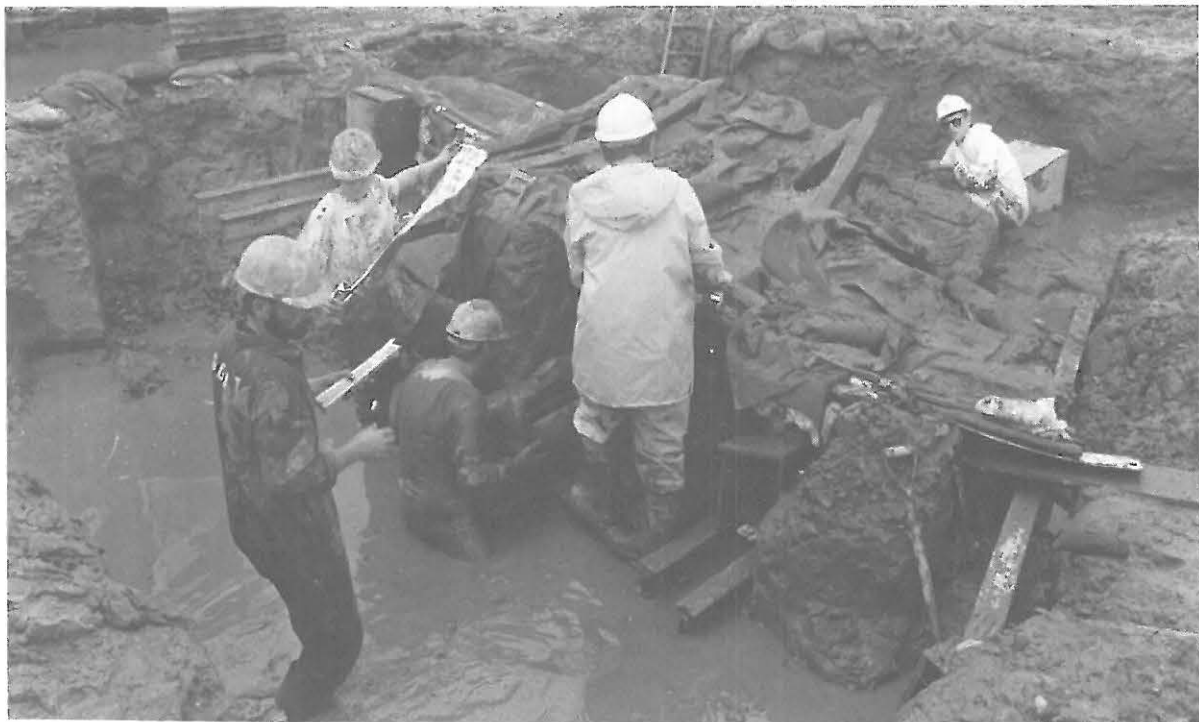
Figure 37. Magor Pill Wreck: Preparation of the lifting frame.

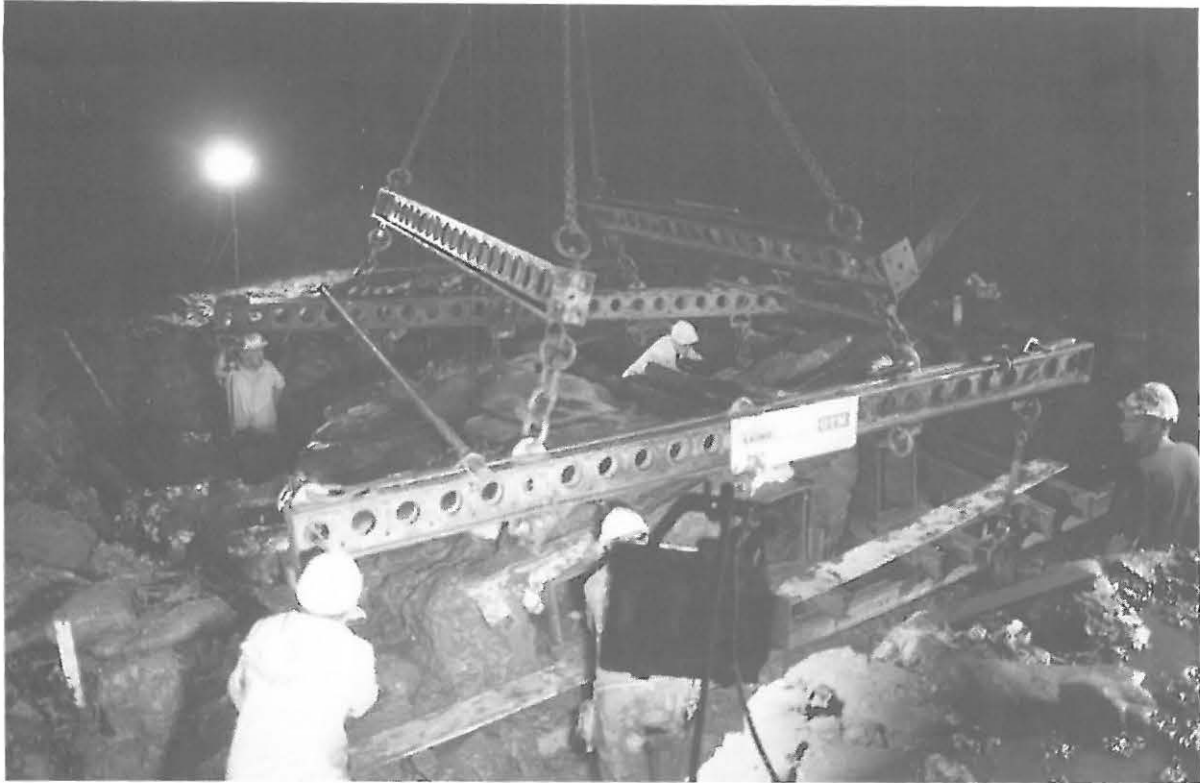
Figure 38. Magor Pill Wreck: The lifting frame taking the weight prior to removal of remaining underlying clay.

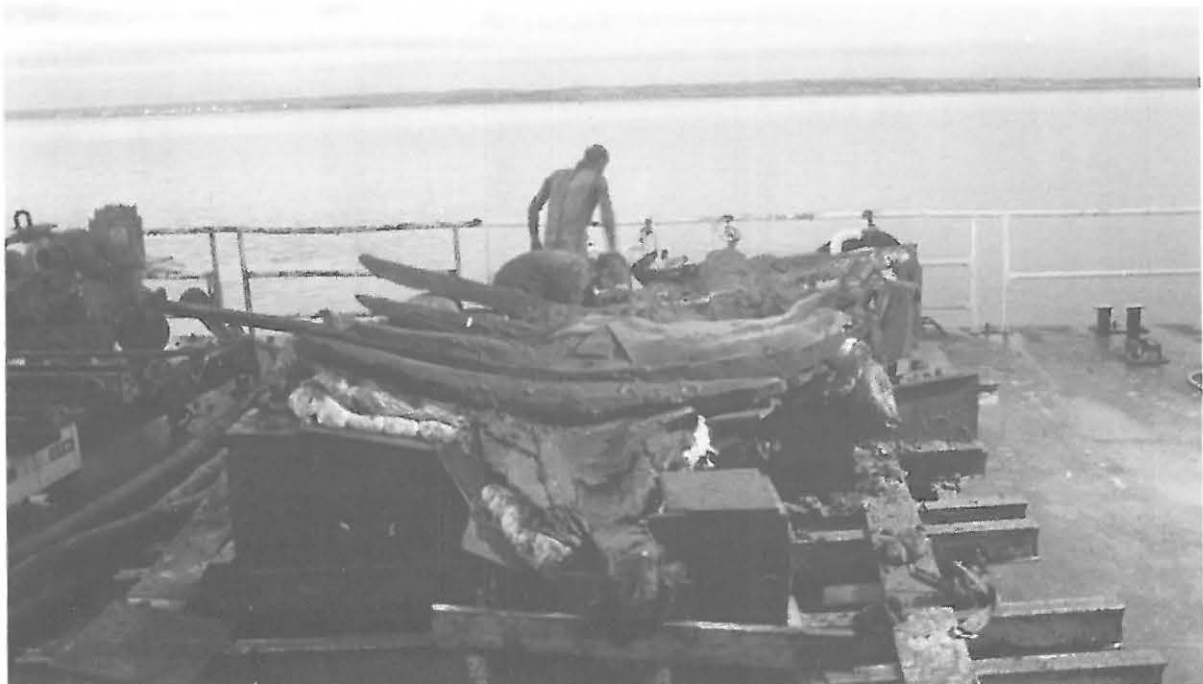
Figure 39. Magor Pill Wreck: The last sea voyage to Severn Beach for transfer to road haulage.

of overlying palaeochannel sediments and gravel, the *in situ* recording of the vessel by photogrammetry, and the removal of the remains of a cargo of iron ore (front cover photo). Whilst the excavations were in progress, wide-ranging consultation with maritime archaeologists sought to identify a suitable method of recovering the remains. An approach for assistance made to Laing-GTM, the consortium constructing the Second Severn Bridge, elicited a positive response, and discussions led to a detailed design for a lifting cradle, to be placed underneath the vessel to allow it to be recovered as a single object (Figures 37 and 38) During the last week in August, a collaborative team comprising Laing-GTM staff and support ships and plant, Diane Dollery from the National Museum of Wales, and GGAT staff worked every available tide leading to the successful recovery of the boat and her transport to storage in dedicated facilities in Cardiff (Figure

39).
