Land to the rear of
31 High Street, Bempton,
East Yorkshire

Interim Report

June 2015

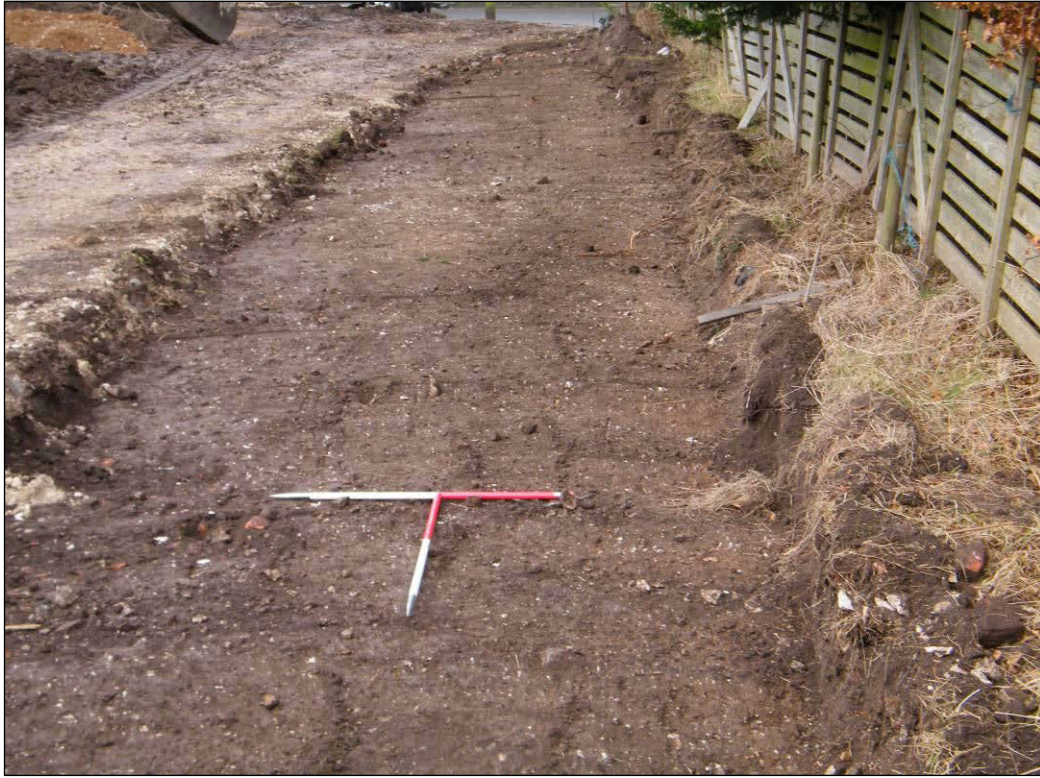
Figure 4: The stripping of topsoil for the access road, looking down towards Gillus

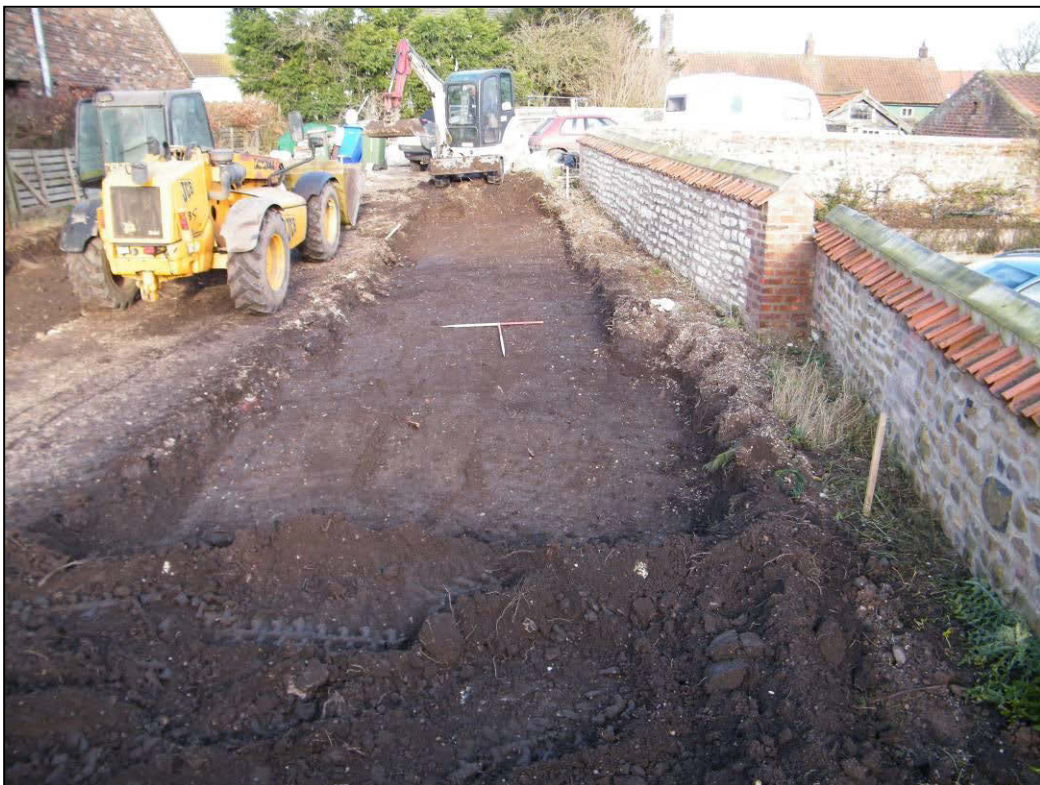
Figure 5: Lane Stripping of topsoil for car park area, looking north

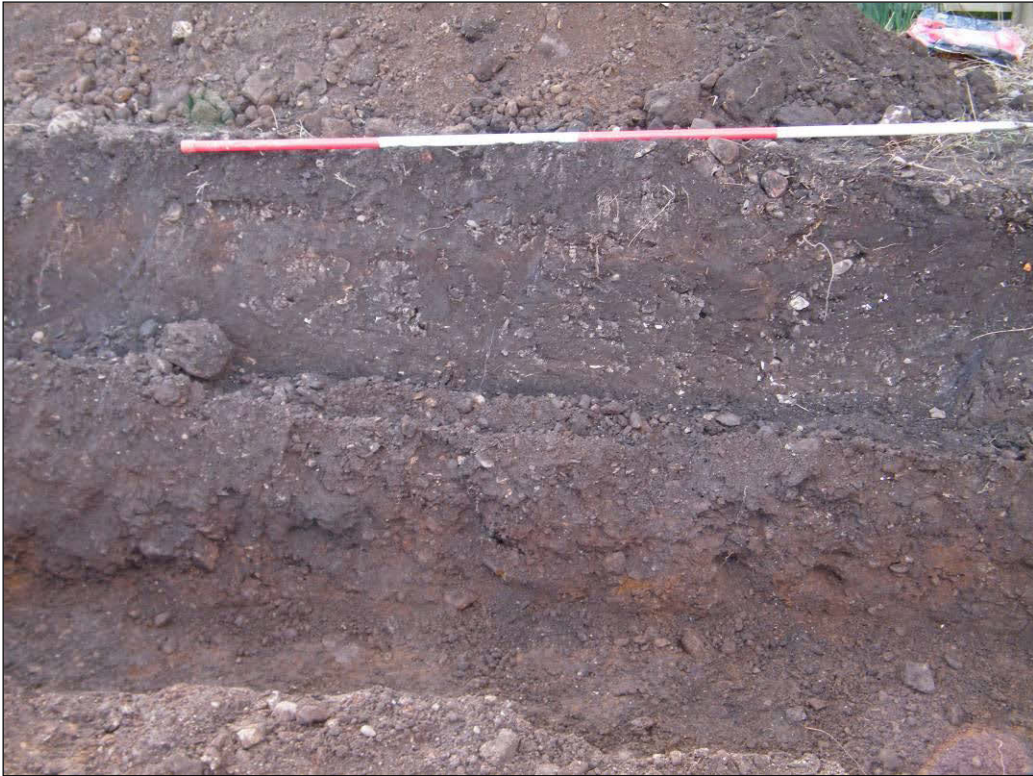
Figure 6: Topsoil (made up ground) and natural deposit

4.3 After the removal of the swimming pool structure measuring 5.0m in width, 14m in length and in places (south) reached a depth of about 2.0m, all the sections were examined and no evidence of archaeological activity was present in this area. The upper ground consisted of a dark brown clay-silt sand material mixed with modern building rubble and measured about 0.40m in depth, overlaying a brown sandy clay natural deposit (**Figure 6**).

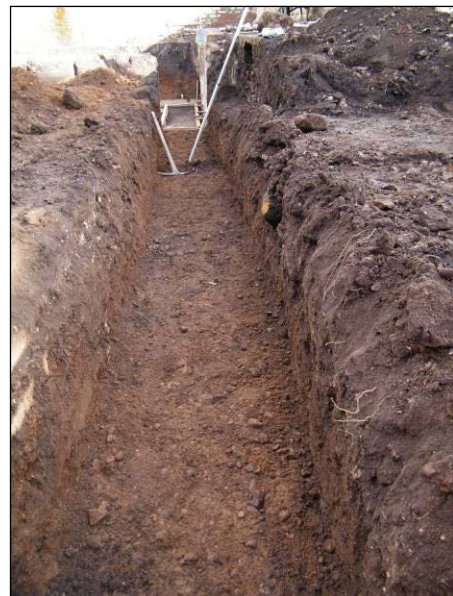
Figure 7: The south foundation, looking east

4.7 Along the north and south foundations of dwelling 1 and 2, evidence of a former boundary wall foundation were recorded. During the excavation fragments of 19th to 20th century pottery were observed among the fill of the foundation wall ditch.
