Archaeological Building Recording Level II Report  
Manor Farm, Dunnington

Site	Manor Farm, Dunnington, North Yorkshire
Site Codes	MFB17
County	North Yorkshire
NGR	SE 6536651352
Planning Application No	16/02505/FUL
Development	Conversion of barns into dwellings
Date of Issue	
Site Dates	18/02/2017
Project by

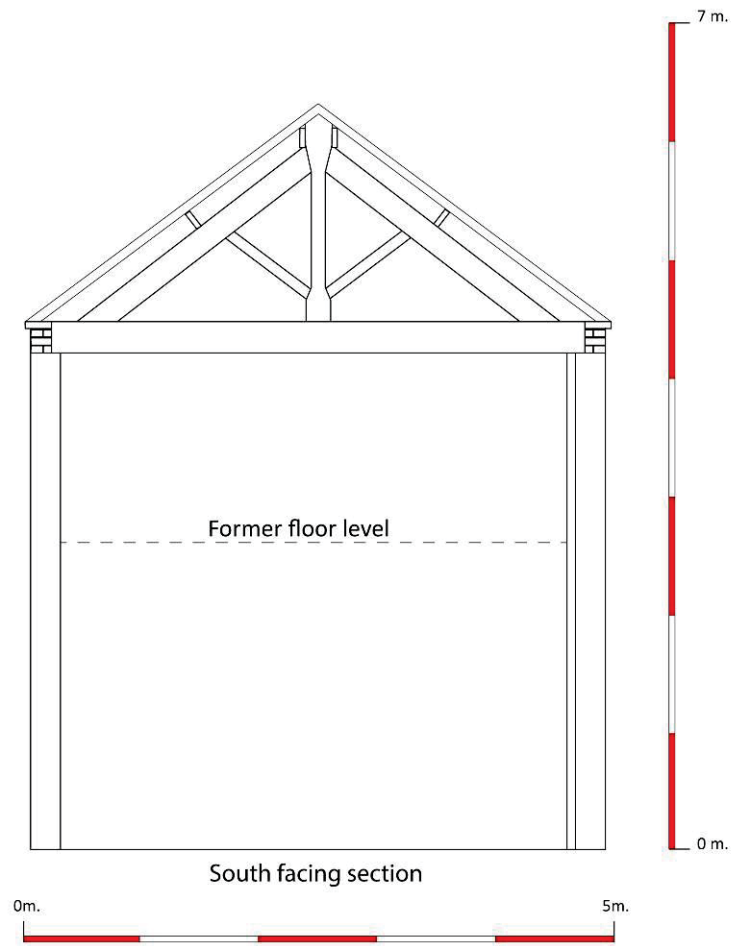
Figure 10: Section 1- through the east barn

The Barn walls are built using handmade bricks measuring in average 23cm in length, 11cm width and 6cm in depth, bonded with a grey sandy mortar. Access to the building is through a 2.0m by 1.80m open space along the south wall. Remaining external features such as a rail indicate that there may have been a sliding door on this elevation. There are three other doors within this barn, one situated along the east wall has been blocked with breeze blocks and two open into to the courtyard on the west elevation, one double one, single.

The roof structure is of a traditional King post truss, and covered with asbestos corrugated sheets. Within the roof there are three square wooden chimney/ vents.

Although at present the building appears to be of one open plan, there is evidence within the wall that an upper floor was present. The upper store had two small square windows, one along the southern end of the eastern wall and the other along the southern wall. A blocked square opening on the upper part of the southern wall may indicate the presence of a former door/opening. A series of air vents are also present along the east wall, these vents measure on average 0.12m in width and 0.25m in height.

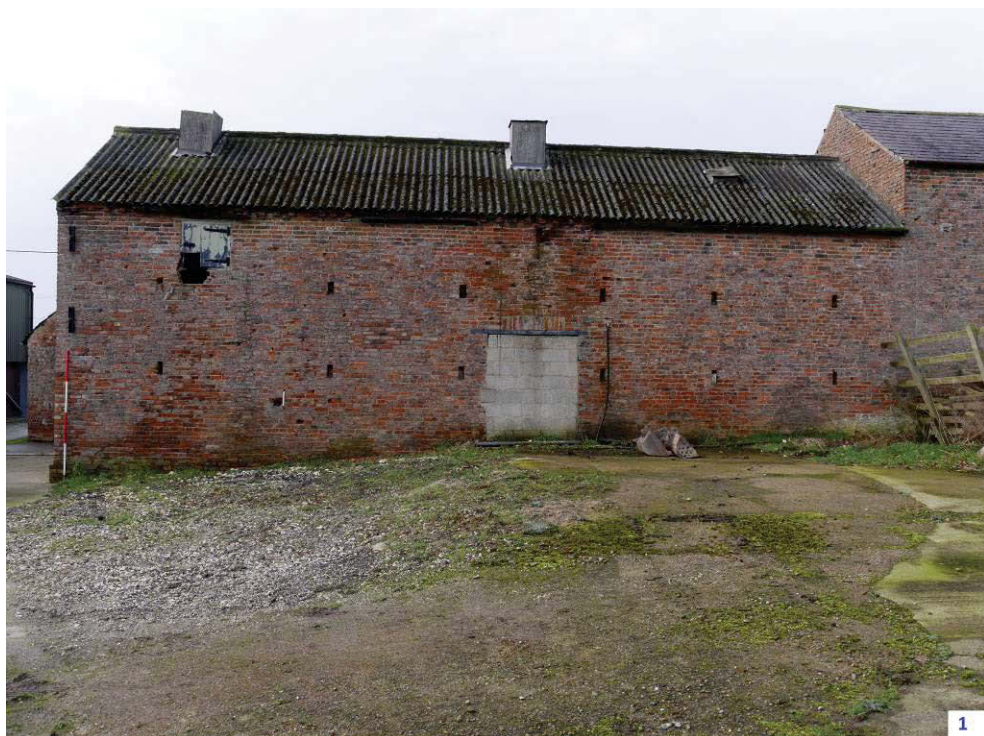
Image Number	External East Barn
1	East elevation with view of the two layers of ventilation slits
2	East elevation view of the window with remaining wooden shutters and fixtures
3	South elevation with detail of sliding door fixtures and bricked in upper floor opening

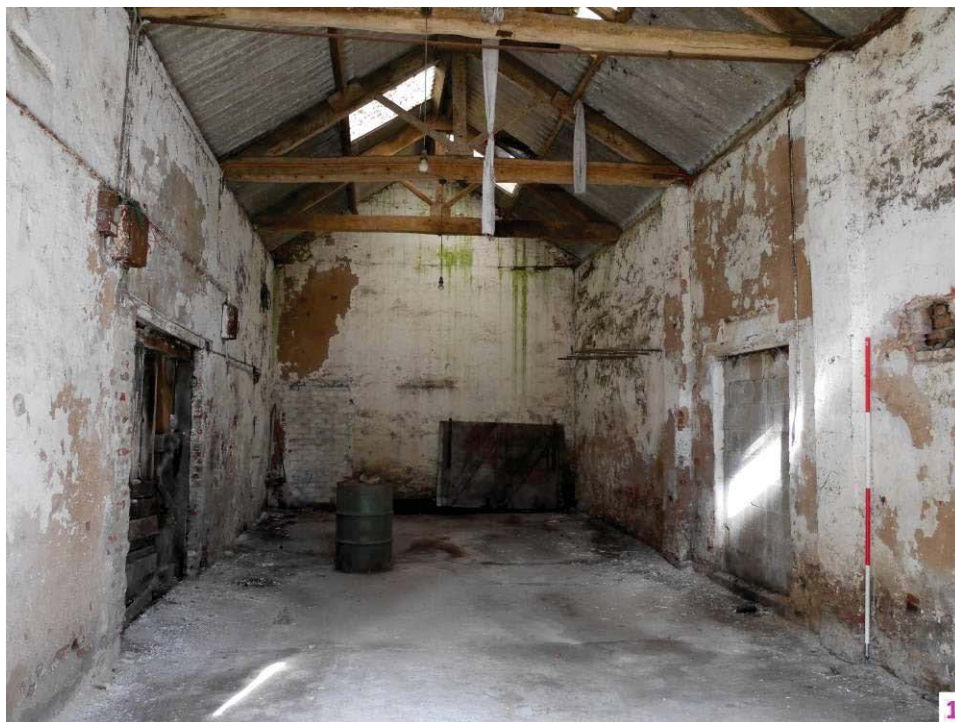
Image Number	Internal East Barn
1	Facing north with general view of the internal space in the east barn
2	Facing west with details of the door showing patched repair work to the left and the original half x brace stable door and fixtures to the right
3	Door within the west elevation showing access to the courtyard
4	Facing south showing the main entrance with the altered window/opening, to the right, on the upper floor
5	Facing east door filled in with breeze blocks
6	Modern electrical fixtures positioned on the wall of the east elevation
7	Earlier electrical fixture on the east elevation
8	Facing north with the details of the roof- rafters with king post truss
9	Cast iron trough located in the north west corner
10	Electrical fixtures located above the double doors on the west elevation
11	Electrical fixtures situated on the left hand side of the double doors located on the west elevation
12	Details of the modern ceiling fan and corrugated asbestos roof sheets.

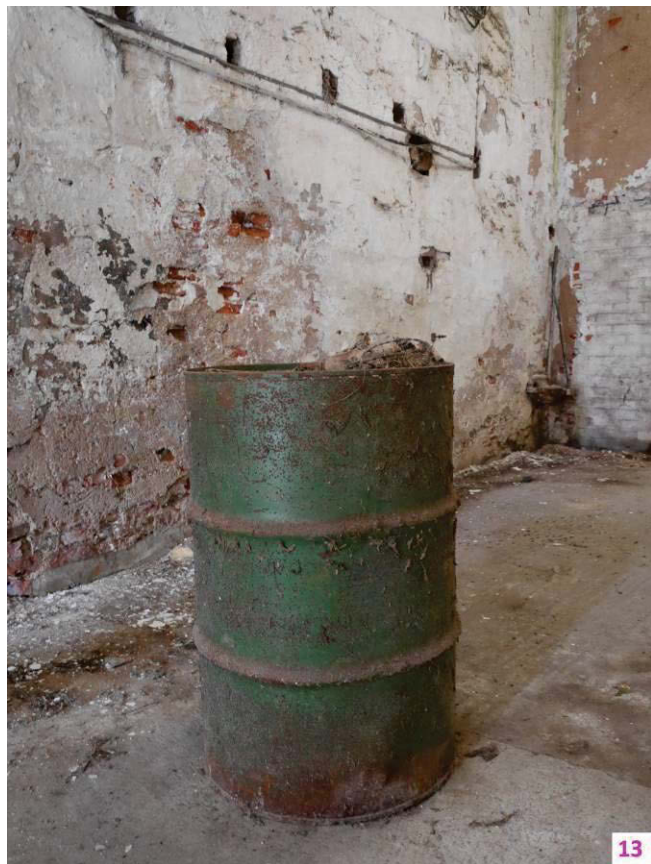
13	Green oil drum with details of the upper floor joist notches in the background to the right

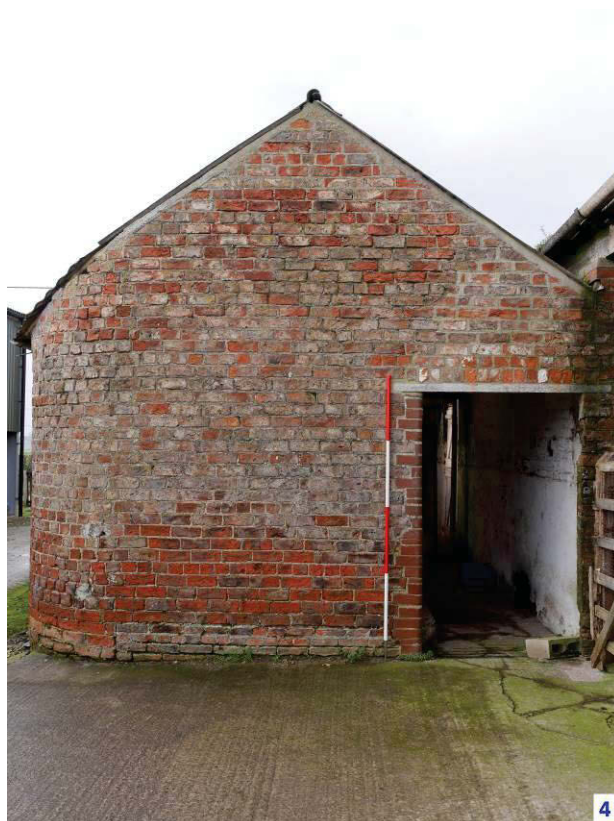
Image Number	External South Cow House
4	East elevation with details of the bevelled edge
5	General view of the south cow house and adjoining south pigeon cote
6	Eastern elevation with details of the brick work and air vent square gaps

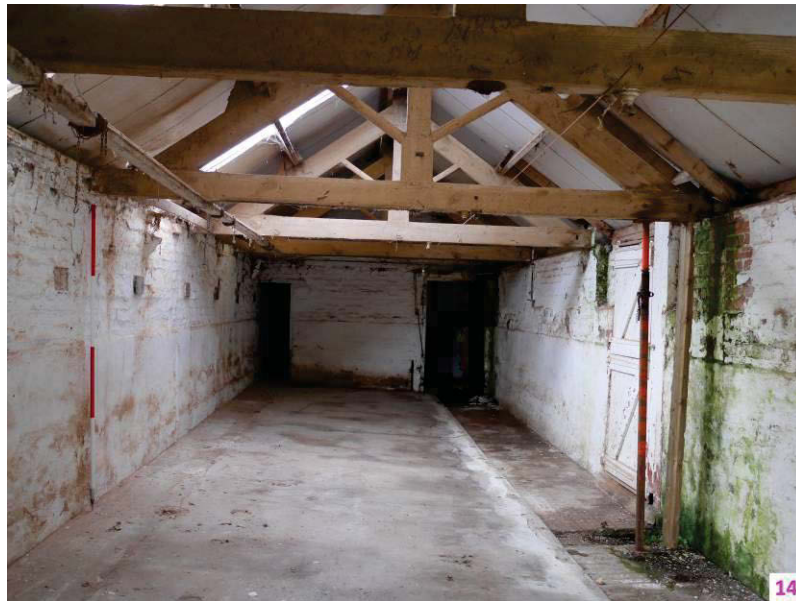
Image Number	Internal South Cow House
14	General internal view facing west roof details
15	Facing east showing the walk way positioned adjacent to the north elevation
16	Details of the wooden double Z door, positioned within the northern elevation, leading to the courtyard
17	Details of the square block entrance area positioned underneath the double Z style wooden door
18	Details of the concrete flooring adjacent to the entrance blocks as seen in image 17. This flooring forms a path from the east entrance to the south pigeon cote
19	Clay pipe air vent one of three situated along the south elevation
20	View of the narrow passage way leading to the south pigeon cote. One of two entrances to this building

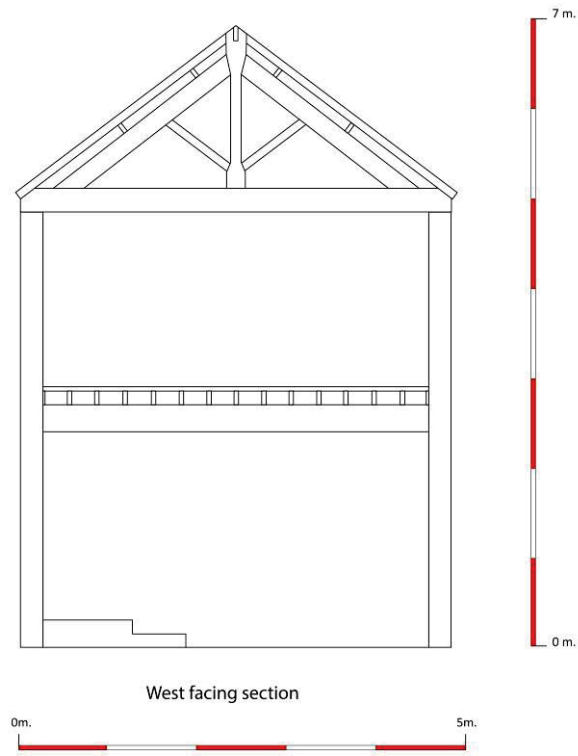
Figure 14: Section 3, drawing through the south pigeon cote

The pigeon cote is a two-storey building with a wooden shuttered opening to the upper floor and a double width door to the ground floor. Both these are located on the southern elevation. This entrance provides access from the exterior to the ground and upper floors. Internally access to the upper floor is through a narrow opening via a wooden stepladder positioned along the east wall.

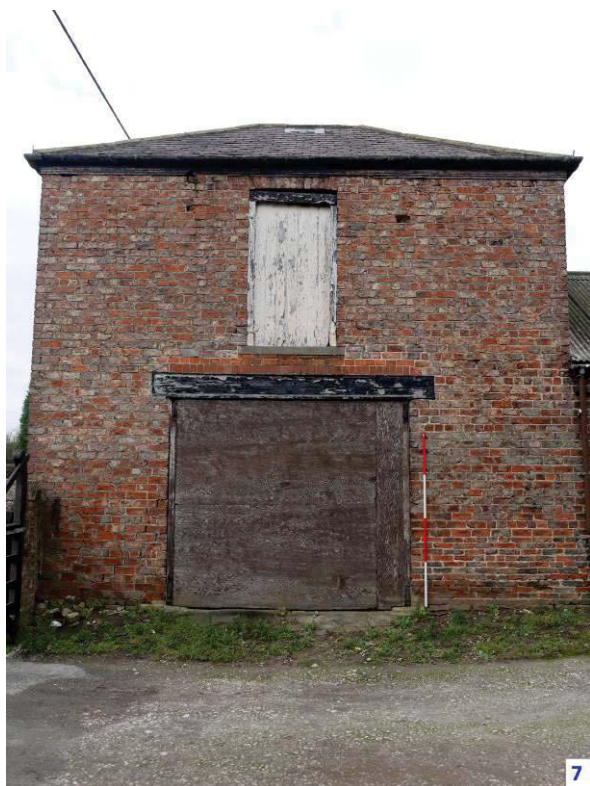
Image Number	External South Pigeon Cote
7	South elevation with blocked double width door and original upper floor opening
8	General view of the south pigeon cote

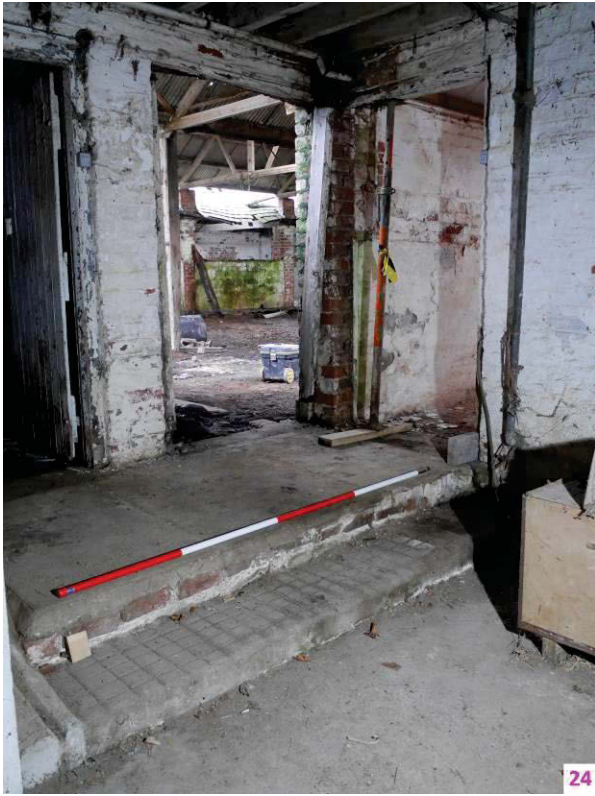
Image Number	Internal <b>Ground</b> Floor South Pigeon Cote
21	Blocked double width door way on the south elevation
22	Details of the wooden ladder leading to the upper floor. Adjacent to the partitioning wall between the south cow house and south pigeon cote
23	Modern wood and glass door entrance to a small utility room. This room is a secondary addition, created inside the open space within the south pigeon cote
24	Details of steps leading north with the same blocked pattern on the first step as seen in image 17
25	Details of small utility room
26	Details of small utility room
27	Items associated with pig breeding
28	Details of small utility room

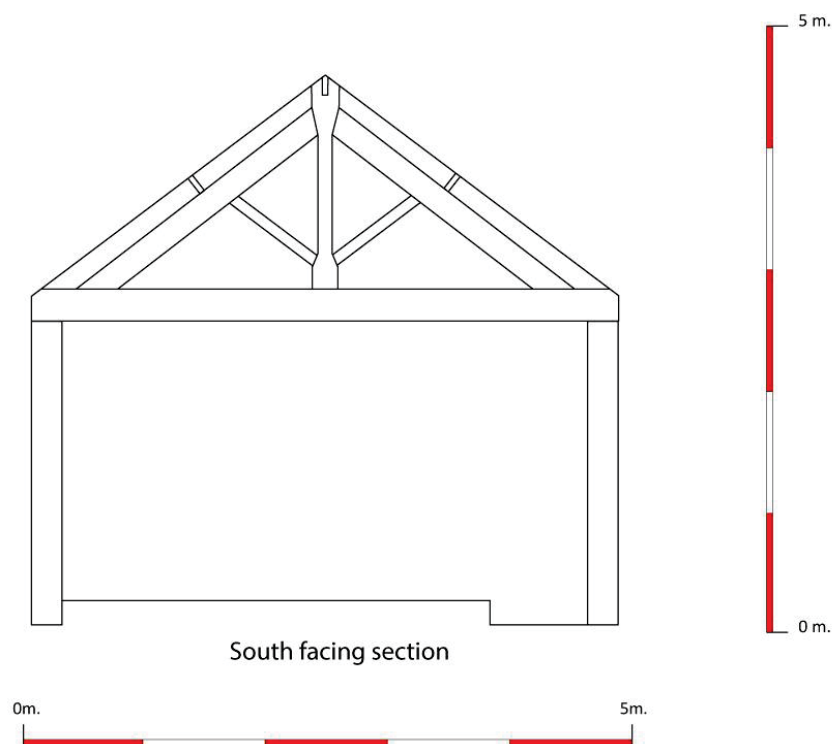
Figure 16: Section 4, drawing through the west cow house

The walls of this building have been built using handmade bricks measuring on average 23cm in length, 11cm in width and 7cm in depth, bonded with a grey sandy mortar, similar to the bricks and mortar used for the construction of the east barn. The interior space reflects the same layout as the south cow house, with a 0.9m wide walkway along the east wall, and a raised floor of about 0.1m.

Similarly to the south cow house, this building originally had partially open bays along the east wall. At a later date these openings were filled in with bricks. There are no windows or openings on this building. Light to the building was provided by large electrical lightings set along the west wall. This building has a ceiling set at 2.5m, which consists of large sheets of firm fiberglass wool. The roof structure is similar to the others buildings, consisting of a traditional King post truss, with grey slate tiles covering the west part and asbestos corrugated sheets covering the east.

North and south doors provide access to both pigeon cotes, with direct access to the courtyard via a door inserted into the east wall. In front of the door, leading to the courtyard, the floor is made of concrete tiles with square grooves. To the south of the door, along the floor there is evidence of a small drain, with a cast iron cover. This drain runs through the north wall leading into the courtyard.

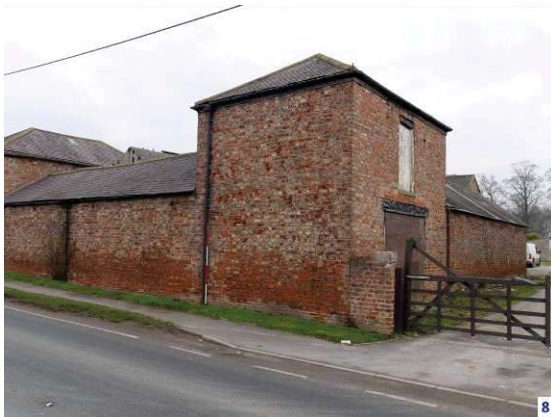
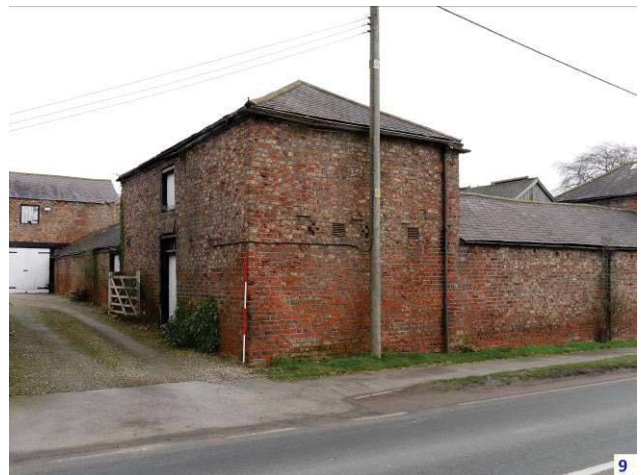
Image Number	External West Cow House
8	West cow house and adjoining south pigeon cote
9	Corner image showing north pigeon cote with west and north cow houses extending either end

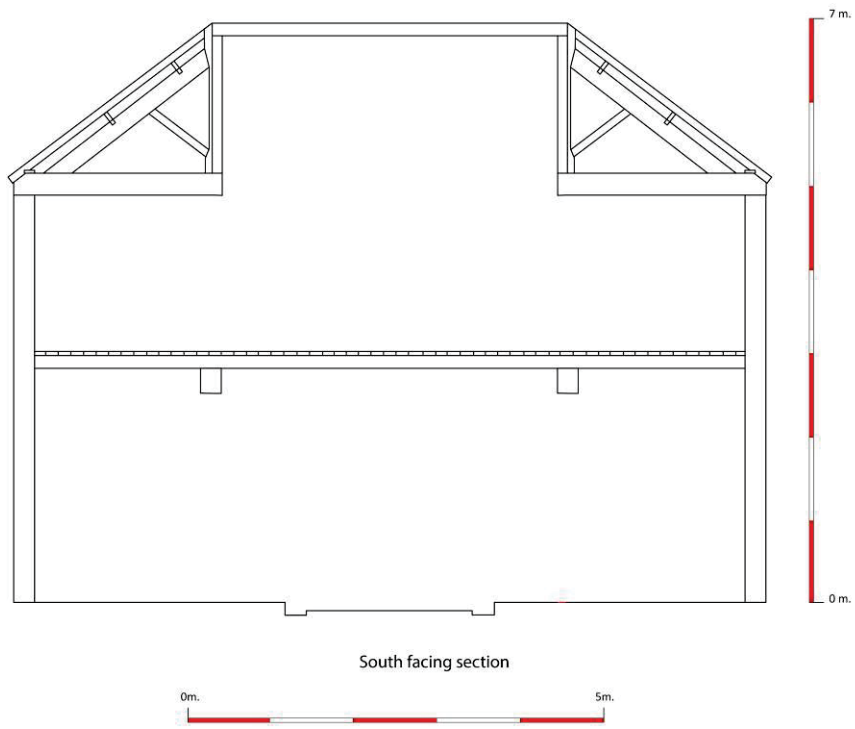
Figure 19: Section 6, drawing through the North Pigeon Cote

The pigeon cote is a two-storey building that has no windows with two doors built along the north wall to provide access from the exterior to the low ground and upper floors. Internal access to the upper floor is through a narrow opening on the floor via a wooden stepladder positioned along the south wall.

Two doors along the south wall provide access to the west cow house, and the courtyard, whereas there is no access to the north cow house directly from the pigeon cote. It appears that the ground floor of the pigeon cote was at a later stage modified in order to provide space for livestock. The ground floor to the east and west of the central doors is made of concrete and is raised about 0.25m, leaving a central walkway measuring circa 2.5m in width, leading from the north door to the south (courtyard area), at each side of the passageway there is a shallow drain flowing towards the courtyard.

The upper floor ceiling is at 2.5m from ground level and consists of wooden planks. The upper floor of this pigeon cote is a single room with two square door/windows both located at the center of the north and south walls respectively above the main doors.

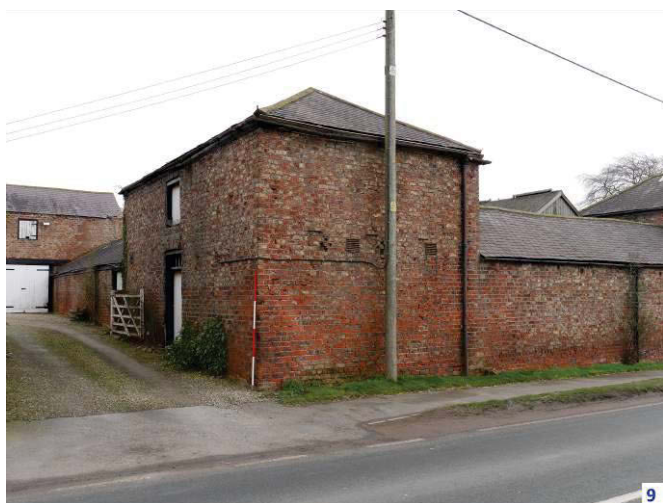
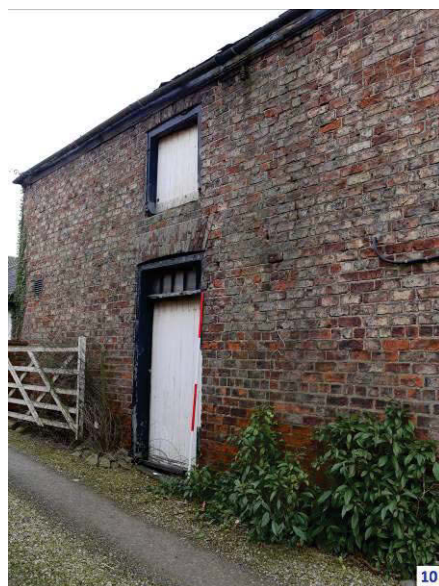
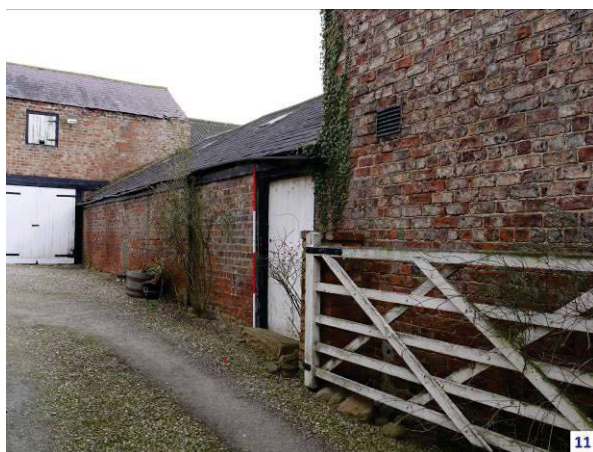
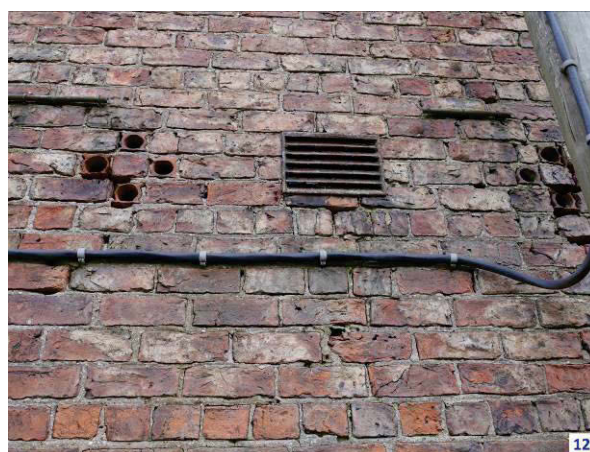
Image Number	External North Pigeon Cote
9	Corner image showing north pigeon cote with west and north cow houses extending either end
10	Details of the door and upper floor window on the north elevation
11	Image showing the north pigeon cote abutting the 4 bay shed with the barn belonging to Hill Farm being located at a right angle in the background
12	Details of the modern air vent and earlier clay pipe ventilation located on the west elevation

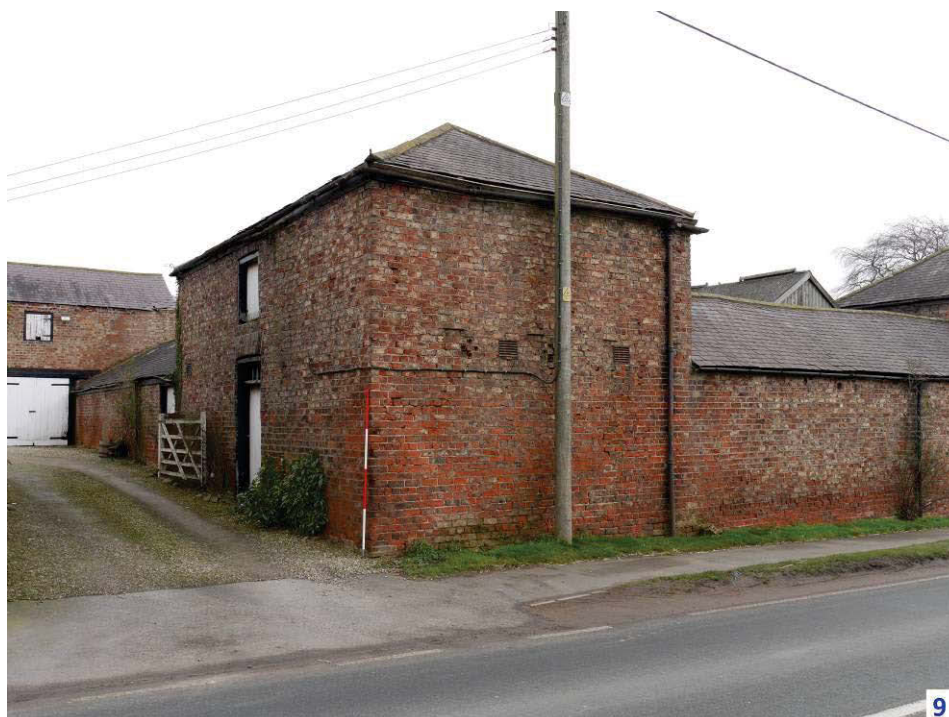
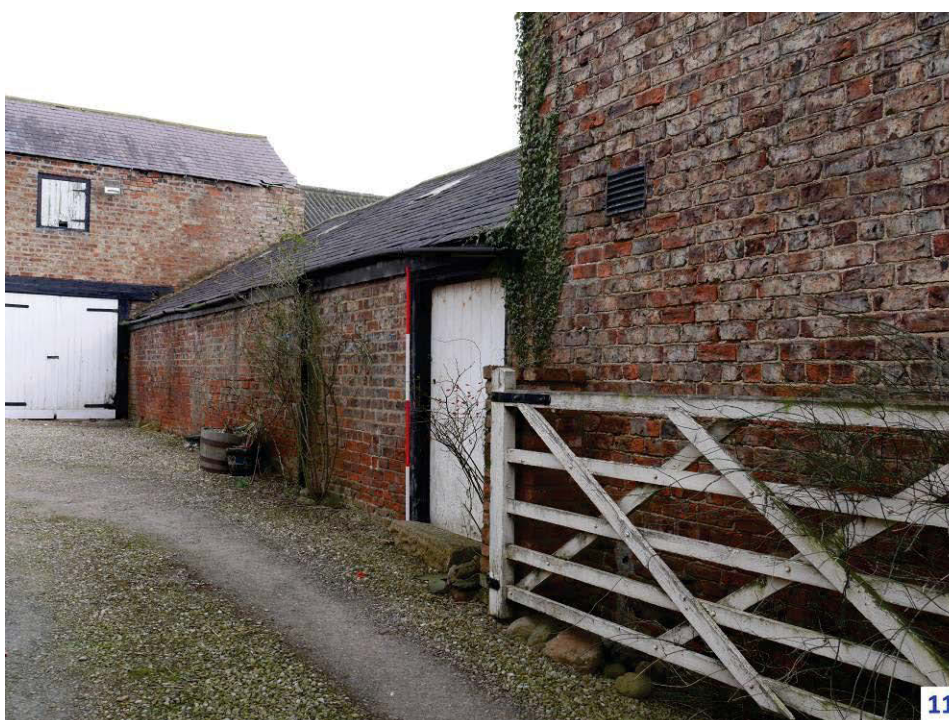
Image Number	External Four Bay Shed
9	Corner image showing north pigeon cote with west and north cow houses extending either end
11	Image showing the north pigeon cote abutting the 4 bay shed with the barn belonging to Hill Farm being located at a right angle in the background

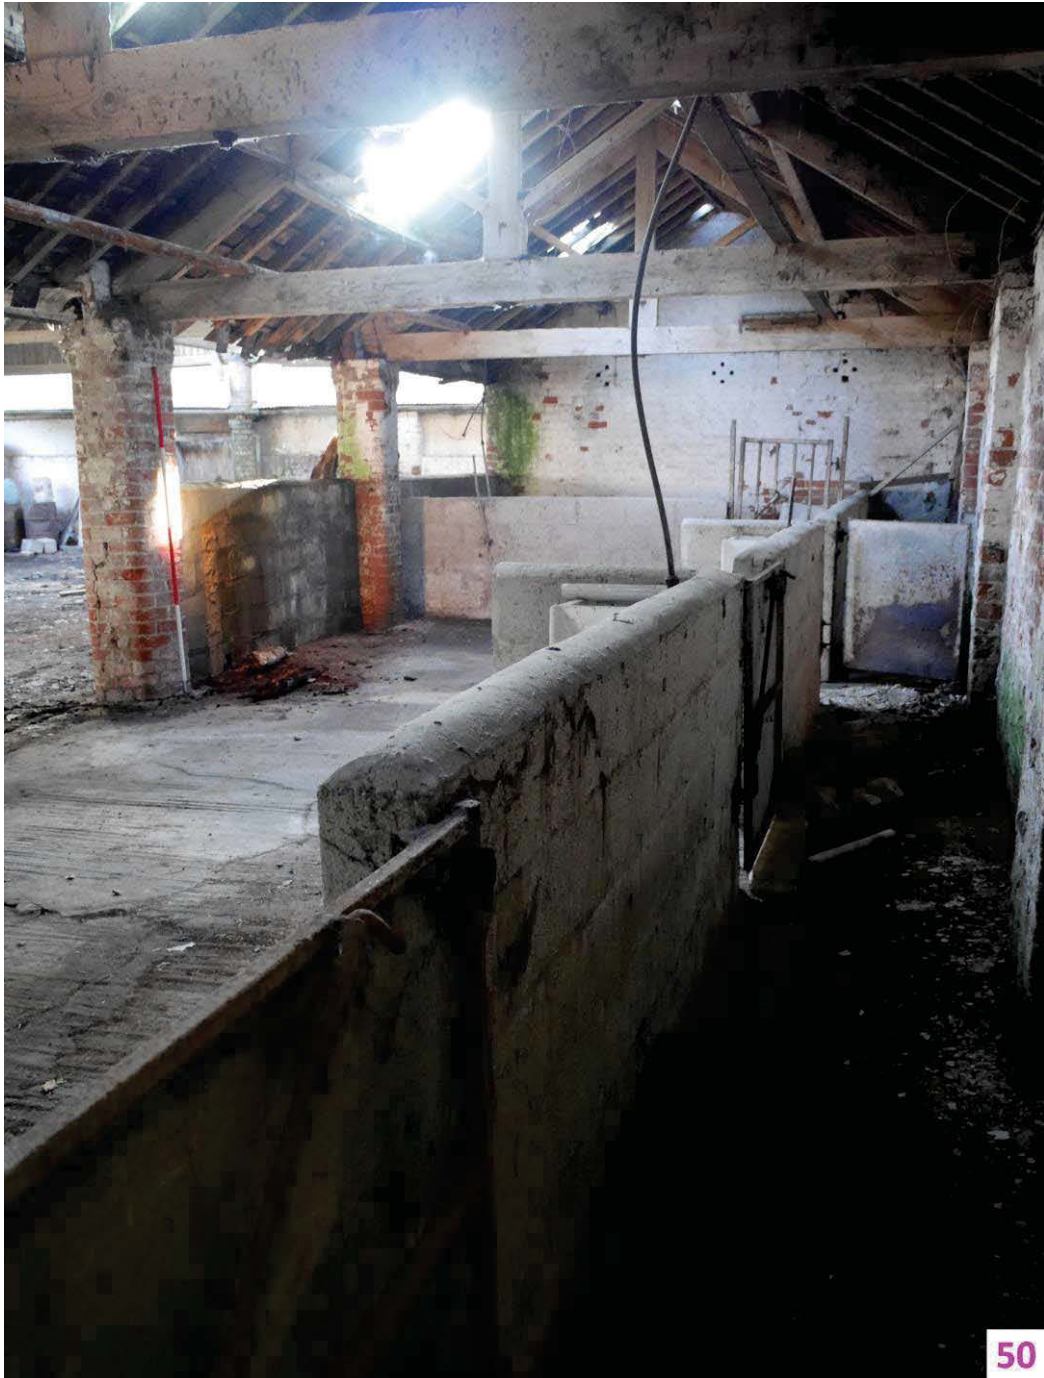
Image Number	Internal Four Bay Shed
50	General view facing west
51	20 <sup>th</sup> century breeze block alterations to create animal pen areas.
52	Breeze block wall alteration facing east
53	Details of the four bays, now partially blocked
54	Elevation showing where the east barn adjoins the Hill farm barn with the four bay shed being incorporated to the west

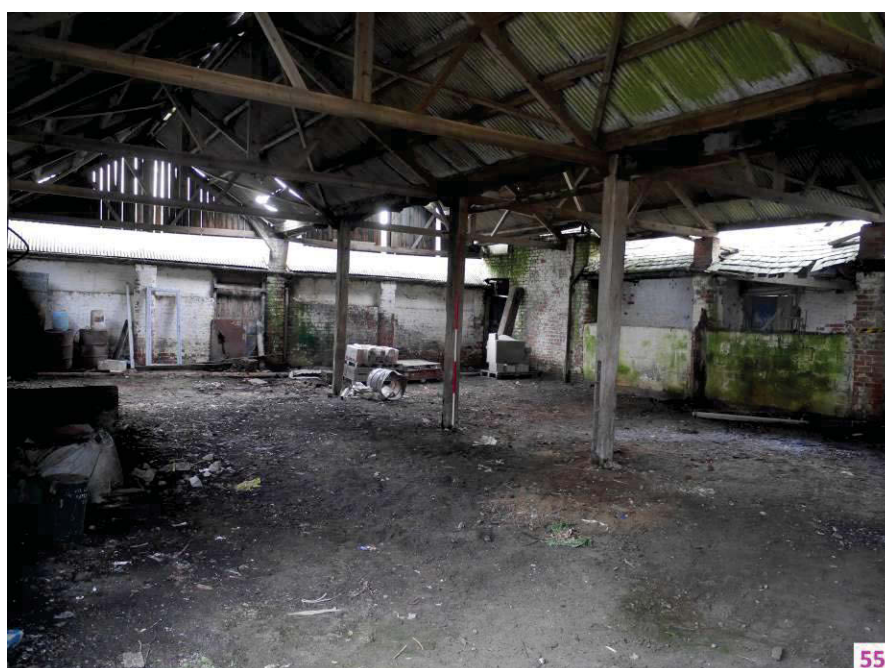
Image Number	Courtyard
55	General view facing west
56	General view facing south
57	General view facing east
58	Details of the cast iron hopper head and down pipe
59	Facing towards the west cow house showing details of the original partially open bays now bricked up and painted white
60	Sewer hole and metal sheet covering located along the north elevation of the south cow house
61	Red brick blocked path with a retaining kerb edge constructed with bevelled bricks leading between both pigeon cotes with central access to the west cow house
