United House, Piccadilly,
York, North Yorkshire

Archaeological Watching Brief Report

Site: United House, Piccadilly, York, North Yorkshire

Development: Housing redevelopment

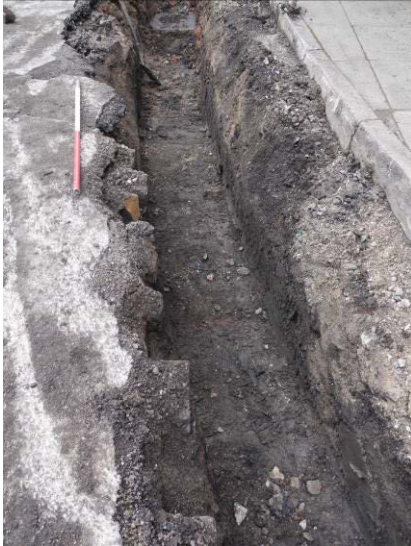
Figure 3: Cable trench looking west

- 8.1 The erection of the Substation, located to the southeast corner of the United House car-park area, required the excavation of a trench measuring 6.7m in width and length and 0.9m deep. The associated cabling trenches, which linked the Sub Station with United House and the main located in Piccadilly road, measured 0.6m in width and 0.8m in depth.

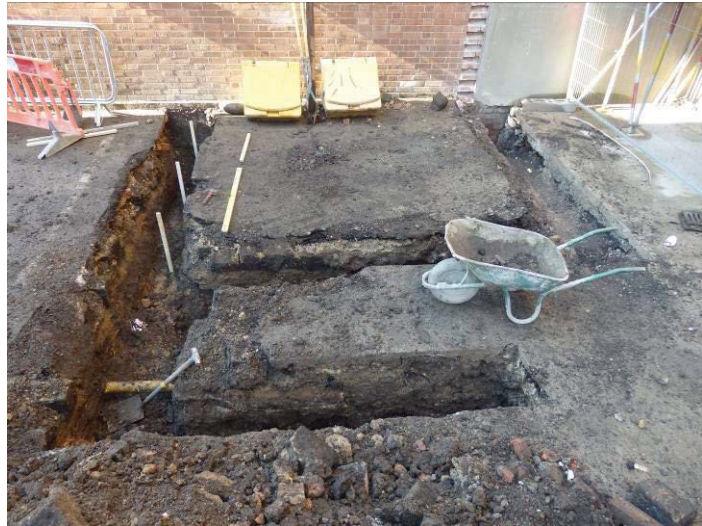
Figure 4: Generator House foundation trenches

- 8.2 The foundation trenches for the Generator House, located on the southern side of United House along the eastern wall of the south extension, were excavated to 0.8m in depth measuring 0.8m in width.

- 8.3 No archaeological deposits were identified within the foundations of the Generator House. The main deposit consisted of a mixture of modern rubble and sandy clay soil.
- 8.4 The excavation of the Substation trench, revealed a sequence of modern (19th Century) deposits overlaying a grey brown silty clay deposit of medieval date, measuring in average 0.4m (context 7).
- 8.5 The removal of the tarmac surface (context 1) revealed the presence of a former floor surface, made of regular yellow sandstone block measuring 0.4m in length 0.2m wide and deep (context 2), laid on top of a 0.1m deep sandy gravel deposit (context 2).
- 8.6 Along the northern and southern side of the trench, cutting through context 2 were two shallow gullies (context 9 and 11) excavated in order to lay a metal pipe (context 13).

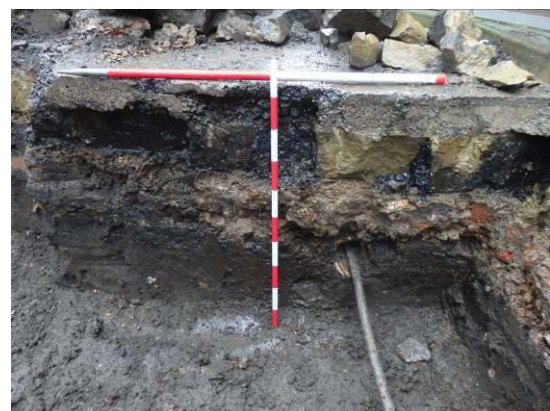
Figure 6: east section of the Substation trench showing the metal pipe context 13

Contains a ceramic and lead pipe. Mid-late 19th century.		
10			Cut	Cut of small square feature	Linear	Squared	/	0.59	0.14	The cut of a possible linear feature cutting into the clay layer (5). Runs N-S with straight sides and a flat base. Not present in the south section suggesting it terminates in the south. Possible utility ditch?	Section 1
11		11	Cut	Cut for water pipe trench [11]	Linear	Concave	6.7	0.75	0.2	A cut for the deposition of a lead water pipe. A modern service trench for a 40cm lead pipe.	Section 1
12		11	Fill	Rubble and mortar fill over (13) in [11]	Linear	Concave	6.7	0.75	0.2	A loose grey 100% gravel and mortar fill for the service trench [11] containing (13).	Section 1
13		11	Structure	Lead water pipe (13) in [11]	Linear	Round	6.7	0.04	0.04	A lead water pipe which runs along the NW side of trench A then turns at a right angle along the SW side and then again turns at a right angle to be fed into drain pipe (9). Probable pre 1970's as lead pipes ceased to be used in new construction.	Section 1

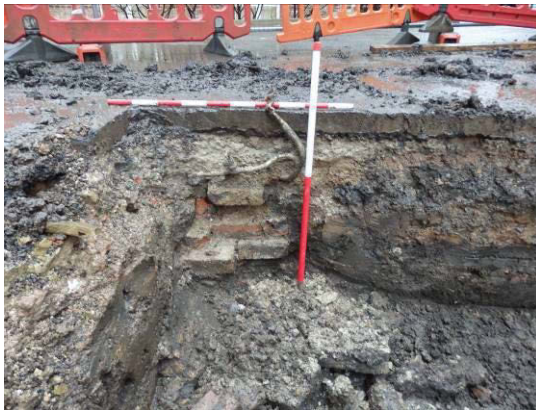
Figure 9: east section of the Substation trench wall 14

- 8.7 Overlaid by context 3 was a dark silty clay deposit, measuring 0.2m in depth (context 4) laid on top of a grey clay deposit measuring 0.3m deep (context 5). Both these deposits appeared to be associated with the east to west foundation wall (context 14). Although of unknown date, it is likely that the brick wall (context 14) and the two deposits (context 4 and 5) belong to a late medieval date.

14	15	Structure	Brick wall NE-SW in trench [15]	Linear	Squared	6.7	0.5	0.4	A brick wall running along the NW side of the trench. Consists of 4 layers of bricks each measuring 25x12x10 cm bonded by a loose mortar made of sand/gravel and concrete.	Section 1	
15	15	Cut	Foundation trench [15]	Linear	Squared	6.7	0.6	0.4	The cut for the foundation of a wall that runs along the NW edge of trench A. Vertical edges and a flat base. Extends beyond the trench limits.	Section 1	
16	16	Structure	NW-SE wall visible on NW corner	Linear	Squared	0.6	0.2	0.8	A brick wall located on the south west corner of Trench A. Consisted of 8 layers of bricks 20x12x10 cm bonded with strong mortar.	Section 1	
17	15	Fill	Fill of trench for wall (14)	Linear	Squared	6.7	0.2	0.4	A hard very dark brown 95% clay silty sand fill with 5% small stones and occasional CBM. Identified as the backfill of a foundation trench for the wall (14).	Section 1	CBM

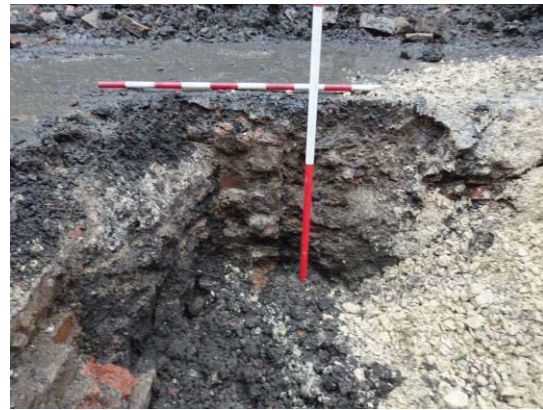
Figure 8: north section of the Substation trench wall 16

- 8.9 Another small brick wall (context 16) was present, along the north-west corner of the Substation trench, abutting wall 14, and running on a north to south direction.

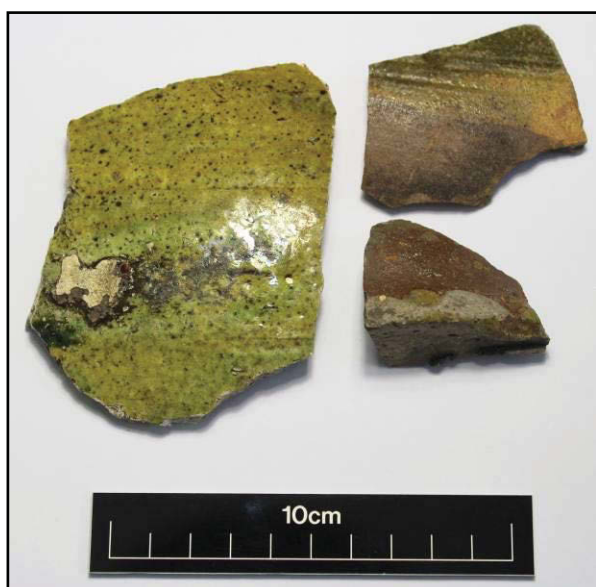
Figure 1: Brandsby-Type

Three sherds of this ware were identified; two body pieces and one base. All three displayed a green glaze on the exterior surfaces. The base had a diameter of 9cm, this being 10% of the whole. Jugs are the most common form in the ware.

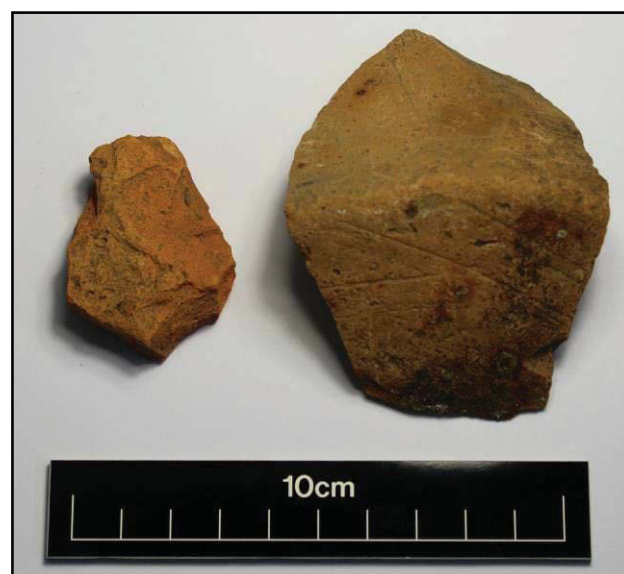
Figure 2: Sandy Red ware.

Two base pieces of this ware were identified. One was immeasurable, the other had a diameter of 9cm, this being 12% of the whole. Neither of these sherds displayed decoration. Jugs are most common form of this ware.

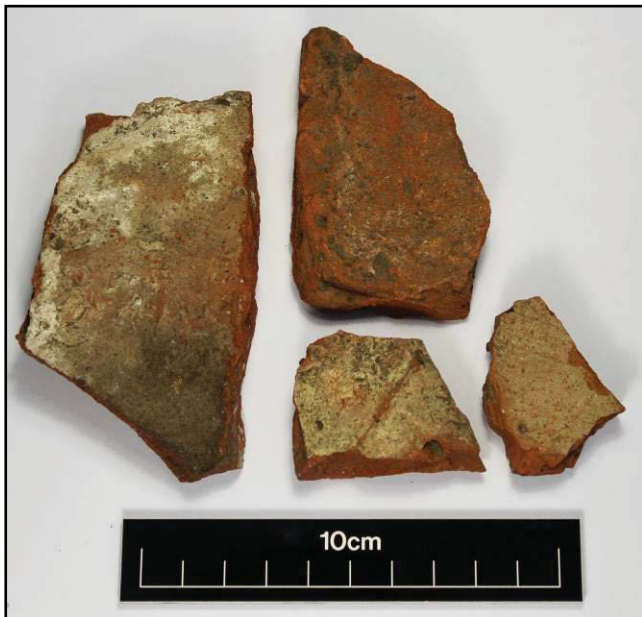
Figure 3: Walmgate

Four body pieces were identified. Three of which displayed a white slipped exterior. The largest sherd displayed evidence of light burning or sooting suggesting its use as a cooking jar or one which had been warmed by a fire, perhaps containing wine or ale. Jugs and storage jars are the most common forms of this ware.

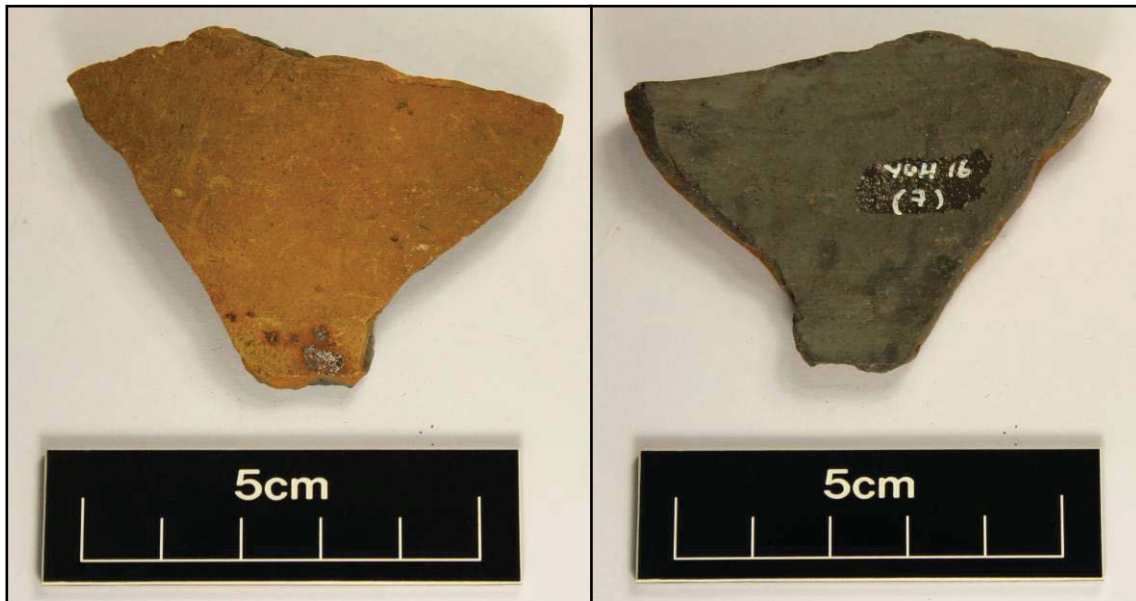
Figure 5: Humber

One body sherd of this ware was identified. The glaze typical of this ware was absent on this sherd. Jugs and jars are the most common forms of this ware.

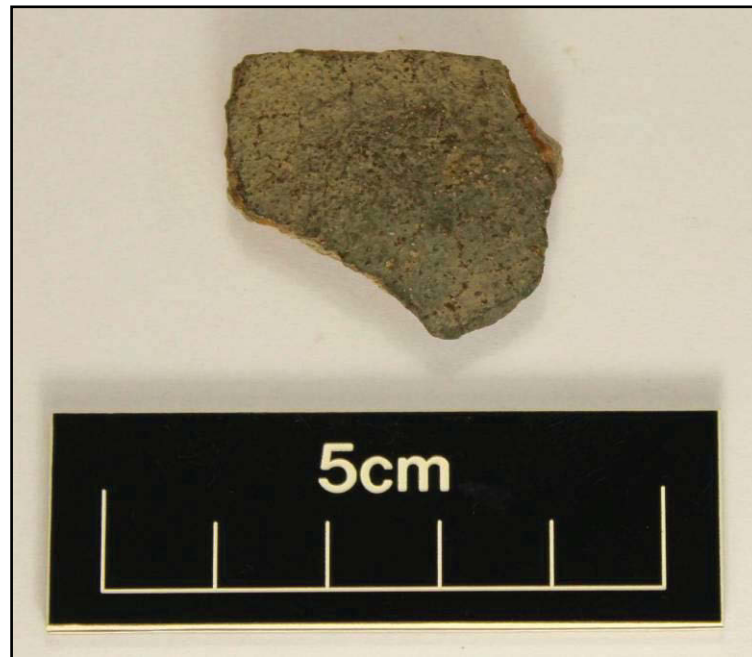
Figure 7: Gritty Ware.

One sherd was identified. There are many variations of gritty ware. The fabric of this sherd displayed a pale grey core with orange margins and dark grey surfaces. No decoration was present. Gritty ware vessels were the main cooking pots in York over their period of production.

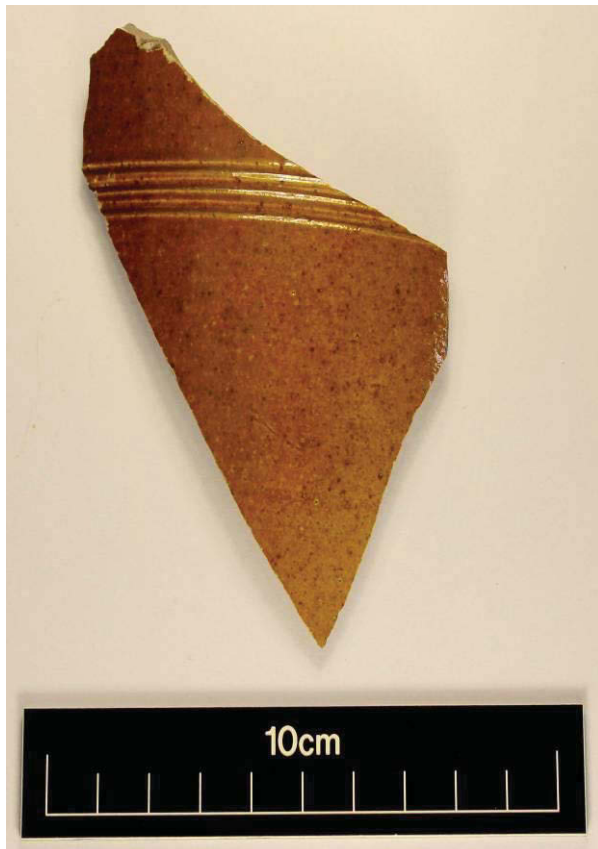
Figure 8: Mwk1.

One body sherd of this fabric was identified. This is a reduced grey wheelmade fabric with mica inclusions. It has thin white margins and an orange-brown glaze is present on both surfaces. Three narrow spaced, indented horizontal lines were present on the exterior as decoration.

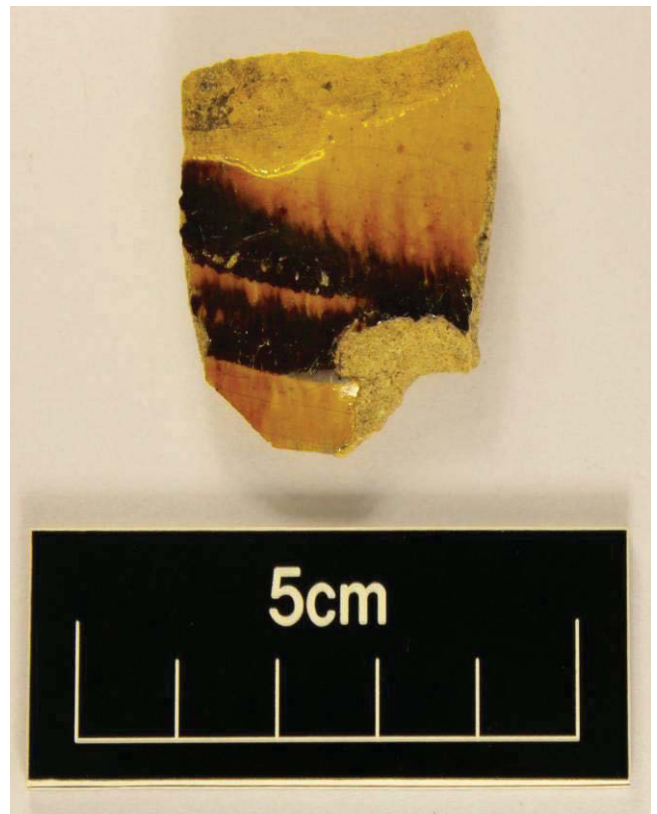
Figure 9: Sxwk1.

One body sherd of this fabric was identified. This is a pale cream wheelmade fabric. A creamy-yellow glaze is present on both surfaces. The exterior has the addition of decoration in the form of two horizontal lines in brown glaze.
