**Archaeological observation and recording on
land opposite 33 Easton Lane, Bozeat,
Northamptonshire, April 2014**

1 May 2014

Iain Soden BA MIfA

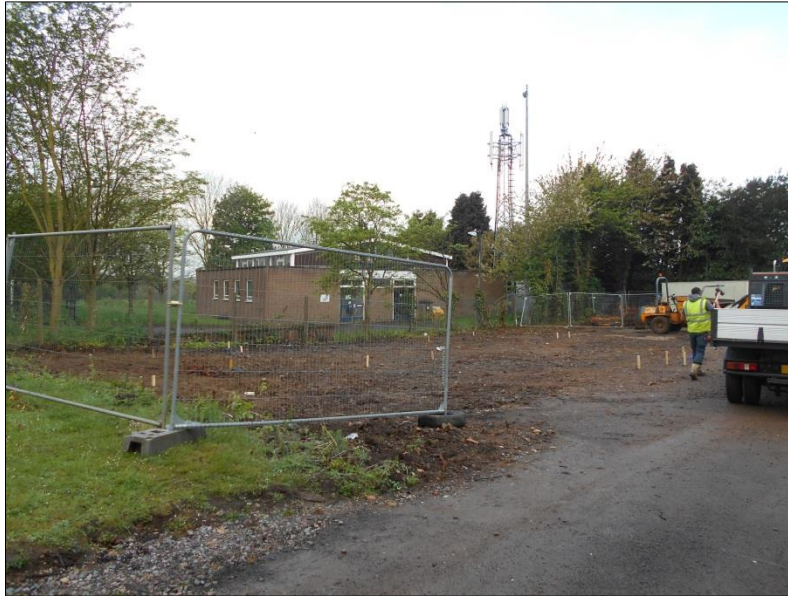
Fig 2: The site after the car park had been removed but before the house foundations were dug; looking north-west, telecom building beyond

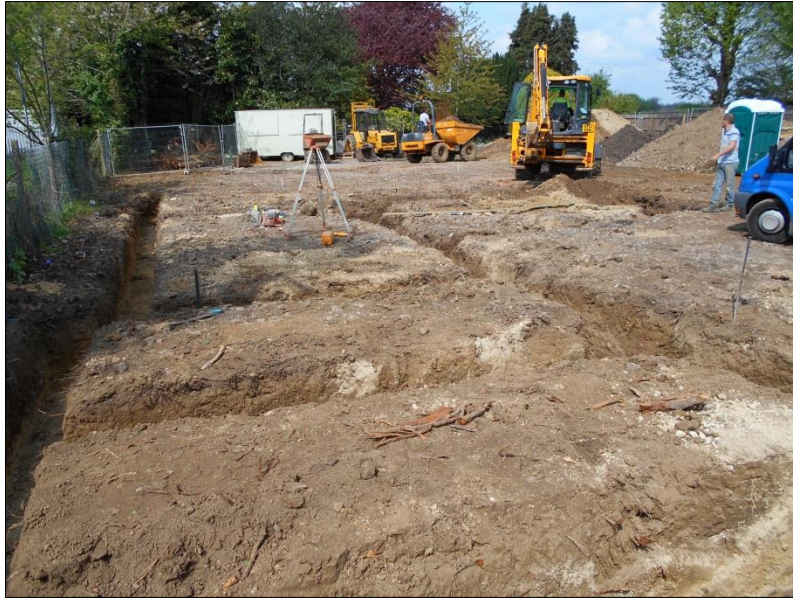
Following the clearance of dense brambles and other undergrowth, the former granite/stone car-park surface which had previously characterised the site was stripped off with a mechanical excavator, reducing the site levels down to the subsoil in places or deeper topsoil where a 10m-high, 15m-across wild cherry tree was cut down and removed; the house footprint was then marked out. The strip foundations were then dug using a 600mm-wide toothless bucket. These were reduced by up to 1.3m, well into the fractured limestone natural geology. An archaeological presence was maintained throughout.

Fig 3: The site reduced and with the foundation trenches dug; looking north, cemetery planting beyond

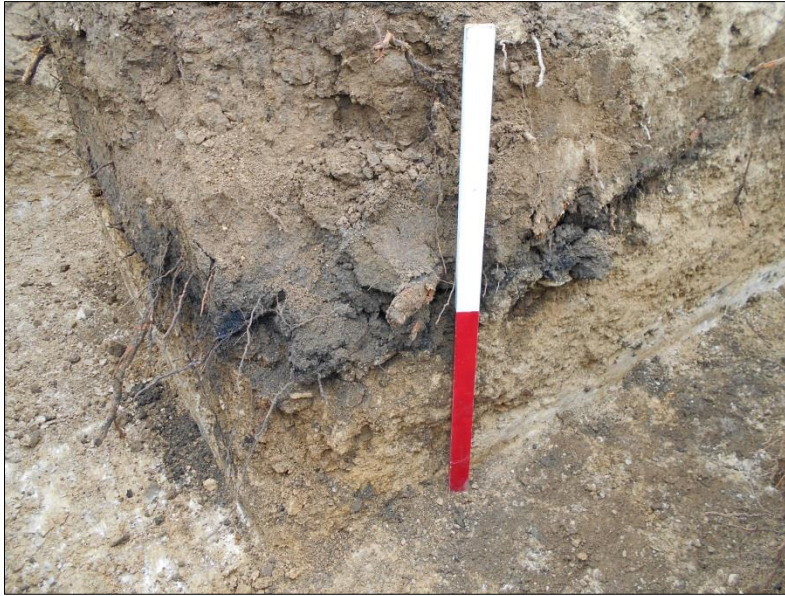
Fig 5: The ash deposit, here much infested with the fibrous roots of the nearby felled wild cherry tree; scale 1m

A sample totalling about 10 litres was taken of the ash (as much as could be scraped out from amongst roots and within the foundation trench), which was found to contain numerous charred and very damaged seed-grains from bread-wheat. A sub-sample of these were later extracted carefully by hand and retained in the archive for future potential study, in the event that new, nearby sites may provide a better context than this site possesses.

The dump of ash close to the roadside boundary is likely to be waste burnt after being left-over from agricultural processing in the vicinity. So close to the roadside hedge, it is not clear where the dump might have originated, possibly another plot altogether. The presence of brick fragments might suggest that the material later burnt was shovelled up from a slightly worn-out threshing floor. Since brick locally is unlikely to date earlier than the 18th century (limestone is ubiquitous hereabouts), such a floor might be very much later. There is also a possibility that the ash with bread-wheat represents the raking out of a nearby bread-oven. However, no evidence for such an oven was present.

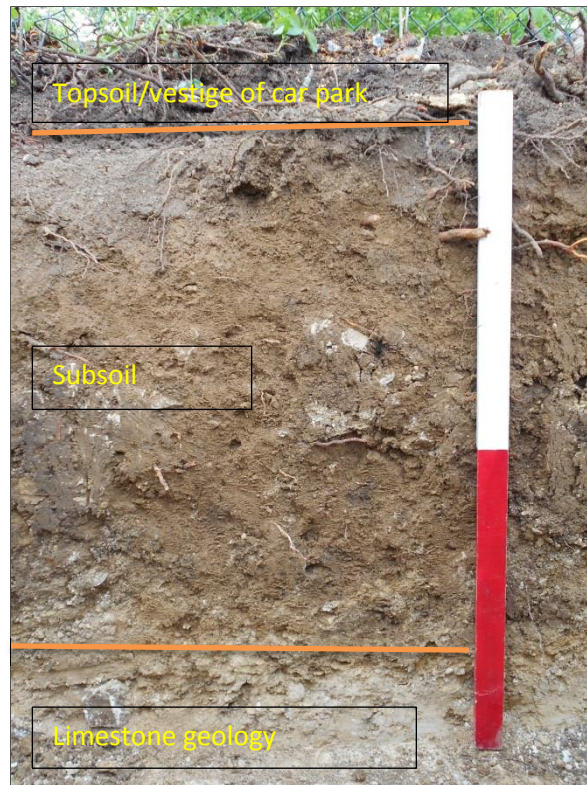
In places, the subsoil appeared to be as thick above, as it was below the ash, although the disturbance by the tree and by its removal reduced the clarity of the recording the closer to the tree the ash lay. However, at the base of the subsoil the natural limestone's very flat surface was featureless throughout. It was viewed in plan during machining and later also the sections were inspected, revealing no features, layers or any sign of previous occupation or archaeological activity.

Fig 6: Typical section following cleaning. Note here the 800mm thickness of the subsoil; scale 1m
