An Archaeological Evaluation at Bilton Grange School Walled Garden

An archaeological Evaluation at Bilton Grange School Walled Garden

Iain Soden BA MIfA and Dr Michael Dawson FSA MIfA (CgMs)

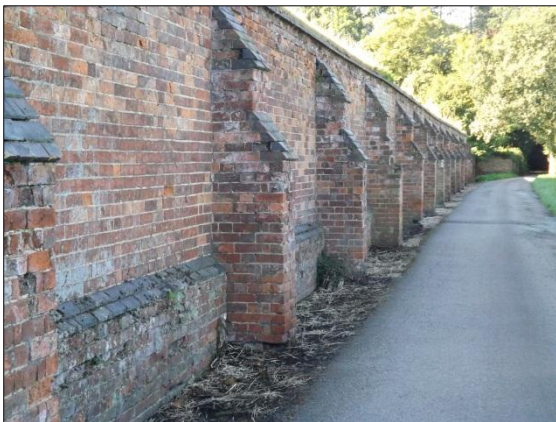
The wall encloses the garden on all four sides, forming a rectangle. It has a plain interior face, while on the exterior north-east, north-west and south-east sides it is heavily buttressed. A large double gateway stands at the midpoint of each side, but for the south-west where it has been largely removed. A pedestrian doorway stands in the wall at the west end of each of the short ends of the garden. Details and coping are picked out using Staffordshire blue engineering bricks. The whole is cemented with a creamy white clean lime mortar. The south-west wall once supported a row of heated greenhouses on the outside; of which only the foundations and the dilapidated stub-walls of a boiler house now survive.

The heavily-buttressed north-west wall

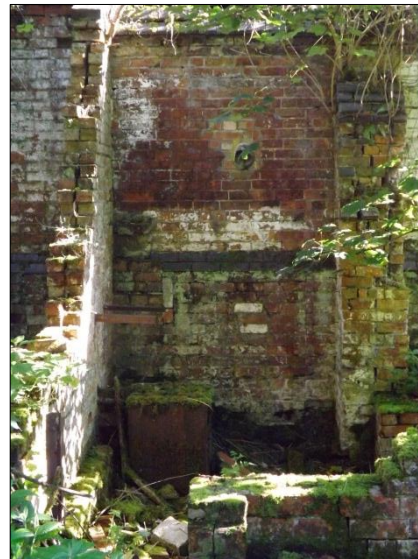
Ruined boiler house on south-west wall

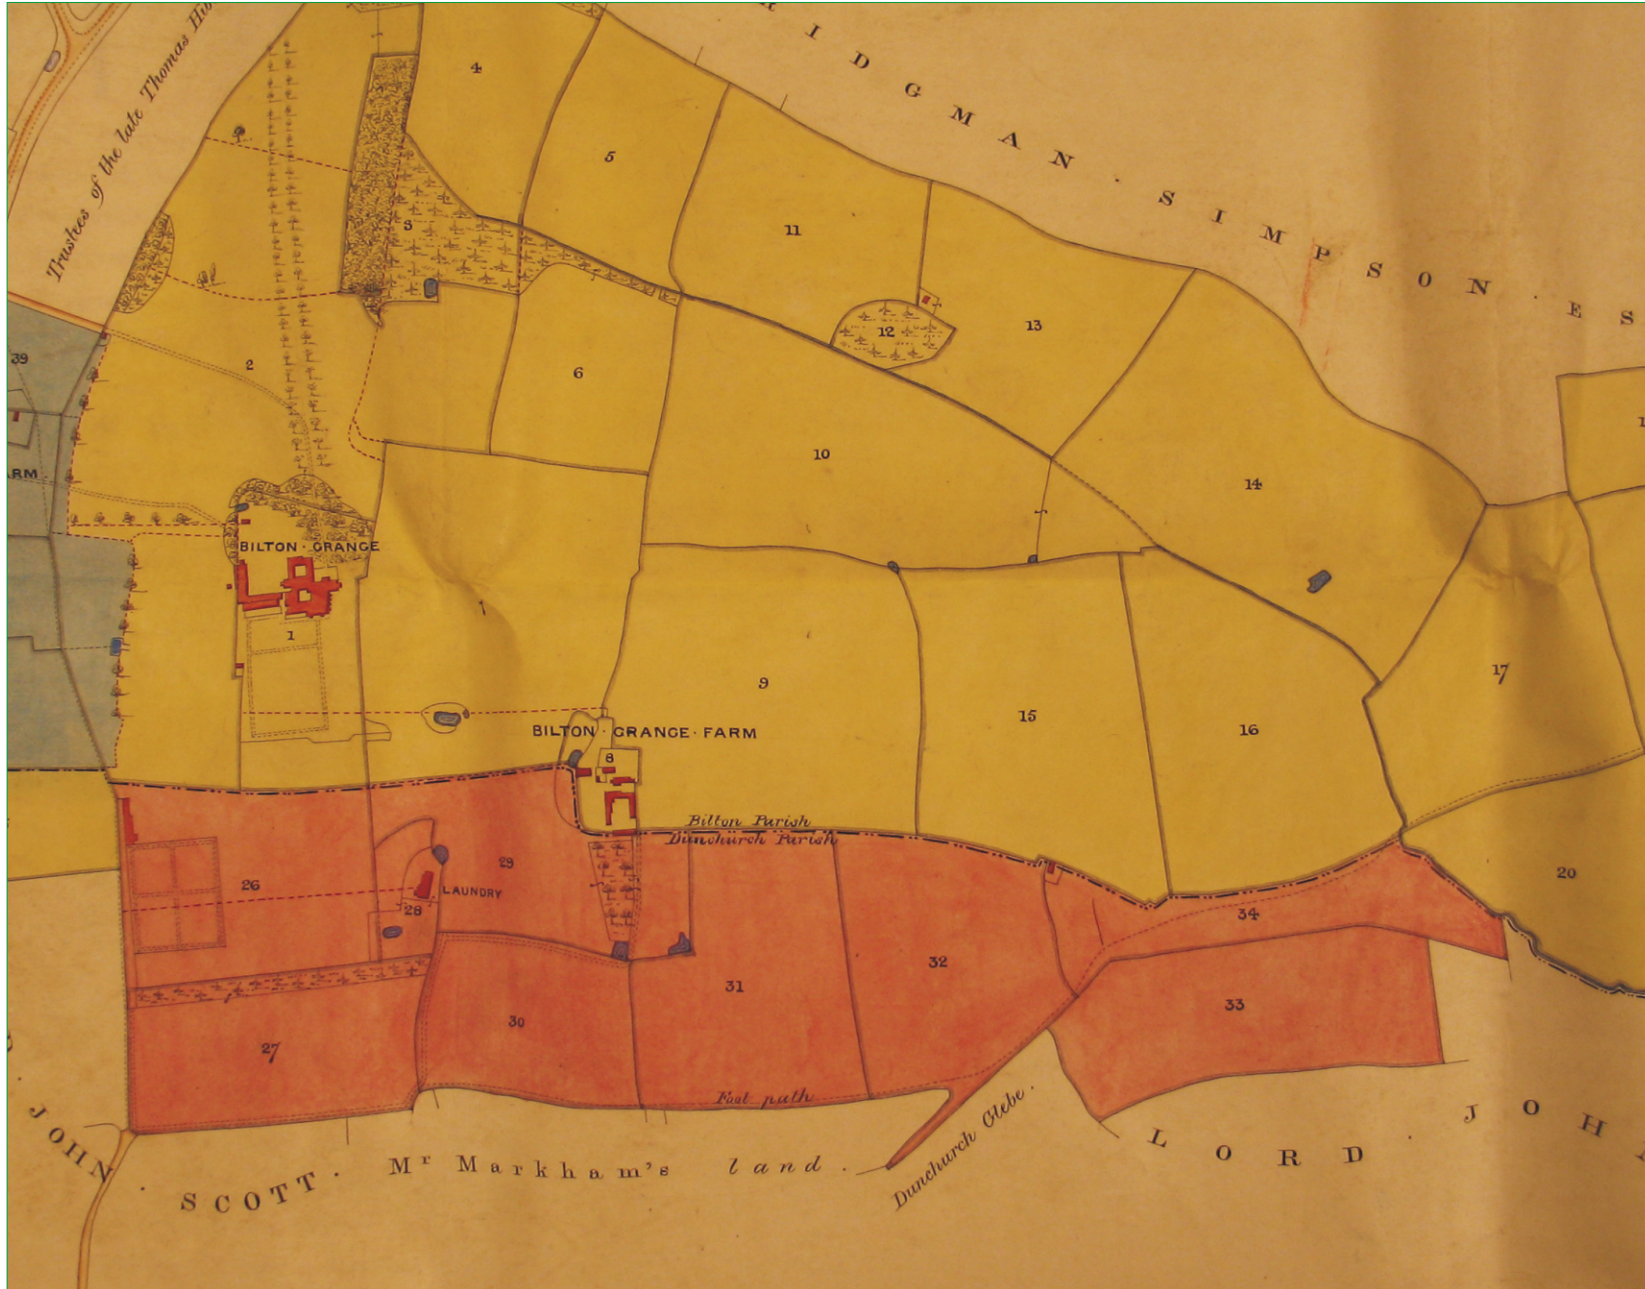
Figure 3:
Bilton Grange
Indenture 1855

The summary and conclusion of the test pit evaluation is that the surviving archaeological evidence comprises the insubstantial remains of the basal layers of four paths which quartered the walled garden. The paths, also identifiable as parch marks on aerial photographs from the early 21st century, were laid out in a similar pattern to that first illustrated on an indenture of property belonging to Captain Hibbert in 1855 (Fig 3). This pattern was subsequently illustrated in 1861 on the sale catalogue of the Bilton Grange Estate (Fig 4). The pattern of paths on both the indenture and sale catalogue show the simple cruciform layout, though the early plan does not show the central pond and the indenture appears to show paths flanking the enclosing walls.

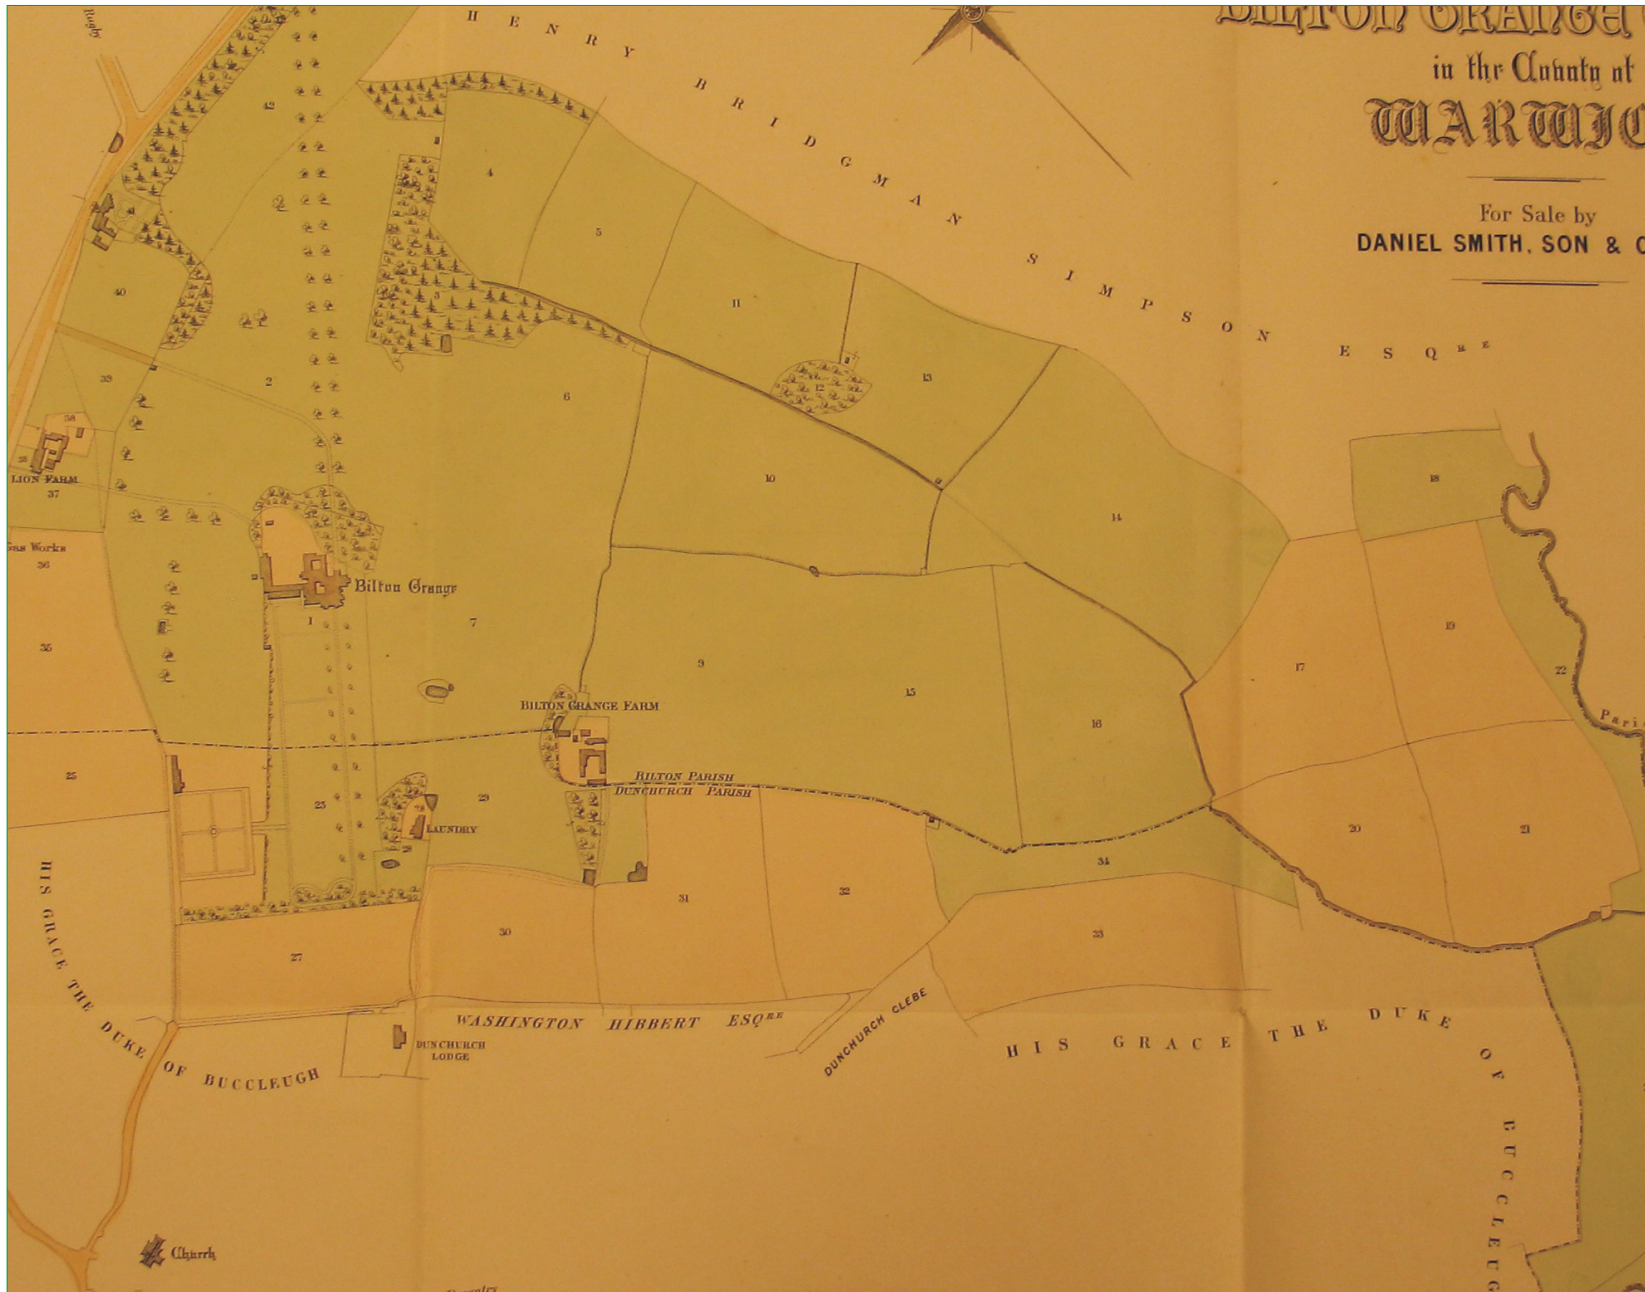
Figure 4:
Bilton Grange
Sale Plan 1861

“The kitchen garden containing about 2 acres is enclosed on every side by a substantial 10ft brick wall with buttresses and coping and has 4 entrances through solid oak doors with a gothic arch at each. It is intersected by broad asphalt¹ walks and in the centre is a large reservoir into which the garden is drained, affording a constant supply of soft water. There are outer slips on three sides with a melon ground, a winter house and a small vinery. The walls are covered throughout with the choicest fruit trees, beautifully trained and in full vigour. The gardeners house; adjoining is a very substantial building of ornamental character, with stone dressings, and in keeping with the mansion.”

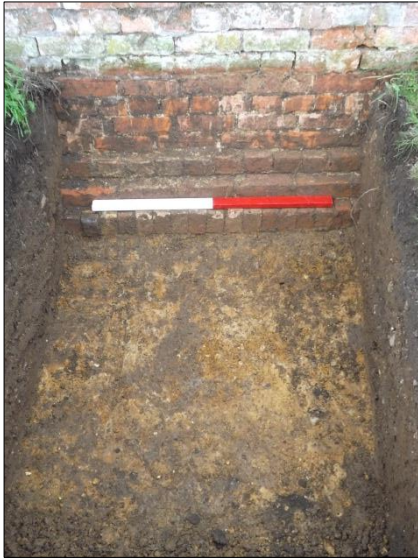
The wall at the south-west side stands (c9.68 feet) c2.95m above the interior ground surface (where counted on the west wall -clear of ivy- this equated to 41 courses). Where Test Pit 1 was dug there were five courses of walling brick below ground on three offset courses (Fig 2 and Photo Appendix, below).

The south-western end of the trench was formed by the foundation of the garden brick perimeter wall (4). This stood upon three successive brick offsets. The uppermost offset comprised a course of headers, the middle one was a course of stretchers and the base offset was a row of bricks laid on edge. All were of the same brick type as the wall superstructure, but for two yellow-stock bricks within the base offset. At this lowest offset the wall must be at least 7 bricks thick, and up to 10 bricks thick if the arrangement is mirrored exactly at depth on the garden exterior.

Test Pit 1, looking south-west.

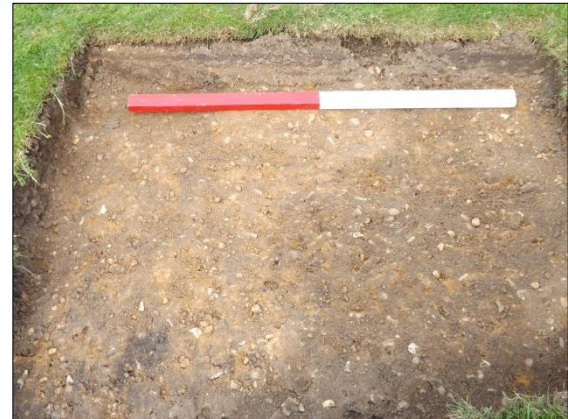
In a further two test pits, 4 and 10, the survival of the truncated base of gravel paths to the gates in the long sides of the garden was confirmed, in both cases directly below the turf. Both test pits measured 1.2m x 1.2m in plan. Neither was extended although one located an edge to the eastern path, a location and alignment which indicates the path was approximately the width of the eastern gateway. For record photos of the sequence see Photo Appendix, below.

Test Pit 4, looking north-east

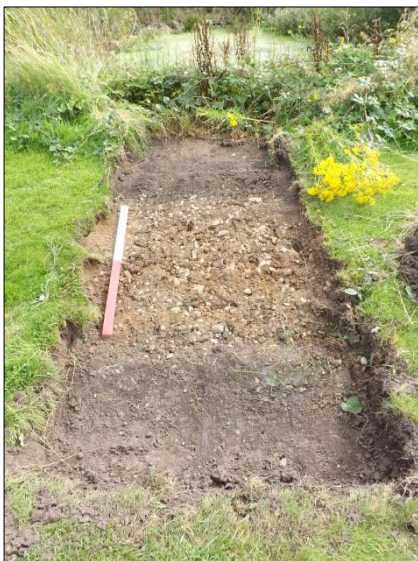
Directly beneath the turf was exposed the heavily truncated base of a 1.7m-wide sand and gravel path (5) concentric upon the central pond. The pond-facing edge was lined with a sloping glacis of tarmac to prevent gravel spreading towards the pond edge. The opposite edge had also apparently been formed of tarmac but this had degraded. Topsoil (1) lay beyond the edges of the path base on both sides. The path had no wearing-course or top-dressing of gravel. The latter may have been lost c1990 when the garden was turned into the archery ground which survives today.

Test Pit 6, looking south-east to pond

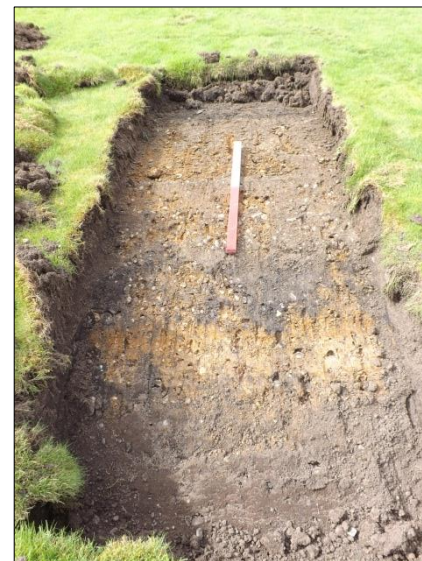
Dug mid-way between the pond and the gate in the north-east wall, this test pit measured 3.5m long x 1.2m wide. Like test pit 6 it exposed the base of a former gravel path (5), this time 2.4m wide, with scattered former edges of tarmac, largely now lost. To either side lay dark grey loamy topsoil (1). Hereabouts the path retained a camber which is still visible as a low earthwork across the garden. The top dressing, assumed for the path, had not survived in this area.

Test Pit 7, looking north-west

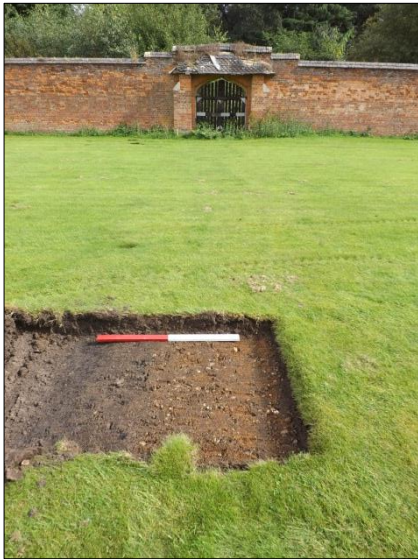
Test Pit 10, showing path to SE gate

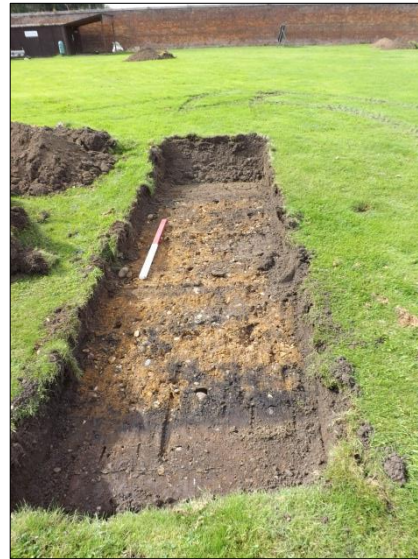
Here too lay the basal remains of a gravel path (5), once edged in tarmac, the whole having been largely scraped away and having lost its gravel top-dressing. Dark grey loamy topsoil (1) lay to either side. The path here had been 2.6m wide, was slightly cambered, and its remains lay approximately 100mm below the turf. The modern ground surface here lies at 121.185m above OD.

Test Pit 12, looking north-west

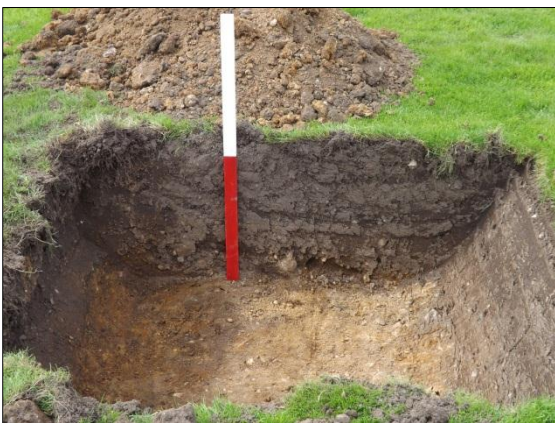
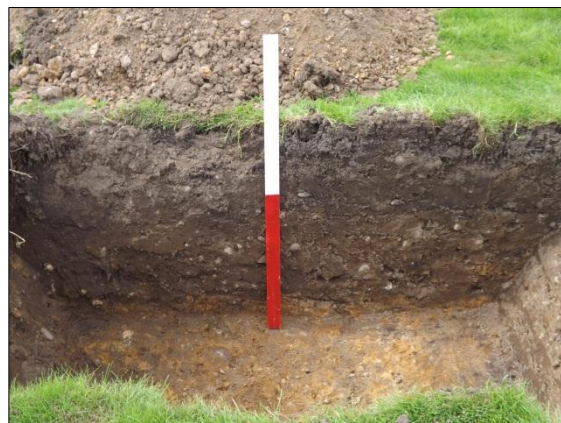
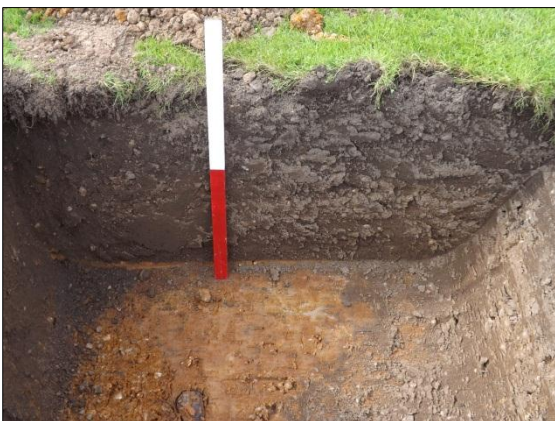
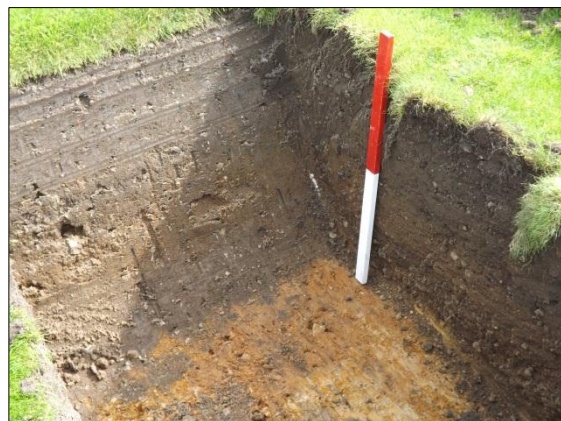
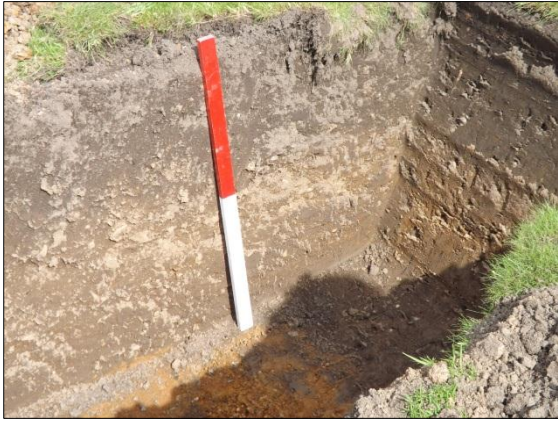
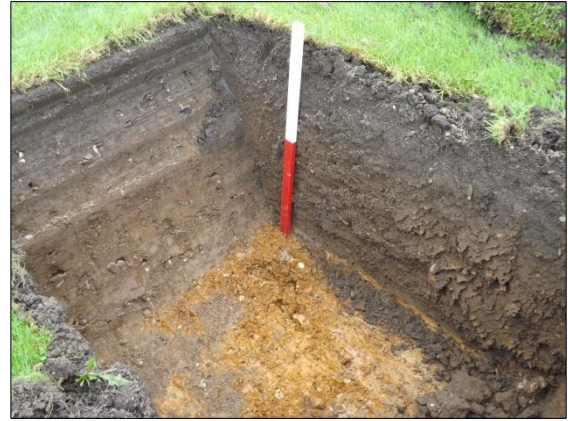
Record photographs containing only the soil build-up (For locations see Fig 1)

In the six remaining pits no structural remains of the garden were encountered. In each of these test pits the sequence present was loamy topsoil (1) over thick subsoil (2), down to the natural substrate (3). The thicknesses and overall depths varied considerably but this was the simple horticultural tilth of the garden. The results of these test pits, negative in that they contained no garden structure, are
