**Recording the central pond at Bilton Grange
walled garden**

2 September 2014

Bilton Grange walled garden – the central pond

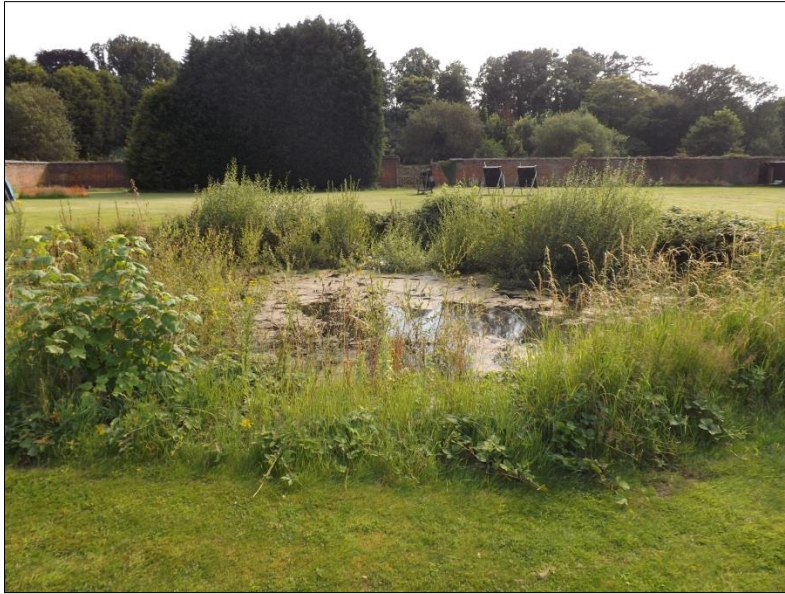
Fig 1: The central pond, overflowing in 2012; surroundings overgrown

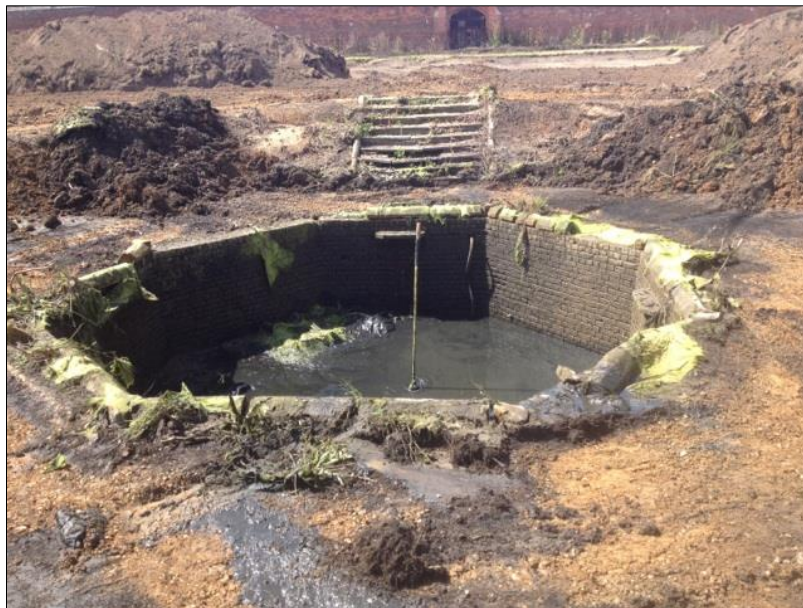
Fig 2: The pond and the best-preserved (north) set of steps, during earthmoving, 2014

The sunken area around the pond had originally been served probably by four sets of eight or nine steps (of which three had mostly survived), built of brick with projecting bull-nosed stone treads. Side kerbs followed the 45-degree angle of each flight, into which the ends of the treads had been scribed to hold them in place. The steps lay at the end of four paths aligned on the points of the compass which can be seen on all maps from 1855 onwards.

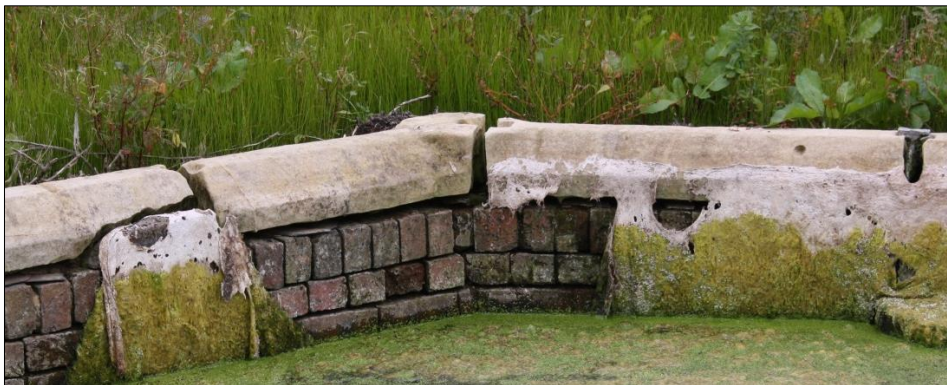
Fig 4: Stone kerb with sockets for uprights; possibly indicating a former rail, note the uppermost course of brick laid on edge

edged the top of the whole structure. The kerb may once have supported a railing, since there were sockets for uprights at intervals. There was no sign of the railing otherwise.

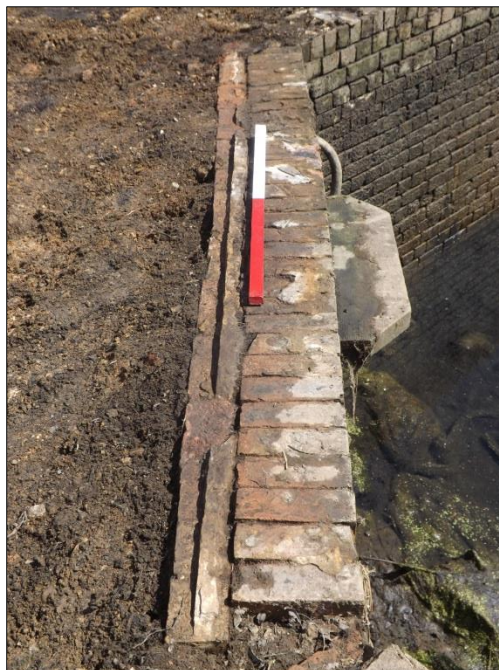
Fig 5: Kerb removed during pumping, to reveal the uppermost course of bricks and the kerb-support-line of bricks behind, otherwise unseen; scale 1m

It was 1.98m deep, lined with 22 courses of brick in alternating courses of headers and stretchers (English bond), using the same brick-type from which the garden wall was created. A top-most course was added laid on edge, while a third line was laid behind this, to support a stone kerb which

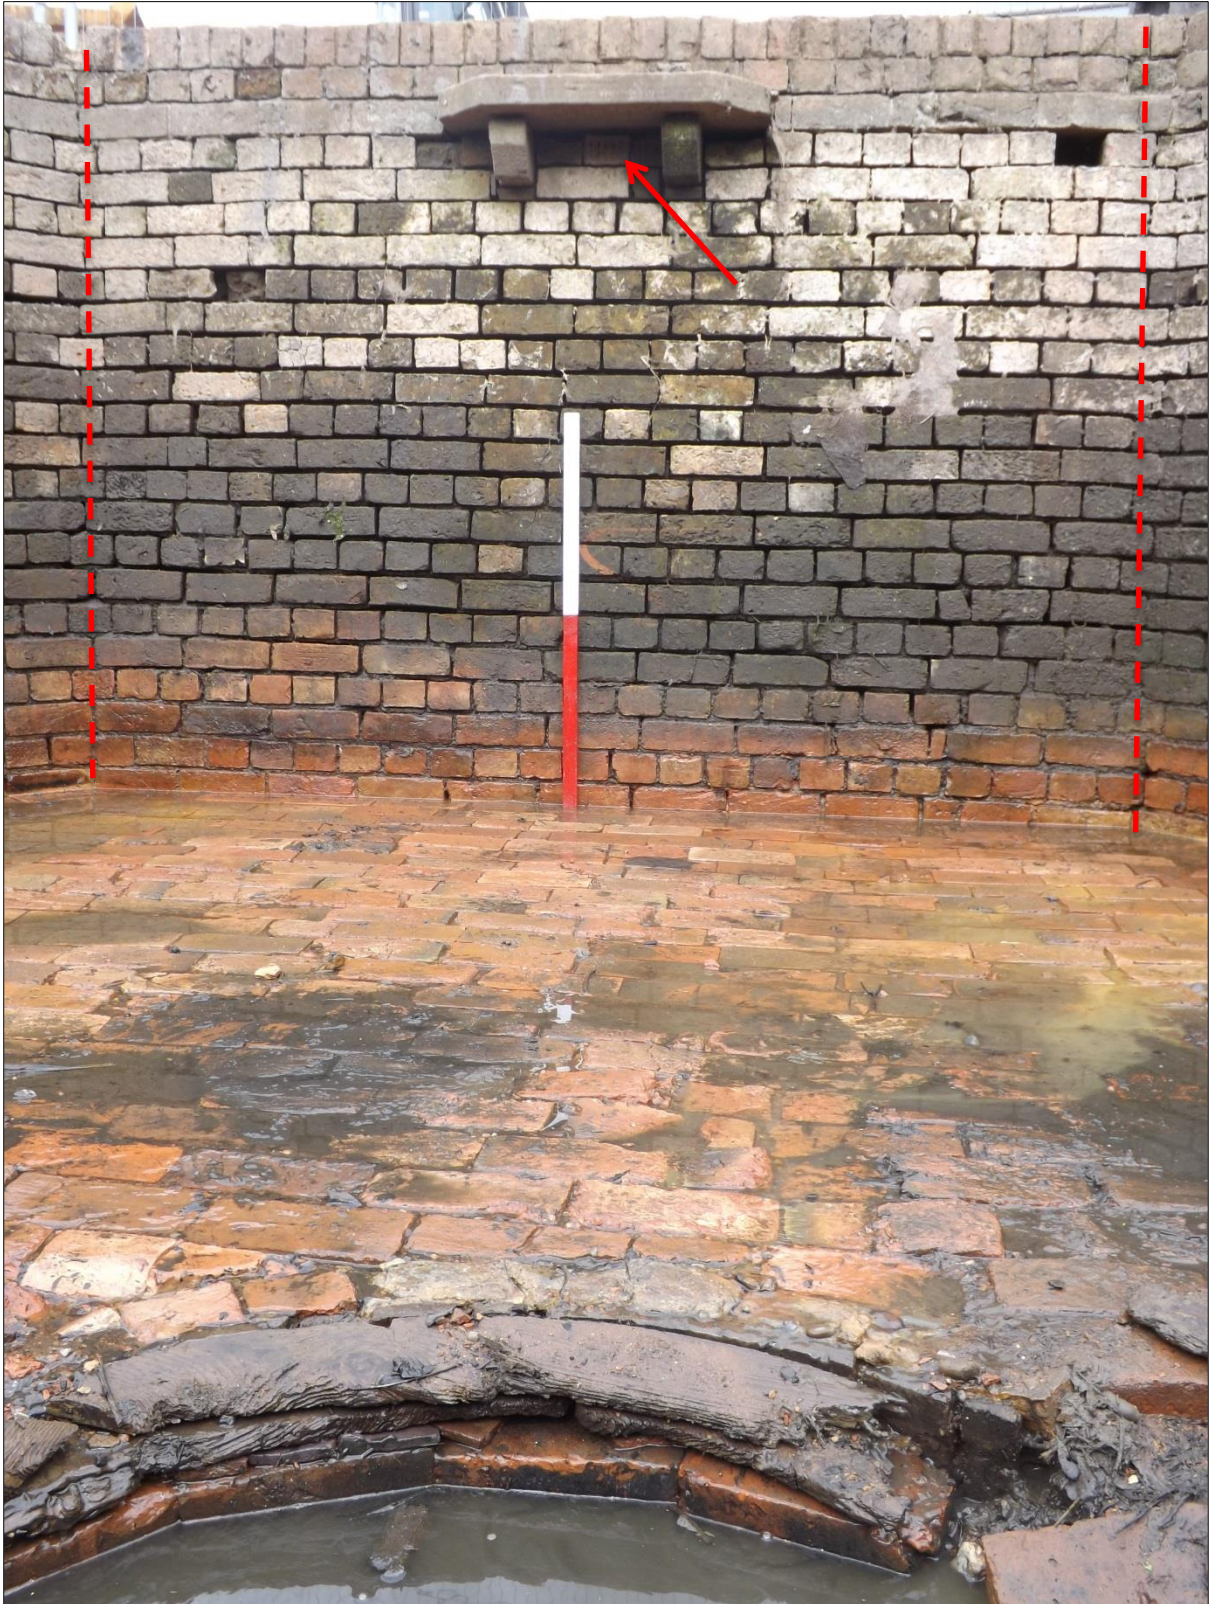
Fig 6: View from the centre of the pond, timber-lined and timber-topped well in foreground; one side of the octagon is marked (red dashes), drainage grille arrowed; scale 1m

Each of the four sides which lay beneath the foot of the steps also had a cantilevered stone ledge built into the upper portion of the lining. Hidden from view underneath each lay the iron drainage grille mentioned above. The stone ledges may once have been stands for water-loving plants, but also hid the exits to the drains.

The base of the pond was of brick. At its centre was a 1.5m-diameter circular well, lined in brick but with a circle of barrel-type timber staves behind this lining. The edge of this 1.8m-deep well was surmounted by a fitted, curved edge of three superimposed cut planks. Although these had probably been fixed tightly together in a laminate, these had sprung apart and were partly dislodged when viewed.

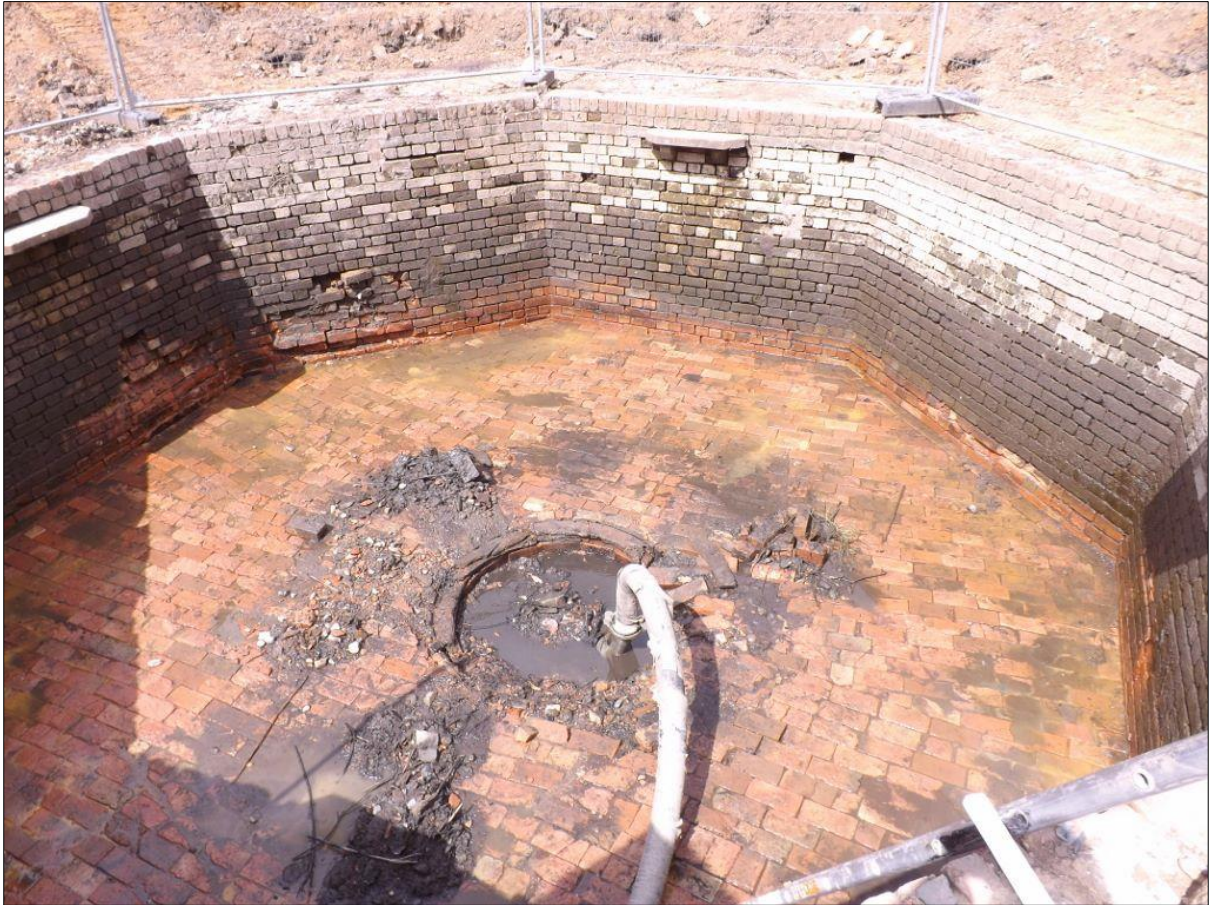
Fig 7: The pond, fully pumped out. The central well was augured and found to be 1.8m deep.

Whilst the steps and the former topsoils of the garden were removed, the existing slope down to the pond was machine-smoothed into a batter. The stone kerbs were also removed, leaving the pond itself, which was filled in prior to the laying of the all-weather sports pitch.
