An archaeological evaluation on the garden plot of the
former 10 O'Clock Public House, 42 Main Street,
Little Harrowden, Northamptonshire

Summary

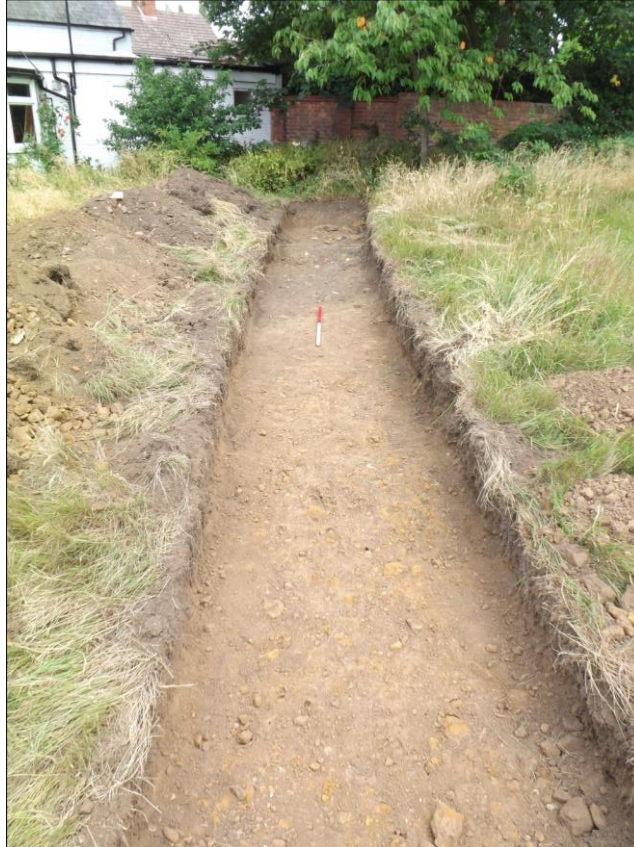
Trench 1 contained a large pit (at 90.54m aOD) from the surface of which spilled quantities of Victorian –early 20th century pottery, bottle glass, tile, clay tobacco pipe fragments, 12-bore cartridge cases and other well-dated detritus. This was sufficiently close to the back of the former Public House to be associated with its use during the first half of the 20th century. No further excavation was undertaken on this well-dated feature. Finds were not retrieved.

Fig 3: Trench 1, looking north-east; scale 1m. The large modern pit is in the background, just beyond the scale

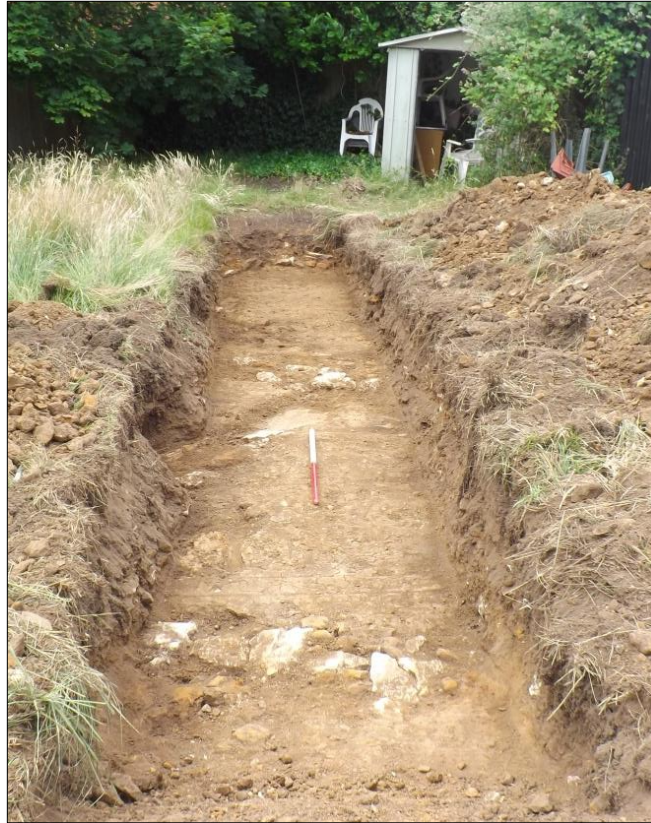
Trench 2 contained a layer or hardstanding of crushed ironstone and the occasional piece of limestone, directly at the base of the topsoil. This was undated and machining continued through it to expose a configuration of stone-lined drains directly beneath, set into the natural geology (90.16-90.26m aOD).

Fig 4: Trench 2 looking south-west; scale 1m. Drains criss-cross the trench

The drains were generally constructed of rough-hewn blocks of Northampton Sand with ironstone, with the occasional block of limestone. They were capped with flat blocks of limestone, and one or two pieces of probable Collyweston tile-stones.

Early post-medieval stone-built drains survive under a possible hardstanding or floor at the south end of the plot (Trench 2). These may lie beneath a building or under a courtyard adjacent to a building. Other than higher-status buildings, such drainage was usually only provided in the case of industrial needs (with no such evidence here) or expensive ancillary structures, such as stables (since horses were more prized than all other stock). While no clear identification is currently possible, the proximity of the medieval manor house facilitates a tentative manorial function as an interpretation for these drains. The stony layer encountered above them may be a courtyard/hardstanding or an internal floor; in this respect the evidence is equivocal.

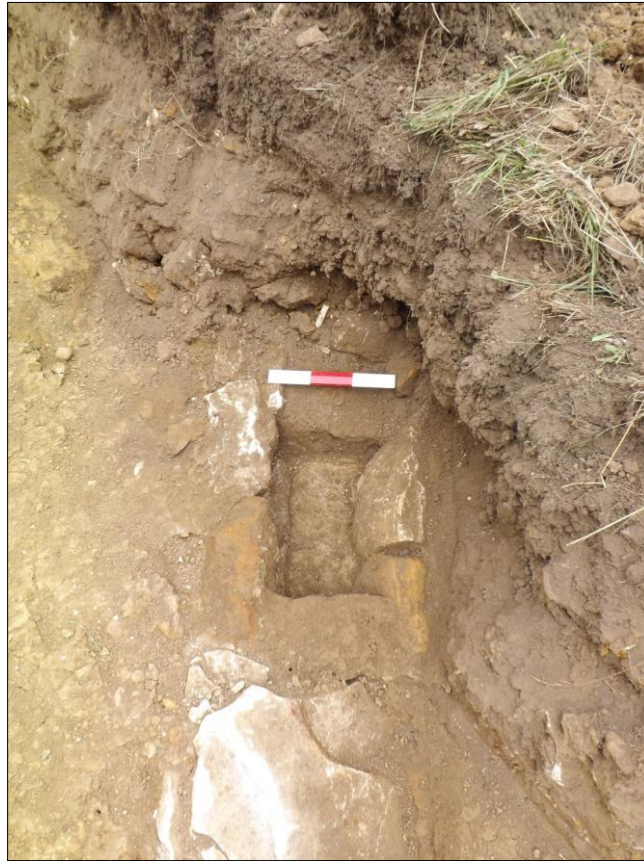
Fig 5: Trench 2, Drain 6, cap removed and contents sectioned, looking north-east; scale 300mm

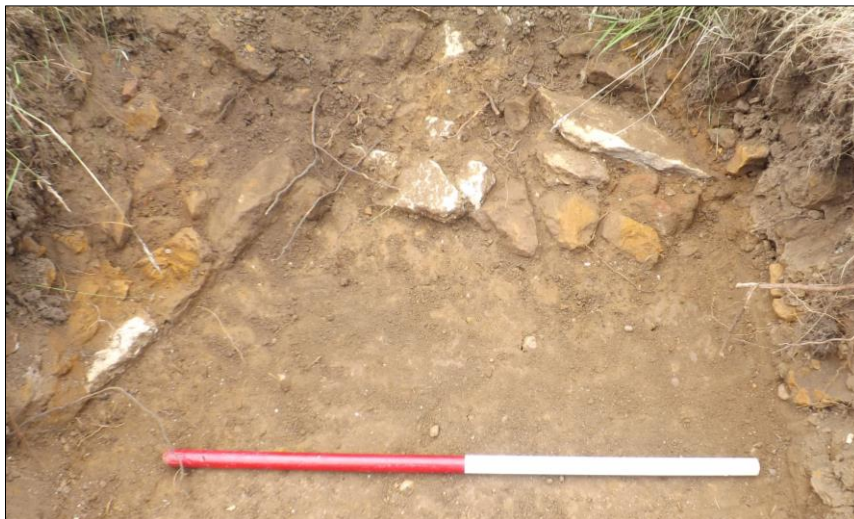
At the south end of the trench lay a right-angled alignment of stonework which may be another drain, but also has the characteristics to have been the corner of a building (Fig 6).

Fig 6: Trench 2, Feature 5, looking south. This may be the corner of a building; scale 1m

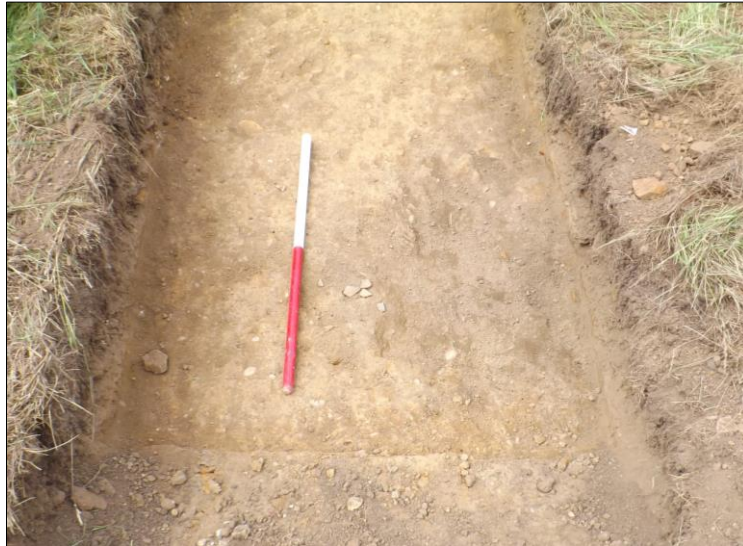
Trench 3 contained a modern land drain at one end, with a single 1m-diameter pit part-exposed at the other (8; Fig 7). The surface of this pit spilled out 21 sherds (220g) of Shelly Coarseware medieval pottery, roughly dated between c1200 and 1500. Since it was so well dated by this abundance of pottery, it was not further investigated. It lies at 90.42m aOD.

Fig 7: Trench 3, pit 8, looking west; scale 1m

The evaluation has shown that medieval remains in the form of a single pit survive within the south-west part of the former garden (Trench 3). Such remains may otherwise be sparse.

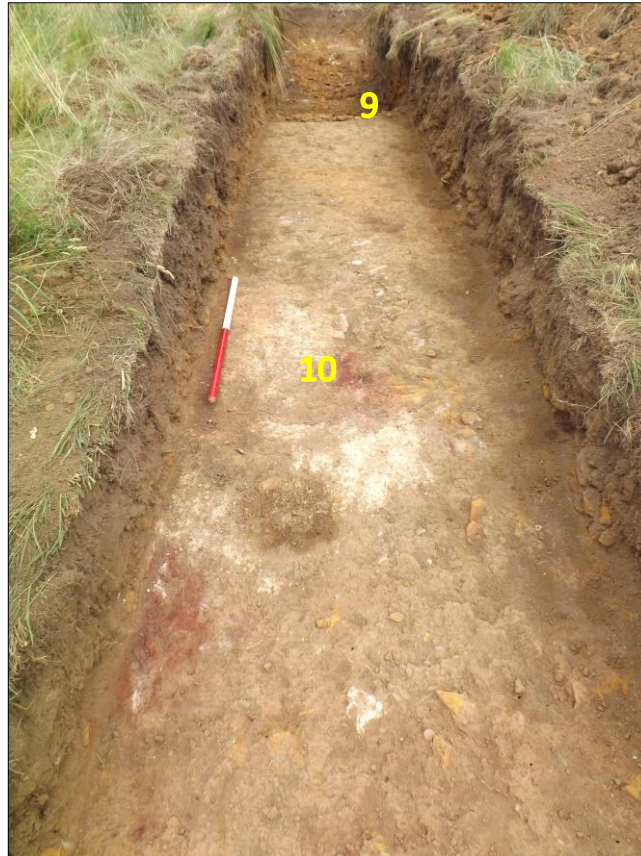
Trench 4 contained a substantial disturbance into the natural geology, with one edge apparent in the trench (9). This was sampled using the machine, and within a matrix of shattered ironstone fragments was a single large sherd from the base of a Midland Blackware Tyg (an upright tankard) of the 17th-early 18th century. This disturbance was tested to a depth of c1.4m but not bottomed. It is considered to be a post-medieval or later quarry pit, its surface at 90.37m aOD (Fig 8).

Nearby was an admixture of clays and ironstone pieces, some scorched red (but not burnt *in situ*), together with spreads of mortar, which are believed to be the backfill of a second such quarry pit at 90.57m aOD(10; Fig 8). From close to the edge was derived a broken, square copper alloy buckle of post-medieval form, with iron pin. It was not further investigated.

Fig 8: Trench 4, looking east. Quarry pit [9] in distance; surface of another [10] closer to camera; scale 1m. A ridge of natural geology survived between them.

18th- 19th-century quarry pits and a 19th-20th-century rubbish pit comprise the only features in the north-eastern half of the site (Trenches 1 and 4).
