**A programme of archaeological observation and
recording on land at Hinton-in-the-Hedges,
Northamptonshire**

Hinton-in-the-Hedges

A programme of archaeological observation and recording on land at Hinton-in-the-Hedges, Northamptonshire

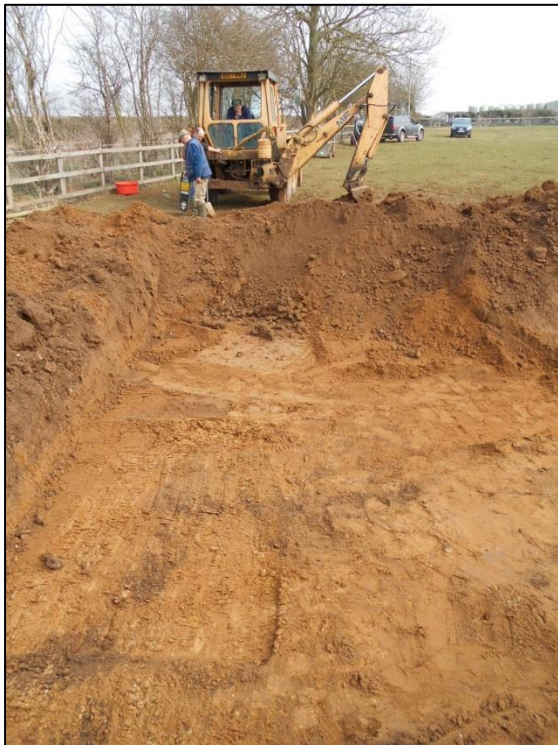
Fig 3: During mechanical stripping looking east

An area of some 120 sq m was stripped of topsoil using a wide toothless ditching bucket. There was no subsoil present and the relatively thin topsoil (an average of 150mm thickness) lay directly on top of the natural geology, which was soft free-draining orange sand. The soil overburden was thicker (up to 400mm) where a former imported soil bund had previously been removed, and its remnants survived.

No cut or upstanding features were present and no finds of any date or description were forthcoming.

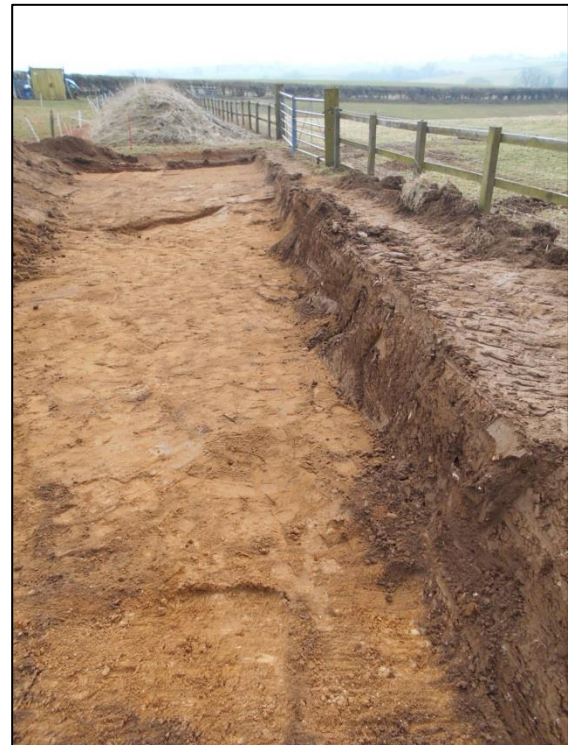
Fig 4: During mechanical stripping looking south; part of soil bund beyond
