**Level 2 Building recording on part of Stanwick
Hall Farm Barns, Northamptonshire**

September 2013

Level 2 Building recording on part of Stanwick Hall Farm Barns, Northamptonshire

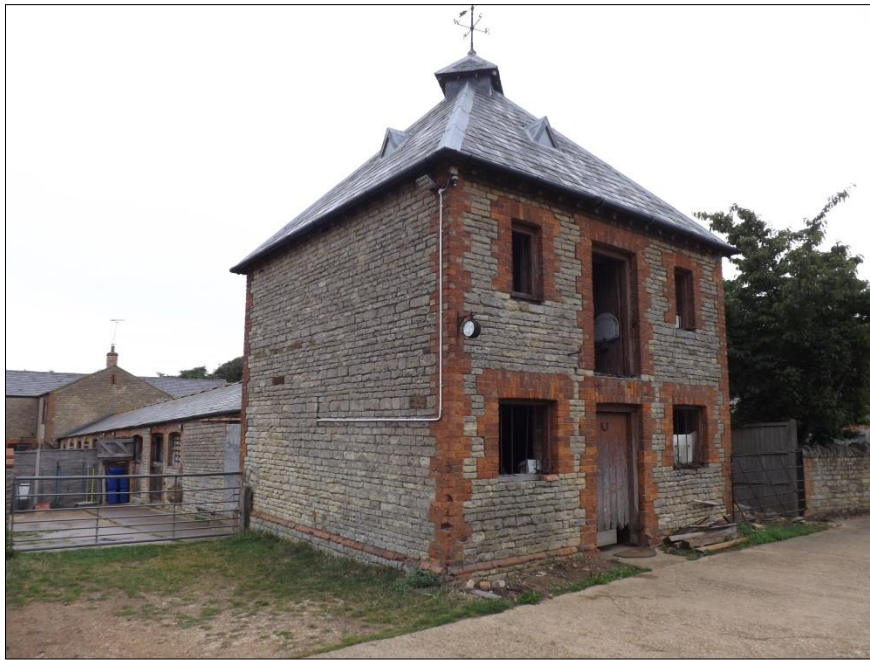
Fig 4: The buildings, from the south-west

The front building is of two storeys under a hipped roof with a lead-sheathed timber cupola supporting a weather-vane (Fig 4). It is known as 'The dovecote'. To the north lies a single-storey range of stables, coterminous with other such buildings beyond (Figs 4 and 5). These adjacent buildings beyond the current site were not accessed.

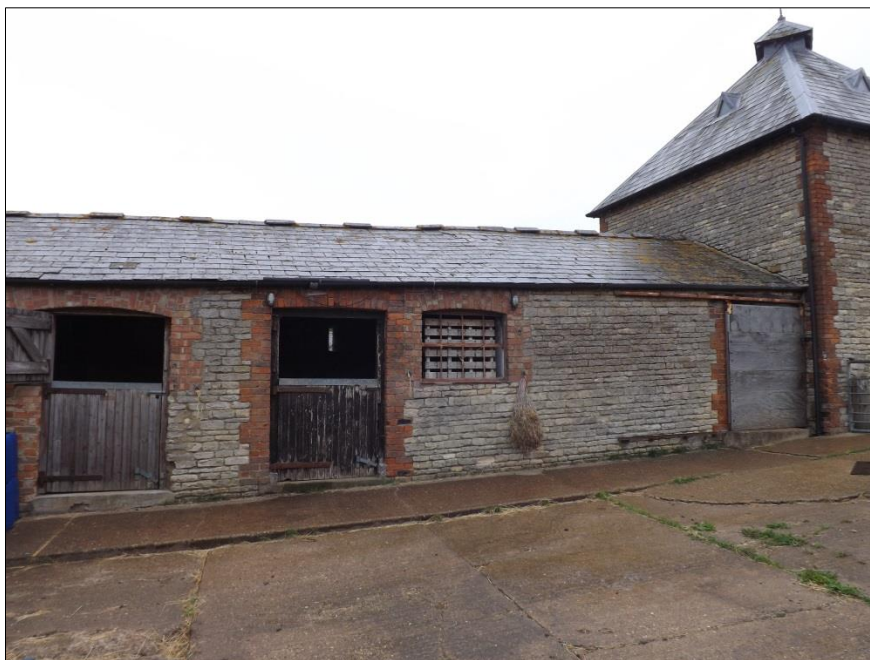
Fig 5: The buildings from the north-west (formerly the western stock yard, now stable yard)

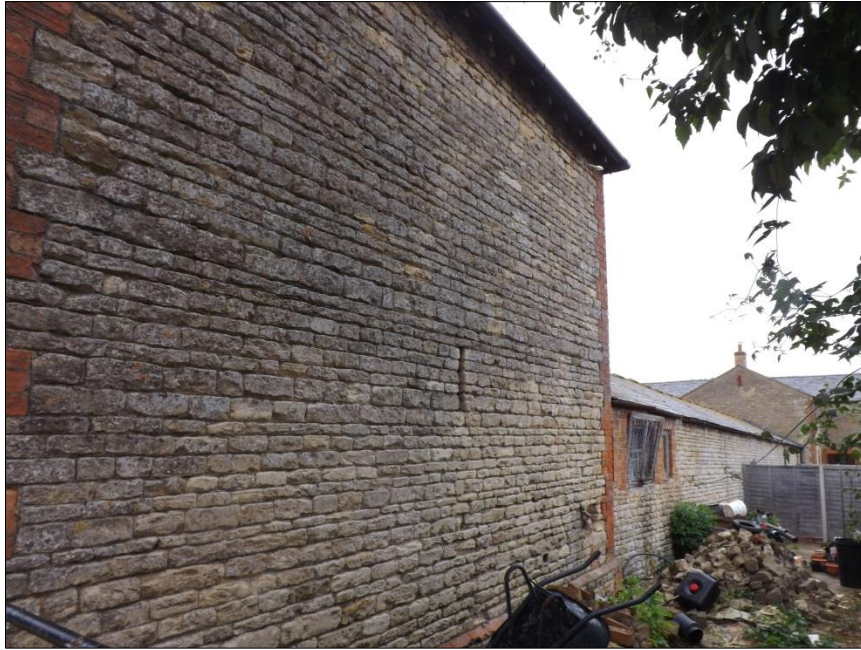
Fig 6: the almost inaccessible east side (formerly the eastern stock yard)

The main structure of this building is of one phase, the original work of between 1838 and 1885, and in all probability 1852-85 (Fig 3). It is furnished with a central, south-facing door on both storeys, each flanked by a pair of matching windows, slightly smaller on the upper storey. Woodwork is painted in a maroon livery. The windows are barred for security on both storeys. The east and west faces of the ground floor room are each provided with a ventilation slit high up in the wall (Figs 4 and 6).

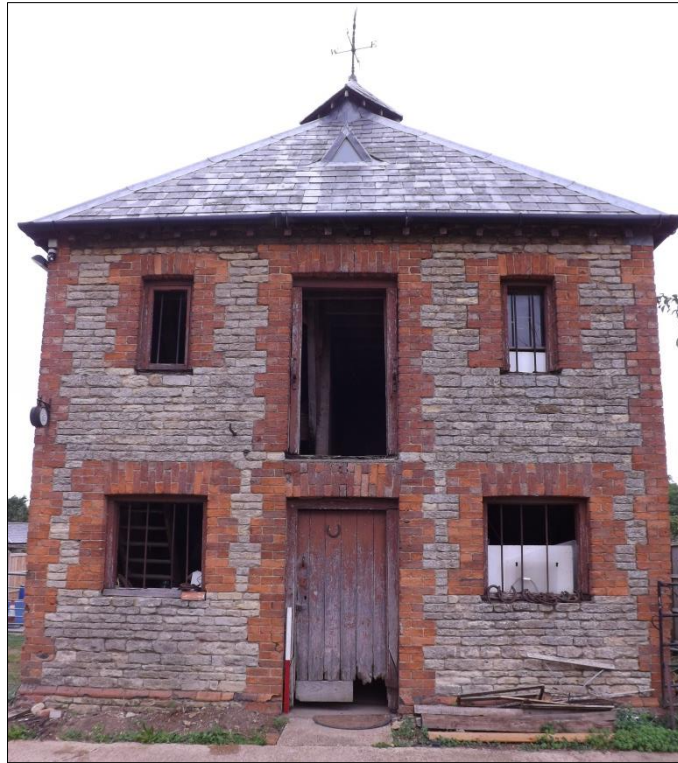
Fig 7: The so-called dovecote, front (south) face; scale 1m

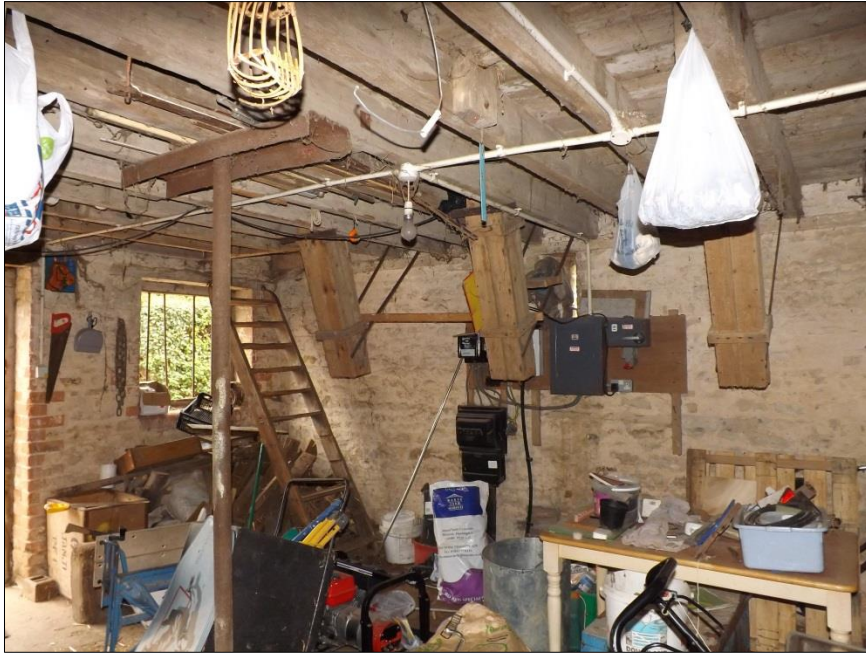
Headroom on the west side is interrupted by three downward-pointing timber chutes, each braced with iron straps (Fig 8). These have been put through the ceiling from the room above where later feed hoppers make for a huge loading on the floor, braced by a single iron strut from floor to ceiling (Fig 8).

Fig 8: Ground floor interior, looking south-west towards the ladder access; note the three chutes, strapping and the iron ceiling strut

simple timber frame inserted into the room and their additional weight, when in use, was taken by the iron support for the joists below (Fig 8). The roof above was not accessible, as it was provided with only partial boarding. A view up to the cupola underside was possible for photographic purposes (Fig 11).

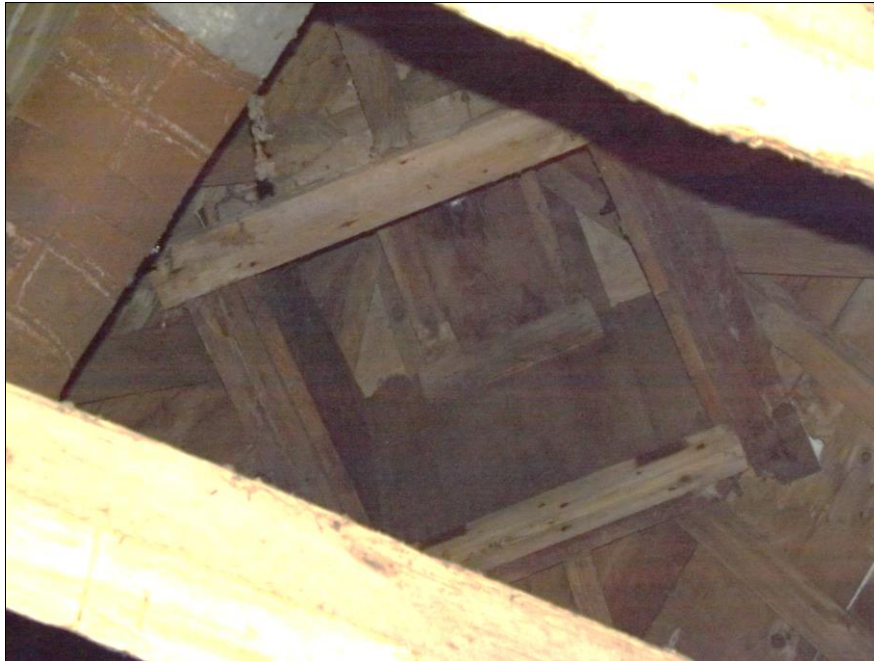
Fig 11: View through the second storey ceiling joists to the underside of the cupola
(brightness enhanced, contrast reduced)

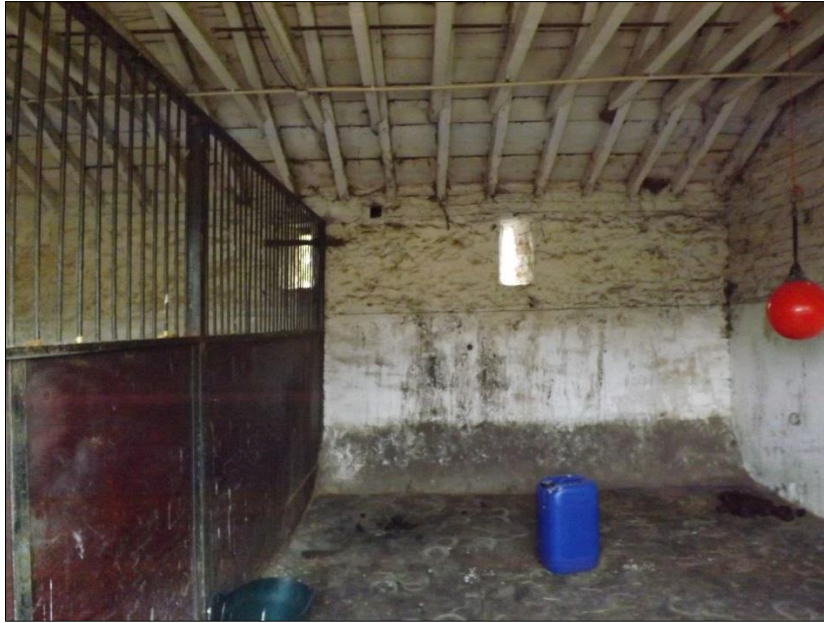
There are currently two stalls, to which only the more southerly has an original doorway. The brick jambs of its northern counterpart's doorway have been partly rebuilt using Fletton bricks. They are separated by a steel partition (Fig 11). No early travis or hay-racks, troughs etc survive. Their east-facing lighting is by a ventilation-slit only. A larger window in the west wall is a more recent insertion.

Fig 11: The stable interior

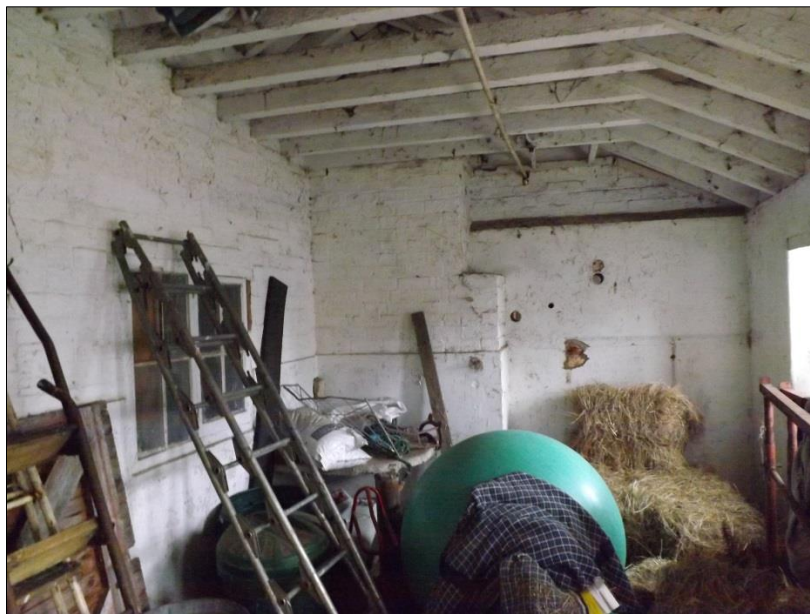
The southerly portion of the block, adjacent to the stable, is a tack-room (Fig 12). It was originally served by a fireplace in the dividing wall, backing onto the stable, but this has been blocked. Of three windows in its east face, only one is original, flanked by two later insertions, deploying Fletton bricks. The room is today used for storage. Its doorway to the stable yard has been modified to take a sliding door (Fig 5, right hand side). Within this room is a smaller space subdivided off in single-skin brick stretchers, some of it textured brick of the 1970s, and lit only by borrowed light through a window from the feed room (Fig 12). This tiny space is used for storing tack.

Fig 12: The former tack room, subdivided again on the left to make a smaller tack-store.
