**Archaeological building recording at Mulberry  
Barn, Queen Eleanor Road, Geddington  
Northamptonshire**

**February 2014**

## Archaeological building recording at Mulberry Barn, Queen Eleanor Rd, Geddington, Northamptonshire

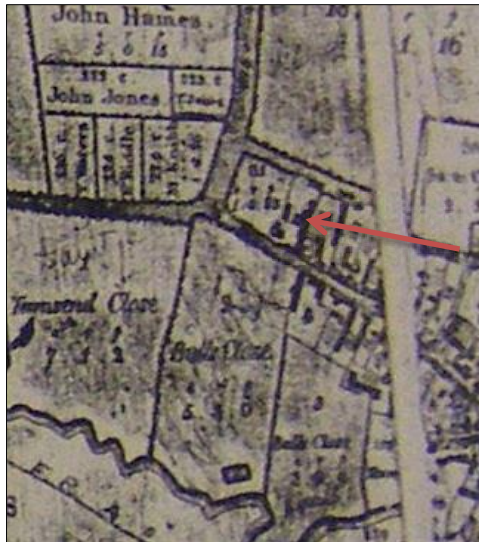
Fig 2: The Eagle Map of 1810. The barn, aligned east-west, may just be discerned (arrowed) with farm buildings adjoining to both north and south.

There is a fine run of historic maps surviving for Geddington. However, while Mulberry Barn is certainly shown with the rest of the farm on the 1886 1<sup>st</sup> Edition Ordnance Survey, the scales of all the foregoing maps are so small that it cannot be identified with any certainty on all but one, the 1810 map by J. Eagle. It may be inferred from an almost amorphous ‘blot’ on the 1817 Ordnance Survey Surveyor’s drawing (Kettering sheet on [www.bl.org.uk](http://www.bl.org.uk)), but no more. The Pre-1886 maps are all unhelpful in this case. No documents have been found which relate specifically to the barn.

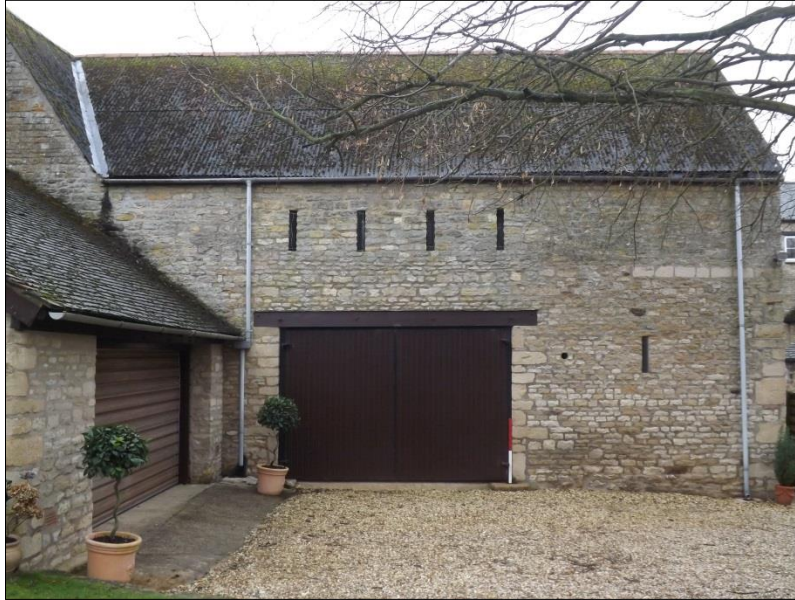
Mulberry barn is a single rectangular crop barn constructed of coursed limestone rubble with stressed ashlar quoins in the same stone. It measures c16m x 6.5m in plan.

Fig 3: Mulberry barn from the north side. Note the inserted row of windows at first floor; scale 1m

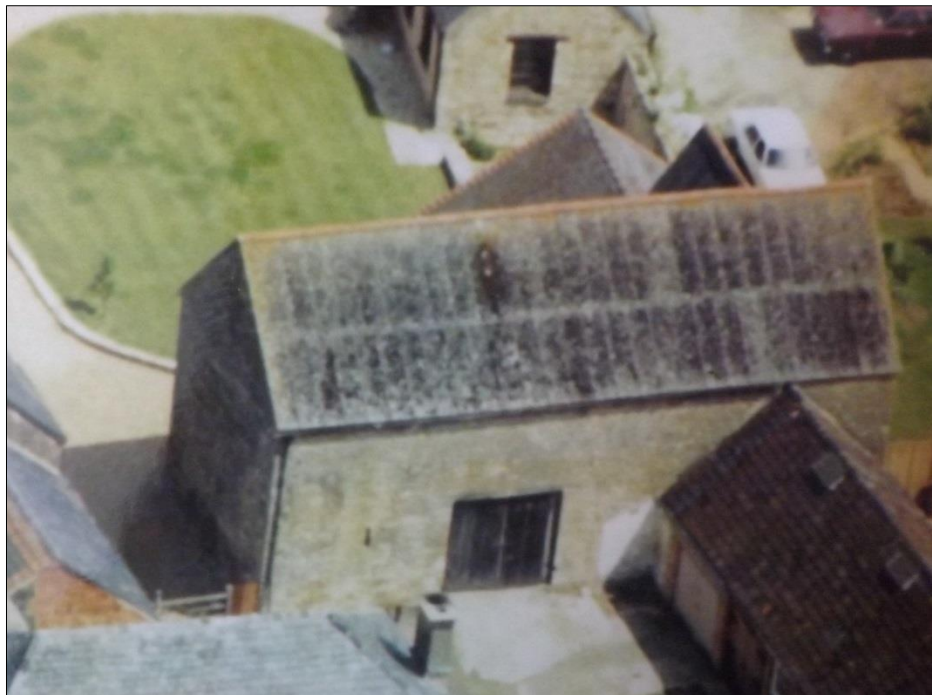
On the north side is a modern pair of barn doors within an original hay-wain entrance. A corresponding entrance on the south was blocked up in recent decades but can be seen in an aerial photograph taken c1979.

Fig 4: An aerial photo of c1979 from the owner's own collection. Note the barn doors blocked in the recent conversion and the virtual absence of features in the west gable.

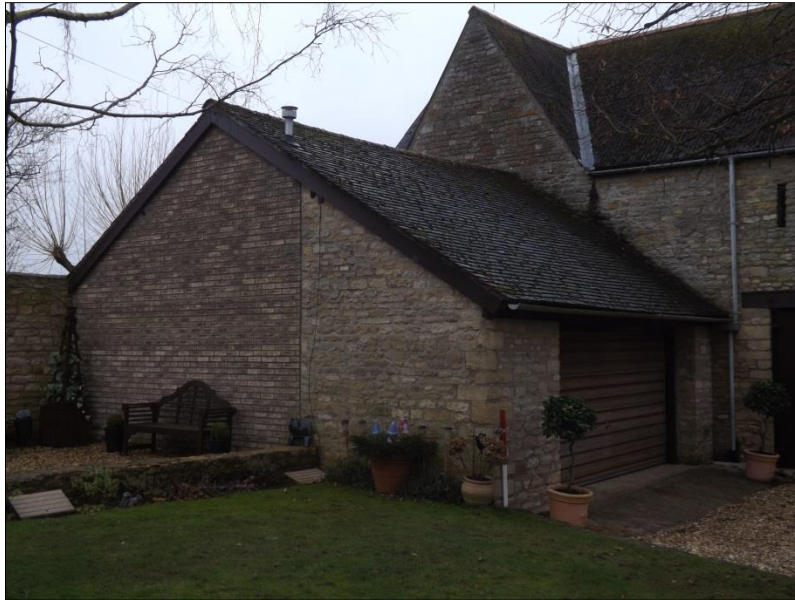
Fig 5: The added garage, partly occupying the footprint of an earlier agricultural building; scale 1m

A secondary building was added to the north side of the barn before 1886 (in all probability before 1810) but which was subsequently knocked down. It was replaced after 1979 by a wider, taller example which was designed as a double garage for the bungalow which today forms the other residence on the plot, itself a re-configured footprint of a farming structure. Apart from its east wall, which forms a boundary, the entire garage, which is of stone, blockwork and brick, with a ceramic tile roof, is modern. Above it, a corresponding cross-gable in the barn has had its stonework restored.

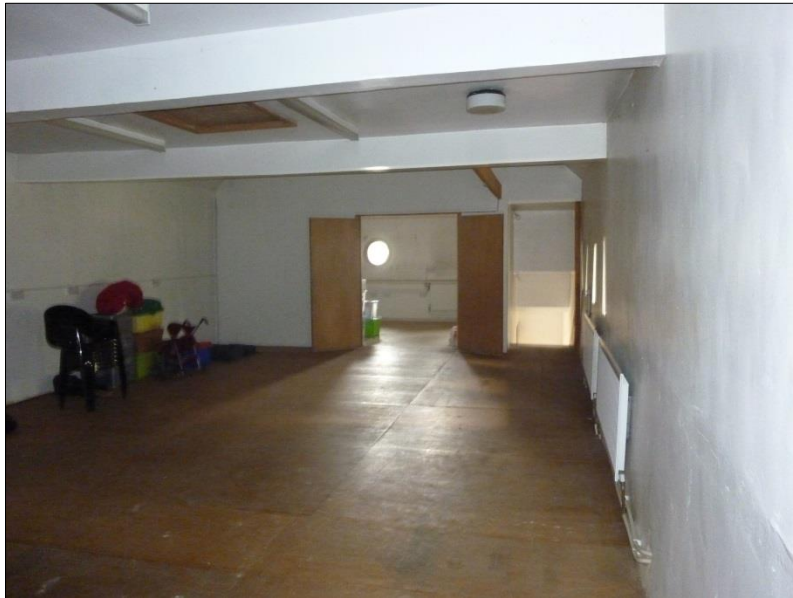
The barn was converted after 1979 for business/commercial use and the entire interior is modern. No historic fabric is visible anywhere inside. At the west end, conversion involved the piercing of three circular oculi in the gable, which light a discrete first floor room there. Elsewhere the majority of first floor space is dimly lit by insertion of a row of mock ventilator windows. This conversion is accessed at ground level via a doorway piercing the west gable.

Fig 7: The modern interior at first-floor level. Note one of the inserted oculi visible in the end gable.

At first floor level, in common with the ground floor. There is no historic fabric visible.

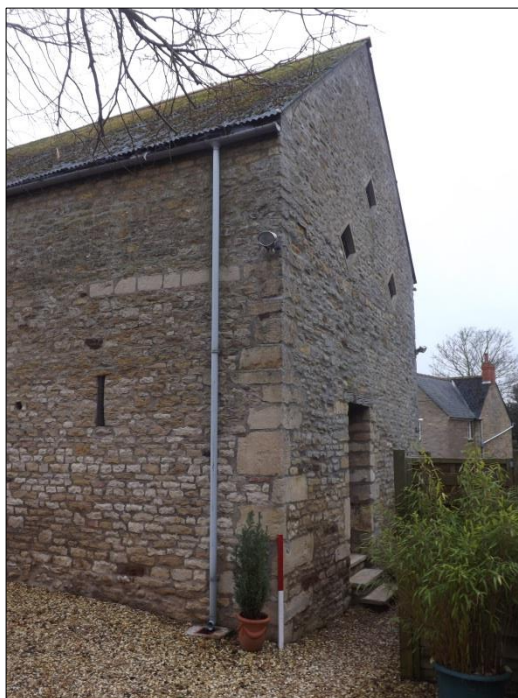
On the north side of the barn part of a course of ashlar at high level may denote an early raising of the roof. It may be argued that the long walls under the eaves have been raised, as the prominent ashlar quoins change size markedly at that point, but no change is apparent in the gable so the evidence is equivocal.

Fig 8: An ashlar course may denote a previous change. The west gable doorway is modern as are the gable windows; scale 1m
