Building Recording at the Moravian Chapel,
Parsons Street, Woodford Halse,
Northamptonshire

July-August 2014

Building recording at the Moravian Chapel, Parsons Street, Woodford Halse, Northamptonshire 2014

Summary

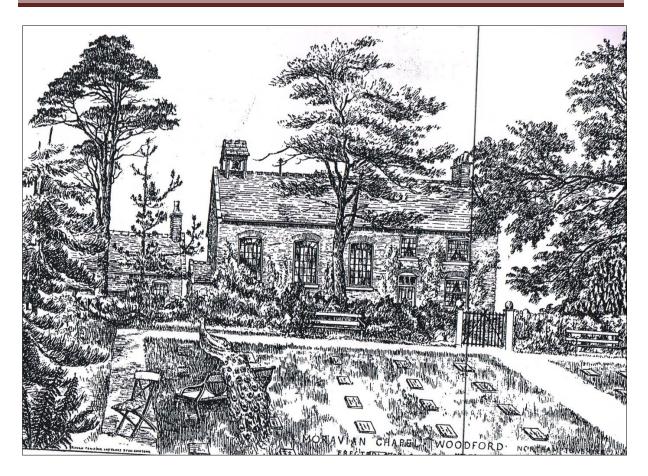
Fig 2: 1886 sketch of the south side of the 1799 chapel (from Anon, 1886); note the western porch later lost in the 1906 chapel building, also the old bell cupola.

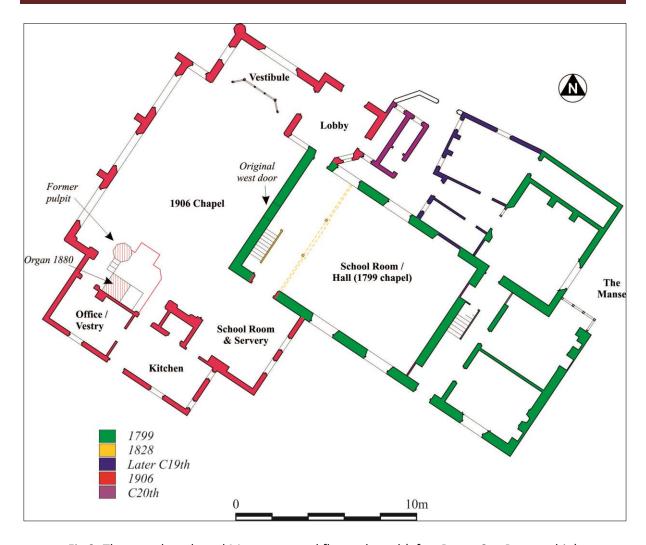
Fig 3: The two chapels and Manse, ground floor, phased (after Roger Coy Partnership)

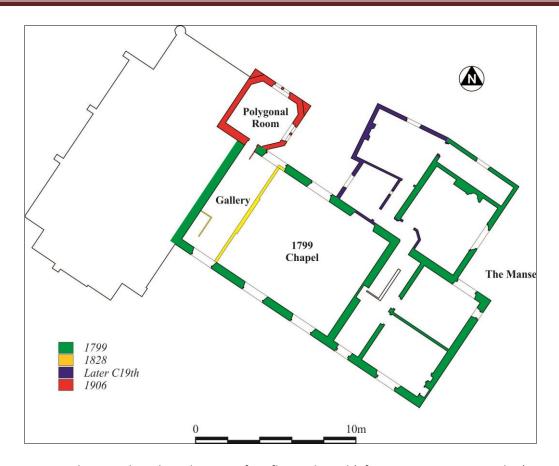
Fig 4: The two chapels and Manse, first floor, phased (after Roger Coy Partnership)

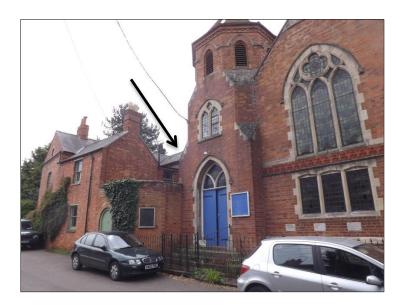
Fig 5: The view from Parsons Street; sandwiched between the manse (left) and the 1906 chapel (right), the 1799 chapel (arrowed), on the other side of a small yard, is barely visible

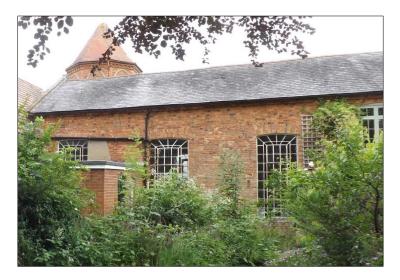
Fig 6: The 1799 chapel, from the rear; the coeval Manse is to the right

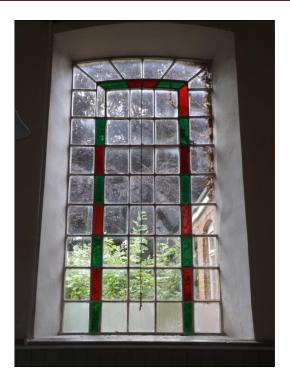
As the unusually full listing description notes, the windows comprise large, late-C19 windows under shallow, segmented brick heads. The windows are multi-paned with thin, metal glazing bars, inset with a border of red and green coloured glass.

Fig 7: A typical later 19th-century south-facing window in the 1799 chapel, viewed from the inside

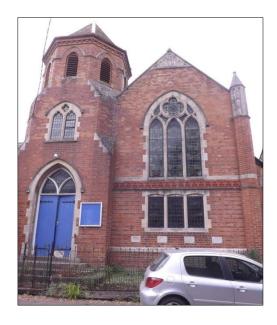
Fig 9: 1906 build, rear (south) gable

Fig 8: 1906 build, front (north) gable

On the outside (front gable) are a number of details which presage interior arrangements. Most notable is a terracotta band of terracotta brick detailing which marks the level of an interior false ceiling and shows that the vestibule and its constituents are original to the 1906 work. The band also differentiates between the principal neo-gothic window in the gable end and the more mundane three-part lobby window below.

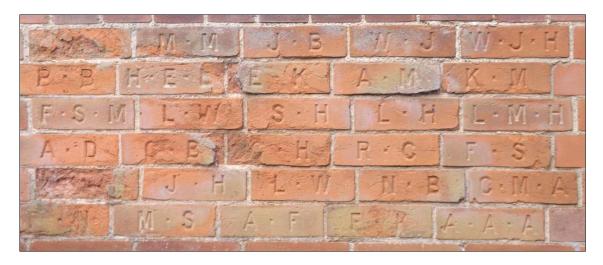
Beneath the lobby window is a row of four commemorative stones, noting the laying of the foundations and related construction events and the principal persons involved in 1906. Around the side of the building, less prominently, is a large panel of brickwork (breaking the walling brick bond) with the initials of the prominent church members in 1906 routed into the face. These have become increasingly frost-damaged over the years.

Fig 10: Panel of inscribed brickwork on north-west outer face of vestibule

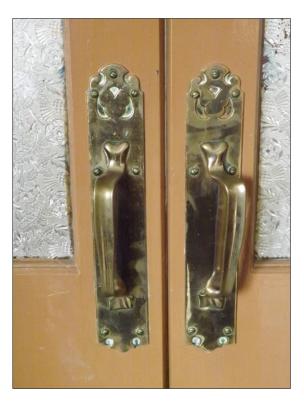
To the west is a pair of six-light swinging doors with etched and moulded rose and thistle motif (painted blue on lobby side, brown on vestibule side). They also have notable brass matching Art Nouveau push handles and finger-plates. Above these doors is a blue painted cross. The window bears a repeating fleur-de-lys motif seen elsewhere. Otherwise the walls are simply plastered and

Fig 11: Matching brass Art Nouveau door furniture; vestibule-side of doors from lobby; note the ubiquitous etched glass with Tudor rose and scotch thistle, added everywhere in 1906

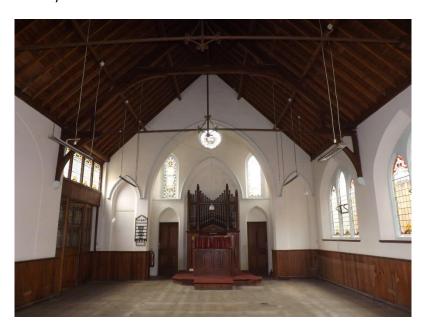
The main worship space is three-bayed in plan with grouped lancet windows on the south side. The windows have simple lozenge mullions. Each lancet has a repeating pattern of stained glass with a repeating and formulaic fleur-de-lys type motif, with elements of blessing, plenty; directly redolent of Art Nouveau. The windows each comprise simple rectangular pieces of square leaded glass. The window in the north-western side above the vestibule is square but with similar square leaded windows with fleur-de-lys motif.

Fig 13: The principal worship space, built 1906, folding doors to left

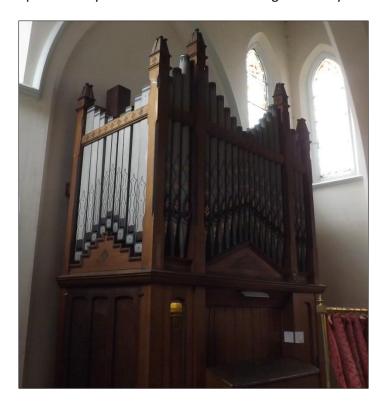
Fig 19: The organ

The organ is located on a raised dais and the fixed organist's seat is screened and curtained off from the congregation. The organ pipes are painted with stylised flowers and stars. Two brass plaques on the left hand side of the organ read:

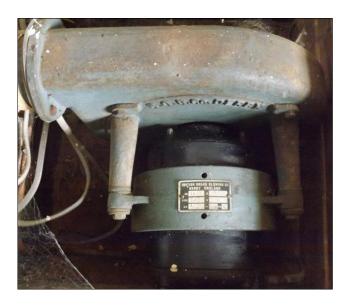
An electric blower was installed in June 1949, S^r Knibbs to the glory of God and in loving memory of B^r E Knibbs.

This blower lay in the corner of the adjacent office.

Fig 20: The 1949 organ blower

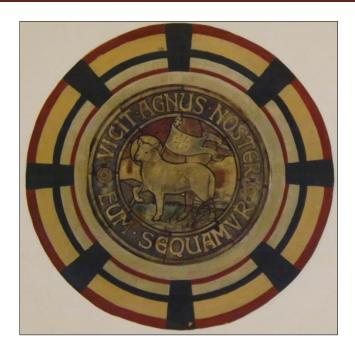
Painted centrally and high on the eastern wall is the favoured Moravian motif of the Paschal Lamb and Flag.

Fig 29: The painted Paschal Lamb and Flag motif, painted high on the eastern hall gable

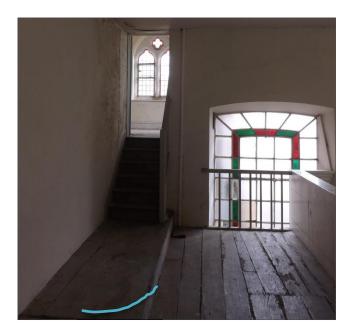
The 1828 gallery at the western end of the hall is very plain, its front and its inserted stair simply panelled, although in the floor of the gallery is preserved a curved timber which might suggest it may originally have been formed around the rump of some other structure or fitment, its identity now unknown. When the 1906 chapel was built, and more particularly its accompanying tower, a doorway was cut through the old 1799 fabric to link with the first floor room of the tower, via a short flight of steps, which are currently its only communication. The room thus accessed is an irregular polygon in plan and is bare of any fixtures or fittings. Two redundant iron brackets suggest it formerly held a header tank or similar water supply. The room is lit by two simple neo-gothic style

Fig 31: Gallery, looking north to the tower; note the curved timber edge in the step (marked)

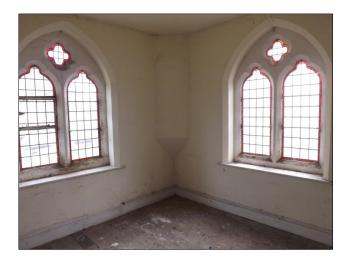
Fig 32: The 1906 tower, first floor room, looking east; currently only accessible from the gallery

The otherwise isolated location of the tower room is inexplicable, since this clearly 1906 room, an integral part of the later chapel build, could apparently relate only to the older hall, by then a redundant chapel space, and then only via the gallery and its stairs. The tower room was in effect very restricted in its applications.
