# Towards a greater understanding of the construction of the funerary monument of Sir John Montagu, St Edmund's Church, Warkton, Northamptonshire

#### Iain Soden BA MIfA

#### **Summary**

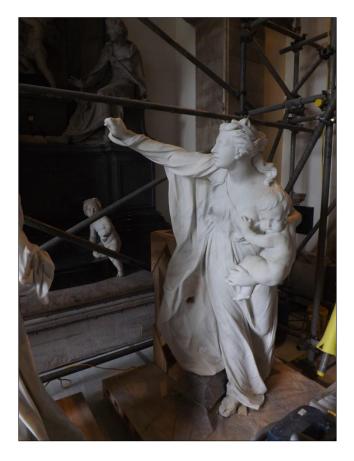
Fig 4: Part of the monument, dis-assembled and set aside for cleaning, pending reinstatement

The monument itself was carefully dis-assembled piece by piece, each element set aside carefully in the chancel, which had been sealed off from the nave and set up as a mason's lodge specifically for the purpose. A steel gantry supporting a high-level viewing platform and a sliding mount for a block and tackle provided the means to remove the heaviest pieces and carefully separate them from the core. These were then set aside for cleaning within the chancel area before eventual re-assembly.

The monument core was manually cleaned. Extraneous stonework was taken out and set aside for study as appropriate, while any degraded elements to the core were provided with block-work props in the interim, before reassembly using appropriate matching mortars.

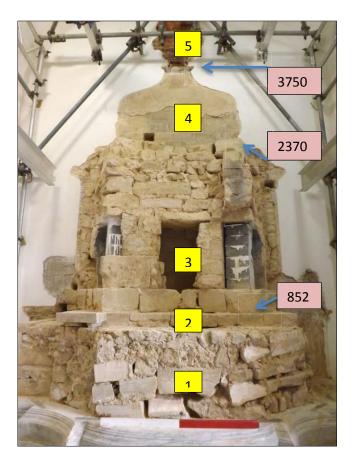
- 1. Polygonal base, of rubble, incorporating re-used architectural fragments, projecting out 1m from the chancel wall, and just over 2m across.
- 2. A slightly narrower table finished with flat but not polished slabs, shaped, 852mm from floor.
- 3. A narrower superstructure of stone 'pylons' or columns, supporting an upper mass of stonework, and resembling a haphazard 'entablature'. Top 2370mm from floor.
- 4. The exposed ashlar of the chancel wall, to which the monument is affixed directly; partly plastered. The eaves of the former chancel can be seen as the uppermost course of stonework. At 3750mm from floor.

5. Brickwork, to which the stone plume of the monument is attached; this extended the original chancel wall upwards and changed the chancel proportions completely.

Each of these distinct build-elements can be seen in the Figure below, numbered. The total height of the monument core, and the mounting scars up to and including those of the plume on the added brickwork, is 4.85m.

Fig 5: The monument core, viewed at eye-level for the onlooker; scale 1m. Measured dimensions in millimetres from the floor are added.

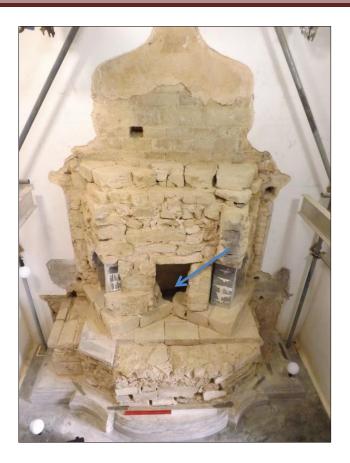
The third stage of the structure, involving the use of pylons or haphazard columns of stone, preserves a large deliberate void in the centre of the core. This had simply been packed with loose rubble (of which more below). At the rear and base of the void lies the apex of an arch, barely visible, but which appears to have been blocked prior to the monument being constructed. Some of the blocking mortar at the apex has either perished or been omitted (Fig 6).

This view is not ideal, but enough is visible to postulate a blocked four-centred arch behind the monument, which may have been a former tomb-canopy in the north chancel wall. How it now relates to the added later Montagu family vault beyond (to the north) is unclear, no better view being afforded by the current works.

Fig 6: The monument core viewed from the dismantling gantry above; scale 1m. The apex of a low, flat arch hidden behind the monument is arrowed. The eastern spring of that same arch (on the far right here) can be seen in detail in the Figure below.

The core of the monument appears to mask a low, flat arch, perhaps four-centred, which may mark the location of a former tomb-canopy in the chancel wall, probably related to the medieval holders of the church's advowson (the right to present the vicar), the Abbey of Bury St Edmunds. Such a monastic-inspired tomb-canopy would have become irrelevant at the Dissolution of the Monasteries in 1539 and its replacement soon after would not have been uncommon; not least here where the Montagu's were given the former monastic advowson by the Crown. It is not clear whether this arch was blocked to accept the current monument or whether this constitutes an earlier blocking. The Northamptonshire county historian, John Bridges, may have seen the arch when he made his field notes c1720-25 (although his work was not edited and published until 1791). However, his edited, published work notes the chancel with the beginnings of the current array of sepulchral monuments (1791, I: 263-5).

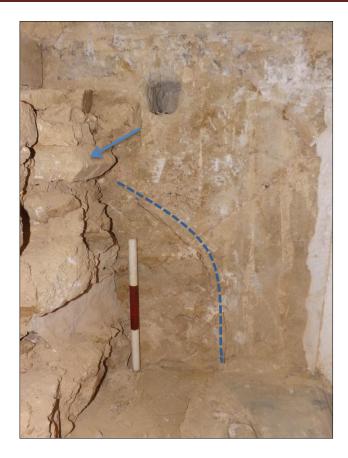
The spring of this arch can be clearly seen behind the monument low down on its right (Fig 7), including a number of voussoirs. The blocking has settled very slightly, cracking at the join. The monument is constructed in such a way that the left hand springer cannot be seen as easily, but a vertical butt joint is postulated at the edge of the current monument.

Fig 7: Spring of an arch behind the monument core; scale 300mm. Note a built-in architectural fragment to top left (arrowed)

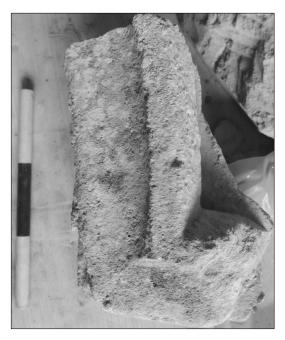
century, and despite medieval forms, have mullion profiles which are different from those found. Only the hood mould has a similar example, to be found on the 15<sup>th</sup>-century west window of the tower (Fig 8).

and equivalent piece on St Edmund's tower; scale 300mm.

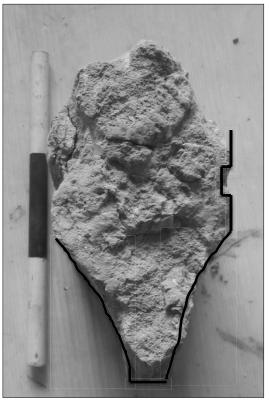
Further, battered fragments had also been incorporated into the monument core, perhaps suggesting that the loose ones were the leftovers of the leftovers, merely placed where they would not be seen and where they could be disposed of. All are items which derive from windows and in some cases doorways, which derive from the medieval church, probably of the 14<sup>th</sup> or 15<sup>th</sup> centuries. They are in poor condition and do not add anything to our understanding of the medieval church, since it cannot be certain where they come from. While the chancel is the obvious place, this is not certain. All of the windows in the present aisles of the present church were restored in the 19<sup>th</sup>

Fig 9: Battered 14<sup>th</sup>-15<sup>th</sup> century cavetto mullion with glazing groove; scale 300mm

Fig 10: a better-preserved 14<sup>th</sup>-15<sup>th</sup> century cavetto mullion fragment still built into Stage 1 of the monument core (arrowed); scale 300mm
