Iain Soden Heritage Services Ltd

**Archaeological observation and recording of the
retaining wall at The Croft, Queen Street,
Geddington, Northamptonshire**

22 October 2014

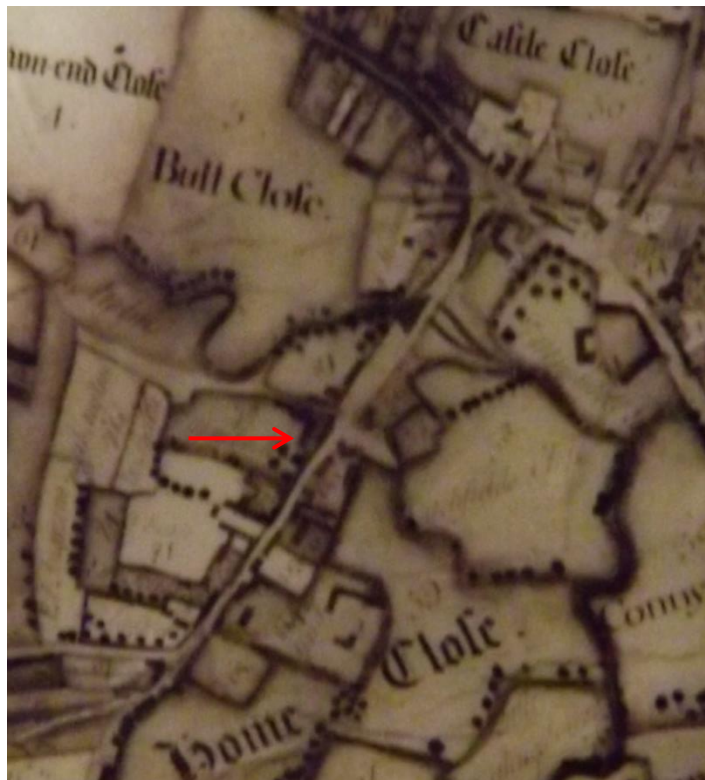
Fig 2: Detail from the 1717 photostat map, The probable Croft is arrowed

The earliest depiction of The Croft is on the 1717 map of Geddington open fields. The map depicts all the furlongs in the open fields of the parish nearly a hundred years prior to its eventual enclosure. The photostat copy of the map held by NRO, though tiny, shows a narrow range parallel to Queen Street in the location of the Croft; given its probable 17th century origin, it is likely that it is the Croft. A series of further buildings extend to the rear.

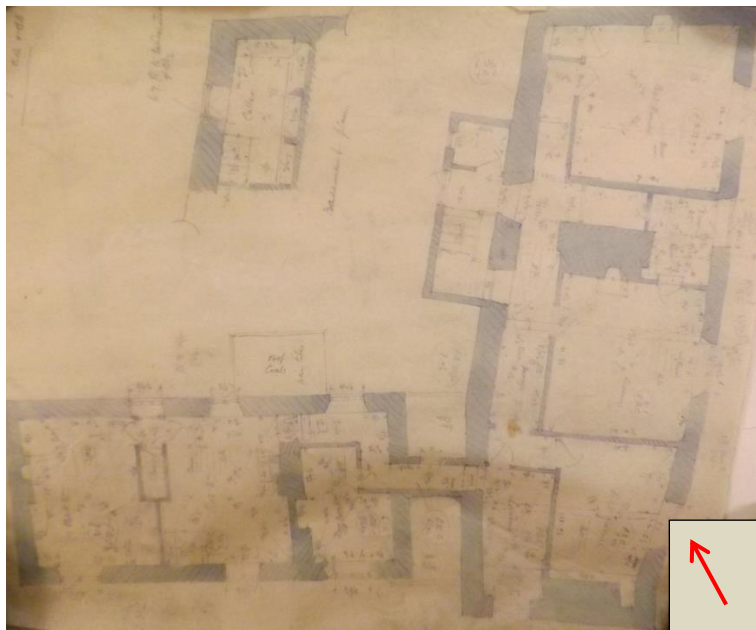
Fig 5: The Croft, ground floor, as planned in 1917

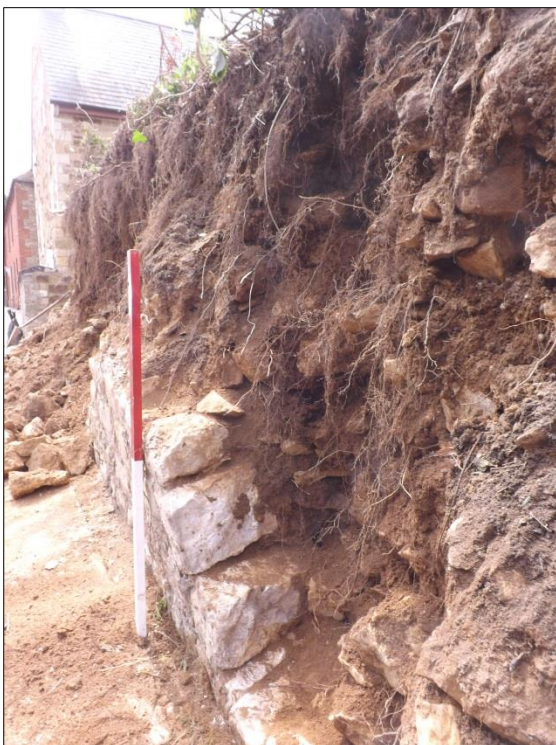
Fig 8: The section at 5m from the corner; note the collapse and thrust of loose soils which destabilised the skin; scale 1m.

structure. When prolonged heavy rain fell in 2013-14, the degraded stony soils behind the wall skin, simply failed to hold it and it poured through the wall in a number of places, causing the weakening wall to bulge dangerously.

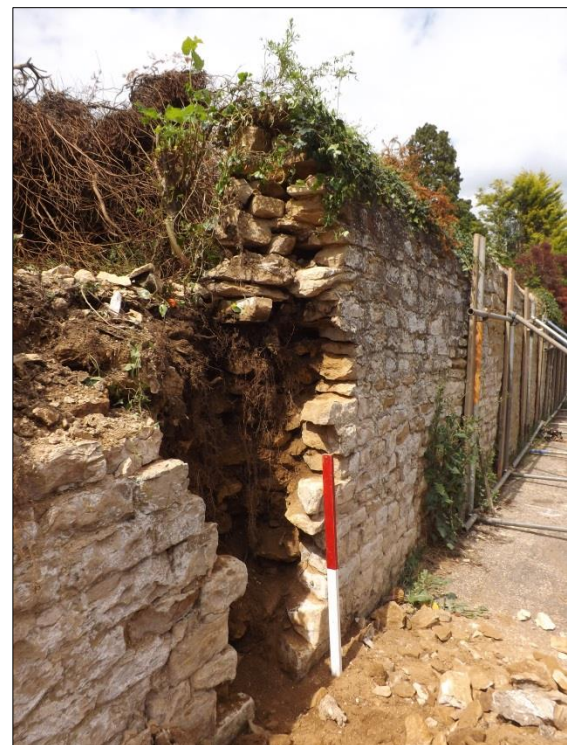
Fig 9: The wall at around 20m from the corner, preparatory to drawing; scale 1m.

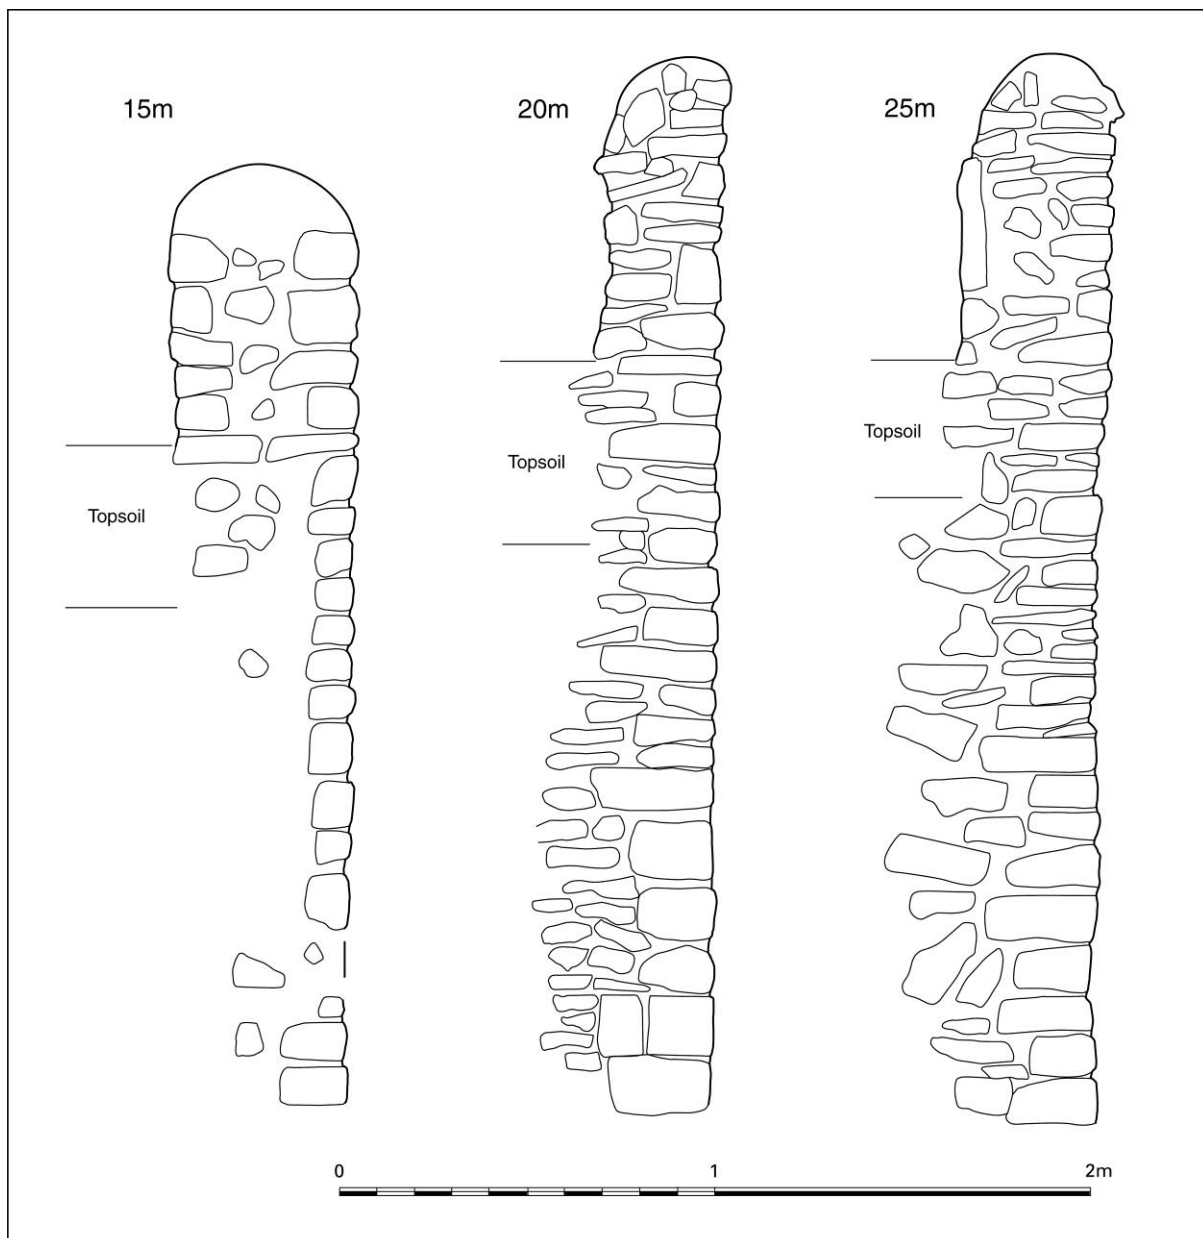
Fig 10: The wall at 15m, 20m and 25m from the corner. The top of the wall here is flanching in profiled mortar/cement. Drawing by Andy Isham.

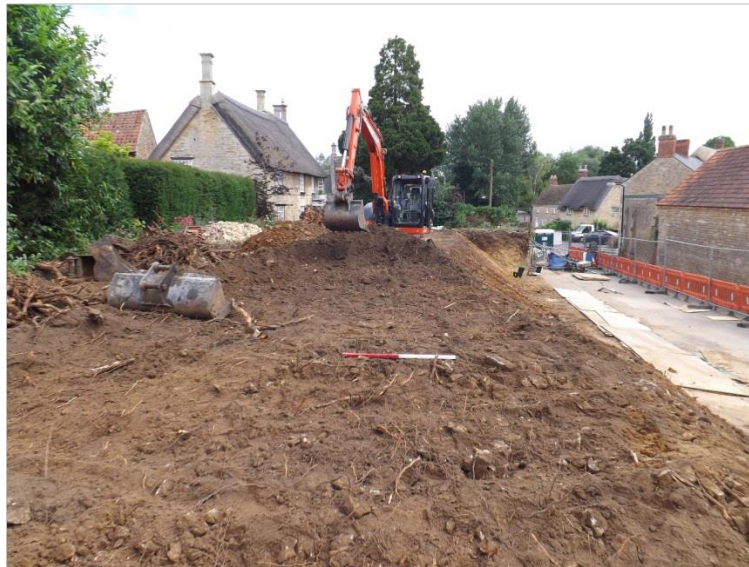
Fig 12: Topsoil strip of the garden to the rear of the wall, looking north-east. Note the far end of the works battered back from the road, recorded in Fig 10; scale 1m

The ground face directly behind the wall was battered back at an angle of 45°, extending c4m into the garden. The loose dark grey-brown topsoil overlay a mid grey-brown sandy silt subsoil, up to 0.50m deep. This was heavily disturbed by tree roots. This in turn overlay a light yellow-brown silty sand with frequent limestone pieces, becoming darker with more ironstone-type rubble to the north-west. This was the natural bedrock geology, which for the most part appeared to comprise limestone rather than ironstone. Known outcrops of the Lower Lincolnshire Limestone Member are recorded nearby.

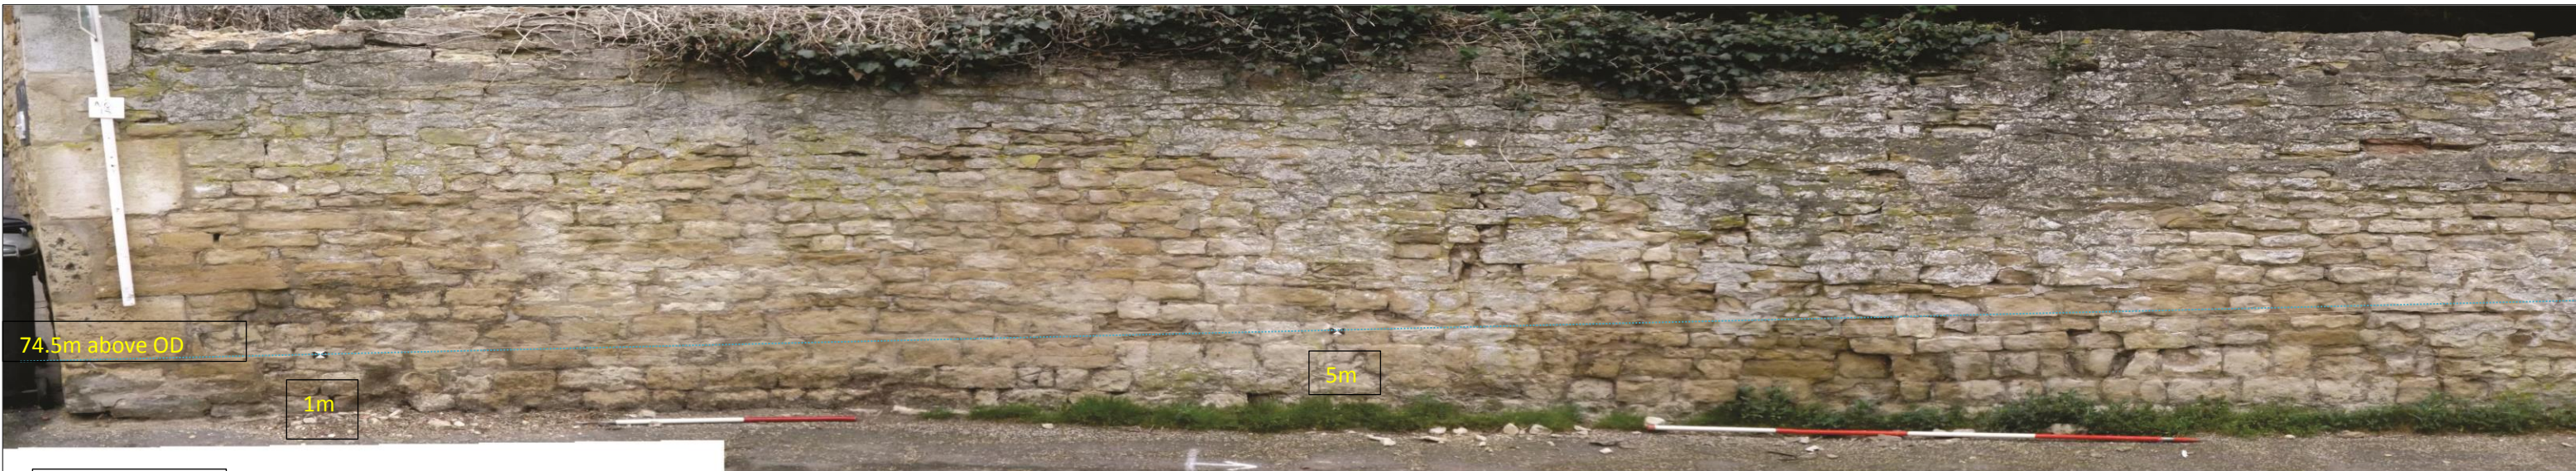
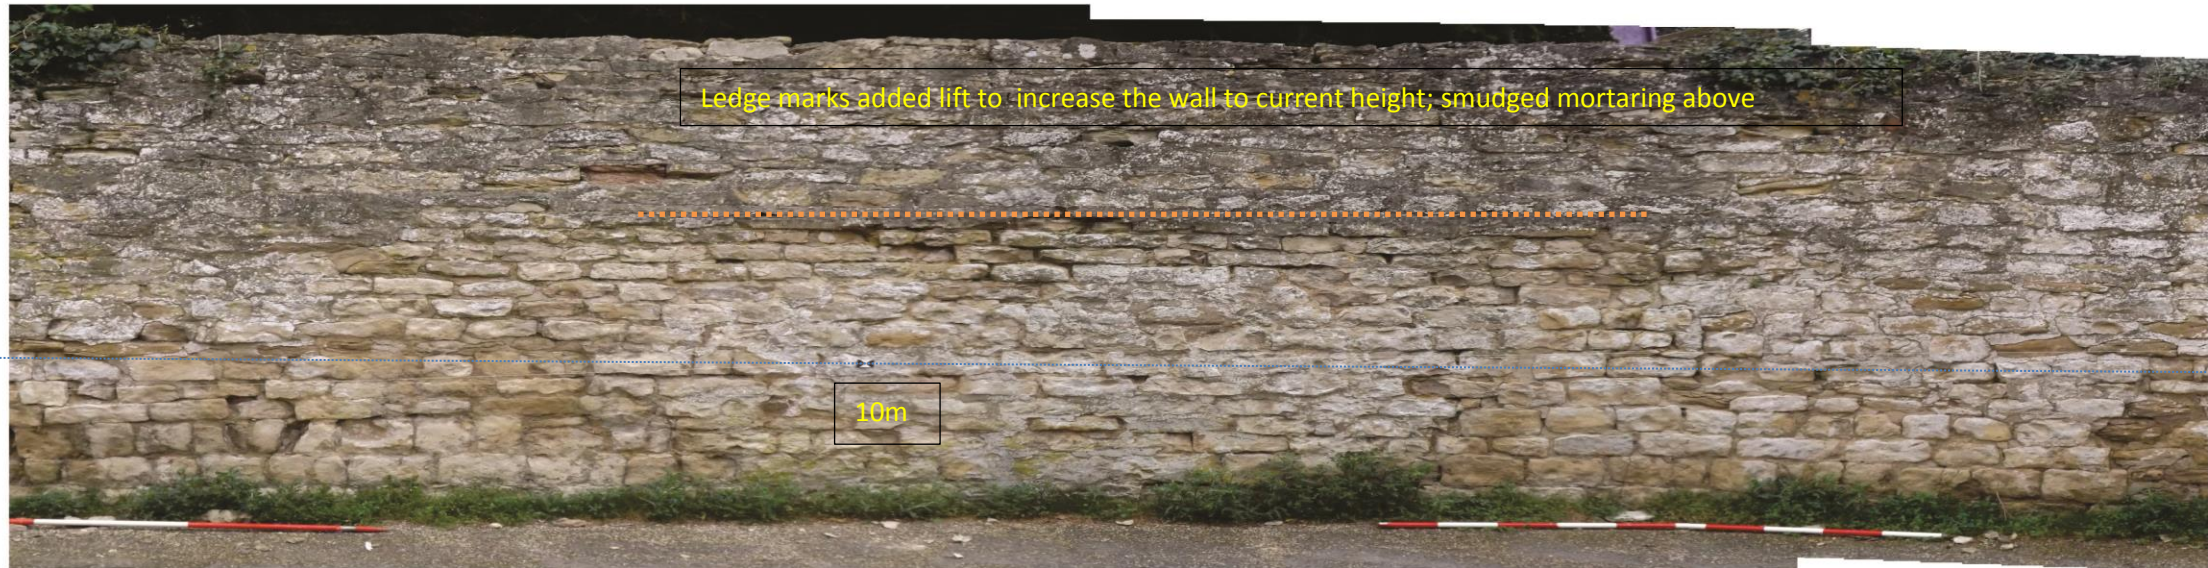
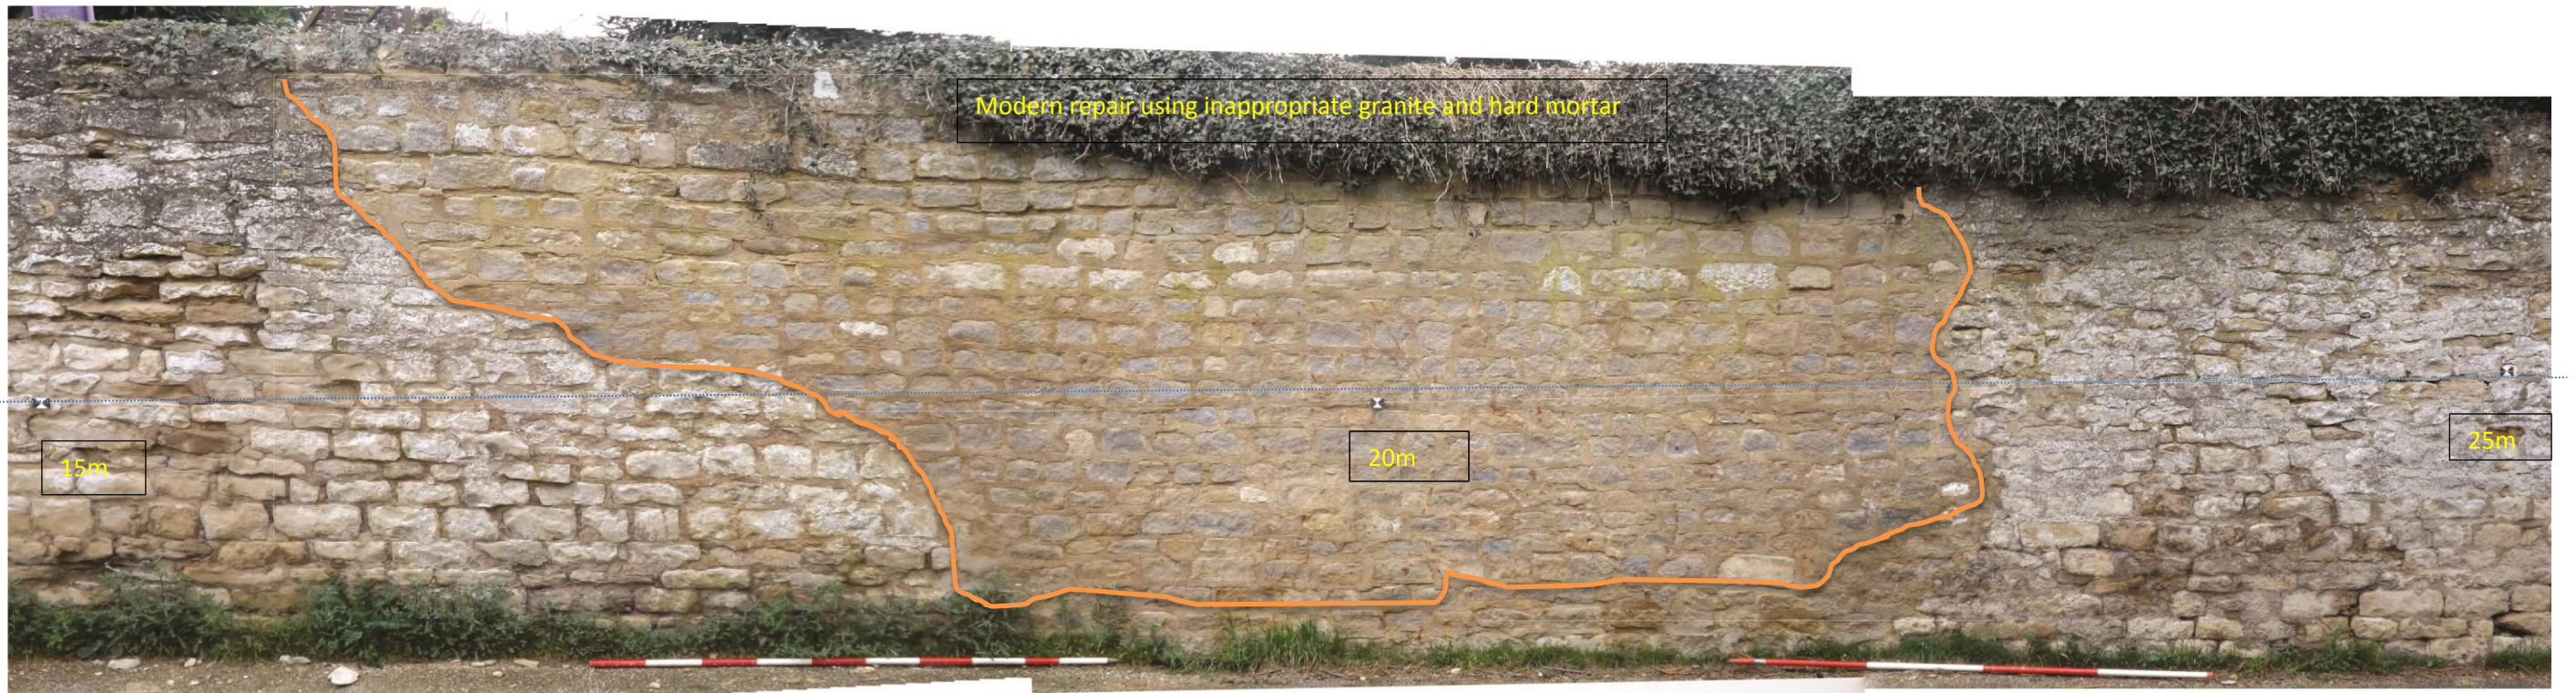
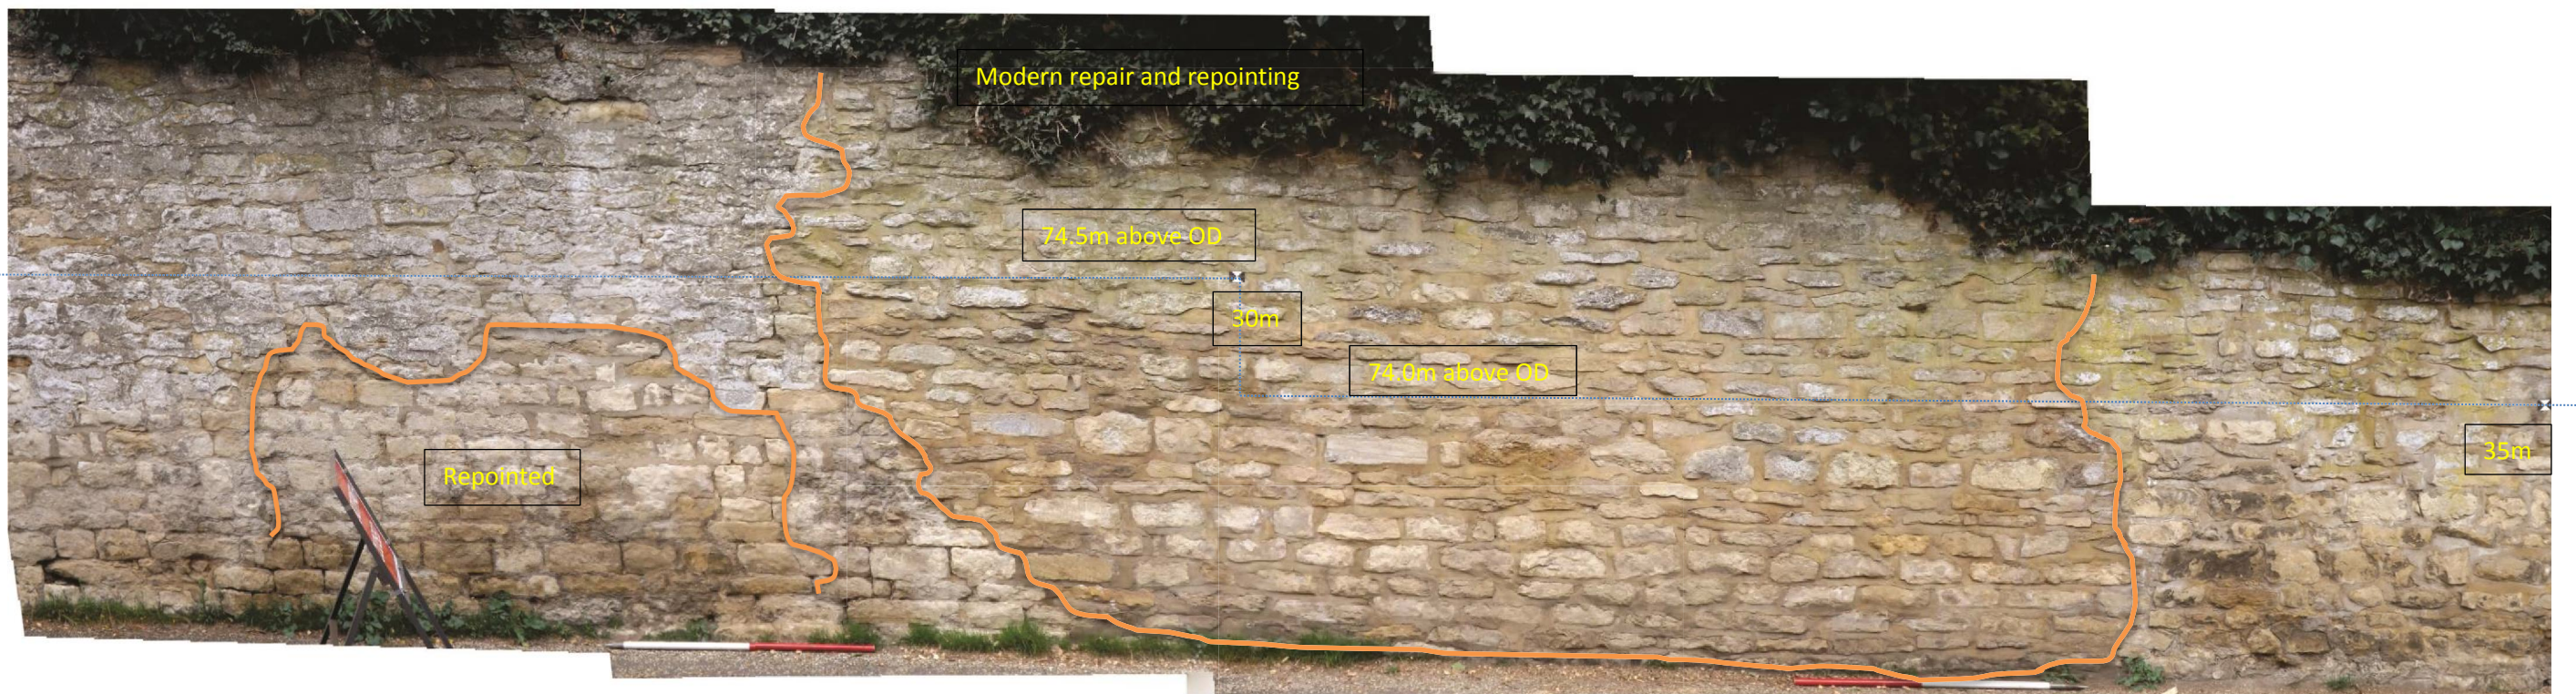
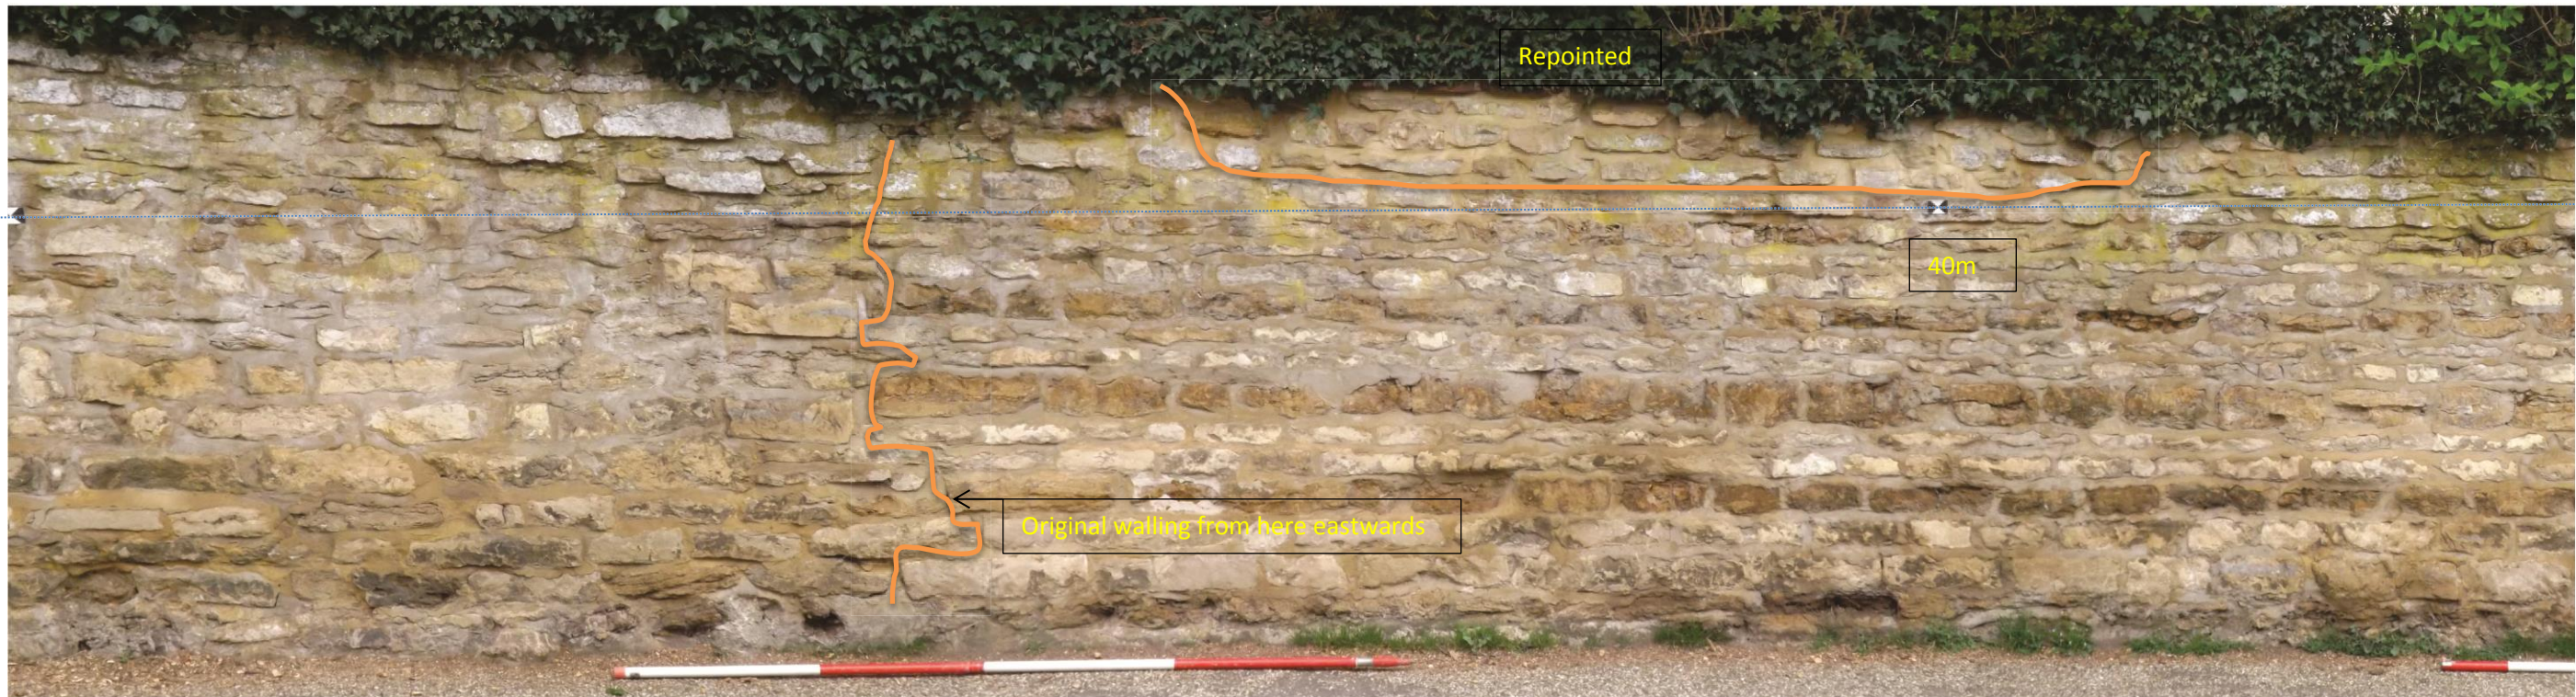
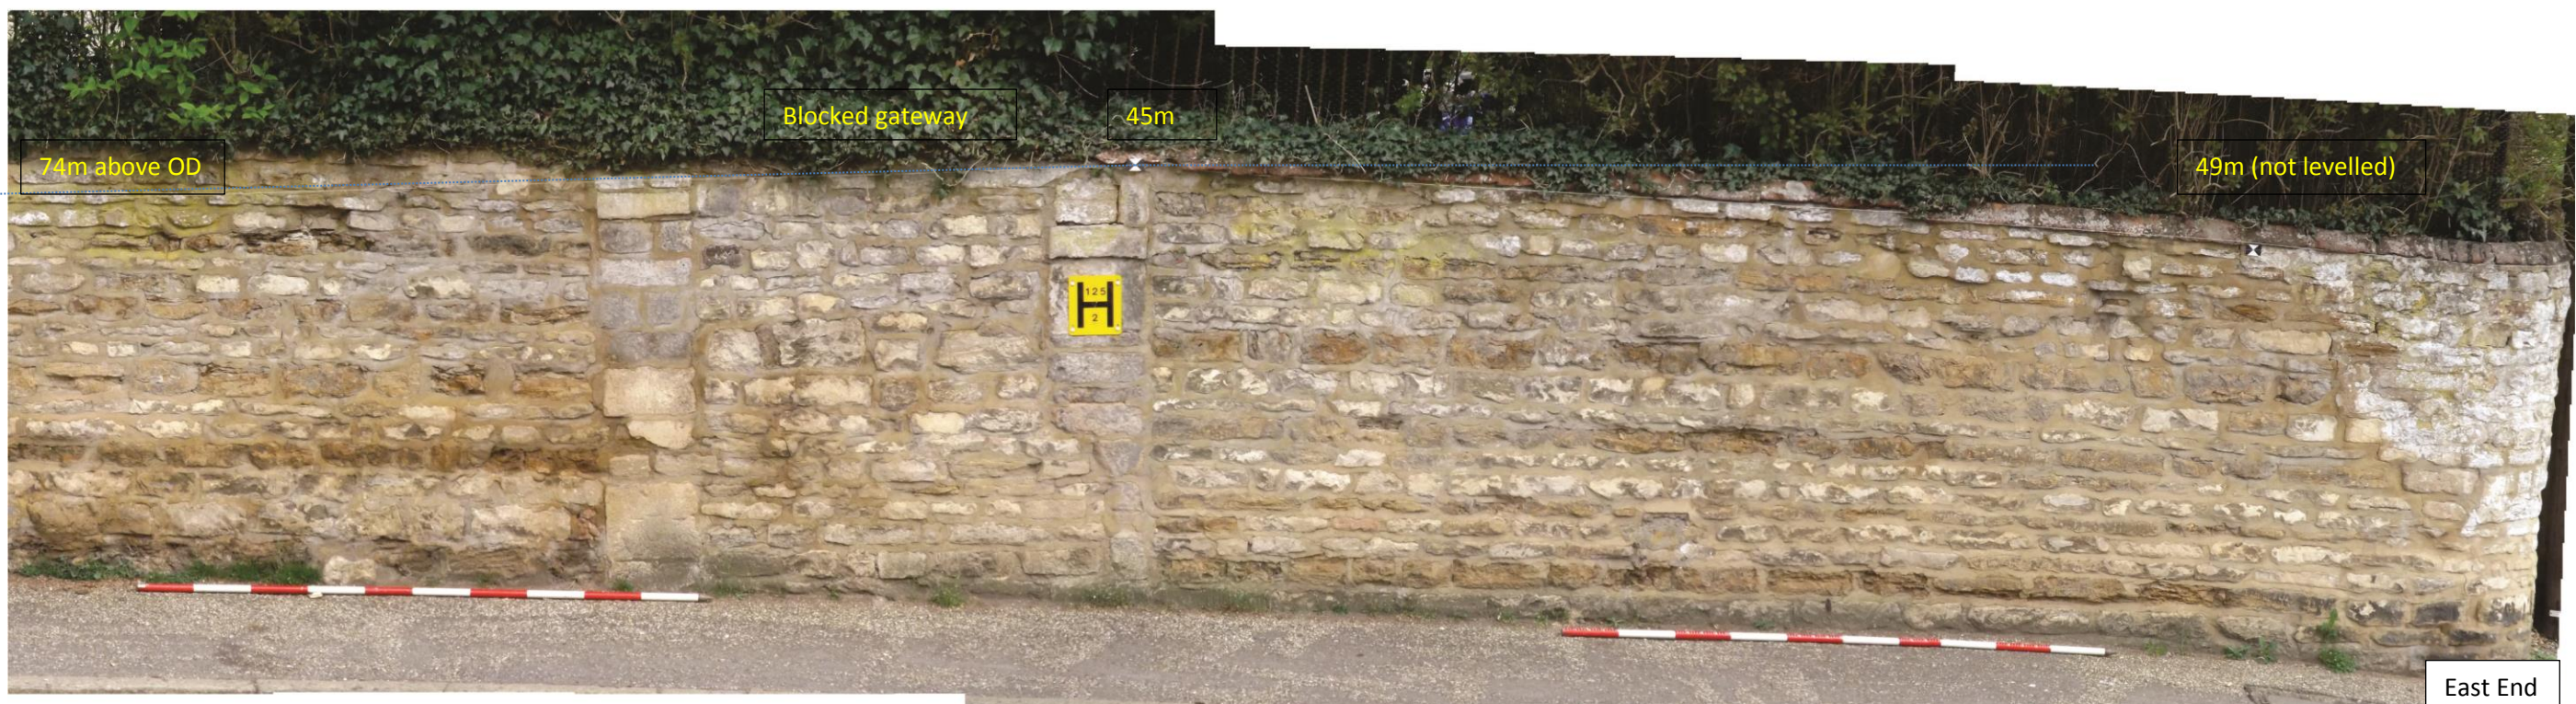
WEST END

The digital photographs were mounted in a continuous photo-montage of the street-facing portion to iron out any converging verticals and with sufficient overlap to ensure full coverage without visual distortion. The result was deposited before works began as an interpretable record pre-dismantling. The images are re-attached to the end of this report.
