Iain Soden Heritage Services Ltd

**A Level II Building Record of former barns and
other farm buildings at Spring Hill Farm,
Bozeat, Northamptonshire**

Charlotte Walker and Joe Prentice

Planning consent has been given to GAT Developments for the conversion to domestic use of a group of former farm buildings at Spring Hill Farm, Dychurch Lane, Bozeat, Northamptonshire (NGR: SP 9091 5896; Fig 1).

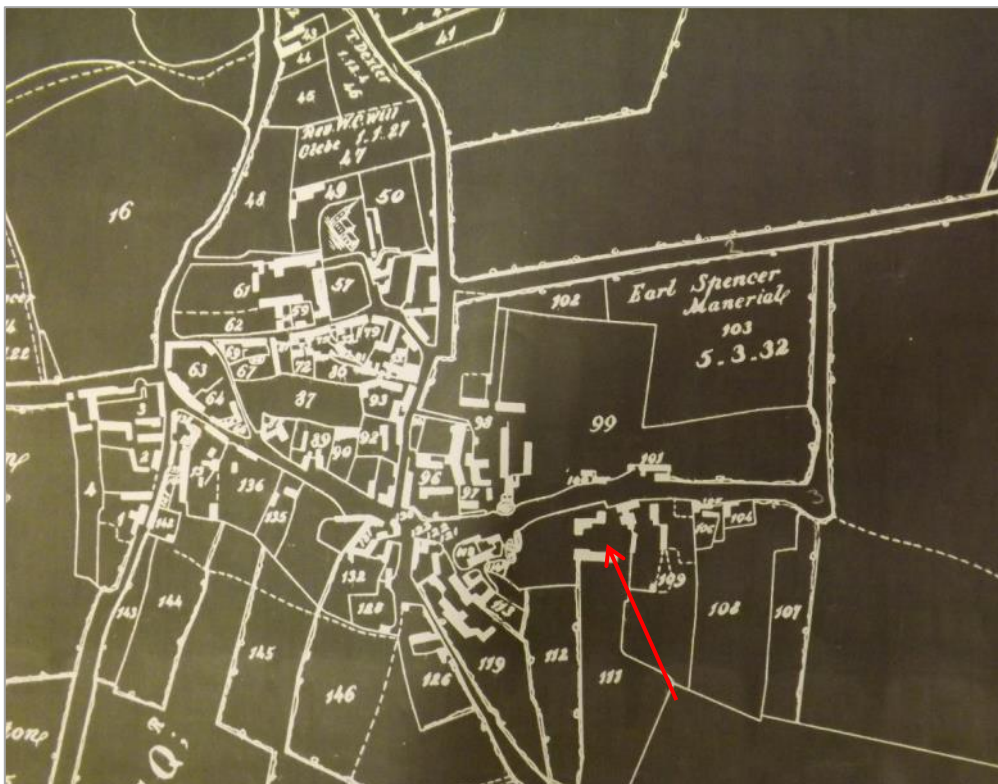
Fig 2: 1798 Inclosure map of Bozeat. Spring Farm is arrowed.

At Inclosure in 1798, both Spring Farm and East Farm were held by Earl Spencer, plot 111 (Spring Farm) is marked as *Home Close* and plot 109 (East Farm) was *Homestead & Orchard*. At Spring Farm, the large threshing barns (Barn B and west annexe) to the rear of the farmhouse appear to be

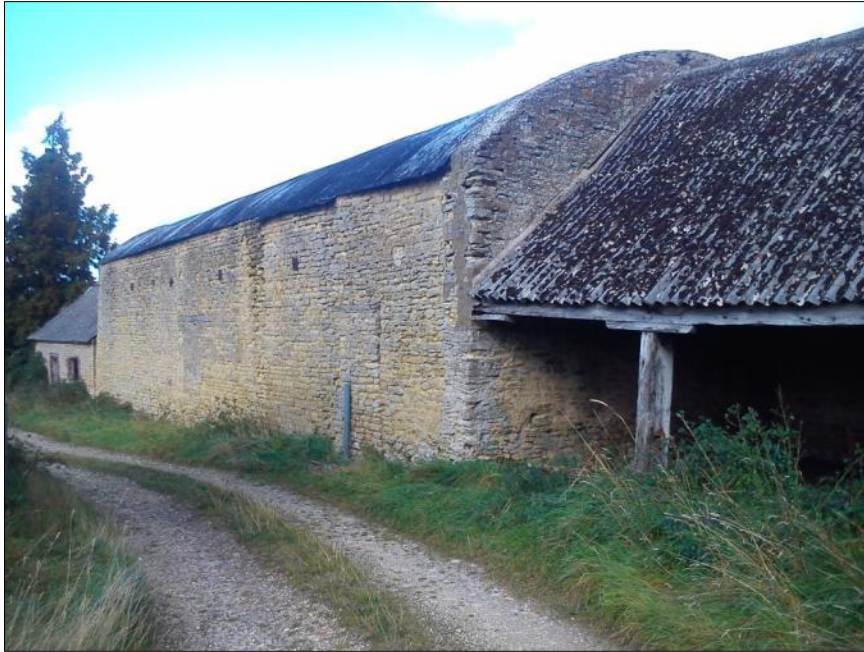
This is a rectangular building aligned roughly north-south and is constructed of coursed limestone bonded in lime mortar; it measures 20.5 m x 6.7m internally (Figs 5 and 6). The external face of the north gable end is now obscured partly by a later addition (see below, Barn A north annexe) and that part not built against was, at the time of survey, covered by a thick growth of ivy and adjacent trees which limited visual examination apart from the upper section above eaves level.

Fig 6: Barn A, its west face and south gable, looking north. North annexe to left, south to right

Both gables had been truncated to form a shallow segmental profile which was created to allow the addition of a replacement roof structure comprising corrugated metal sheeting over a frame of iron trusses of the traditional 'Dutch barn' type roof. This type of roof is usually supported on thin vertical iron or occasionally timber posts to form a covering and was mostly used to form a shed to protect hay and straw but has presumably been used here due to its pre-formed nature and cheapness. That the original roof was not re-covered in similar corrugated sheeting or tile suggests that the timber structure had deteriorated to such an extent that replacement was necessary. The date of replacement is unknown as corrugated sheeting was used from the mid nineteenth-century until the present, but its condition would suggest a twentieth-century date.

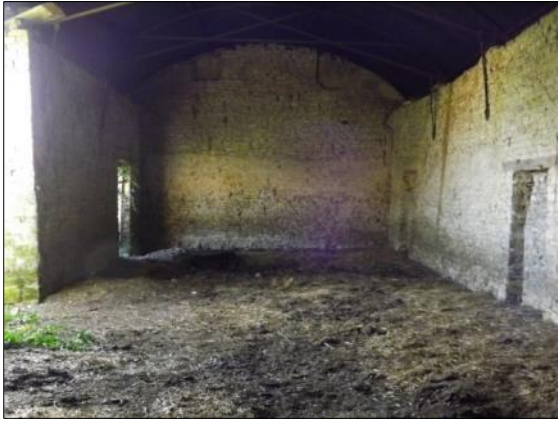
The barn has been accessed only from the east side through a wide cart door placed centrally in the east wall and a single pedestrian doorway at the southern end of the same wall (Fig 7). Both appear to be original and there is evidence of a second pedestrian door on the north side of the cart door now filled with brick (Fig 8). On the opposite, west, wall two blocked doorways are evident but here both filled with stone and each is placed opposite the central cart doorway and southern pedestrian doorway. All the pedestrian doorways have oak lintels.

Fig 7: Doorways; east to left, west to right

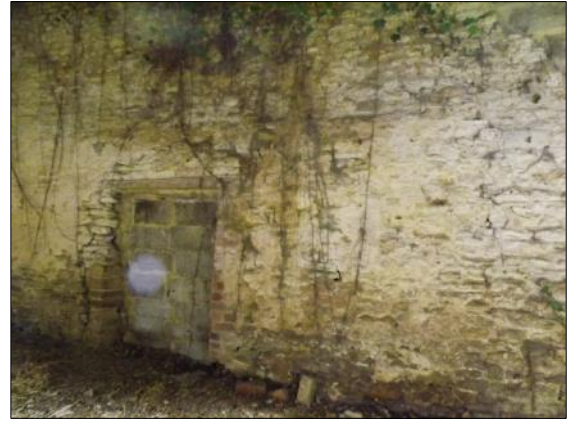
Fig 8: Blocked doorway north of cart doorway

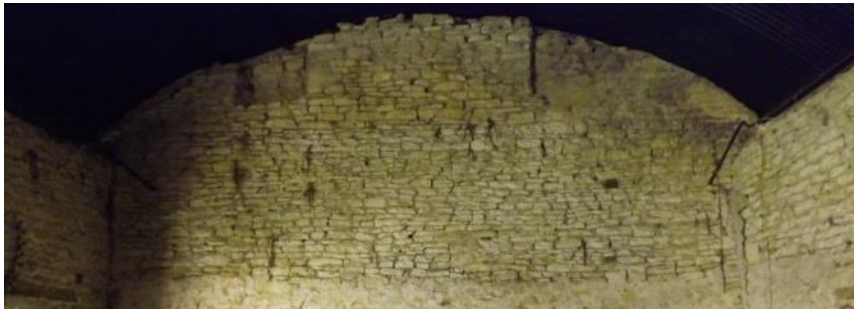
The southern gable wall is unadorned apart from filled and truncated splayed openings above eaves level that would presumably have been simple air vents (Fig 9) and there are two similar blocked vents in the north gable wall though less obvious and similarly truncated.

Fig 9: The southern gable's upper portion, with blocked, roof-truncated vents

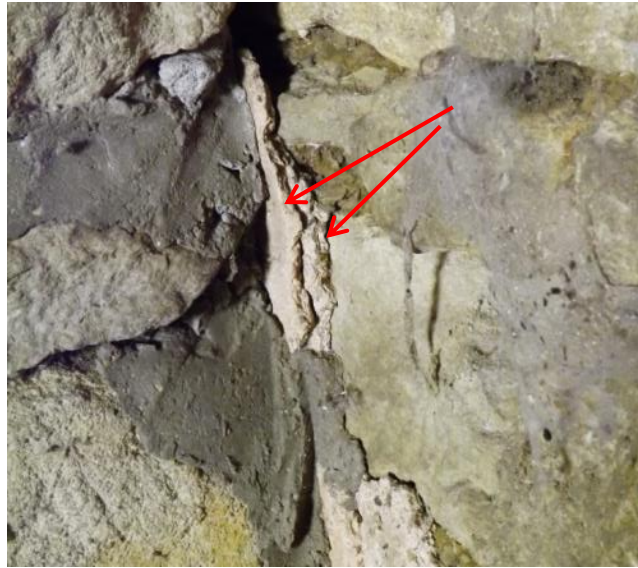
Internally the barn is a single open space with lime-washed and partly plastered walls. The floor was not visible due to the presence of many years build-up of animal dung. Both the north and south gable walls show signs of being plastered at the lower level and this plastering is covered by (and therefore earlier than) the construction of the west wall, suggesting that the barn is partly constructed from a better-quality precursor. A scar at approximately 2m above the present top of the dung level suggests that the barn (or perhaps the predecessor) may have been floored in part, but probably only at the northern end. A single beam socket in the north gable wall supports this theory.

Fig 10: Former north-wall plastering layers, sandwiched at the north-west corner by the construction of the west wall

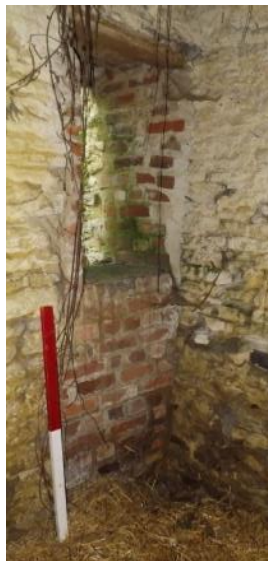
The only other alteration to the fabric was a narrow slot cut into the north gable wall (Fig 11). This was to allow the drive belt of a threshing machine on the inside to be passed through the wall from a steam engine standing on the outside. This alteration is likely to date to the latter part of the nineteenth or early twentieth-century.

Fig 11: Threshing belt opening in north gable wall; scale 1m

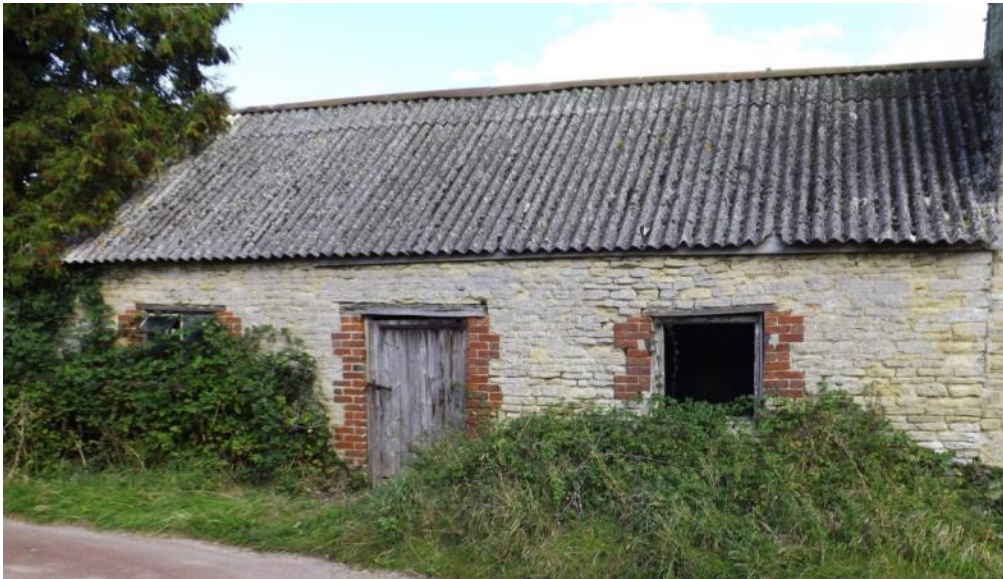
A single storey building constructed of coursed limestone with red brick dressings to the door and windows, all set beneath oak lintels 10.9m x 3.8m internally (Figs 5 and 12). The barn has three free-standing walls, the fourth is the north gable end of the principal Barn A. The roof is currently covered with corrugated asbestos sheeting. Accessed only from the west side through a centrally placed doorway fitted with a single leaf door comprising vertical planks, ledged and braced internally

hung on simple iron hinges a closed by a simple drop latch. The window openings are fitted with, to the north of the doorway, a Critall style cast metal glazing frame and to the south of the doorway a timber frame, now only retaining the frame, all of the glazing bars being broken and missing.

Fig 12: Barn A, north annexe, front (west) face; Barn A to right

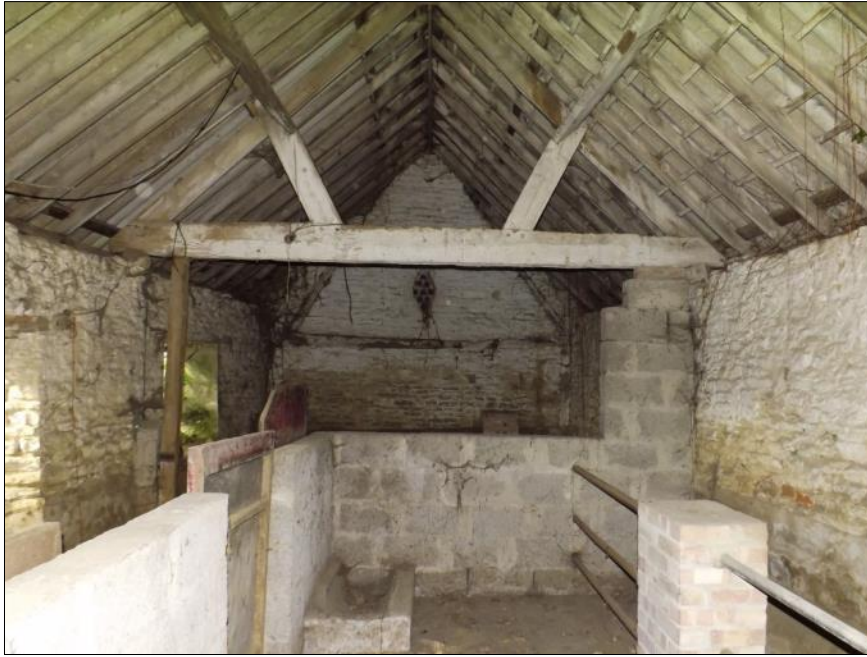
Internally the annexe was probably built originally to serve as a cattle shelter since there is evidence for a manger against the east wall where stumps of timbers remain in the wall. The floor is of concrete (Fig 13). Latterly the building was used to house pigs and the internal space was divided into three separate pens with a small passage adjacent to the doorway formed by low walls of concrete blockwork fitted with wooden doors covered in metal sheeting (pigs being renowned for chewing wood). The two southern pens were fitted with farrowing bars, hollow section iron bars set in blockwork pillars which allowed the piglets to get away from the sow and probably to lie beneath a heat lamp. Farrowing bars are considered an essential part of modern pig-sties since sows and notorious for lying on and smothering small piglets. Each pen was furnished with a small trough made from a salt-glazed half-section drain pipe laid on its side and set in cement with a metal water trough positioned close by.

Fig 13: Barn A north annexe, interior, looking north

The roof comprises two simple pine queen-post trusses with raking struts originally covered with tile or slate, the laths still remaining in a few places (Fig 13).

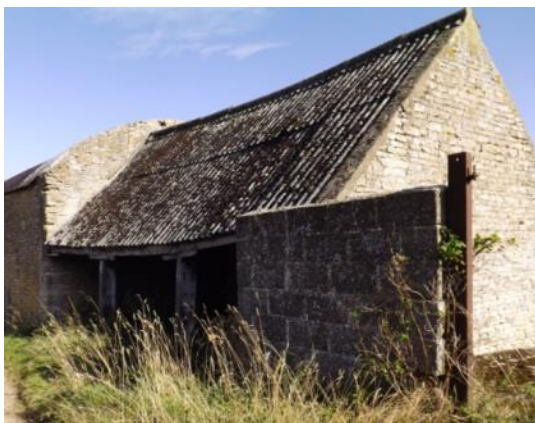
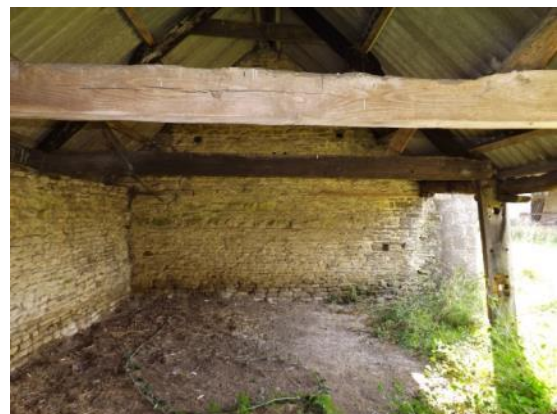
This comprised an earthen-floored cart hovel constructed of coursed limestone consisting of two walls laid in an L-shape with the third enclosed side formed by the southern end of Barn A and with a west-facing open side; it measured 7.9m x 5.0m internally (Figs 14, 15). The external face of the east side had been refaced in block-work. The open side comprises three bays divided by two posts made from reused railway sleepers supporting the wall plate. The roof is of pine queen post trusses with raking struts which support four thin purlins on either side.

Fig 14: Barn A south annexe, exterior

Fig 15: Barn A south annexe, interior

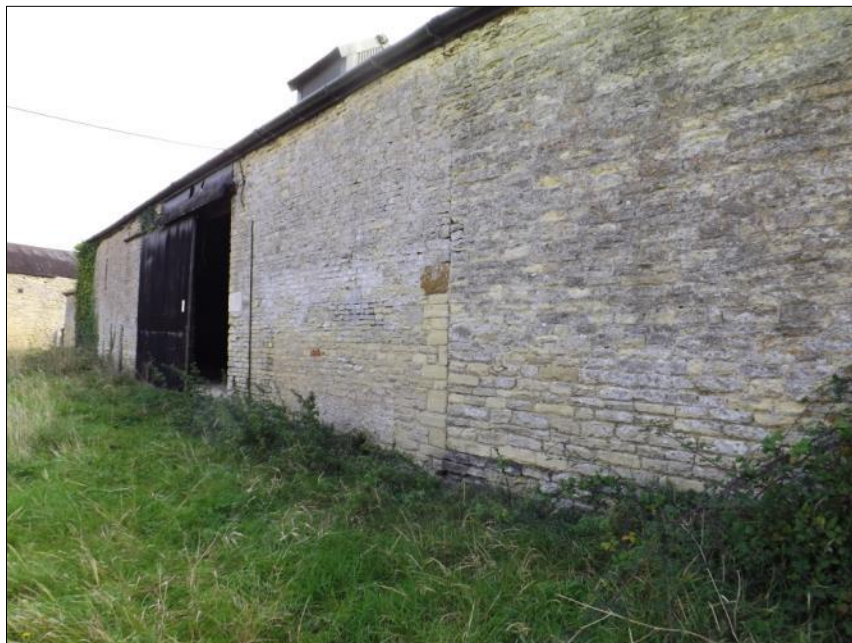
This was a large rectangular barn constructed of coursed limestone bonded in lime mortar aligned east-west and measuring 17m x 6.1m internally (Fig 16). It is entered through opposed cart doors on north and south; that on the north is un-altered and of almost the full height of the wall while the southern door has been widened as evidenced by a change in the coursing of the stonework to either side and vertical cracks where the new reveals have not been fully tied in to the original work. The northern doorway currently has a sliding door fixed on an iron rail set into the wall above the opening, the door supported on metal wheels currently covered with corrugated metal sheeting. The southern doorway is currently fitted with corrugated metal sheeting fitted to a fixed pair of horizontal timbers and does not open. It is uncertain what the original width or height of the southern opening was and it has subsequently been further altered by the insertion of brickwork at the base of the opening due to the higher level of the ground on the exterior of the south side.

Fig 16: Barn B, north side, looking east towards Barn A; west annexe (butt joint) on right

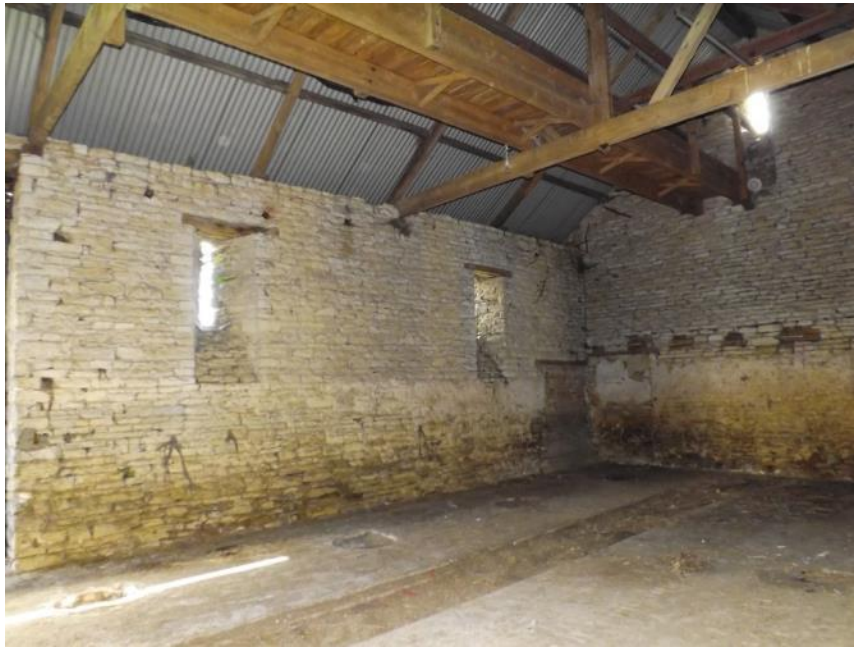
The floor of the barn is concrete and retains the scars of settings for what appear to be grain bins or silos set out either side of a recessed central channel of unknown depth. This is further supported

by the presence of a high level walkway made of pine which is seated on the upper surface of the tie beams of the roof trusses and appears to be present to allow either physical or visual access into the upper level of the former silos or bins (Fig 17). Probably contemporary with this raised walkway is a louvred roof vent supplying further ventilation. The roof structure itself, which appears to be original, comprises king post trusses now covered by square-section corrugated metal sheeting.

Fig 17: Barn B interior, east half. Note original ventilator windows, the high walkway and the silo/bin slots in floor

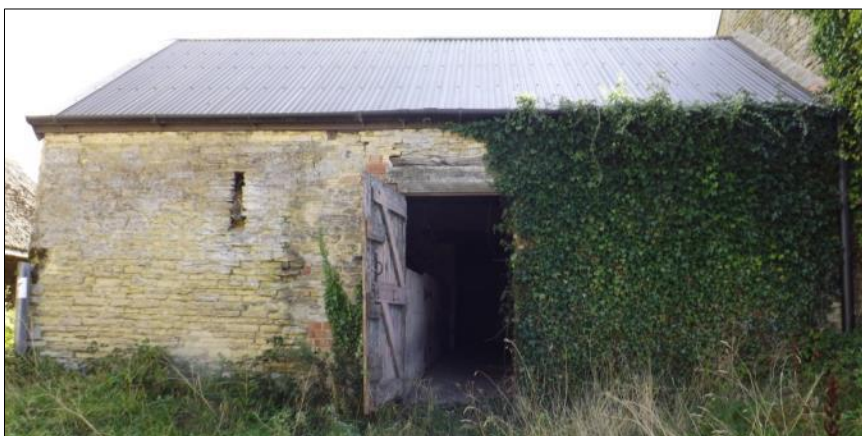
A coursed stone single storey building constructed against the east end of the main barn B, 7.7m x 4.8m in size internally (Fig 18). It has two vertical splayed air vents in both the north and south walls as well as a larger glazed metal framed window in the east gable, though this appears to be a secondary insertion.

Fig 18: Barn B, east annexe; view of front (north) face

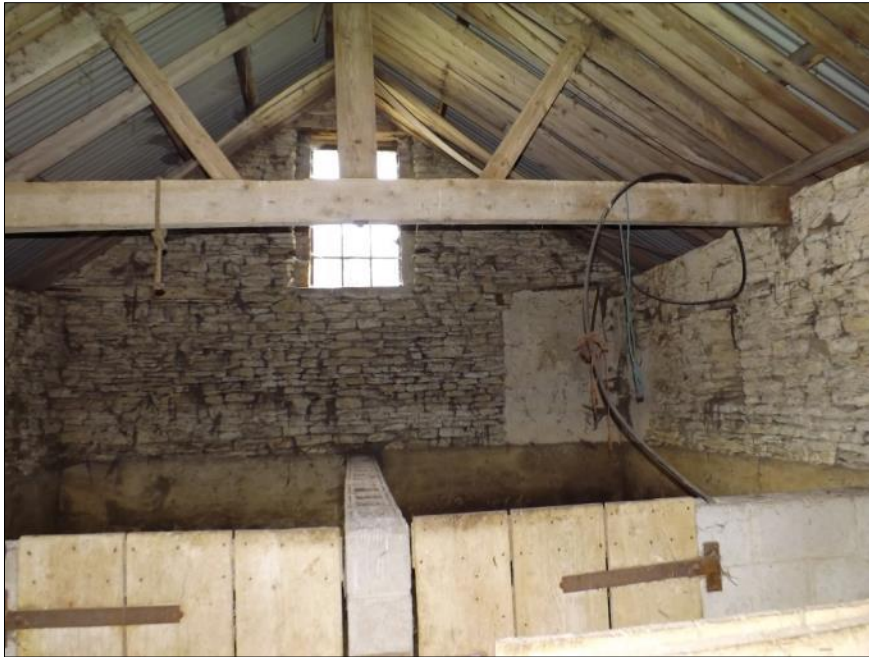
The present floor is of concrete and the roof is a pine king post truss with raking struts currently covered with square section corrugated metal sheeting. The underside (internal surface) of the roof has been boarded with tongue and groove pine planks which suggest a higher level of finish and insulation which might indicate that this was originally the piggery mentioned in the 1886 sale particulars since pigs are rather more susceptible to cold and draughts than horses or cattle. At a later date the barn has been subdivided by the insertion of blockwork walls to create four equal sized pens, each fitted with elm board doors and equipped with concrete troughs.

Fig 18: Barn B, east annexe; interior

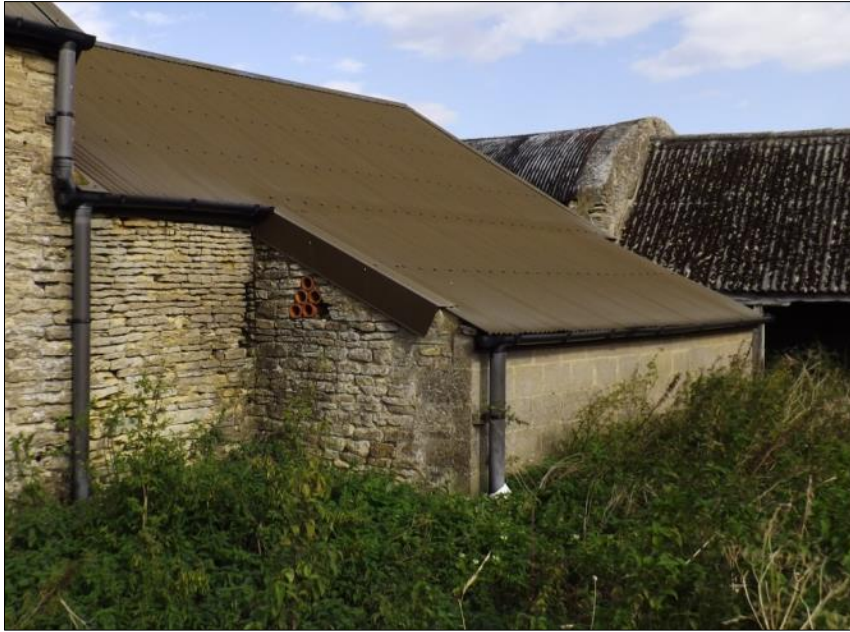
Built against the south side of this annexe is a further, later addition (Fig 19). The two gable walls (east and west ends) are constructed of coursed limestone with circular section red clay field drains set into the gables for ventilation and decoration while the south side is of modern blockwork. It is not clear if this was originally built with just the two gable ends and the south side was open-fronted or if the south blockwork wall is a modern replacement of a collapsed section. Internally the structure is plain.

Fig 19: Out-shut on the rear of Barn B east annexe

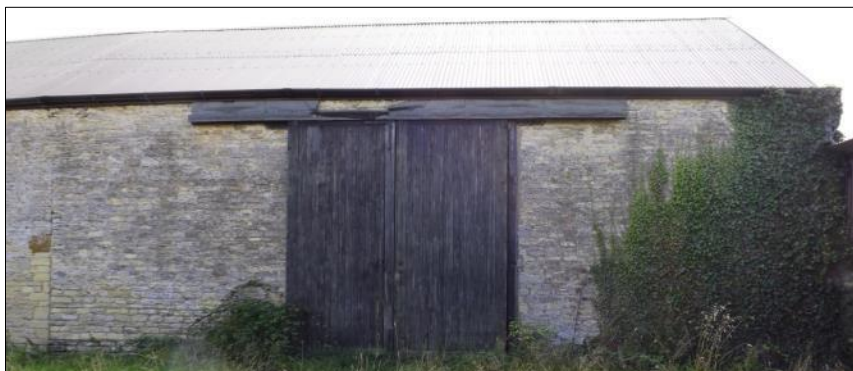
Built of coursed limestone bonded in lime mortar this barn is identical in width to the first Barn B and 11.2m in length (Fig 20). It has two doorways opposite each other in the north and south walls, that on the north side is fitted with two timber sliding doors hung on an iron rail set above the timber lintel, the southern doorway has been blocked with modern, Fletton, brickwork. There are no ventilation slits or window openings suggesting that this was a storage rather than livestock barn, although even in storage barns some ventilation is usual to prevent the stored materials becoming stale. The floor is of blue engineering paviments and the only other feature is the blocked doorway which formerly led into the central barn. The walls have been covered in a cement render suggesting that in its recent past this barn was used for the storage of grain, the covering of the walls with this smooth, impenetrable covering, an attempt to prevent rodent ingress.

Fig 20: Barn B west annexe

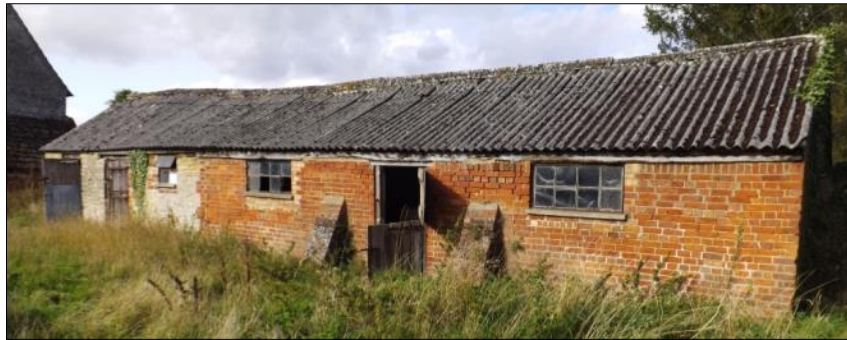
This structure lies on the north side of the farmyard and comprises a single storey livestock building, partly stone and partly brick (Fig 21). The north, west and western end of the south wall are of coursed limestone and appear to be original, the remainder of the south wall and the east gable wall are of red brick and have been rebuilt. There are two doors in the south wall, one in the stone section and one in the brick. The surviving stone section at the west end was originally a single, separate room but has subsequently been joined to the remainder of the building by the insertion of a doorway against the south wall. This single room may be the loose box referred to in the 1886 sale particulars.

Fig 21: The so-called Barn C, looking north. The gable of Spring Hill farmhouse is to the left

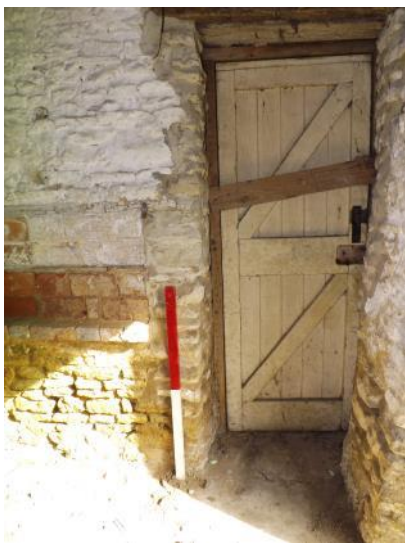
At the far western end lies a separate room unlike the remainder of the interior. The walls are of limestone to the south and west where there is a small window fitted with a simple wooden frame. The north and east walls have a band of red brickwork laid on edge which appears to be either infilling of a shelved area or patching for a reason which is unclear. It is of a size and fabric which suggests a nineteenth-century date and may have been inserted when the eastern section was rebuilt in brick. The internal doorway which now links this room to the remainder of the range is a modern introduction, with poorly finished jambs and the stone re-set in hard, Portland type cement.

Fig 22: Barn C, west room, interior; note the brick-blocked band at 1m high

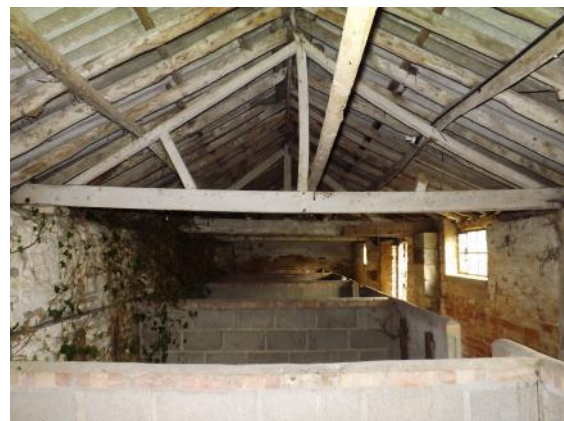
Fig 23: Barn C interior with pig pens

The eastern portion of the range is a single space which in its latest phase was sub-divided by low blockwork walls providing individual pens set on the north side of a corridor which is located along the south side of the range, accessed via the doorways. This range was most likely for the housing of pigs (Figs 5 and 23). Each is provided with a small concrete trough and water. The floor is of concrete throughout. The door at the western end is a single leaf pine door of simple ledged and braced construction with standard iron strap hinges and drop latch, the eastern door is a two leaf stable door, each part similarly ledged and braced with similar ironwork. The windows are mid twentieth-century Critall-type metal windows. The roof is poorly made of quartered pine timber, some of which still retains its bark and which has had little attempt at finishing. There are three trusses and the roof is covered by Trafford tile.

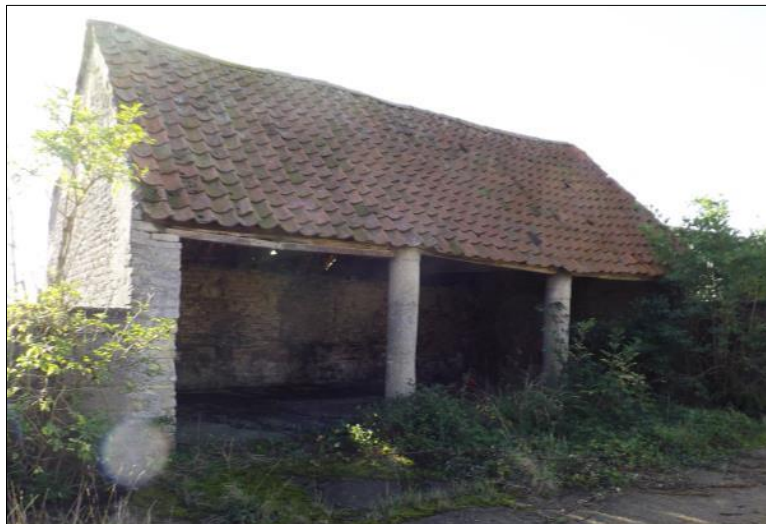
This lies to the south-east of the main group of barns and comprises a simple structure built of coursed limestone and open to the north, typical of a cart hovel (Fig 24). This orientation militates against the expansion and shrinkage of timber joints.

Fig 24: Barn D, a cart-hovel, looking at its open north face

There is, unusually, a blocked owl or ventilation hole in the east gable, a seemingly unnecessary inclusion in a structure which has one entirely open side. The hovel is of three bays with two trusses which are of elm and comprise raking queen post construction. Each truss is supported on concrete pillars which clearly have been inserted beneath the trusses and replace original posts or possibly brick or stone pillars (see below, second cart hovel). Each has clearly chiselled carpenters marks cut with a flat chisel (Fig 25), the westernmost truss retains the sequence I, II, III, IIII and V whilst the easternmost the sequence I, II, III and V suggesting that they may have been reused or reconfigured. Both sets of carpenters' marks are on the eastern face of each truss. The roof has two purlins on each side, clasped at the apex with a ridge plank to just the rafters but not the trusses which do not reach the ridge, further supporting the view that this is a reused roof structure made to fit the current building. The whole is covered in red clay pan-tiles and the floor is of concrete. Connected to the north end of the west wall is a blockwork yard wall section which corresponds to that added

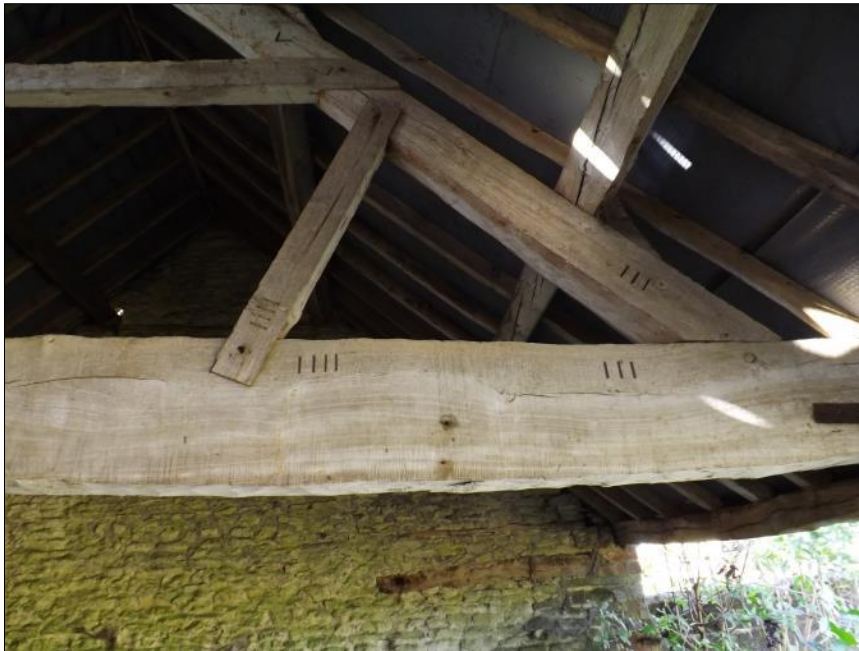
Fig 25: Roof truss in Barn D, showing carpenters' marks

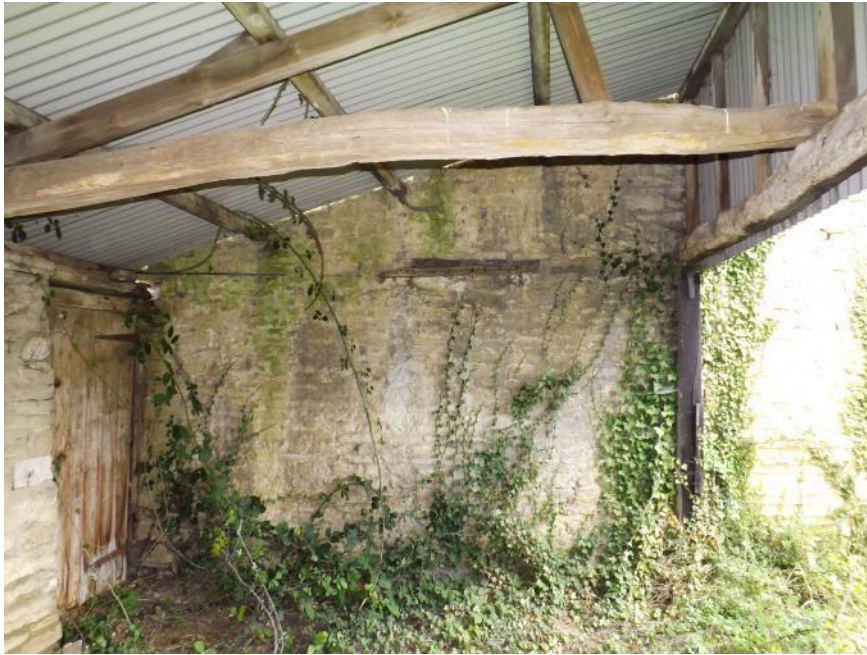
This cart hovel is located close to the farmhouse and as such might have housed domestic rather than agricultural vehicles. Construction of the building is purely functional, being constructed of coursed limestone on the south and west sides with simple butt joints where it abuts the adjoining buildings (Fig 26). There is a single lime mortar rendered stone and/or brick pillar centrally placed on the east side which divides the hovel into two broad bays. It is covered by a very simple single fall pine roof covered with corrugated metal sheeting and the floor is of rammed earth. A doorway in the west wall is currently blocked but as there is no frame this appears to have been simply an access way through to the space beyond.

Fig 26: Cart hovel adjacent to the farmhouse
