## A Heritage Asset Survey of the former 3 Tuns Public House, Whittall St, Kings Sutton

## A Heritage Asset Survey of the former Three Tuns Public House, Whittall Street, King's Sutton, Northamptonshire

### Summary

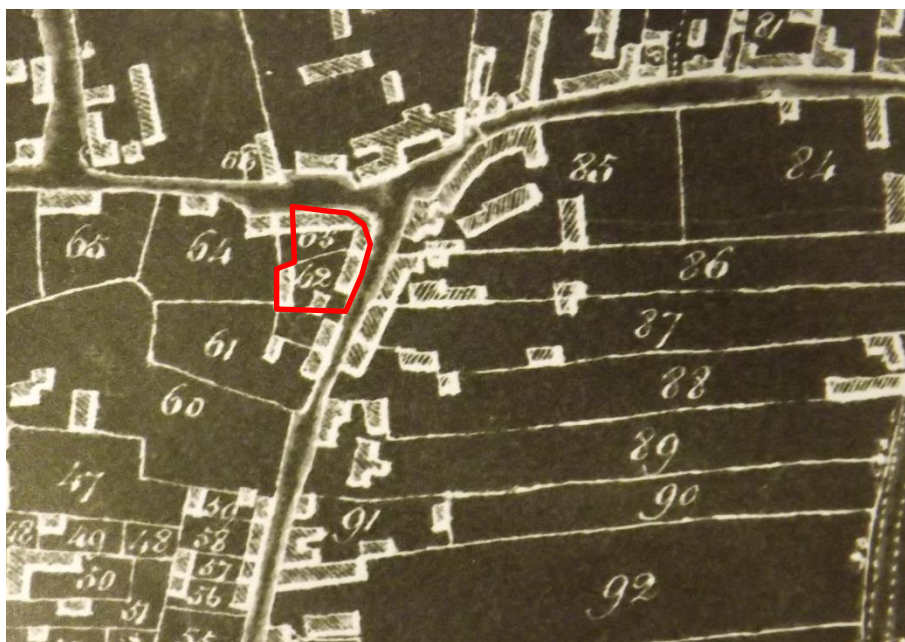
Fig 2: Kings Sutton Inclosure map, 1805 (NRO: Map 2994)

The earliest detailed map of the village is the 1805 Inclosure map. On the 1805 Inclosure map the site is part of two separate properties, both of which were described as house and garden on the accompanying schedule. The current public house car park north of the pub was occupied by a long range of buildings fronting onto Bulls Lane. The pub was named as the *Three Tuns* in the 1827 alehouse recognizances for the district; the proprietor was Alice Jennings (NRO: Box X2333).

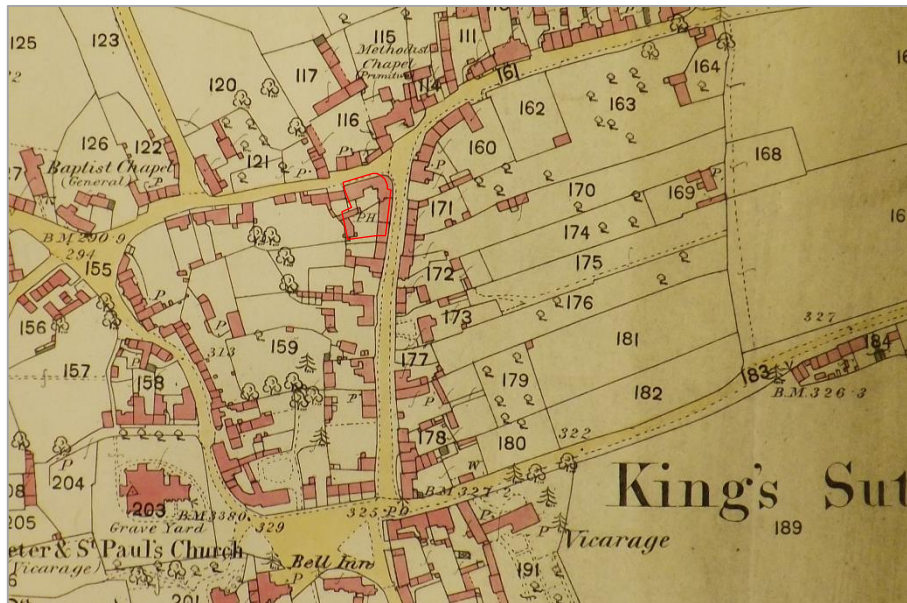
Fig 3: First Edition Ordnance Survey map, 1884

In Whellan's Directory of 1849, A. Jennings, victualler was listed as the proprietor at the Three Tuns, presumably the same Alice Jennings as in 1827, although by 1869 it was Robert Fathers. The pub is marked (PH) on the First Edition Ordnance Survey map of 1884, although it is still shown as two separate buildings with only the northernmost building marked as a public house (Fig 3). By 1900 the pub is marked as a single building for the first time (not illustrated). By 1922 the building situated on the corner of Whittall Street and Bulls Lane had been demolished.

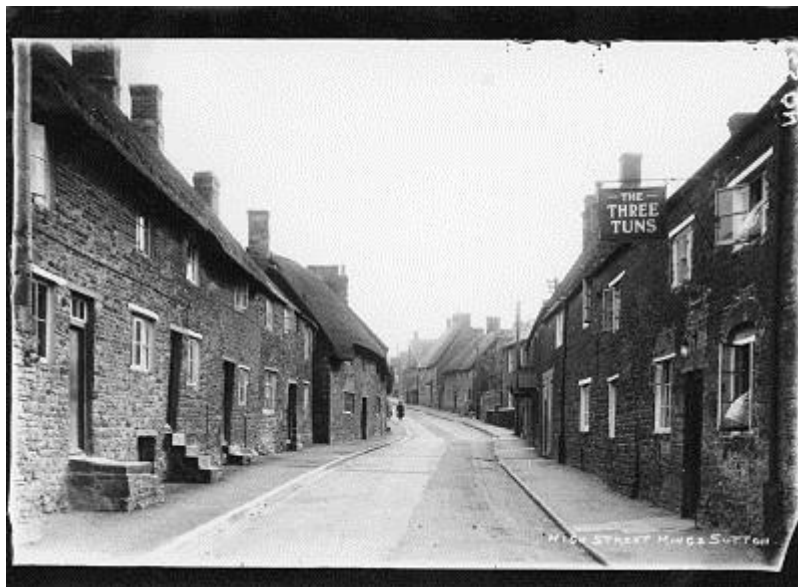
Fig 4: Photograph of the Three Tuns, looking south along Whittall Street, late 19<sup>th</sup> century/early 20<sup>th</sup> century

A historic photograph of the pub frontage indicates that it has undergone very little exterior alteration on the front since c1900. It is not clear from the photograph in Fig 4 whether the Sun Fire Insurance plaque was present at this date.

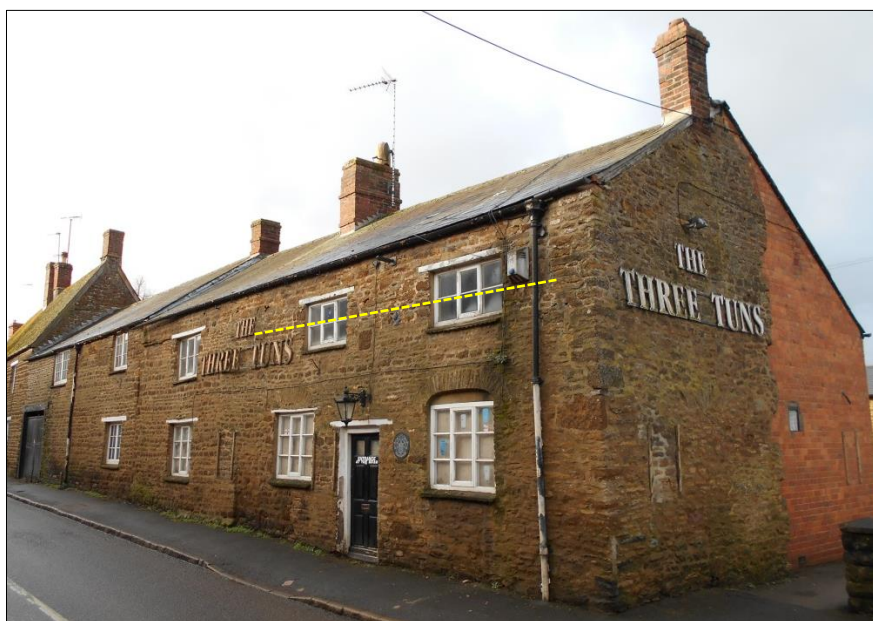
The building appears to be in two distinct phases of development, the earlier of which appears to be the northern half. The later phase comprises rooms and a through-carriageway on the south.

Fig 5: Three Tuns' long building frontage, from across the road. The earlier phase is nearest the camera. Note the through carriageway at far left. The dotted yellow line marks the stonework change where the original eaves were raised and the current windows cut.

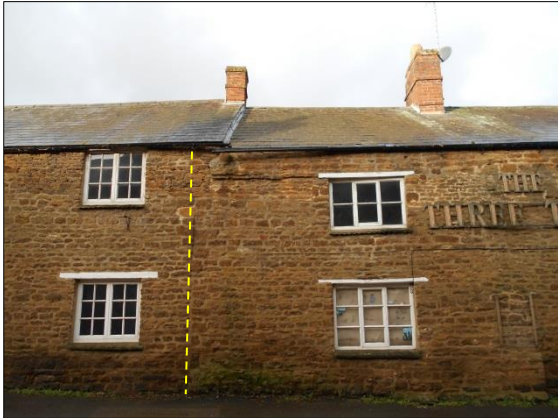
Fig 6: The junction between phase 1 and 2

A stepped-out notch in the front wall stonework just south of the principal block suggests that there may have been a major alteration or re-build, for reasons unknown, where the building range contains an inglenook fireplace and chimney. This whole block may be an extension although an absence of a clear joint might suggest it began as a planned ancillary block.

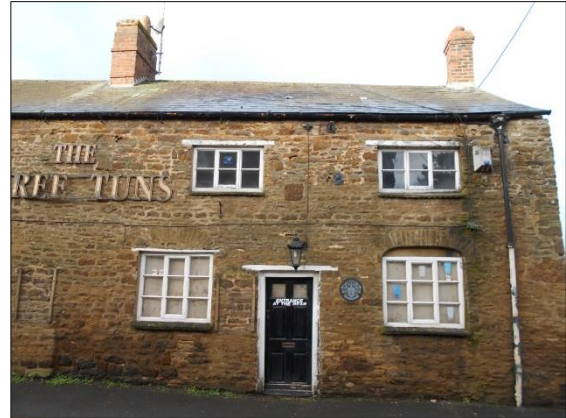
Fig 7: The old core of the building (1690)

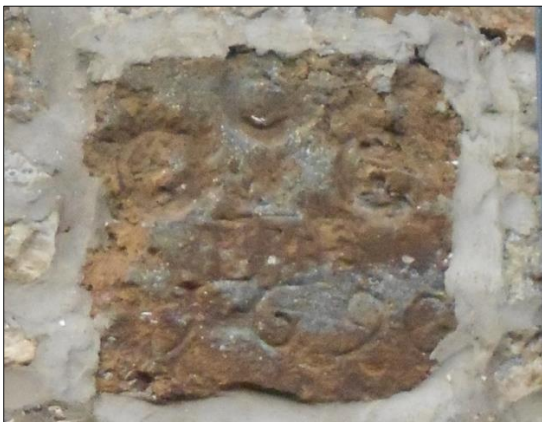
The old core of the building bears a date-stone of 1690, with a stylised (and weathered) three circles, taken to be the three tuns or barrels of the former pub name, suggesting it might have been built as an inn from the start. It also carries a Sun Alliance fire insurance plaque with the number 93148. This may be a leftover of the memory of the Great fire of King's Sutton (1785) but equally may not be original to the building and may have been moved as they have become sought-after antiques in recent decades. Relevant online records held by The National Archives and Northamptonshire Record Office have been consulted but no record of early Fire Insurance has been found for the building.

Fig 8: date-stone of 1690 with three 'tuns'

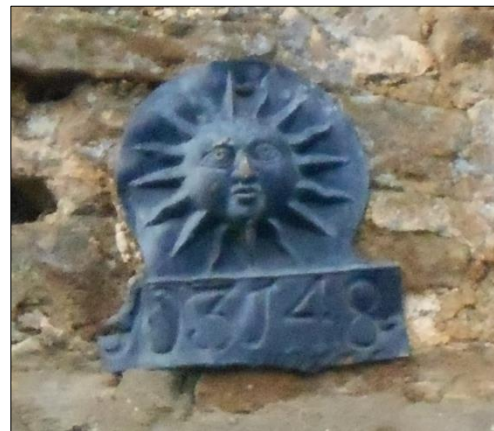
The pub frontage has a sign for the Sun Office attached to it (Fig 9). The sign indicates that the building it was attached to had fire insurance, although it is not known whether the sign relates to the Three Tuns or whether it has been attached at a later date from another building. No evidence for an insurance for this building has been found in the relevant archives. The Sun Insurance Office was established as the Sun Fire Office in 1710, working initially in London but expanding throughout the country via a network of provincial agents by the later 18<sup>th</sup> century.

Fig 9: Fire Insurance Plaque

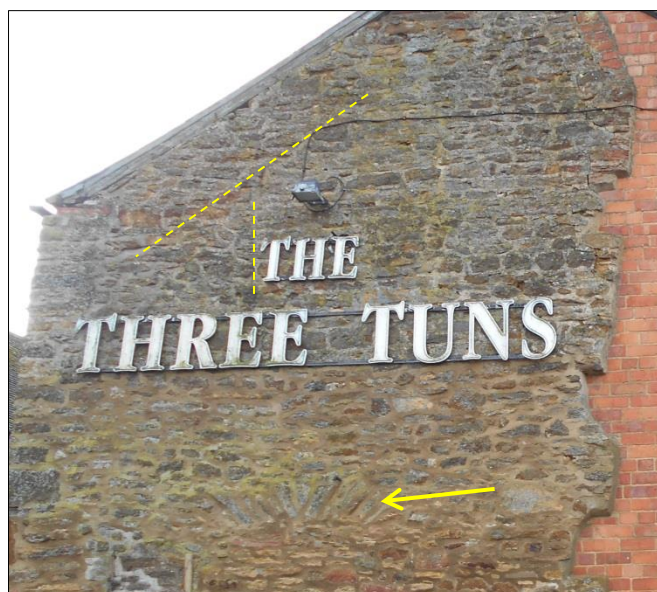
The building probably once had no proper first floor, but was most likely a floor in the eaves, with dormers, under a thatched covering. The thatch has been lost. The roofline has since been raised, as is indicated by changes in stonework under the eaves at the front façade, together with a change in the size of quoins at the front corners. Most telling is the angle of the old roofline visible in the north gable.

Fig 10: the former roofline in the north gable; a butt-joint may mark a former window, or possibly an attic-level hatch into the lost adjacent building; note also the blocked window or fireplace lintel arch on the ground floor (arrowed)

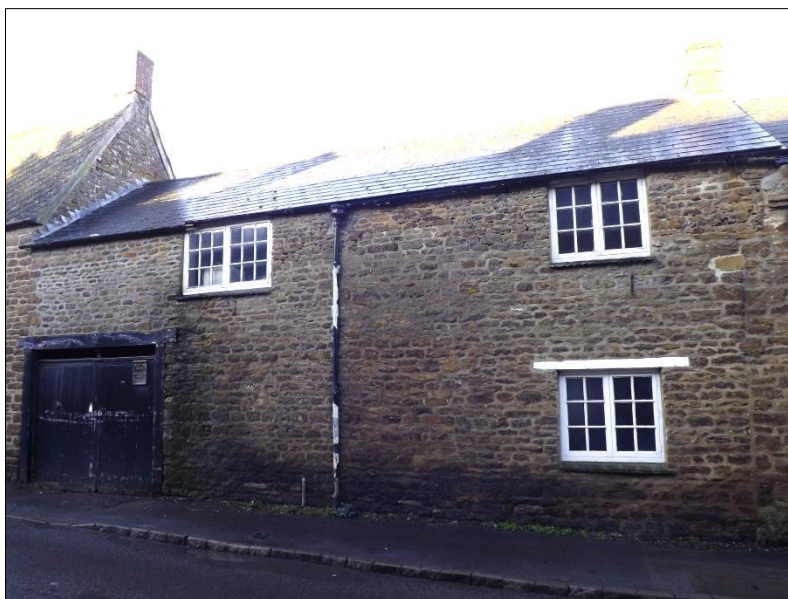
The secondary block on the south probably once housed stabling, staff, and incorporates a carriage-access to the yard behind. It is very plain externally and seems never to have had any other access, either onto the street or the yard behind. None of the windows appear to pre-date the later 19<sup>th</sup> century and may be later. There is a wide variation in pointing detail on the stonework of the rear, so the lack of evidence for any blockings may not be conclusive. The early maps show that this was once a separate property, becoming subsumed by The Three Tuns in the period 1884-1900. As a formerly separate (possibly domestic) property no separate documentation has been found. Its interior now owes little to this former identity.

Fig 11 : The plain front of the former added service range with carriage entrance. Note the butt-joint at the right.

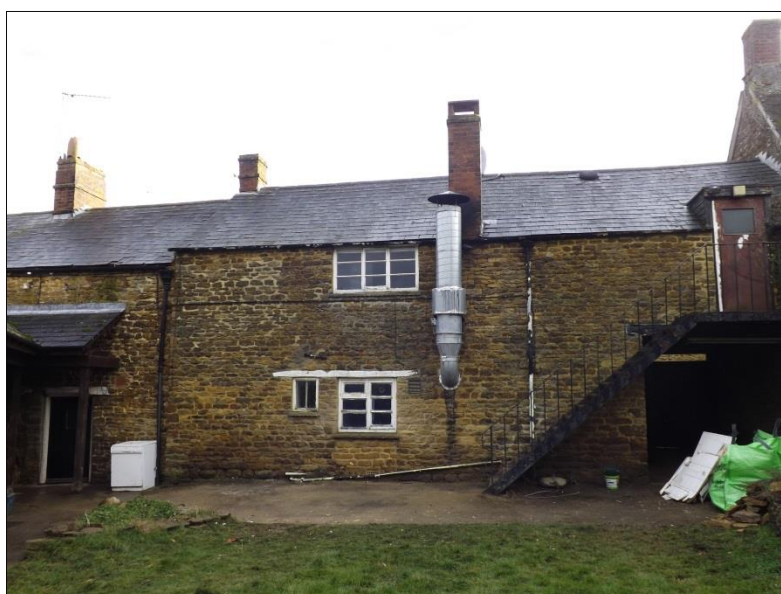
Fig 12 : The rear elevation of the service range; the main block is covered by 20<sup>th</sup>-century accretions at the north end

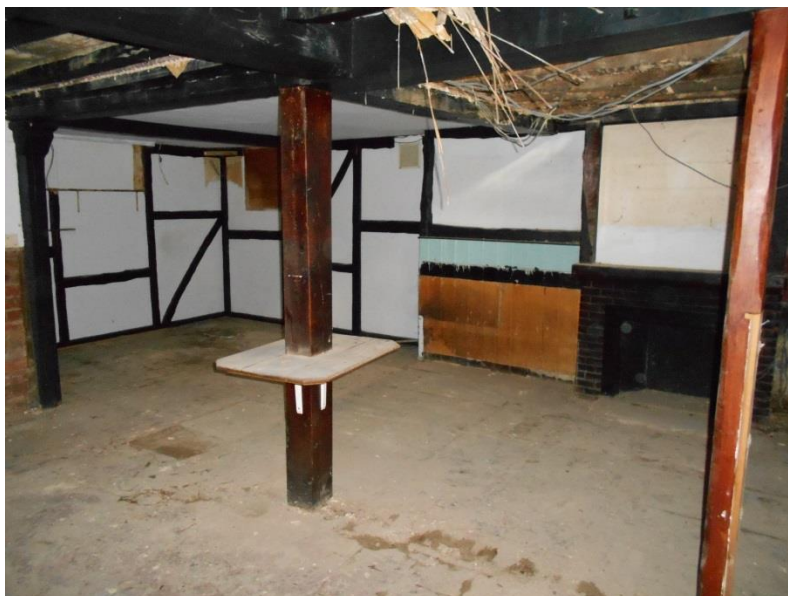
Entering through the former pub's front door on Whittall Street on the east, the main public bar took up most of the block. Once there may have been five rooms (G1-G5), but these had all been knocked into one, the interior having been given over to mock-Tudor applied decorative beams, redolent of box-framing in perhaps The Warwickshire Arden or the Cheshire plain, but totally out of place in the Northamptonshire stone-belt any time after the 17<sup>th</sup> century. Only the axial spine beams of the ceiling and a few joists are any older. A vestige of reed plaster in the ceiling above G5

Fig 13: The main pub interior; all internal walls taken out to improve circulation and finished with inappropriate decor

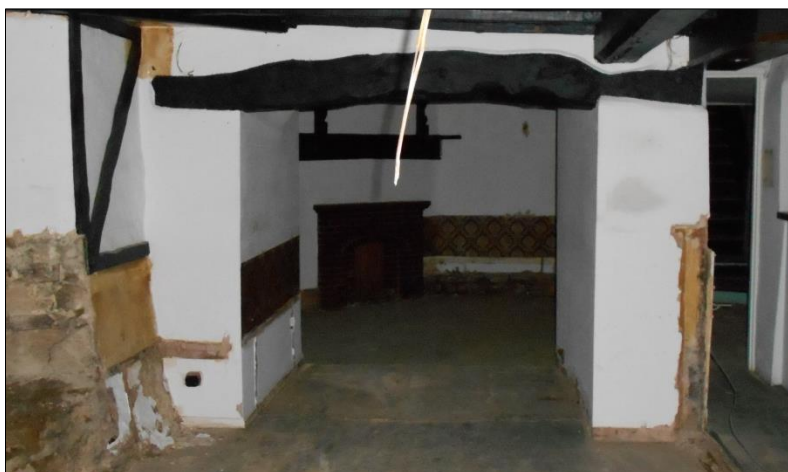
A large former inglenook fireplace marked the other end of the main block between G5 and G6, although this had been knocked through the former end wall to improve air circulation and provide views through the length of the block. Where the original stair once stood, to its side, was until recently the bar, together with a narrow passageway through into G6. A blocked rear door and adjacent window show that G4 once opened and looked out onto the rear yard, but these were blocked to create the pub bar. They may originally have served the foot of the first stair.

Fig 14: The knocked-through inglenook from the front (G5). The stair one stood to the right. Note the spit-rack (see below), glimpsed in G6 beyond

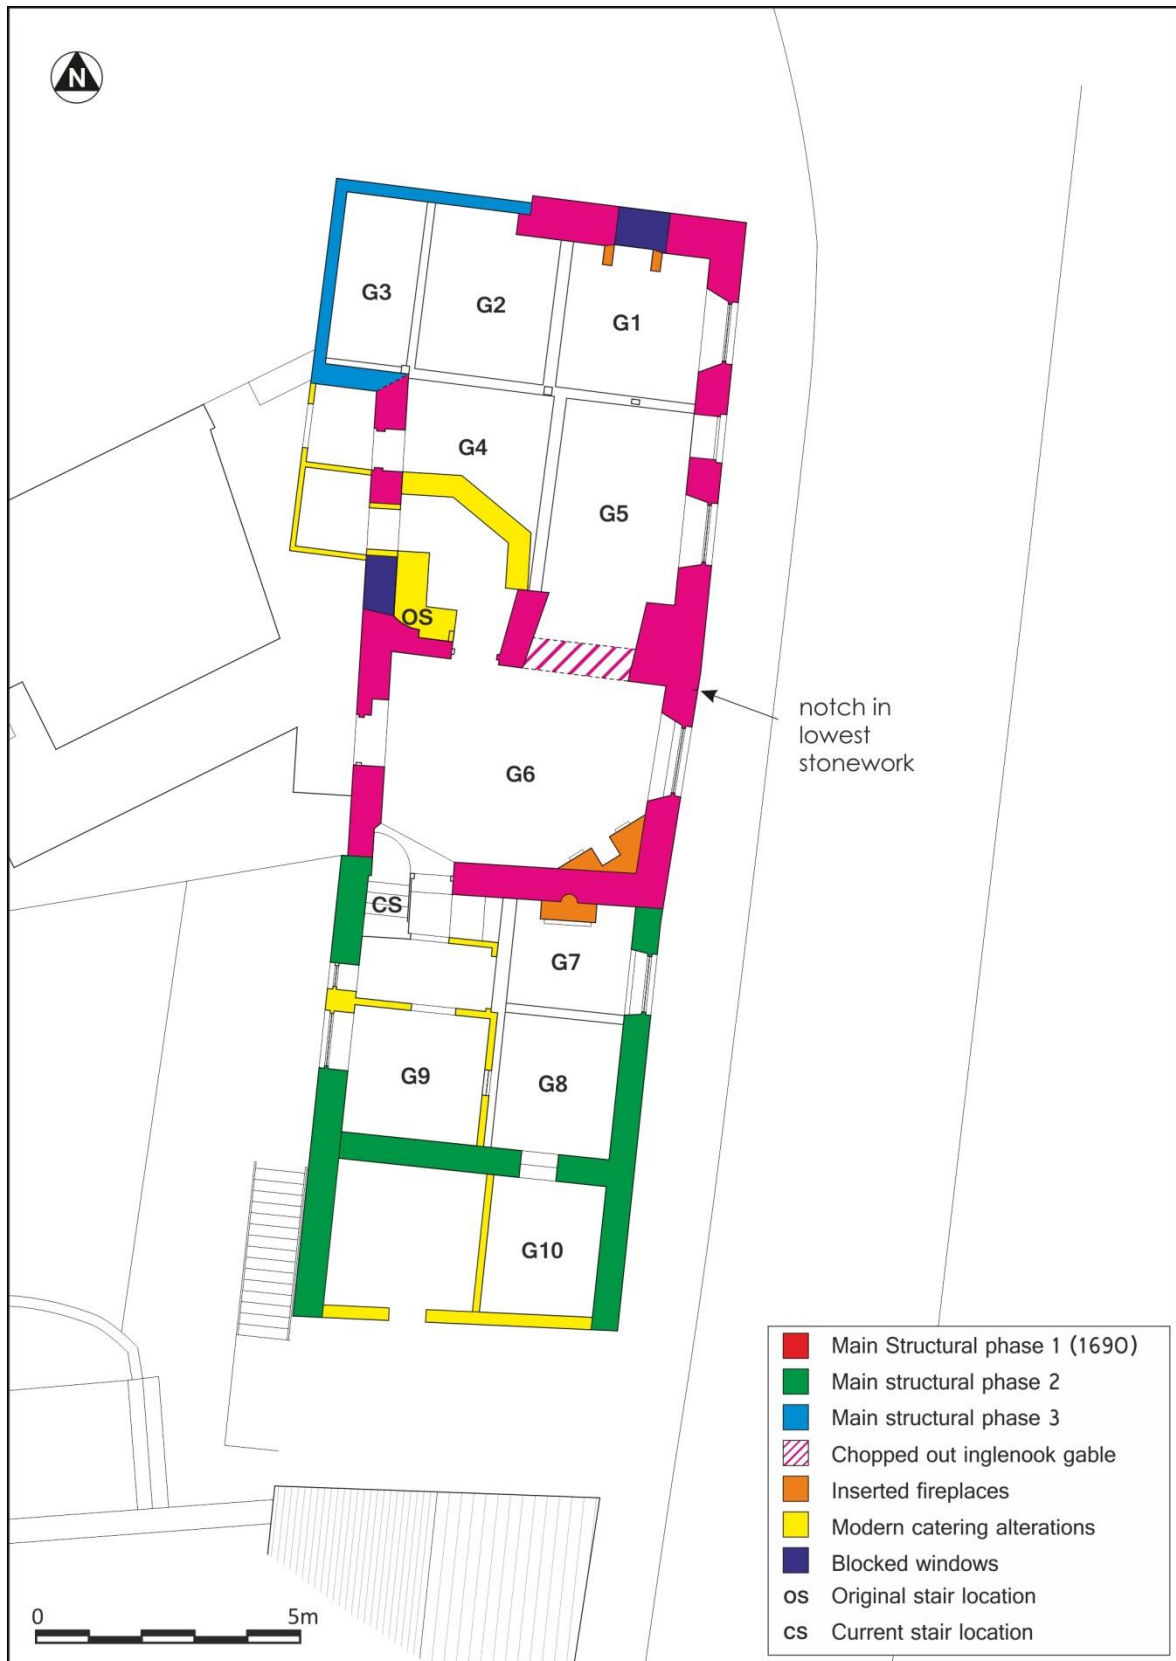
Fig 15: Ground floor, phased; after Roger Coy Partnership

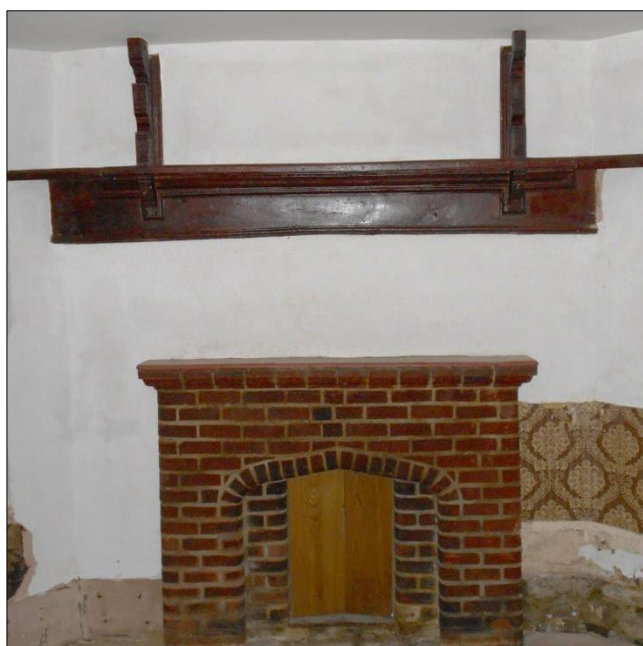
Room G6 is plain, distinguished only by an added corner brick fireplace. This has a late 'Arts and Crafts' styling surround and mantelpiece, and so perhaps of inter-war date at the earliest, but just as possibly a modern revival piece. Above it is mounted an 18<sup>th</sup>-century oak spit-rack (for storing cooking spit parts; Ayres 1981, 30 fig 17). Local examples have been recorded at Cogges Manor Farm, and Great Haseley Oxon (Steane and Ayres 2013, 262, 427). While there is insufficient room for it ever to have been mounted above the inglenook, its natural home, its present location is above a fireplace potentially too small to have ever been used for cooking. It is therefore either in an unnatural mounting location or (possibly) has been brought in as an antique feature from elsewhere, either in the room or another building. It is also possible that it is *in situ*, and that the fireplace masks a larger, older cooking range location, to which the rack does in fact rightly belong.

Fig 16: G6 – Small corner fireplace and oak spit-rack above.

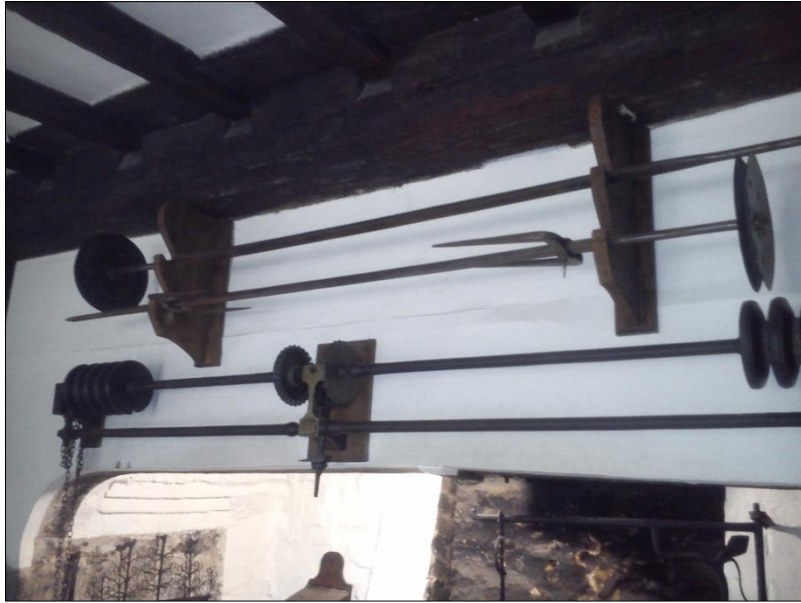
Fig 17: A fully-restored spit-rack, for public consumption at a Shakespeare Birthplace Trust property, Stratford upon Avon.

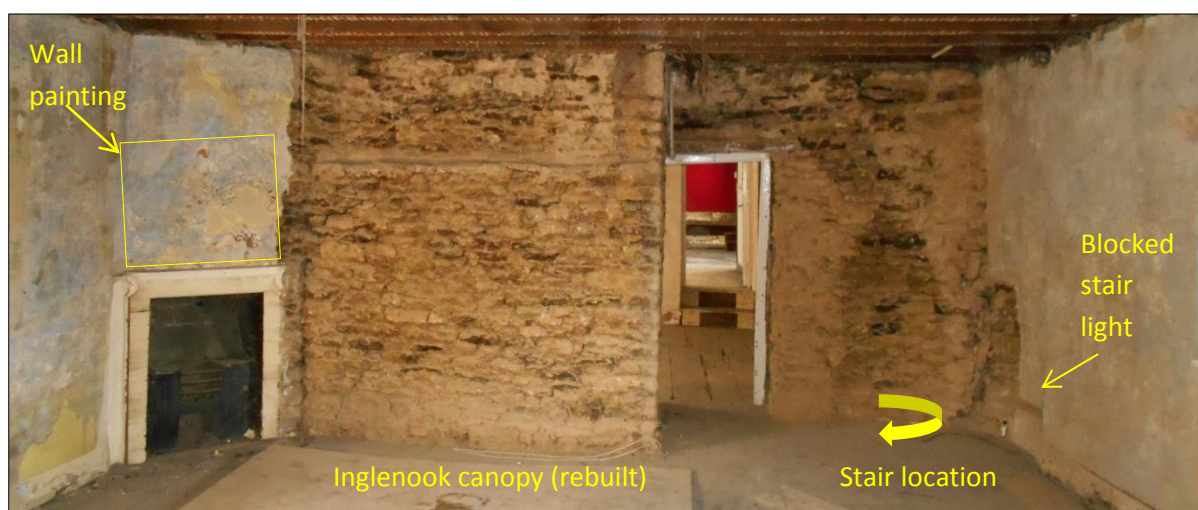
The corner fireplace had side-pieces in brick but it contained a plain Regency cast-iron hob-grate and fire-basket, of perhaps 1820-30, decorated only by a Greek key-fret design, lending it an air of the contemporary Greek-revival (Ayres, 1981, 54; Calloway 2012, 187). Above this were glimpsed patches of an overmantel polychrome wall-painting covering an area c1m x c800mm beneath limewash layers and wall-paper.

Fig 19: the south side of room F3; fireplace and wall-painting to left, stair to right

It is unclear what the over-mantel wall painting depicts. It may be religious or secular. In date it is probably contemporary with the fireplace, which probably predates the subdivision of the upstairs rooms. The fireplace may be as early as c1780 (and one must keep in mind the fire which destroyed a huge part of the village in 1785), although the regency detailing the hob-grate and fire-basket suggests the whole assembly is as late as c1830.

However, it is notable that Mr Cox in his new offices has undertaken to retain the chimney-piece plaster *in situ*, on which the wall painting is drawn, and protect it through the remainder of the works. Thereafter, it will either be retained beneath dry lining for future attention, or further uncovered, consolidated and conserved by an appropriately experienced conservator.

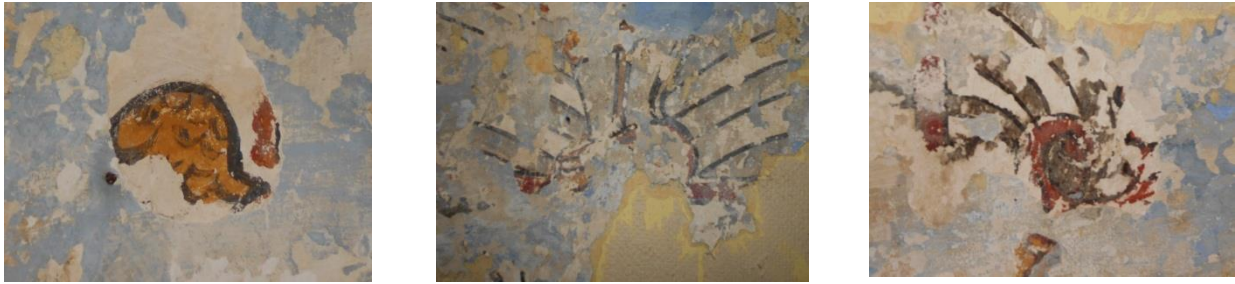
Fig 20: Three details from the overmantel wall painting (L-R)– a ?cherubic wing?, a ?sunburst motif?, a classical volute in red with fan-trails
