Iain Soden Heritage Services Ltd

A programme of archaeological observation and
recording at 20 Denford Road, Ringstead,
Northamptonshire

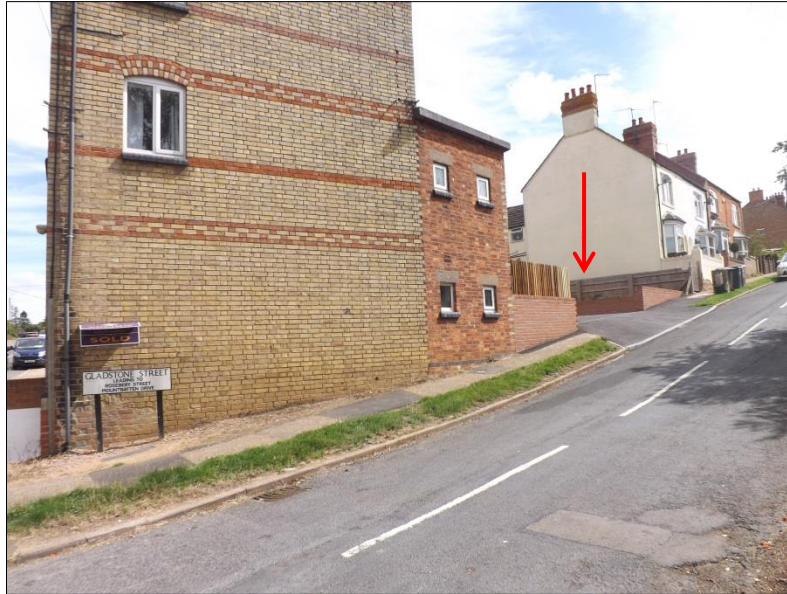
As the mound of debris began to be cleared it became apparent that the groundworks for the car park had cut deeply into the steeply sloping ground which had previously characterised the back-plot of Britannia House and which still characterises the steep hill up which Gladstone Street is aligned at right-angles to Denford Road (Fig 2).

Fig 2: Gladstone Street; Britannia House to left. The entrance to the recent car park is arrowed.

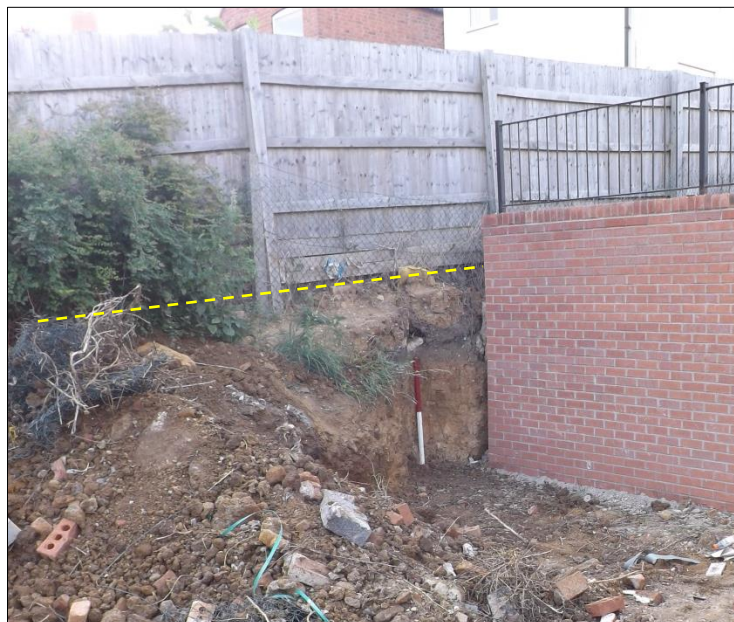
The old terrace cut was clearly visible in the back of the current plot, where it was clear that the level of the natural geology had been reduced by over 1m (Fig 3). This terrace extended across the length of the proposed house in the current development

Fig 3: The earlier terrace being uncovered by the removal of builders' rubble; scale 1m. The dashed line shows the old ground surface cut back to build the car park wall.

This terrace strongly suggested that any archaeology which may have existed would have been lost in such earth-moving. Accordingly it was agreed that foundation trenches should be dug immediately in order to check for the survival of any former ground surface from front to back of the site.

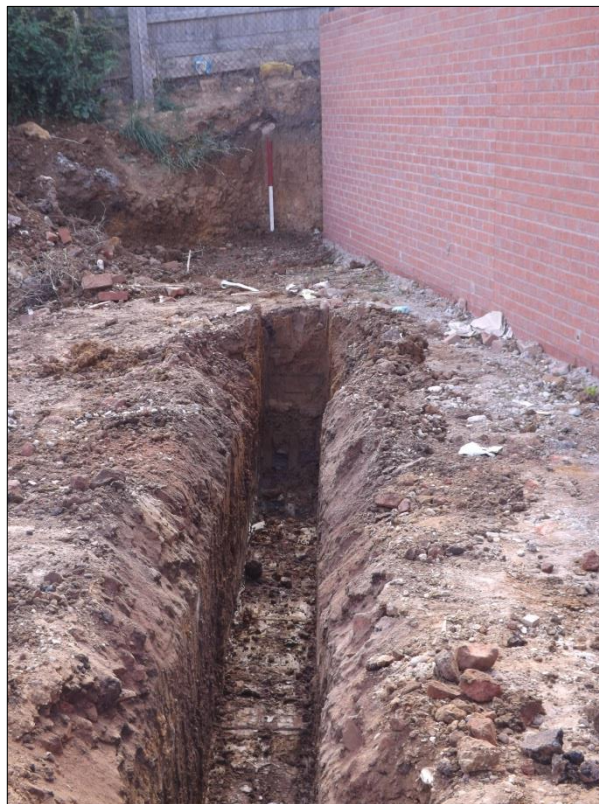
The foundation trenches showed that under the gravel hard-standing on which works were located (and upon which the builders' rubble lay), lay only reduced natural geology (Fig 4). Seemingly the gravel surface had been put down after the truncation had taken place, perhaps for a builders' compound. At the front of the site was a deep pit containing brick and concrete, indicative of a large modern disturbance at depth. Plans show that the front of the site also contains a deep mains sewer. At this point the programme of observation was curtailed as no archaeology stood a chance of coherent survival.

Fig 4: View east along the southern side of the new house foundations, showing the extent of truncation in the existing terracing behind; scale 1m
