**A Heritage Asset Survey of the former village bakery
at 38, Causin Way, Lower Benefield,
Northamptonshire**

Recording shows that this small Grade II Listed cottage of c1700 was much altered and enlarged when it became the village bakery between 1850 and 1864 a function it fulfilled c1903. Evidence survives for its structural alteration (set out below), but it lacks any all but a very few architectural details of note. It is dominated by its extraordinary baker's oven which gives the present cottage its character.

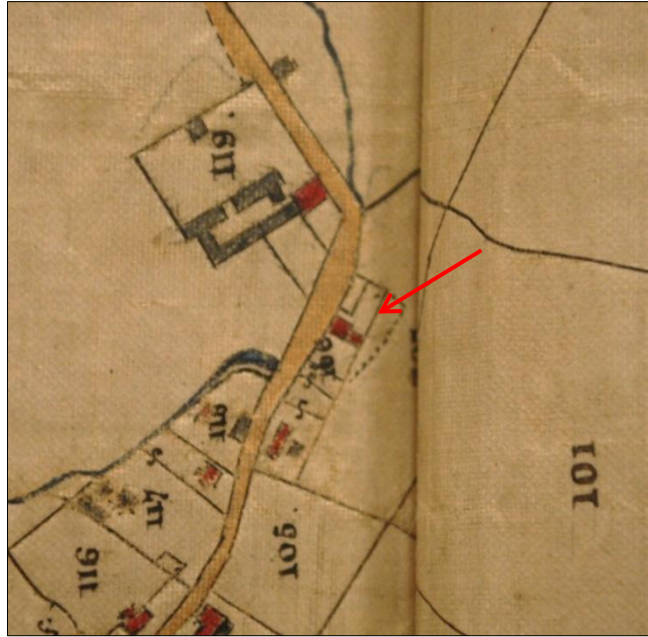
A Watts-Russell estate map of 1864 (NRO map 4652) shows that an addition had been made after 1850 (Fig 2). The cottage, highlighted in red ink, clearly has a smaller square addition towards the south-eastern end where a bread oven extension lies today. Where the current range of outbuildings is located is an un-shaded rectangular outline which suggests that they too had been built. Therefore it appears reasonable to conclude that the cottage was both extended and the service buildings constructed between 1850 and 1864.

Fig 2 : Map of 1864 showing the property (NRO Map 4652)

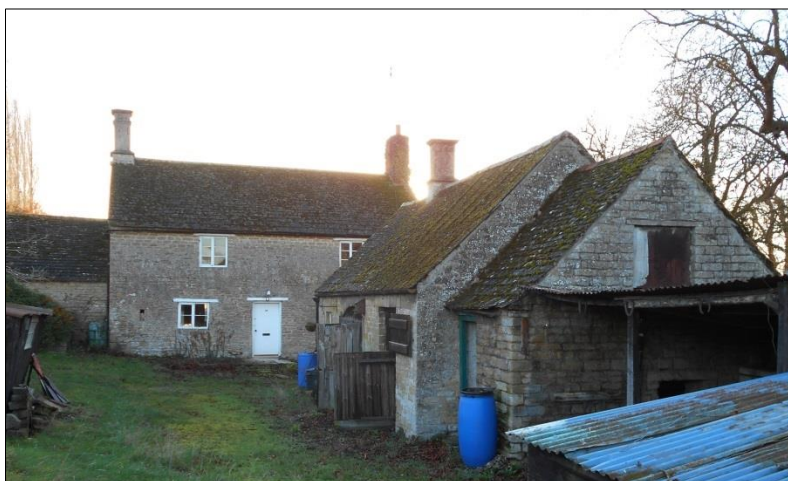
Fig 4: The cottage in the background; outbuildings to the right. View looking west.

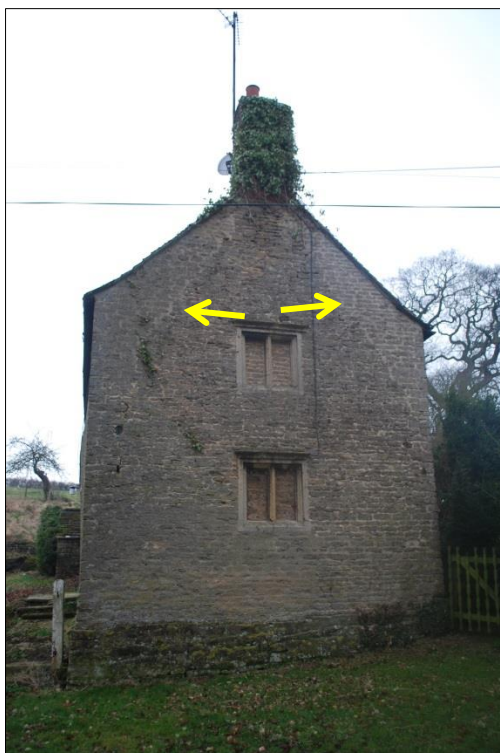
This elevation faces the road and lies parallel to it (Fig 5). Like the rest of the cottage, it is built of roughly coursed limestone bonded in lime mortar but with some surface pointing of modern cement. The main elevation is raised on a rough plinth which projects towards the road and raises the building level which is set against rising ground to the east. The main features of this elevation are two identical finely dressed ovolo moulded limestone mullion windows each comprising two lights although now both are blocked, also with limestone. Each has a simple hood mould above it.

Fig 5: The road-side (west-facing) gable, with blocked windows; note the early gable-lines (arrowed)

The quality of these moulded windows appears a little incongruous in a property of this size though it may be that they were built circa 1700 during a wider upgrading of Biggin estate properties. It is also possible however that they have been re-used from elsewhere and their superior quality was not reflected elsewhere in the building. Although both windows are now blocked it can be seen that there remains a slight groove cut into the inner surface of the mullion and jambs indicating that the windows were once fitted with leaded panels.

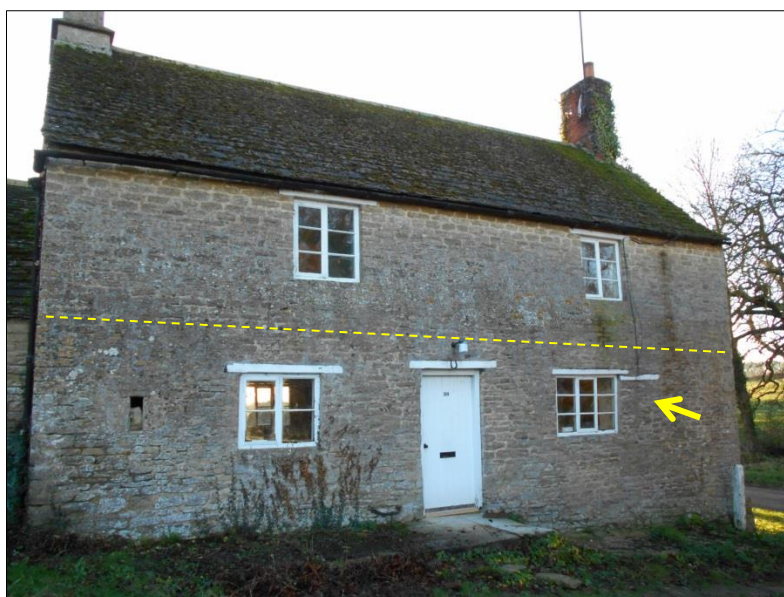
This elevation contains the current entrance to the building which is placed almost centrally along this facade, located between two windows of unequal size (Fig 6). The current doorway is fitted with a simple batten and plank door set within a painted frame beneath a timber, probably oak, lintel. It is furnished with a variety of modern locks and a letter box and is hung on simple strap hinges. The window to the east is a two-light timber casement, one fixed, the other opening. Each panel

Fig 6: The north face of the cottage, showing the old eaves line and original blocked window (arrowed)

Between the ground and first floor windows can be seen the scar of the original roof eaves level. The principal difference between the two phases of building is the size of the individual stones used, the heightened section utilising mostly larger and better-squared pieces of stone.

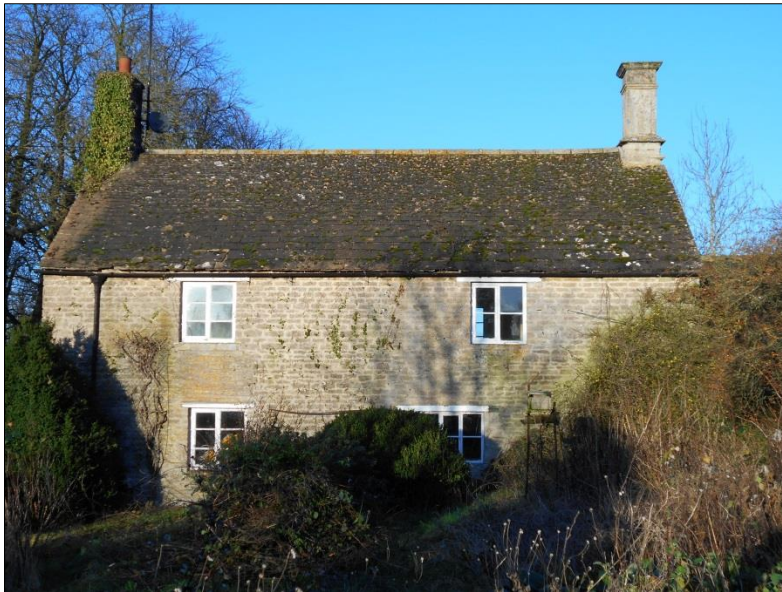
This elevation is essentially the same as the north elevation although without the central doorway (Fig 8). Constructed of the same materials it contains on the ground floor two windows although in this elevation the three-light casement is at the east end and the two-light at the west end. The scar of the original eaves level can also be seen and the first floor windows are both located in the section of heightened walling. The only other visible feature in this elevation is a blocked fire window towards the eastern end of the wall, currently masked by undergrowth. The south side of the secondary addition is largely obscured by the rising ground level, more apparent on this side of the building.

Fig 8: the south-facing elevation of the cottage.

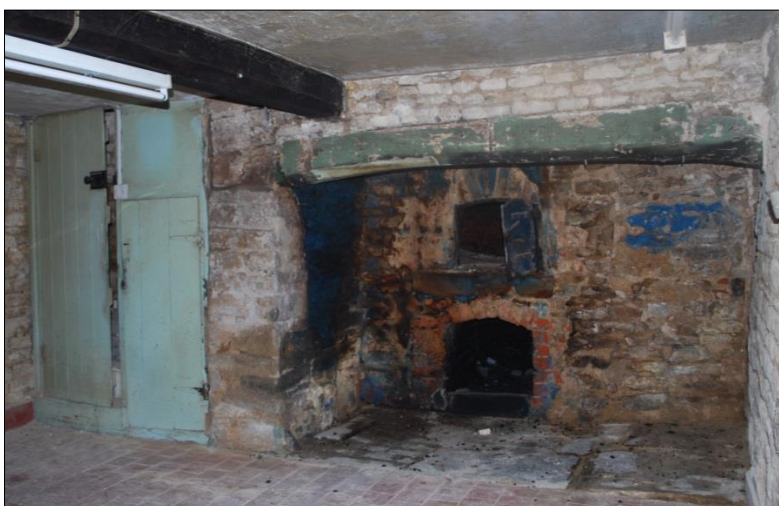
The inglenook occupies almost two thirds of the east wall of the room (Figs 9 and 10).

Fig 10: The inglenook in G1 looking east. Stair and under-stair doors to left.

The north side is constructed of a projecting cheek of dressed limestone, the south side the south wall of the cottage. The rear of the fireplace opening is the east gable wall of the building and the whole is set beneath a roughly-cut oak bressumer, having a chamfered lower edge with a simple run-out stop on the north side and no stop on the south. The floor of the fireplace is a mixture of limestone, brick and concrete. Within the back (east) wall are two openings; these relate to the bread oven located within the secondary addition (Fig 9). The upper opening comprises a simple

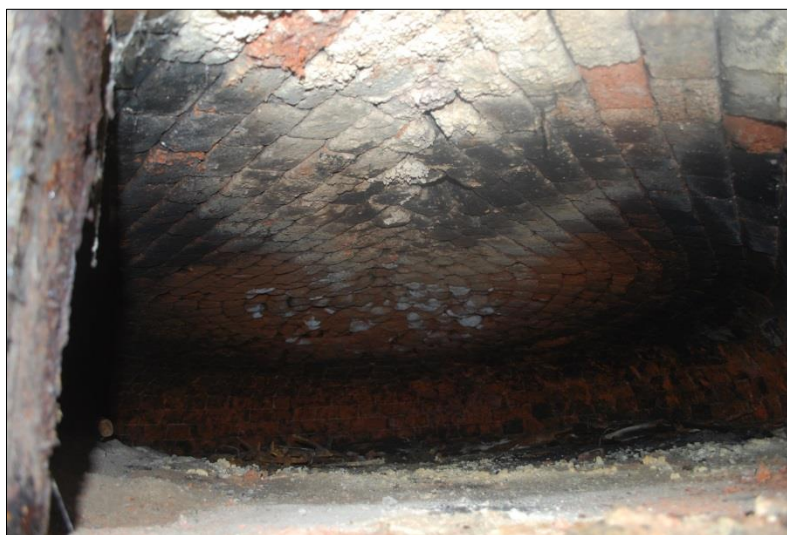
recess with splayed sides set beneath a brick arch set within a rough hole chopped awkwardly into this wall. It has a stone sill and set within the arch is a cast iron frame with a hinged cast iron door fitted with a simple sprung latch. Beyond the opening is a red brick bread oven of unusual size. Although it conforms to the standard shape, roughly teardrop in plan with a shallow, almost flat, arched roof its size is exceptional (Figs 9 and 11).

Fig 11: The bread oven, interior, looking east

Most bread ovens in domestic buildings measure c1m or three to four feet along their long axis whereas this is 3.6 metres across (11 feet 10 inches). This enormous bread oven lies centrally within the secondary addition built against the east gable of the original cottage and is partly buried within the natural slope which lies on that side. This appears to have been a deliberate design since the soil mounded against the external walls would provide additional heat retention.

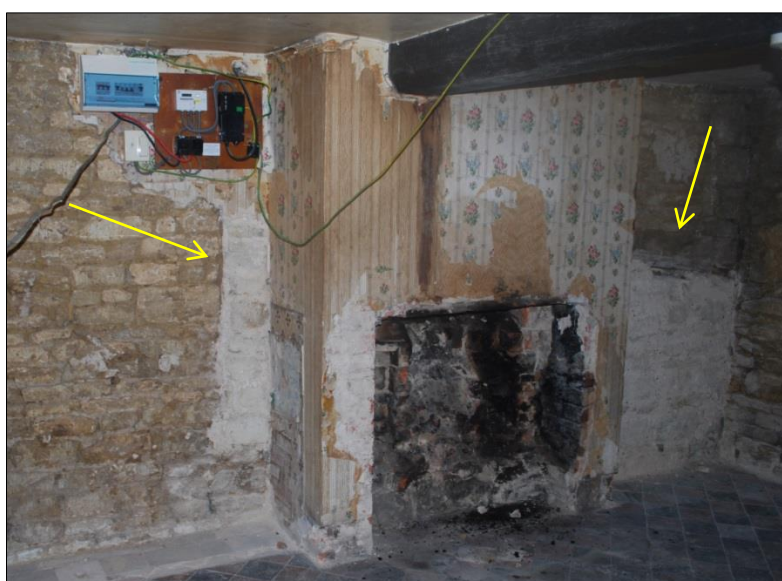
The west wall of the room retains evidence of the first phase of construction (Fig 9). The south side of the two-light mullioned window can be seen and to the north, built adjacent to the north-west corner can be seen the oak bressumer of a fireplace (Fig 12).

Fig 12: Room G2, looking north-west showing inserted chimney breast, blocked window (left) and blocked fireplace (right, both arrowed)

Both have subsequently been blocked when a red brick chimney breast was built against this wall thus rendering both window and fireplace obsolete. The fire opening retains no grate. Both the original window and fireplace are infilled with limestone bonded in white lime mortar.

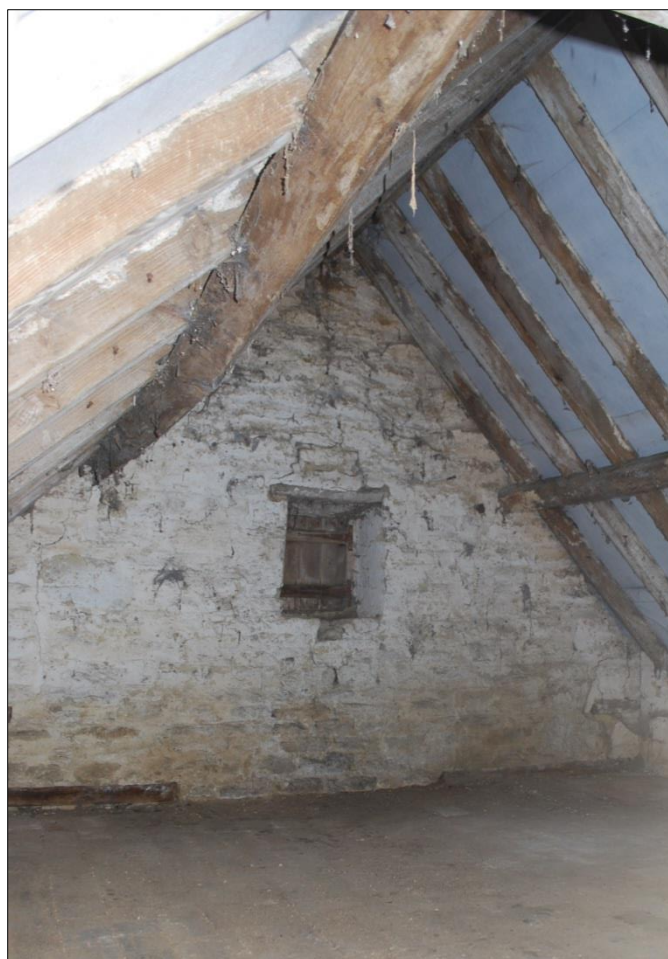
Accessed from the staircase through a doorway inserted in the east gable wall of the original cottage is a store room located above the bake-house oven (Figs 9 and 13).

Fig 13: Store room above bread oven, looking east

It lies off the stairs at almost a mezzanine level, taking account of the more diminutive dimensions of the bake-house addition. Situated almost entirely within the eaves, this room has only low side walls on the north and south; the west wall is the original east gable end of the cottage and the east

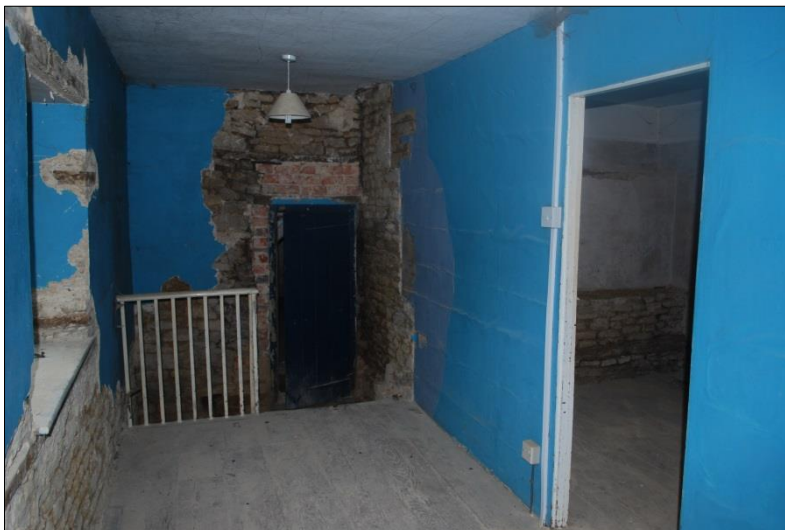
This part of the first floor comprises a large landing at the top of the stairs, although given that in 1881 there were eight occupants living in the house it seems most likely that this was in fact a walk-through bedroom at one stage (Fig 9). At the top of the stairs the stairwell is furnished with a simple banister rail with plain square-section wooden spindles and minimally shaped handrail. The north wall contains a two-light casement, one fixed, the other opening, each fitted with three panes of glass held in place with galvanised glazing bars. There is a plain catch and casement stay to the opening panel and the sill is painted timber.

Fig 14: Landing, F1, looking east towards the blocked window and store doorway; note the flimsy stud partition with F2 on the right

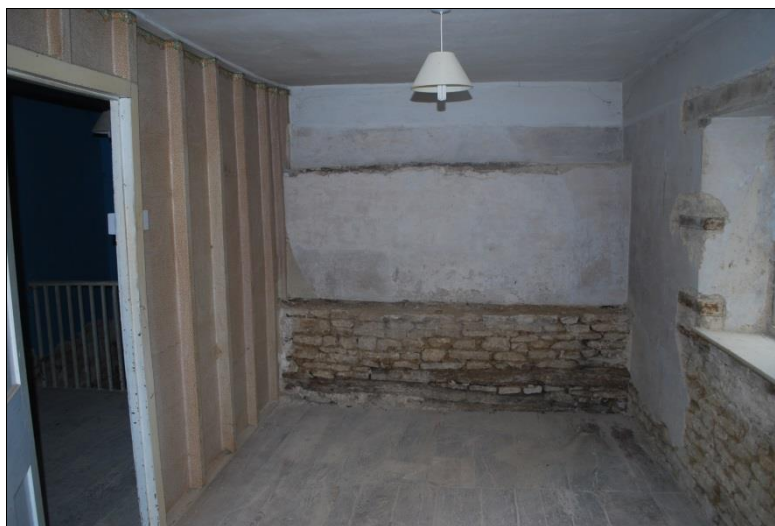
Located on the south side of the cottage this simple room retains few features not previously described (Fig 9). The window in the south wall is identical in size to that in F1, the only difference being that each light is fitted with two panes of glass rather than three. The east and south walls are of plastered and painted stonework although the majority dates from the period when the roof was raised and only the lowest 300-350mm dates from the first phase of the building. The east gable wall comprises a stepped profile since it forms the west face of the large chimney located above the inglenook below; when the roof line was raised the stepped profile was also extended outwards to meet the new eaves line. The west wall is lath and plaster, papered and painted, the north wall retains on this side the vertical timber studs which support the flimsy partition of horizontal timber planks. On this side they have been wall-papered (Fig 15). The floor is of elm and pine, some of the latter very modern patching. The door leading onto the landing is a four panel pine door, painted. Hung on butt hinges, it has an iron drop latch.

Fig 15: Room F2, and F1 through the doorway. This plain room is formed with flimsy partitions, latterly papered over.

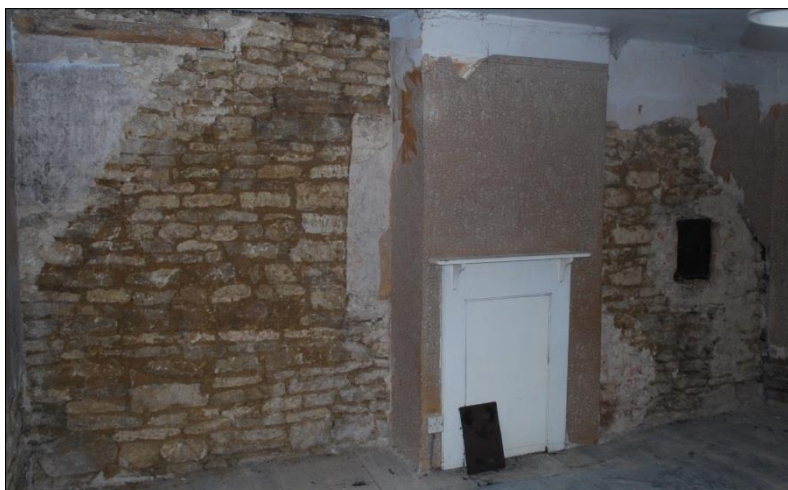
Situated at the west end of the first floor the north and south walls are of stone and, as previously described, comprise mostly the heightened section of walling on those sides (Fig 9). Each wall contains a two light window, identical to those previously described for Room F1. The west gable wall retains scars of the original steep roof line and the southern jamb of the blocked first floor mullioned window can also be observed (Fig 16). Against this has been added the inserted red brick chimney breast furnished with a simple timber surround and mantle shelf; the fireplace opening was boarded over and it is not known if the iron grate remains. To the north of the chimney breast a cast iron door with integral frame has been set into the wall to allow the flue to be swept from this level. The floor is elm and pine boards with some areas overlaid with metal sheeting, presumably covering worn or damaged areas. The door to the room is a painted pine batten and plank door hung on strap hinges with an iron lock box with brass knobs.

Fig 16: Room F3, western gable, showing the old roof line and the blocked window behind the inserted chimney and fireplace.

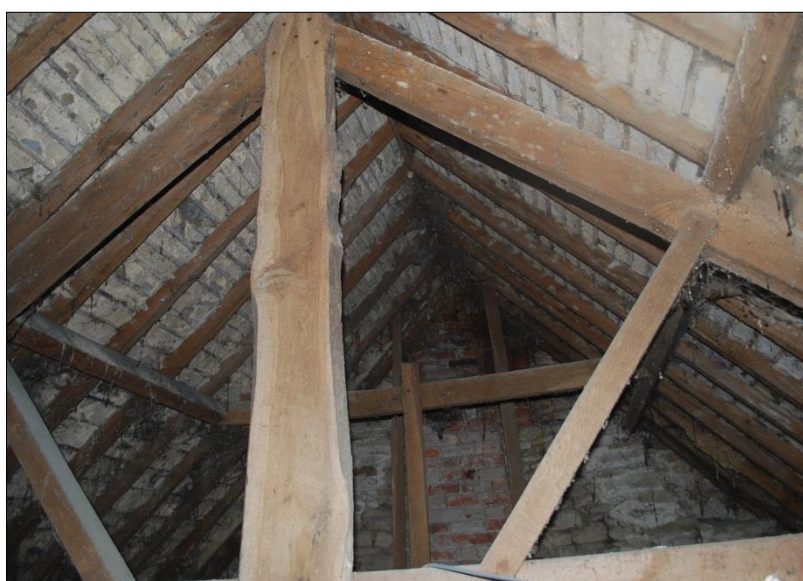
The attic space was observed but not entered via a small opening made in the ceiling above the landing, F1. The roof is supported on two pine trusses each with raking struts of oak and what appear to be secondary king posts, also of oak, although one appears simply to be an unshaped plank with waney edges (Fig 17).

Fig 17: The roof truss and collar, looking west

Curiously neither truss reaches ridge height which therefore 'floats' un-supported above it. Purlins rest on pine cleats on the principal trusses but the rafters are set at a steeper angle than the sides of the trusses which explains why the top of the trusses do not reach the ridge. In between the trusses and the gable ends are what may be secondary collars. The underside of the Collyweston slate roof is torched, a usual feature of such roofing. The ceiling joists are pine. The whole roof has the appearance of a compromise with piecemeal repair and patching.

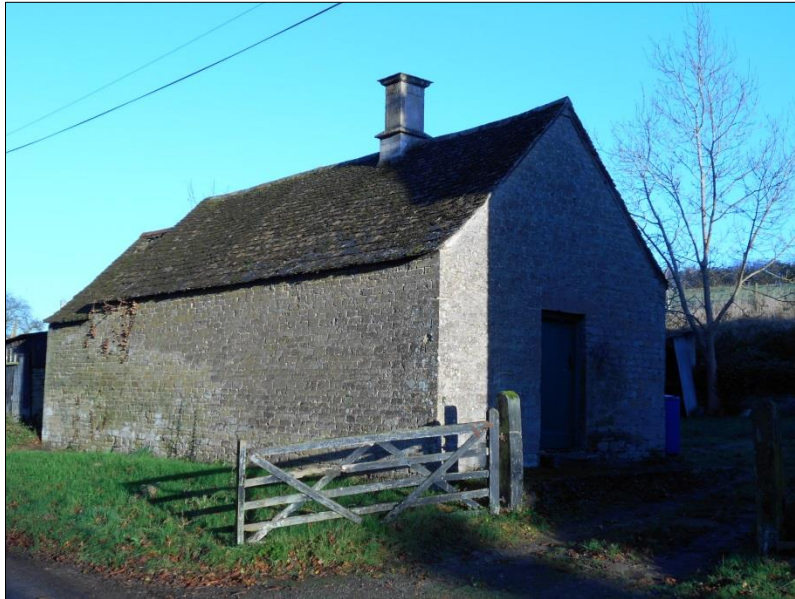
A rectangular range lying parallel to the road and perpendicular to the cottage (Figs 2, 3, 18 and 19). Apart from the small privy at the north end the whole range appears to have been built at the same time, that is, between 1850 and 1864 on map evidence. The external walls are built of coursed, dressed limestone set beneath a Collyweston slate roof although some of this has been lost on the eastern slope and replaced with corrugated metal sheeting towards the north end. The west elevation is entirely plain with no openings; these are all located in the south and east facades. There are three rooms.

Fig 18: The outbuildings, viewed from Causin Way

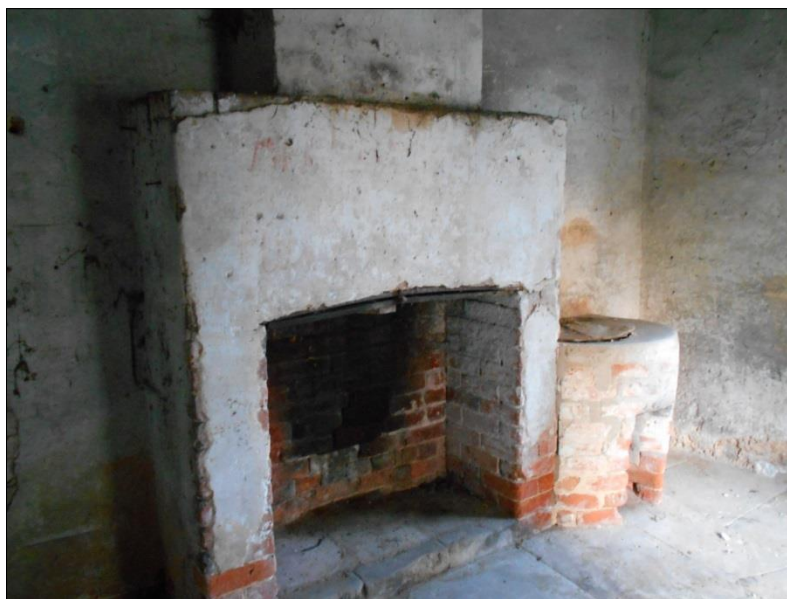
The room at the southern end is a wash-house. It is entered through a batten and plank door set beneath a flat stone lintel in the south gable wall. The room has a single window in the east wall, a two-light, three-pane configuration, all in timber with iron catches and stays. The north wall (internal) is of red brick, against which is built a fireplace and chimney breast and integral water heater or 'copper', also of red brick (Fig 20). The latter retains its cast iron cauldron and iron door to the firebox beneath. The floor is of limestone slabs. The roof has no trusses, just rafters supported on a single purlin on each slope; the underside of the slates is torched.

Fig 20: The wash-house with its brick fireplace and copper

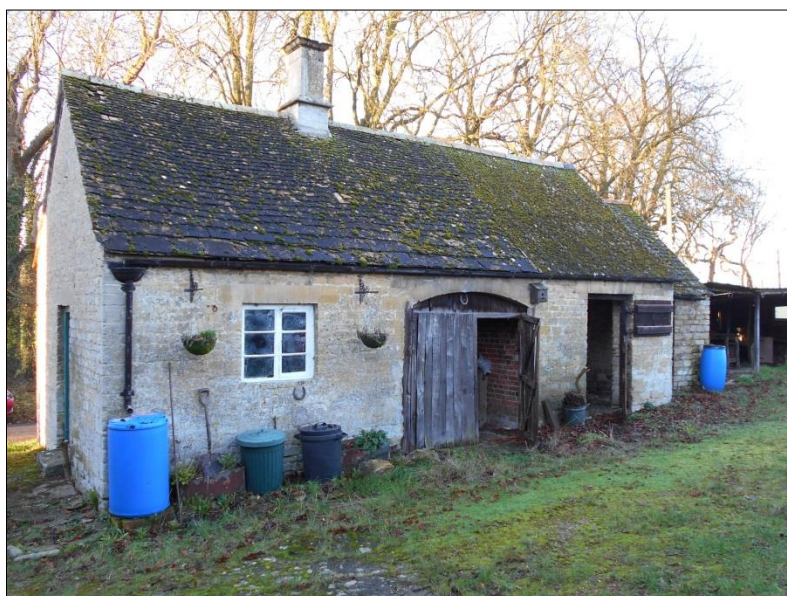
Fig 21: The outbuildings, with (from l-r) wash-house, carriage house, stable; the privy and pigsty lie at the far end

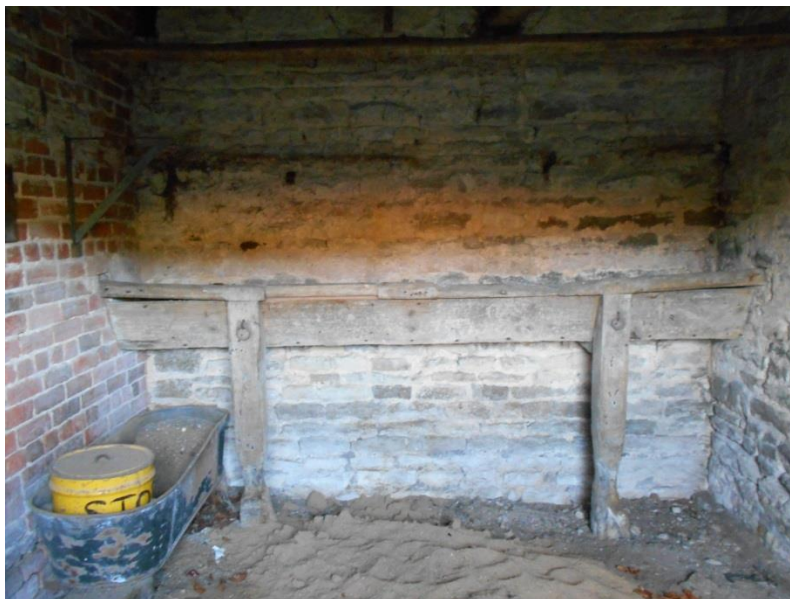
The northernmost room was a stable; it retains its two-part stable door, each leaf of which is batten and plank. Both are hung on plain strap hinges with drop latches. Within the stable against the west wall is a timber manger and above it the remains of a hayrack, only the top rail of which survives (Fig 22).

Fig 22: The stable with surviving manger looking west; the hayrack has disintegrated
