**A Level 2 Archaeological Building Record on  
former shoe factory premises at Bowler's Yard,  
Earls Barton, Northamptonshire**

**Joe Prentice, Charlotte Walker and Iain Soden**

**15 April 2015**

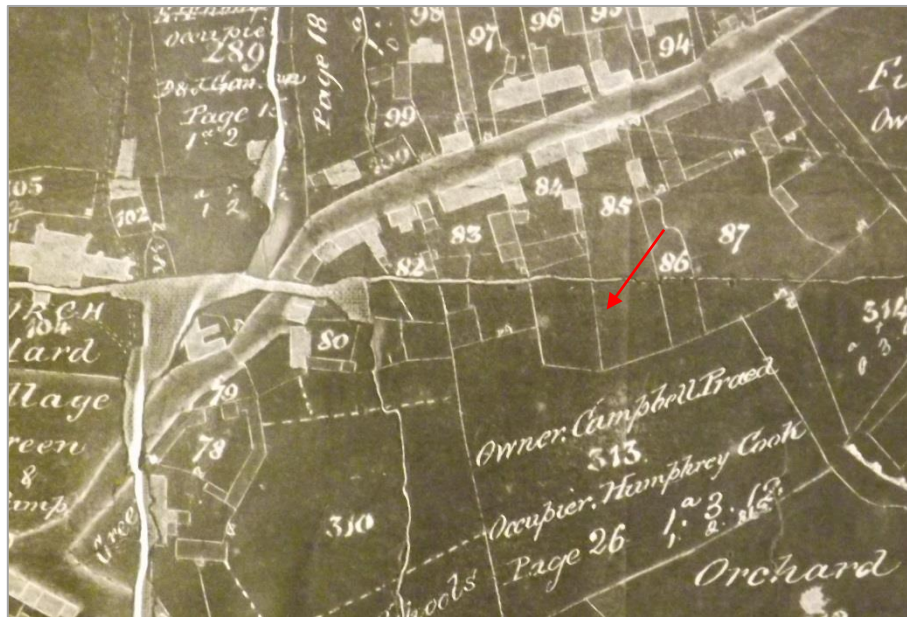
Fig 2: 1838 Inclosure map of Earls Barton, showing approximate location of factory, at that time an open plot

Buildings are first depicted on the rear part of the site in the late 19th century. Prior to this date, the site had been part of a back-plot associated with buildings fronting onto the High Street (Fig 2); it is likely that the area had been similarly laid out since the medieval period. In 1885 the 1<sup>st</sup> edition OS map shows a narrow building aligned north-east to south-west along the former property boundary. It is shown with a possible carriage arch (for which no physical evidence has been seen) through the central part of the building with a number of smaller sheds at the southern end (subsequently lost). By the turn of the 19<sup>th</sup>-20<sup>th</sup> century, the building had been altered. A larger, square-shaped addition had been added at the north end of the building and a smaller addition had been made to the rear. The factory is thought to have been the premises of Austin boot and shoe makers, although there has been no definitive historical proof. In 1890 and 1893, an Austin and Brooks is listed in Trade Directories for Earls Barton. By 1896 an F W Austin was noted as a shoe manufacturer and in 1898 it was listed as Austin Brothers. After this date there is no further mention in available directories.

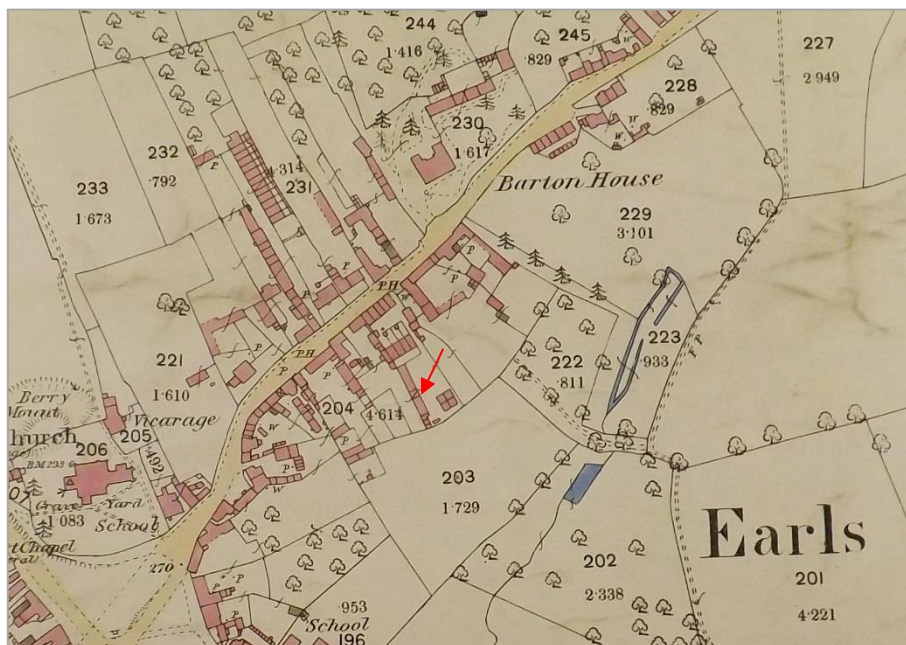
Fig 3: First Edition Ordnance Survey map, 1885

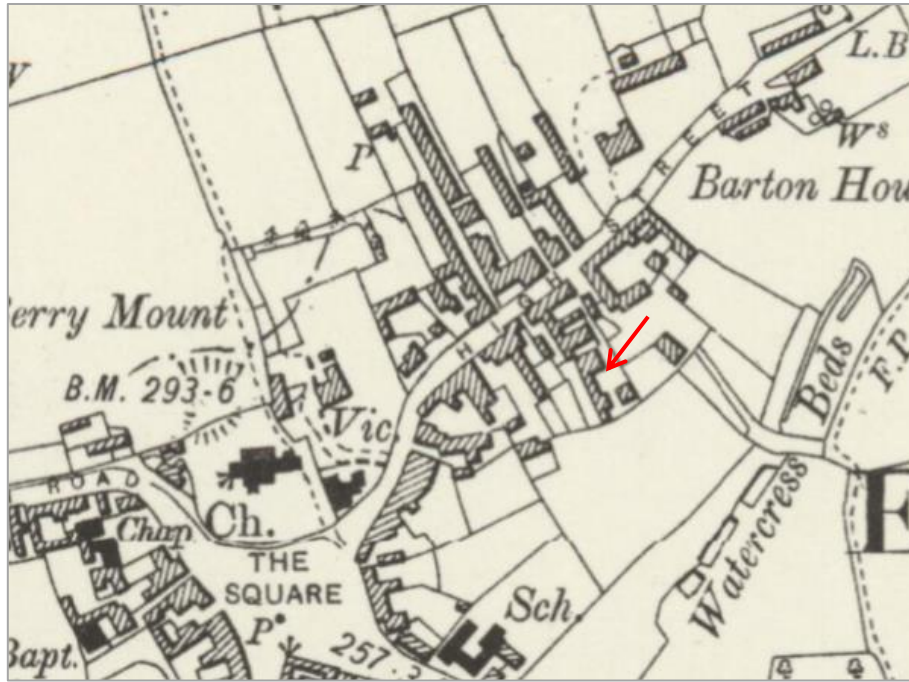
Fig 4: Second Edition Ordnance Survey 1901

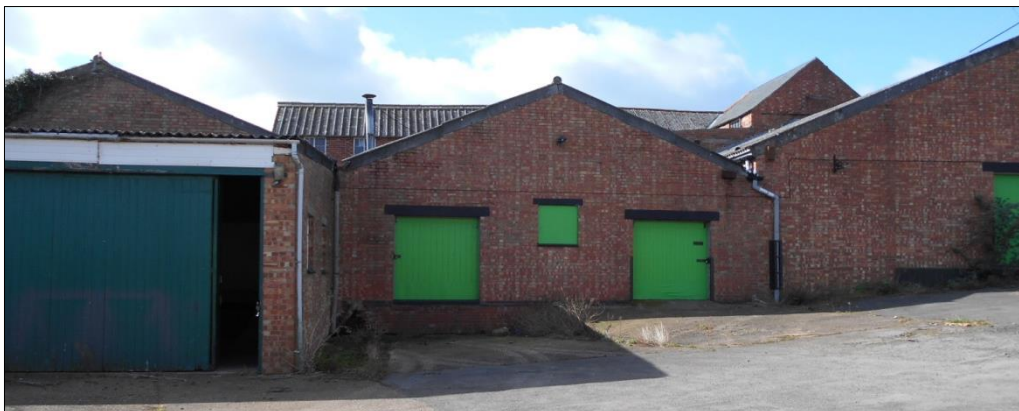
Fig 5: The only restricted view possible from the factory yard on the east, overwhelmed by adjoining Post-War sheds.

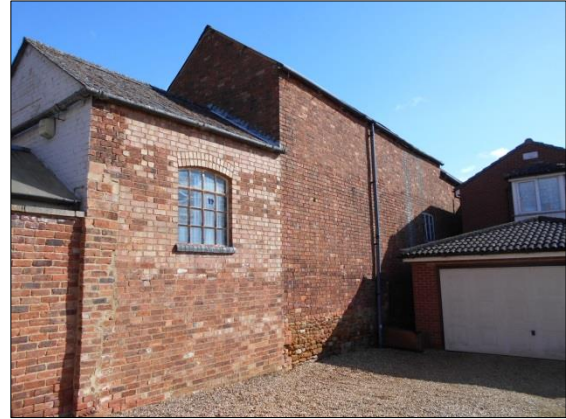
Fig 7: The north end/western side, hemmed in

Part of the north end of the west side was seen from the yard of a nearby property although the southern end of the same side was obscured by a modern house built close against it (Fig 7). Therefore the majority of the recording had to be undertaken from the interior of the building, an exercise further impeded by the fact that many original openings had been blocked and there was no electricity supply which meant that completely windowless rooms had to be investigated only by hand-held torches. Many internal wall surfaces retained modern paint and washes or tiling which precluded any observation of the original structure. The upper floors fortunately retained their windows (the majority of which were not blocked) and permitted daylight to afford adequate levels for full observation.

A large rectangular room added above the double-height room beneath (room G2 and F2) which forms the main part of the phase I building. This added floor is most clearly seen when viewed from the west side high up where the change in brick colour and pointing can be seen (Fig 7). Like the remainder of the building there are no windows in the west and north walls and just two in the east wall. Each contains timber three light frames, each with three panes of glass. There are two simple A-frame trusses with raking struts as described previously. This section of roof retains its slate covering.

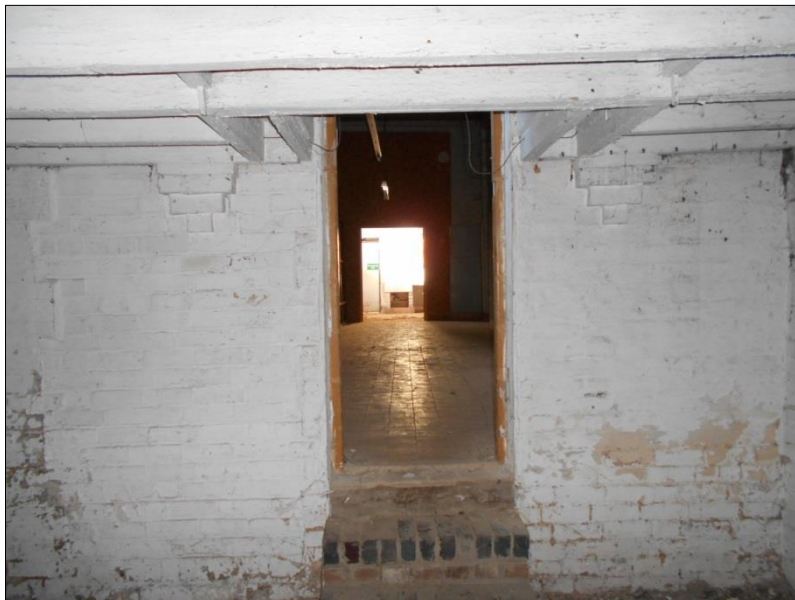
Fig 9: The inserted north doorway through an older, wider opening from G1, looking north into G2. Note the level change and the brick corbels and trimmed joists above which facilitated the doorway-height

Room G1 contained a chimney breast built against the south wall. Although the fireplace opening has been infilled, its presence suggests that this room was most likely the building's office since it appears to have been the only heated room. A doorway exists in the north wall which now leads into room G2; this narrow doorway is located within a wider area of blocking suggesting that at an earlier date, if not originally, it was much wider, allowing almost full access into the adjoining space.

Against the west wall a timber staircase gives access to the floor above; this appears to be an original feature. It is of simple construction with the steps comprising treads, but no risers, half-tenoned into plain pine strings on either side. The room side (including the underside of the treads) of the staircase has been simply boarded in and all of the woodwork painted white. The underside of the ceiling is also painted white; this simply comprises the joists and undersides of the floorboards with no indication that the room was ever plastered. A short flight of steps leads up from this room into G2 which lies immediately to the north (Fig 9). This later interconnecting doorway (previously mentioned above), is also evidenced by the alterations to the ceiling joists above the doorway. Rooms G1 and G2 are positioned at different levels, G1 being approximately 0.6m lower so that when the present doorway was created there was not enough headroom to allow a full height doorway to be made within the height of the north wall into G2. To overcome this, the upper portion of the doorway had to be cut into the lower part of the room above (F1) and a section of the floor removed to give the necessary headroom; this borrowing of space is simply boxed in within the room above (see below, F1). In order to support the truncated joists small brick corbels were built into the north wall which support the trimmed joists located against that wall, the adjacent joist being supported on inserted trimmers which have had their south ends tenoned and then pegged into the next uncut joist (Fig 9).

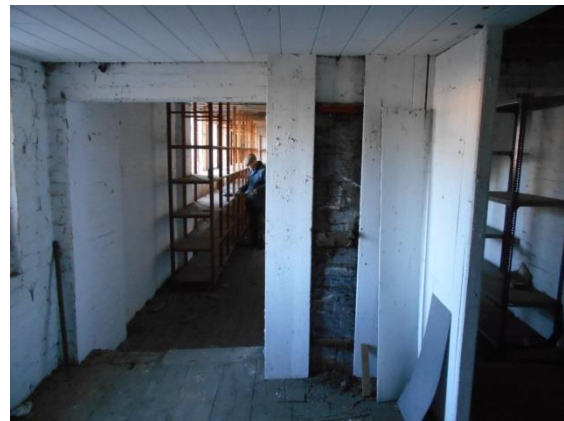
Fig 11: Boarded-out chimney breast rising through F1, looking south into F beyond

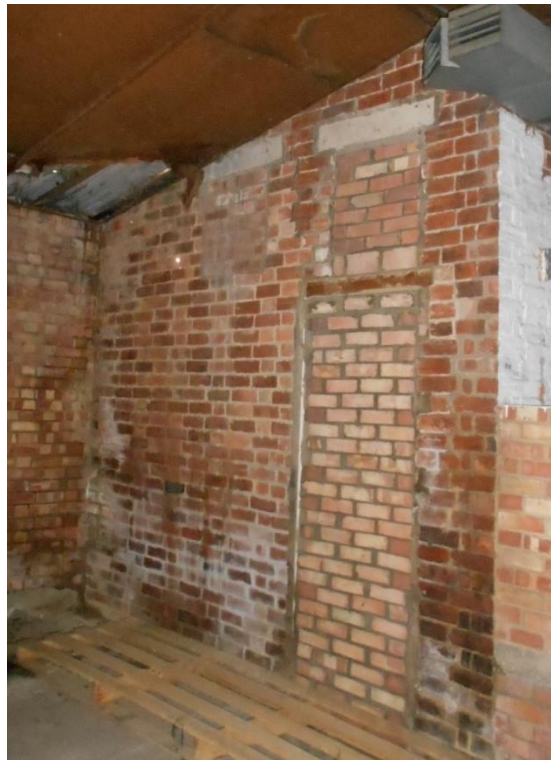
Fig 13: G3, south wall with blockings, viewed from a later room to the south

A red brick range added to the south side of phase I and of the same width (Fig 8). The brick sizes are 228mm x 115mm x 70mm (8 7/8 x 4 1/2 x 2 3/4 inches) bonded in lime mortar. This added range followed the same pattern as the original block in that there are no windows on the western side and none in the north elevation since this wall was originally the south wall of the Phase I building. The south wall (Fig 13) retains evidence of a tall, narrow opening (0.6m, 2 feet) which does not appear to have been a doorway since it seems too narrow to have been practical; it is more likely to have accommodated some form of mechanical equipment although what remains unclear – possibly a belt drive or shaft. Above it are two small windows, both set beneath concrete lintels and both now blocked. Neither is original and their date is uncertain, but is most likely twentieth century.

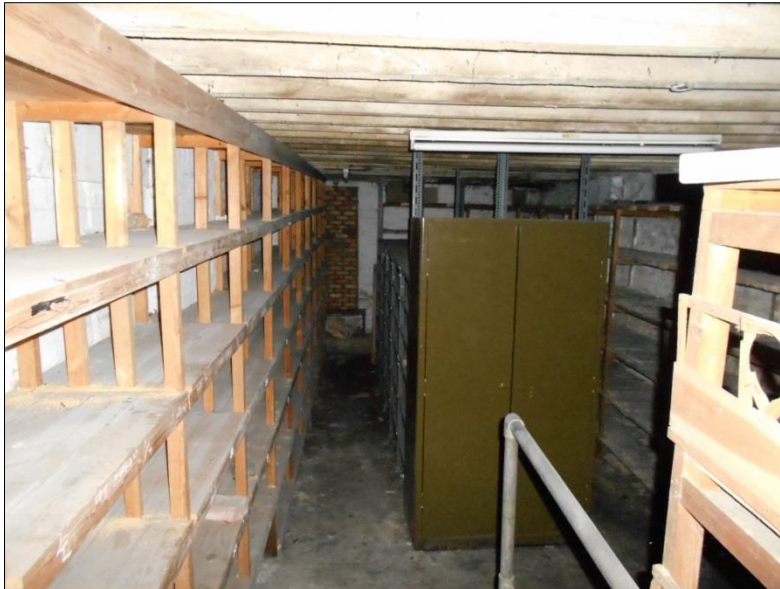
Fig 14: The unlit room G3, looking south down the ramp; fully decked out with wine-racks

than the floor of G3. This does not appear to be an original feature. The floor of the room is of red brick and slopes gently towards the south though the reasons for this are uncertain but may be for drainage if wet processes were carried out here; however no drains were observed at the lower end of the room. Currently entirely unlit, this room contains only modern racking probably installed when the building was a wine importing warehouse; the racks retain wine labels indicating various vineyards. The ceiling comprises the joists supporting the floor above and the underside of the floorboards, all painted white.

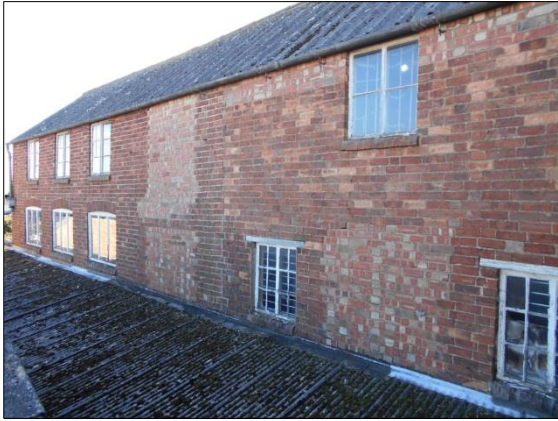
Fig 15: The secondary block with F3 and S3 to left; note possible blocked loading bay doorway at second floor level

Located above room F3 and of the same size, this comprises the upper floor of this three storey added range. Like the floor below it only has windows in the east wall; the northernmost appears to have been a large loading bay doorway rather than a window as evidence by the blocking seen from the exterior (Fig 15). There are three windows located to the south of this; all retain timber two light frames, each light fitted with three panes each, all fixed. They are set beneath timber lintels set at eaves level. The room is accessed via a staircase which rises from F3 and is located against the west wall, a simple construction comprising plain strings fitted with treads but no risers. It has been subsequently boarded in screening it from the room below. The northern end of this room is formed by the south wall of the original building and like on the floor below access has been provided to the added third floor room (S1) located above F1. At this level there is a single doorway situated to the west side of the chimney stack. There is modern shelving along the east and south sides of the room.

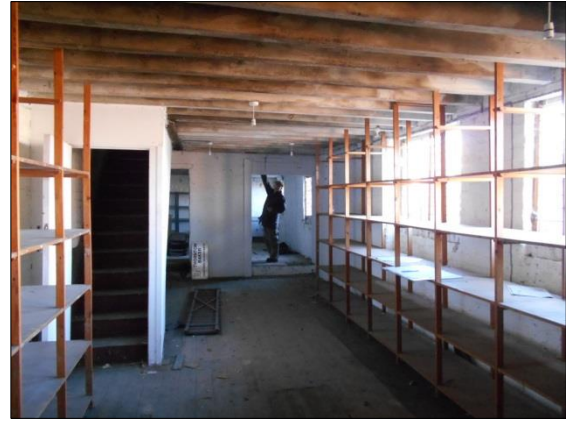
Fig 16: F3 Interior, looking north towards the back of the chimney breast in F1; boxed-in stair to left

Located directly above G3 and of the same dimensions, it has no windows in the west or south walls and originally had four in the east wall; the northernmost is infilled with brickwork, the three southern examples are fitted with timber three-light frames, each light fitted with three panes of glass, all fixed. The windows opening are formed beneath segmental brick arches and have bullnose brick sills externally (Fig 15). When this block was added it was not furnished with a staircase from the ground floor, rather doorways were created in the south wall of phase I, room F1 either side of the chimney stack located there and thus first floor access to this addition was via the staircase which rises from room G1 (Fig 16).

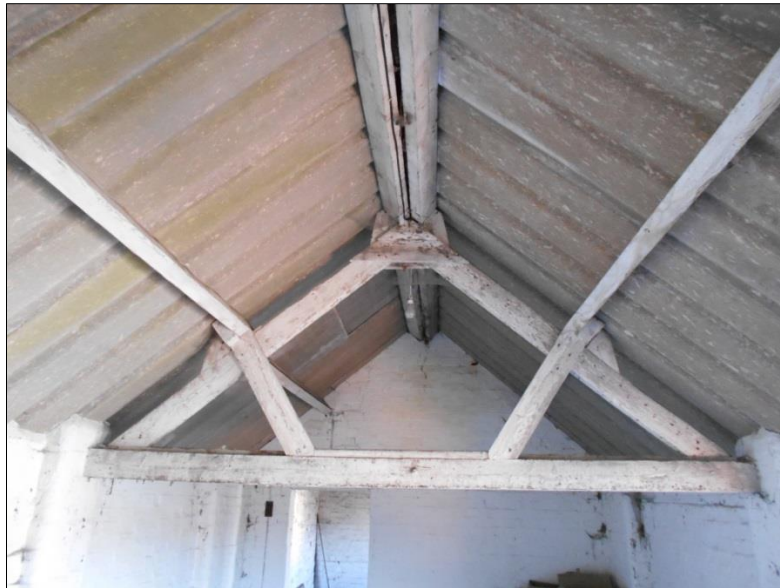
Fig 17: The roof in Room S1, showing the simple and relatively flimsy truss

This added floor is situated above F1 of the original phase of building and was created by the raising of the east and west walls and the raising of the roof, though it is not clear if the original roof was removed and then re-set or a new roof made. Like the remainder of the building there are no windows in the west wall and a single window in the east wall. It retains a fixed two light timber frame, each light fitted with two panes of glass. It is situated directly below the wall plate under a timber lintel. The roof trusses comprise simple A-frames of narrow planks of a flimsy construction – merely two thin timbers bolted side by side. They are supported on internal buttresses built integrally into the construction of the raised side walls. Each truss has raking struts, the upper ends of which also partly support the purlins which are also supported on cleats (Fig 17). The whole is painted white. At the ridge there are two angled purlins/ridge boards, also supported on cleats which supported the roof which is now re-covered in corrugated asbestos sheet. There was

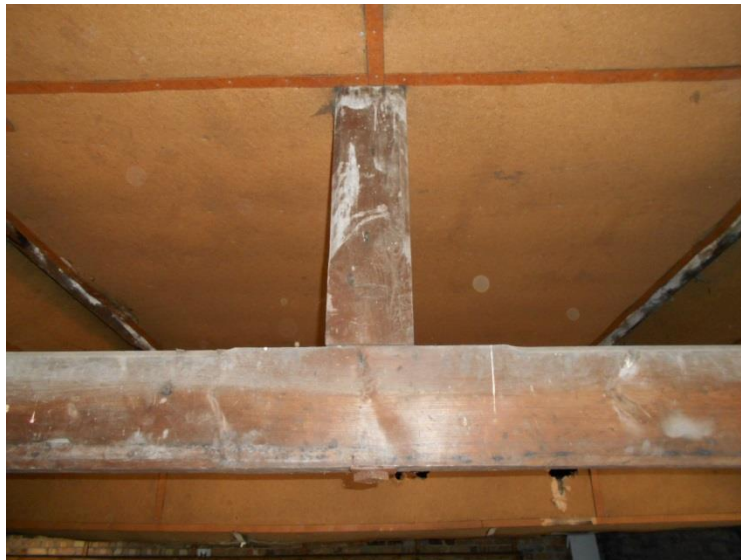
Fig 18: The part-covered roof truss at the junction between S2 and S4, viewed from S4. Unlike all other roof elements, it is chamfered (if only simply) and varnished. Its upper reaches are boarded-in and hidden.

This third-level room set beneath the roof retains four wide, shallow windows; two in the north wall, one in the east and one in the south walls. They all retain the same timber frames comprising four lights each containing a single pane of glass. There was originally a fifth window in the east wall of the same size; this has been infilled as has a further, higher window in the same wall set beneath the ridge line. There is a single truss supporting the roof, this is constructed of well-dressed pine with chamfered edges in a king post configuration with raking iron tie-struts (Fig 18).
