**Building recording of a former meat larder at the
former kennels of Norton Hall, Norton,
Northamptonshire**

Building recording of a former meat larder at the former kennels of Norton Hall, Norton, Northamptonshire

Summary

This former meat larder once served the now demolished Norton Hall, probably to supply the hounds housed there with food. Probably of mid-later 19th-century date, the present record accompanied a change of use of the room to a farm office.

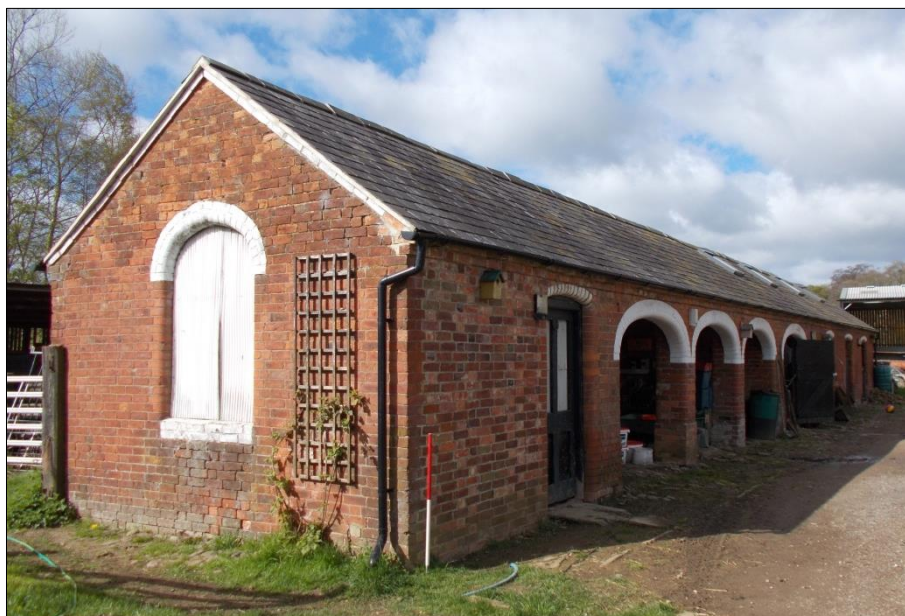
Fig 2: The brick range containing the former meat larder which is located in the foreground behind the arched window in the gable wall. Looking south-west; 1m scale.

The former meat larder, used for hanging game hunted on the estate or other slaughtered meat produced there, lies at the eastern end of a range of brick-built farm buildings aligned approximately east-west to the immediate south of the kennel keeper's cottage (Figs 1 and 2).

The east gable wall is built in the same way and retains a single arched window (Fig 2). The tall arched window has both jambs and the semi-circular arch edged with bullnose brick; the sill is of plain walling brick. From the exterior none of the frame can be seen, the whole opening being covered in modern corrugated plastic sheet.

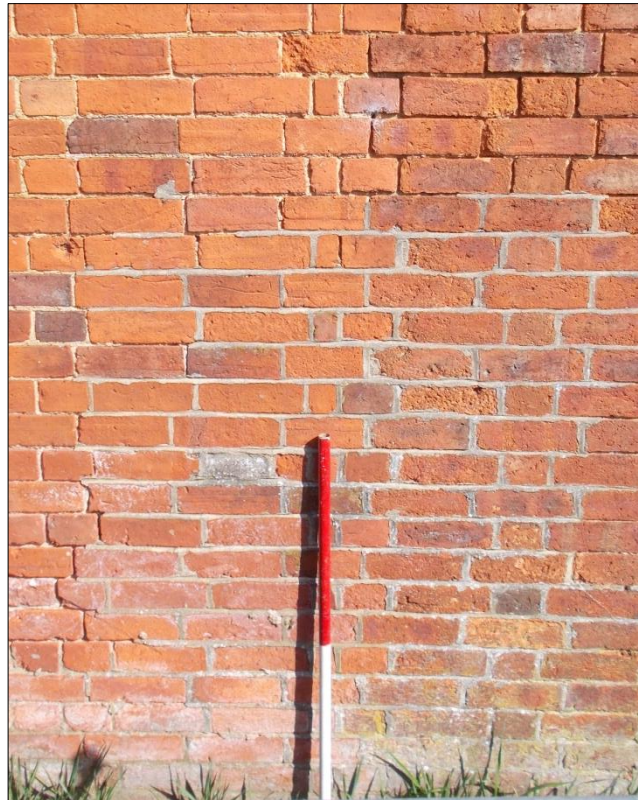
Fig 3: The 'closers' indicating the former south-east corner of the central arched section, directly in line with the scale bar. Looking north, original building to the left; 1m scale.

The whole range is built of red brick bonded in white lime mortar. Initially it appears to be of a single build, but closer inspection reveals that the central four arched bays, originally all open to the north, are the earlier and the single room at the east end which houses the former meat larder, together with two animal shelters and attached pig sties at the west end of the group, are both added. The evidence for this is a change in the colour, but not size, of the brickwork and the presence of 'closers' indicating the former corners of the earlier central section (Fig 3).

The bricks of the original section of the building are a paler orange colour and have a slightly finer texture whilst those of the added sections are generally very slightly redder and have a coarser texture. Both sets of bricks are of the same size and are laid in exactly matching courses with mortar that impossible to distinguish, although many areas have been re-pointed.

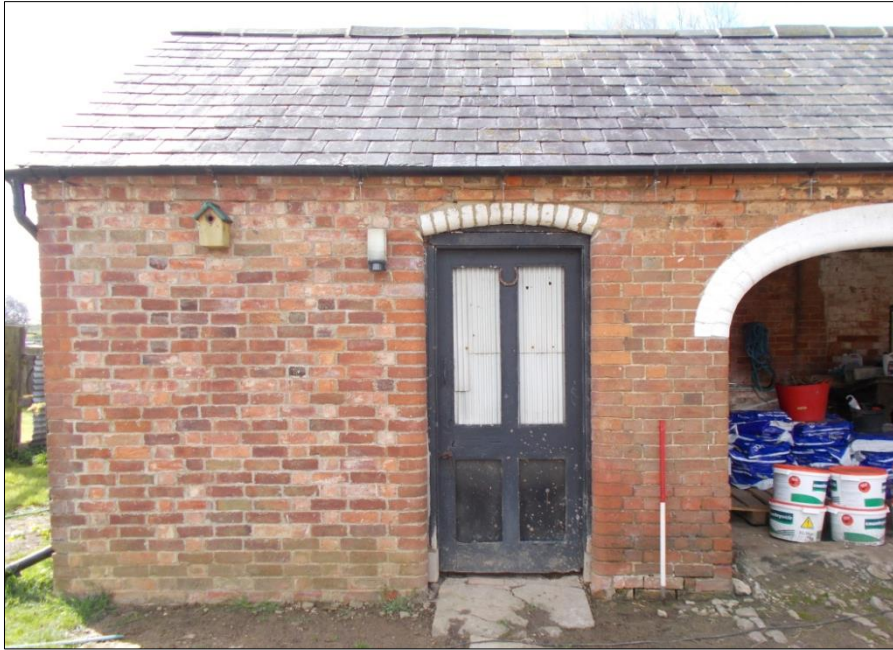
Fig 4: The north elevation of the former meat larder looking south; 1m scale.

The former meat larder consists of a single room, roughly square in plan, accessed via a single door in the north wall (Fig 4).

Much of the north wall has been rebuilt within the last forty years, the meat larder being in very poor condition and roofless when the current owners took up residence (pers comm. Stephanie Goulden). However, the wall has been rebuilt using the original bricks and the timber frame and door retained and re-set. The doorway opening is formed beneath a shallow segmental arch and this, along with the jambs, are formed of bullnose bricks. This type of brick is generally regarded as being introduced around the middle of the nineteenth century and was thereafter much used in agricultural buildings as well as domestic dwellings on doorframes and window jambs to reduce the likelihood of damage, particularly by (and hurt to) livestock, on sharp corners.

The door within the frame is of standard late nineteenth-century four-panel configuration, the lower two filled with timber, the upper two formerly fitted with zinc fly-mesh, tiny fragments of which survive around the edges where they have been cut out or have degraded naturally over time. These two upper panels are currently fitted with modern corrugated plastic sheet. There is part of a simple iron drop latch used to close the door; there is a keyhole which indicates that there was a lock which no longer remains on the interior.

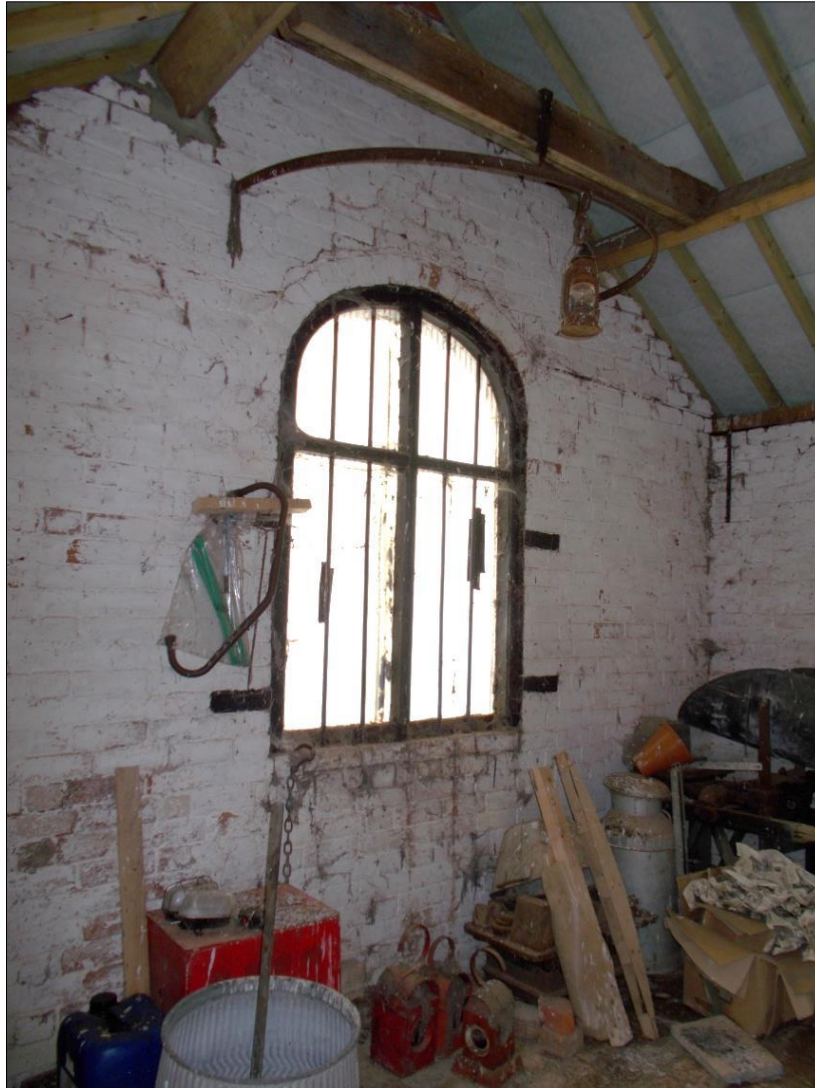
Fig 5: The arched window in the east gable wall, looking south-east with semi-circular hanging rail above.

The interior comprises a single room entered via the doorway in the north wall. The arched window in the east wall retains its timber frame comprising an arched outer frame fitted with a single mullion and transom also of painted wood, most likely pine (Fig 5).

Each half of the frame is fitted with round-section vertical iron security bars fitted into the top and bottom of the frame passing through the transom. Originally each section of the window was fitted with the same zinc fly mesh observed in the door. Here too it has mostly been lost.

The internal surface of the wall is lime-washed. Above the window is a horizontal, semi-circular iron bar used to hang meat close to the ventilated window. The two ends of the bar are set into the brick wall whilst a second brace fixed to the collar supports the loop of the bar at its furthest point from the wall. The collar appears to be part of the original roof structure; the remainder, including the purlins and rafters, is part of the modern replacement.

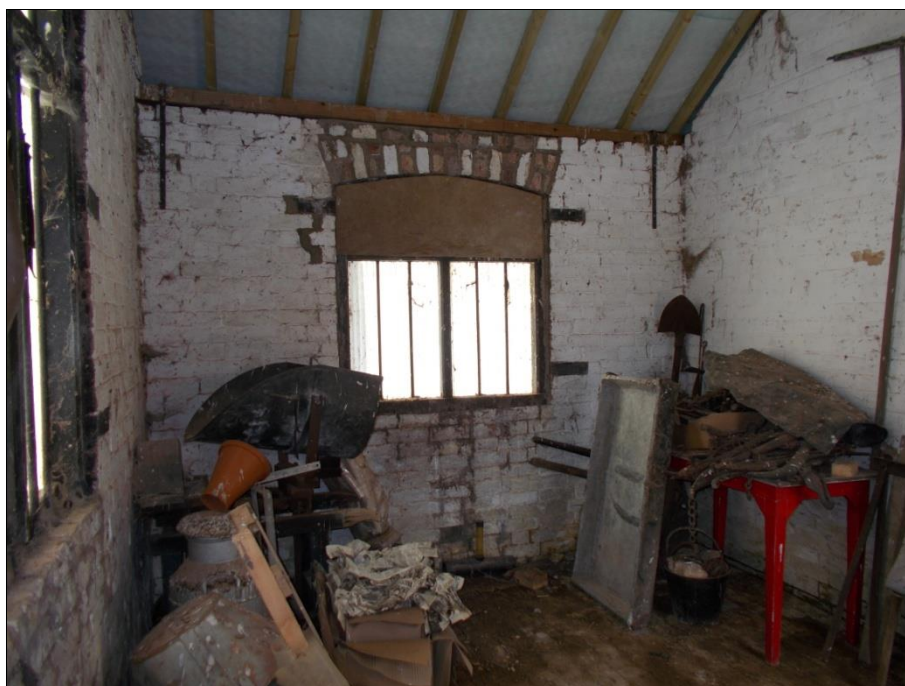
Fig 6: The window in the south wall, looking south.

The south wall contains a single window set beneath a shallow segmental arch (Fig 6).

The south window is of the same configuration as that in the east wall apart from having a shallow segmental arch, partly re-built. It contains the same quartered frame with painted pine outer frame and a single mullion and transom, originally fitted with zinc fly mesh, now covered externally with corrugated plastic sheet. The upper two panels also have plywood fitted to the interior surface. The wall is lime-washed.

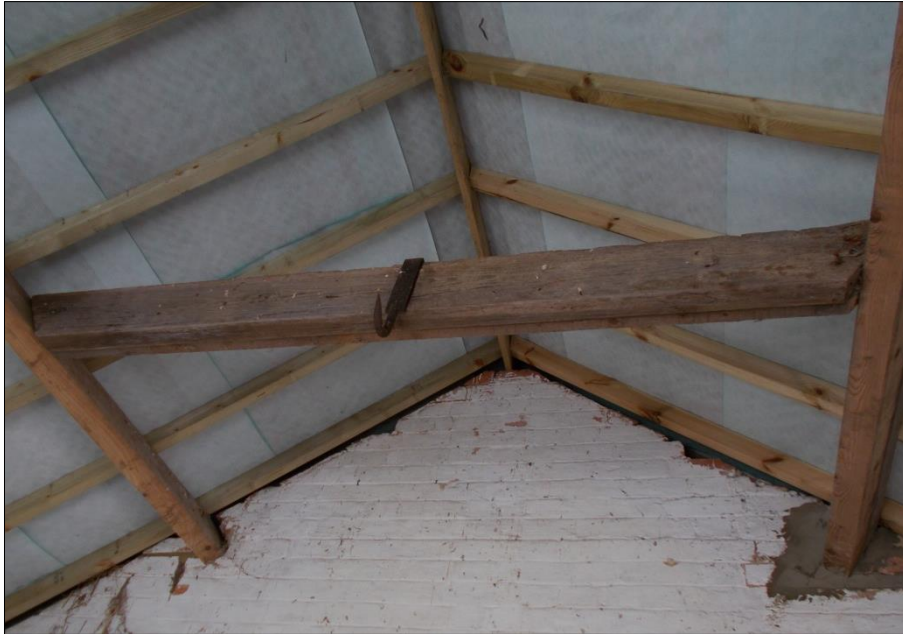
Fig 7: The meat hook on the west collar, looking south-west.

There is a second re-used collar on the west side of the room attached to the modern roof purlins. It retains a single iron meat hook (Fig 7).

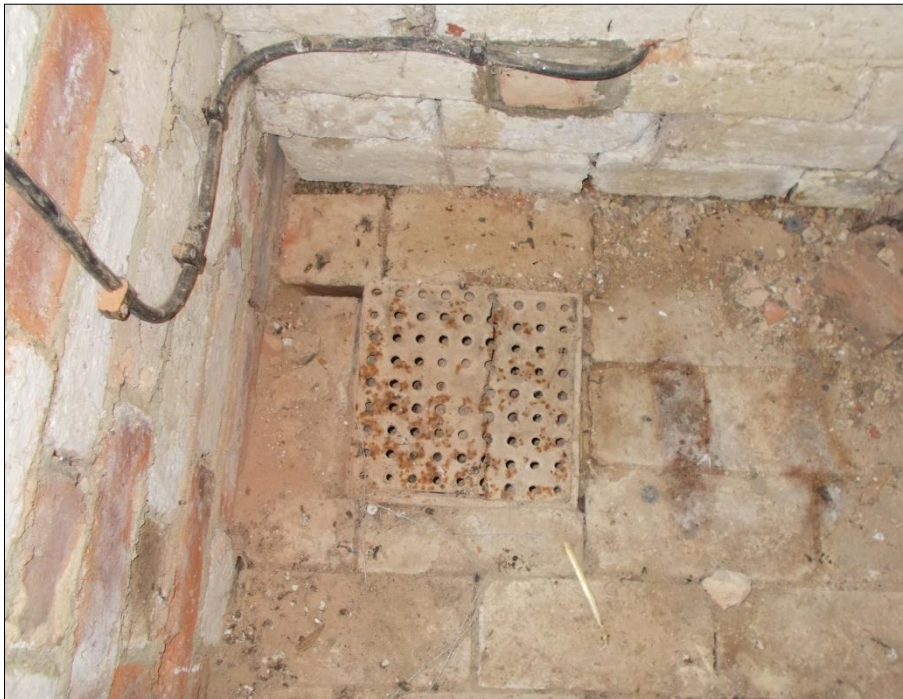
Fig 8: The floor and drain with cast iron cover.

The floor is laid with the same brick used in the construction of the walls set flat rather than on edge. In the north-east corner is a single drain fitted with a (now broken) pierced cast iron cover (Fig 8).

There are no drainage gullies indicating that the presence of the drain was for general washing down and not to collect specific areas of liquid.
