**A report on archaeological monitoring during  
alterations and groundworks at Bridgford Hall,  
Nottingham, 2016**

# Bridgford Hall

### Summary

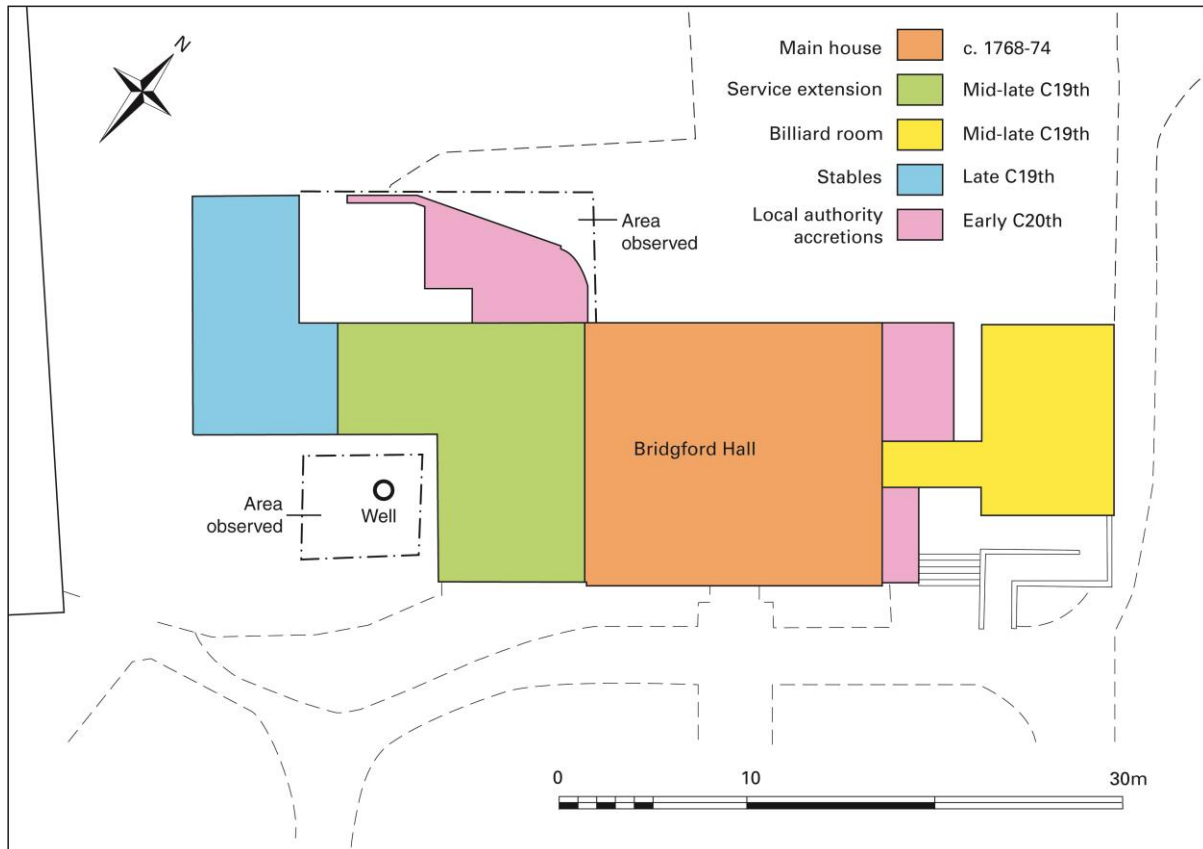
Fig 2: Block-phasing of the hall, with areas of archaeological monitoring (Andy Isham, with acknowledgement to Purcell, Architects).

This structural development of the hall, summarised in Fig 2, below, is fully highlighted in Dix et al (2015) and is not further elucidated here.

The areas of archaeological monitoring are depicted in Figure 2.

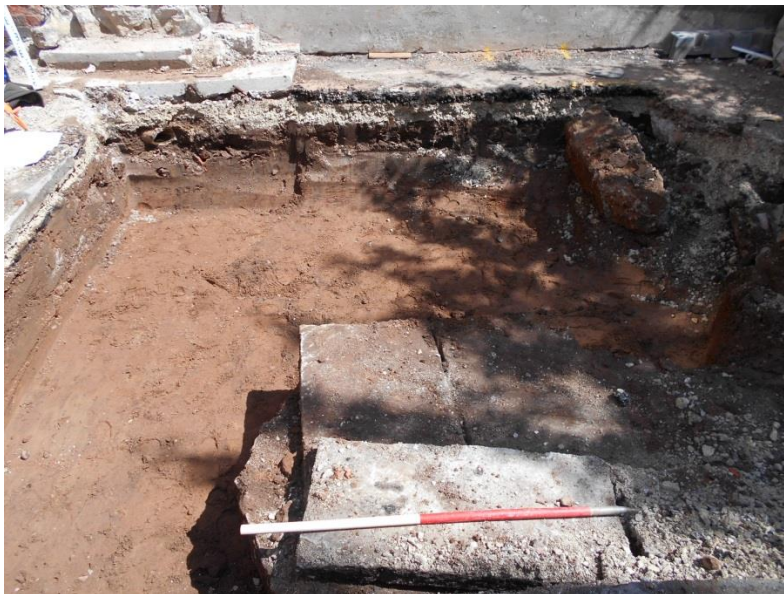
The only archaeological feature present was a brick-built well, 1.6m in diameter externally with a single brick skin. The uppermost surviving six courses of brick had been re-built and bonded in cement mortar, and the well spanned with an RSJ and provided with a plastic-pipe for an overflow. It had then been capped using large slabs of York Stone, before being tarmacked over. The original top of the well had not survived.

Fig 3: The well as uncovered, with its York Stone capping, looking north-east; scale 1m

The depth to water level was 4.2m and upon pumping, the water was found to be about 1m deep. Once emptied it could be seen that the old upper brick courses, broken up, lay at the base of the well. The well had been constructed in a standard 19<sup>th</sup>-century fashion using an iron hoop at the base, dug down within a hand-excavated cylindrical shaft, the bricks being laid above the hoop, which was then dropped bit by bit. The hoop remained *in-situ* at the base.

Since this location was that of the planned lift pit, the well was removed and capped in concrete at depth.

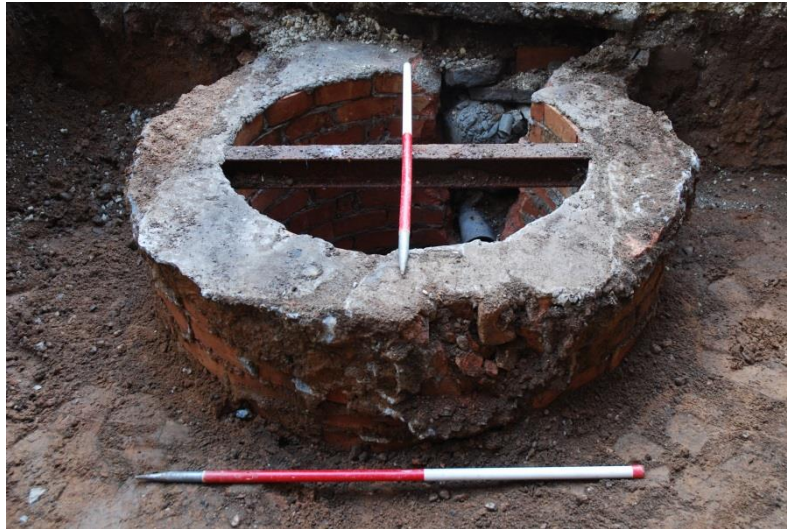
Fig 4: The well, capping removed, showing the rebuilt uppermost courses, RSJ and overflow pipe, looking south-west; scales 1m

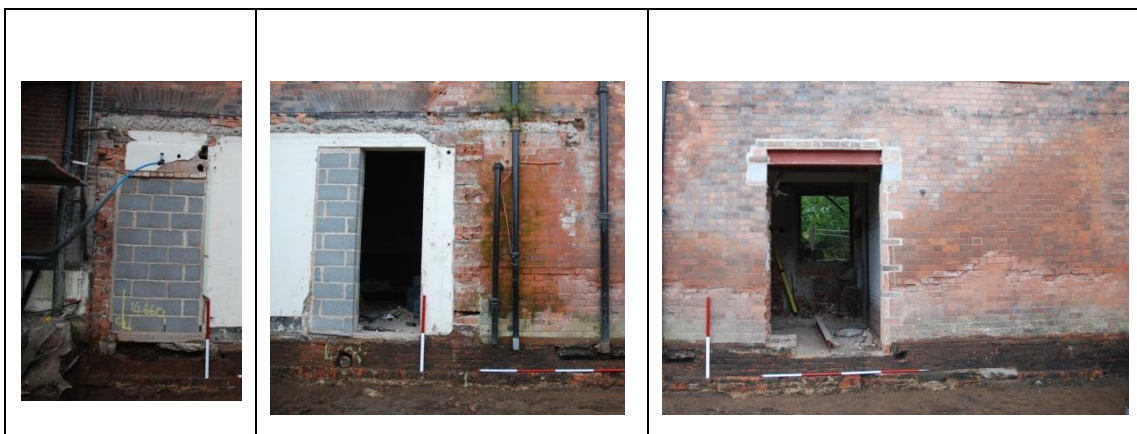
Under a modern concrete yard surface lay very disturbed topsoil c400mm thick, over natural river terrace sands and gravels. There was no pre-1923 archaeology present.

Fig 5: Composite photo-montage showing the exposed rear of the 1886 building after demolition of the modern accretions and ground reduction. Scales 1m and 2m

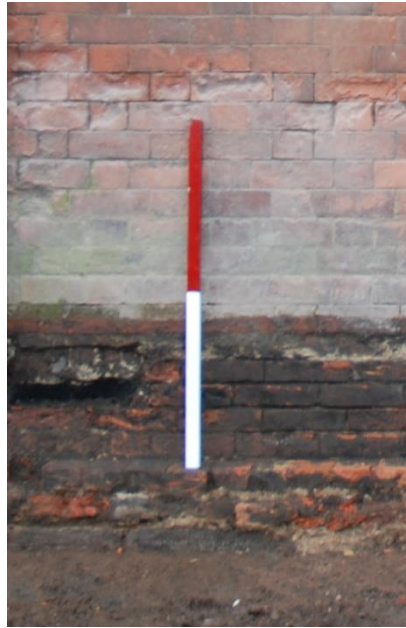
It was noted that the mid-late 19<sup>th</sup>-century service range, both in its single storey and its three-storey phases, utilised foundations of only two offset courses of bricks on top of a single course of stone blocks. The building at this point appears to have no other foundations.

Fig 6: Detail showing the flimsy brick offset and single course of stone foundation; scale 1m
