**The former Fox and Hounds Public House,  
32 Gold Street, Wellingborough, Northamptonshire**

## The former Fox and Hounds Public House, 32 Gold Street, Wellingborough, Northamptonshire

### Introduction

## **Building recording**

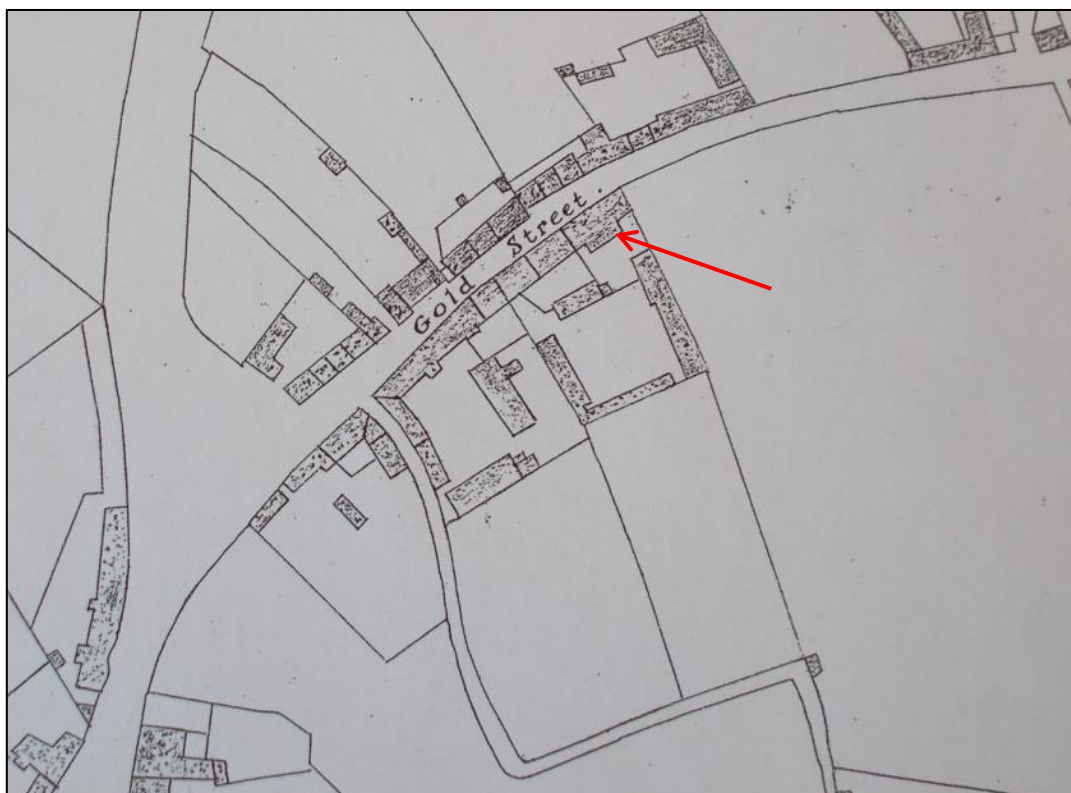
Fig 2: 1803 map of Wellingborough by William James (extract in NRO). The probable Fox and Hounds is arrowed.

The street on which the building is located is understood to have been known variously as Common Town Street, Townsend and its current form, Gold Street from at least the 16<sup>th</sup> century (Palmer and Palmer 1972, 263). A map of Wellingborough of 1803 indicates buildings on both the north and south sides of the street at that time but the shortcomings of the depiction mean that none are easily comparable to the existing building in its earliest form (see below, Fig 2).

This form of construction is common in this area of the county and is well represented in the northern part of Wellingborough. The banding is made of squared blocks with dressed, but not ashlar, surfaces. At the north-eastern corner of the building are large ashlar quoins though curiously these do not occur at the north-west corner. This variation suggests that when built the west side was adjacent to another building whilst the north-east corner might have been free-standing. This would seem to be borne out by the 1803 map (Fig 2).

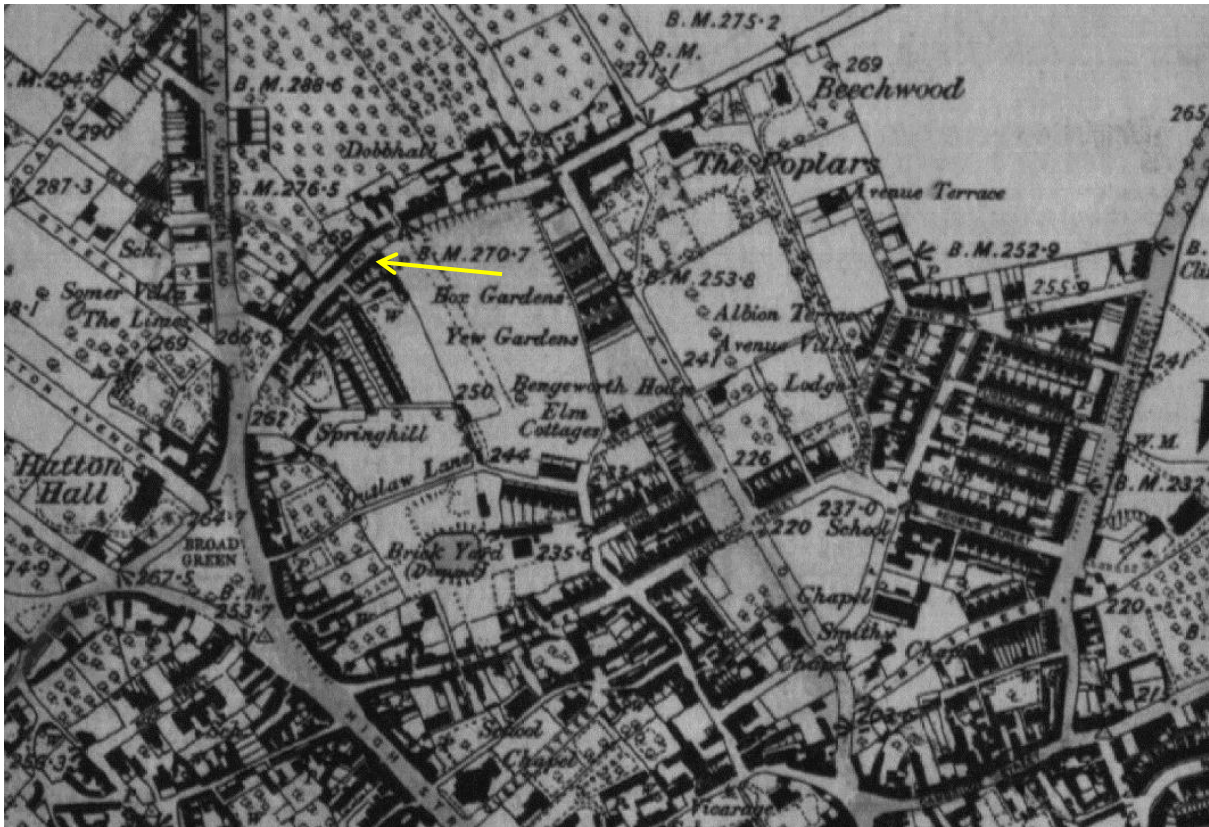
Fig 3: 1886 first edition Ordnance Survey; sheet 39 NE. Fox and Hounds arrowed

By the First Edition Ordnance Survey map of 1886 the area has undergone extensive development with the street frontages much altered and the areas of open ground to the south and east of the site becoming infilled with streets of terraced houses. The area to the rear of the building is shown to have had further additions which correspond with the areas indicated on Fig 3, labelled as C19th buildings (see below).

Little can be said about the agglomeration of structures against the south side of the original building. Most appear on the First Edition Ordnance survey map of 1886 so must pre-date that period (Fig 3). All are built of red brick, by that period the most common building material in this area. All have slate roof coverings and either contemporary or later windows (Fig 12).

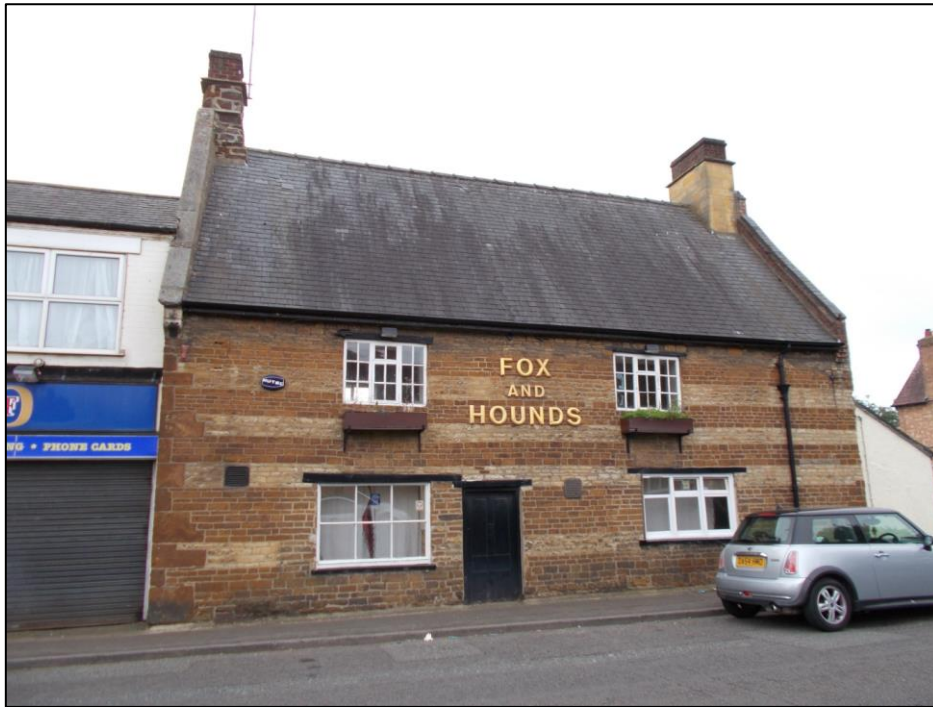
The street frontage shows most clearly the method of construction which comprises alternating bands of varying thicknesses of local limestone and ironstone, each comprising several courses bonded in lime mortar with extensive later re-pointing (Fig 4).

Fig 5: The north (Gold Street) elevation, looking south.

The ground floor contains two broad window openings set either side of a slightly off-centre doorway. The window openings have both been widened as evidenced by pieces of chopped-through stone to each side of the openings which in some cases remain as shallow slips where larger pieces would be expected. This widening indicates that each of the timber lintels has also been replaced. The eastern window (left side in Fig 5) contains six panes of fixed glazing and is modern. The western also contains six panes but one of the lower three is an opening casement with the centre one of the upper three being a hinged top light.

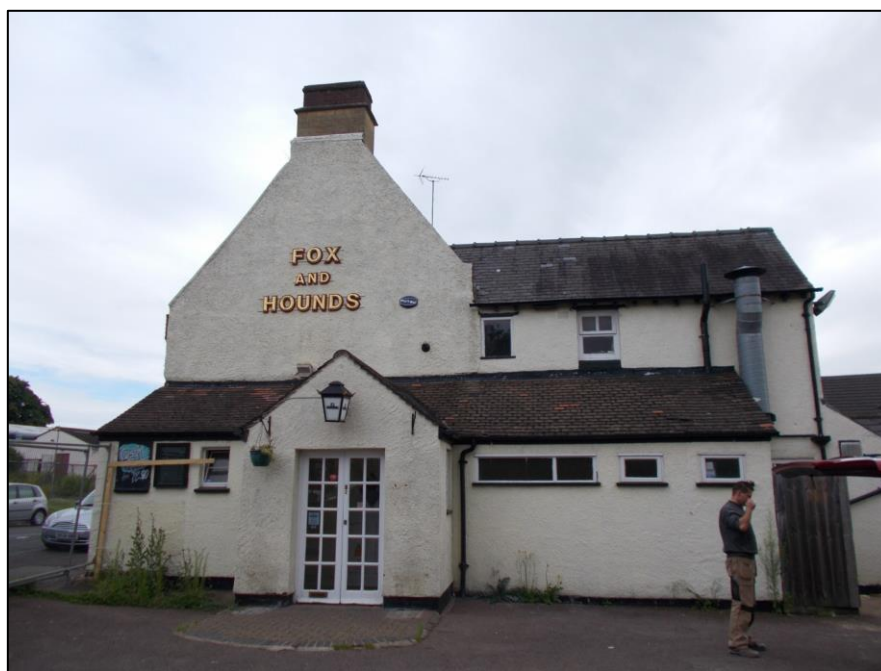
The west gable, though largely visible, has been covered with pebble-dash (Fig 6).

Fig 6: The west elevation, looking east. Later additions at ground level foreground and to both storeys to the right.

Nothing else can now be said of this elevation due to the later covering apart from the fact that the gable parapet has been replaced in brick. The double chimney stack is rendered so it is not clear if it remains in stone or is re-built in brick, which is present in the upper portion.

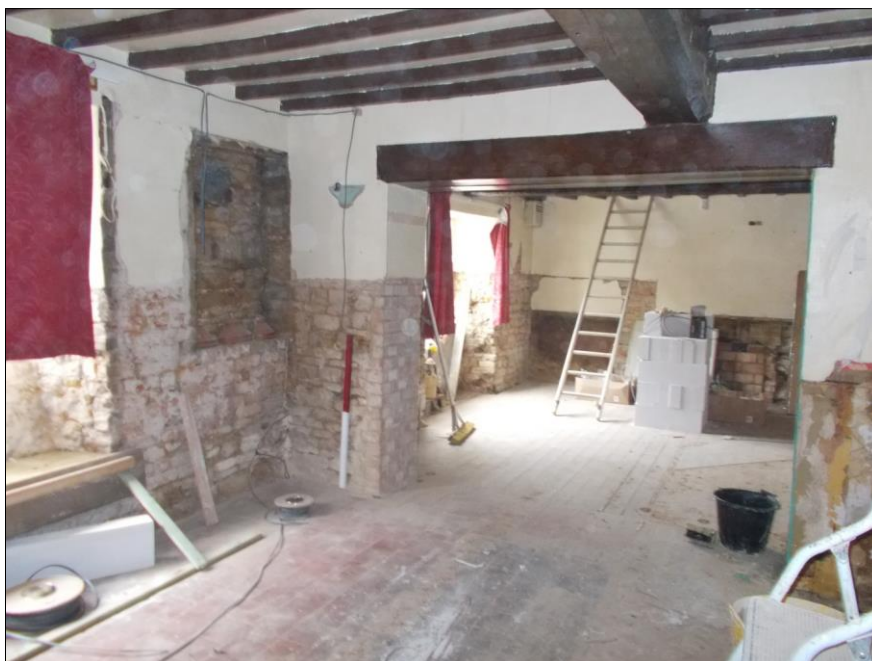
Located at the east end of the north range this room at the time of survey retained almost nothing of historic value having been extensively gutted when in use as a pub and partially stripped during the current renovation (Fig 7).

Fig 7: Room G1 looking east from room G2; 1m scale.

Where revealed beneath modern plaster, the stone construction of the north wall could be observed. In the east gable wall patching with Fletton brickwork suggests that there was a fireplace on the level but since much of the modern plaster remained *in-situ* the jambs and lintel were not visible. No other features were visible apart from the painted underside of the ceiling and the timber axial ceiling beam (aligned north-south) with joists to either side. A large portion of the original south and east walls had been removed during the time as a pub allowing access through to the spaces beyond. All surfaces were plastered. The floor of this end of the building is what appear to be modern narrow pine floorboards.

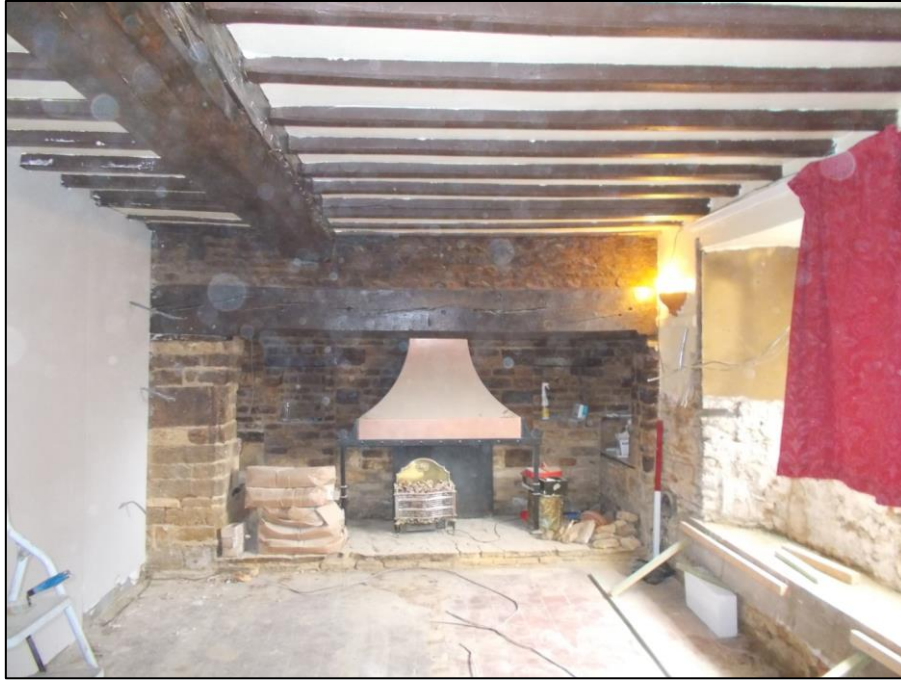
Located at the west end of the frontage range this room retains a large inglenook against the west gable wall (Figs 4 and 8).

Fig 8: The inglenook looking west; 1m scale.

The fireplace retains its large oak bressumer which extends across the opening; its lower edge is chamfered and at each end are ogee run-out stops typical of early eighteenth-century design. In the south side of the inglenook is a built-in seat within the thickness of the wall on that side (Fig 9).

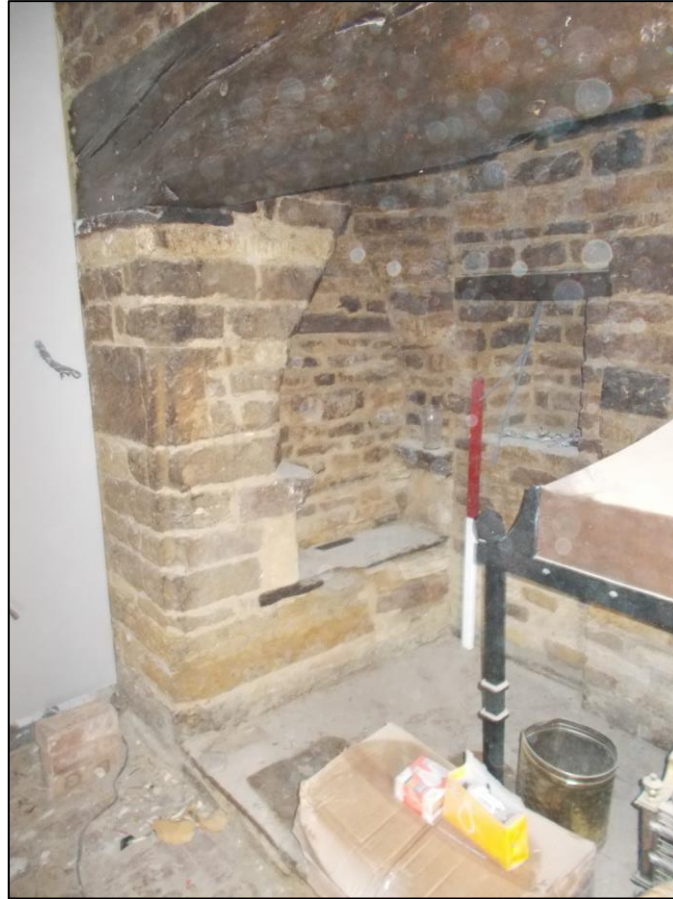
Fig 9: The built-in seat in the south wall of the inglenook looking south-west; 1m scale. Note also the recess in the west wall.

The seat was constructed with a pointed, corbelled top and integral shelves to either side made of stone. The seat, much degraded, is of timber, perhaps elm. In the west wall adjacent to the niche is a shallow recess perhaps for a lamp, though its location here is unusual as it would have been situated next to the fire.

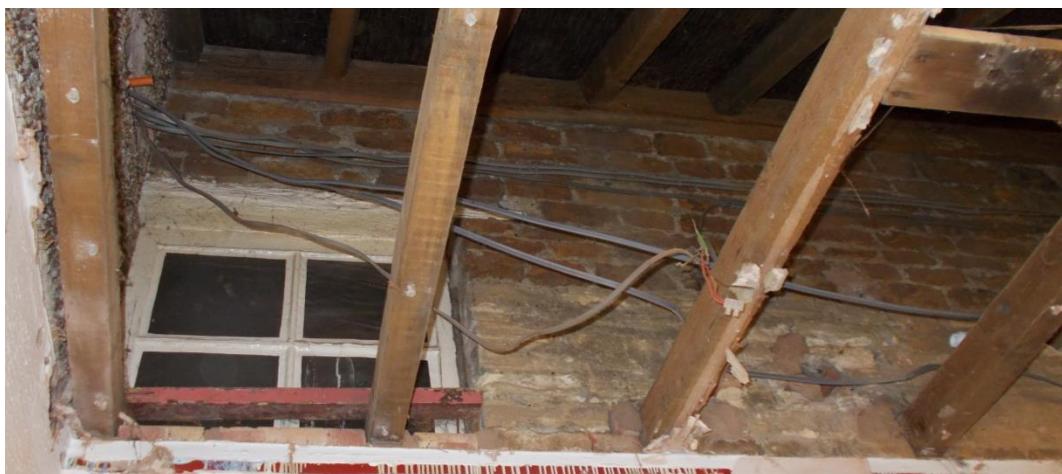
Of interest is a small section of the original external wall surface exposed during the current works when the false ceiling of the nineteenth-century range was added along the west side of the building, most recently housing pub toilets (Fig 4). Above the false ceiling and covered by the section of pitched roof above, the original external wall surface reveals that that side was also constructed using the limestone and ironstone banding (Fig 11).

Fig 11: Original west wall of the eighteenth-century building showing banding at first floor level. Note also blocked window placed to light the original stairwell. Looking east (and upward).

Situated between ground floor and first floor level a small window was also revealed in the roof space of the toilets addition (Fig 11). It is not clear how tall that window was originally as the lower part has been infilled with Fletton brickwork, and nothing of it could be seen from the interior of the original eighteenth-century range. As it survives it contains four panes within what appears to be a fixed frame beneath a timber lintel. The glass has been overpainted indicating that it was retained, but had gone out of use, before the west addition was added.

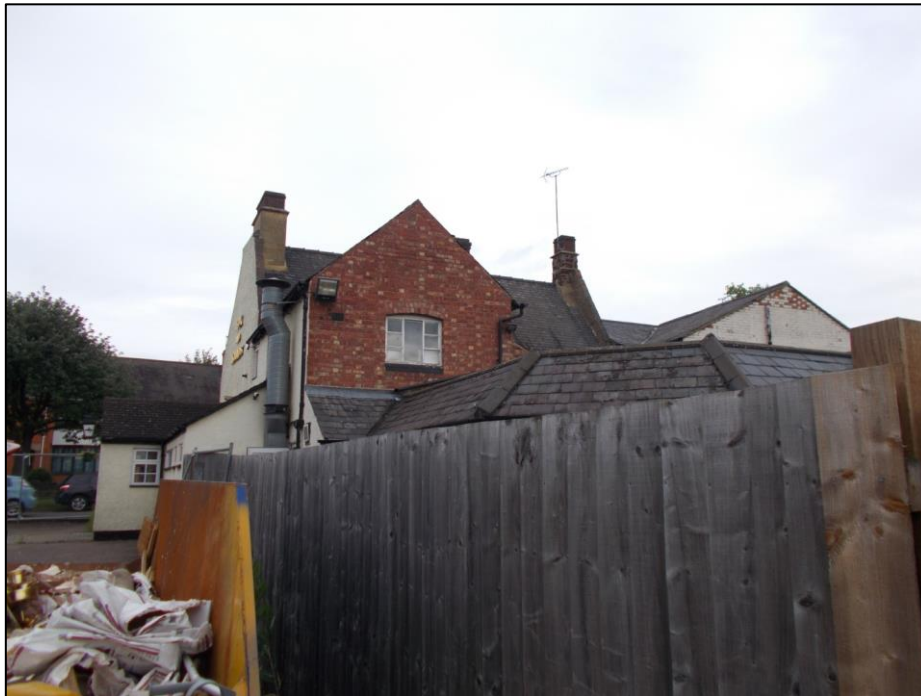
Fig 12: The nineteenth-century additions against the south side of the original building, looking north-east.

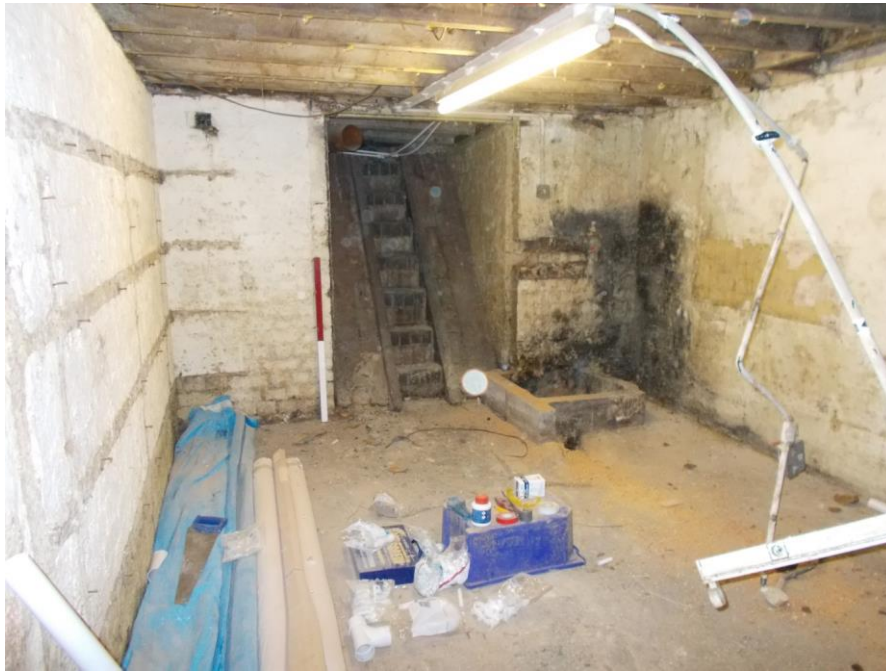
When the building was converted to use as a pub a beer cellar was built (Fig 4). Given its location, part of the south wall of the original north range and east wall of the south range had to be underpinned; this was done using brick (Fig 13).

Fig 13: The nineteenth-century cellar, looking south towards beer barrel chute. 1m scale.

The cellar is a single rectangular space with a beer barrel chute located at the south end with an integral flight of engineering blue brick steps incorporated into it between the sloping timber rails down which the barrels would be rolled.

In the south-west corner is a contemporary drain to accommodate spillage and there are scars of racking along the east wall (Fig 13, at left). The floor is now of concrete.
