## An archaeological desk-based assessment of land adjacent to Bank House, Church Stowe, Northamptonshire

## **An archaeological Desk-Based Assessment of land adjacent to Bank House, Church Stowe**

### **Summary**

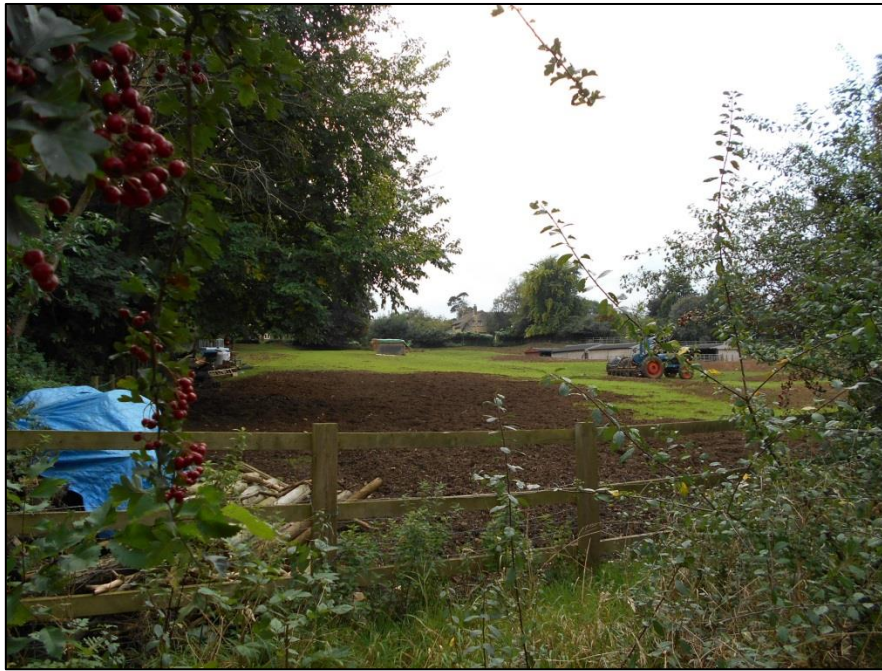
Fig 3: View of the site looking west from Pit Cottages along the former Pound Close (see below). That portion of the earthworks recorded by AE Brown (see below) in the former Pound Close have been smoothed out in recent decades.

The earthworks of the village core were the subject of a survey in the 1980s by academic archaeologist, A E Brown, formerly of University of Leicester, including the present site. The results are deposited in the Northamptonshire Historic Environment Record (ENN 103903). These were also later published by Brown (1987, 78-9 & fig 42). His interpretations concentrated upon those earthworks to the north of the parish church and west of Manor Farm, which were felt to be medieval. However, although they mapped those to the south east of Manor Farm, including the present site, they did not interpret them (see Fig 5, below). These have since been somewhat softened by concerted levelling (Fig 3).

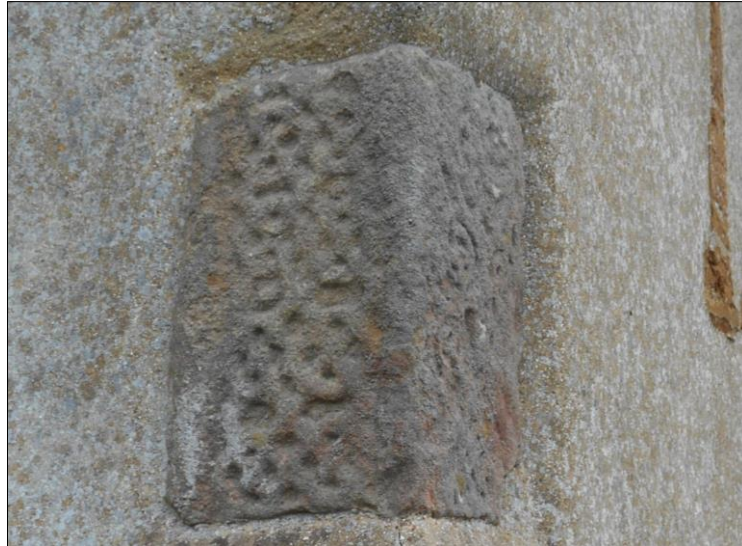
Fig 4: Anglo-Saxon cross-shaft with interlace decoration, built as a quoin into the medieval parish church tower

The Pre-Conquest archaeology of the village of Church Stowe has been the subject of academic enquiry for some time, most notably in respect of rare, surviving Anglo-Saxon boundary charters which reveal it as an important pre-conquest estate (Brown et al 1981). There is a notable fragment of Anglo-Saxon Cross-shaft built into the north-west corner of the parish church tower, with others elsewhere in the structure (Fig 4; Taylor and Taylor 1965; Brown et al, op cit, 1981).

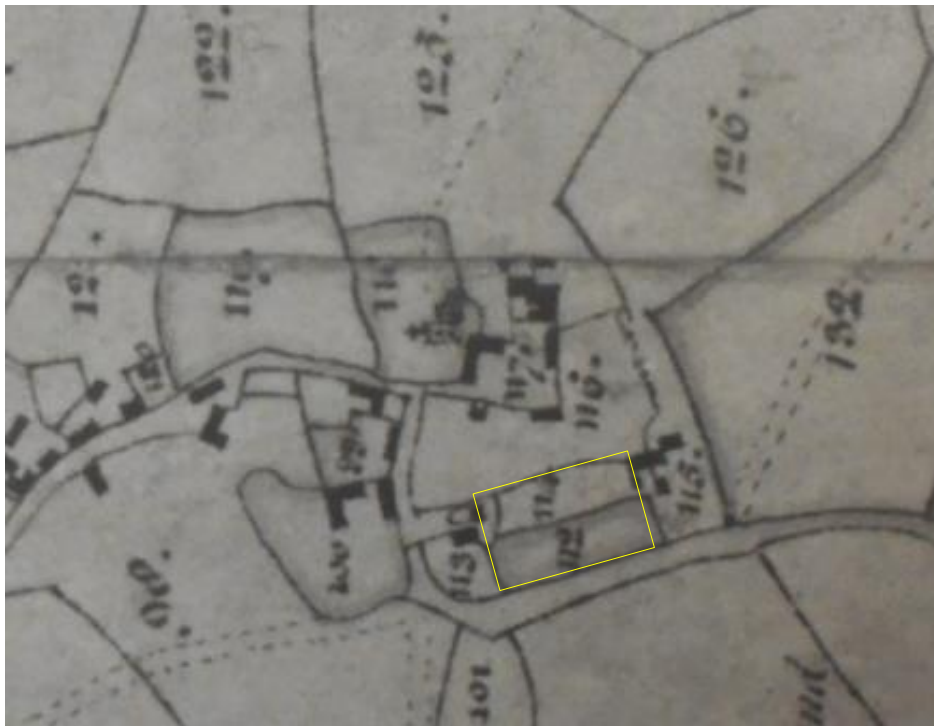
Fig 8: The site mapped in 1773 for the Corporation of the Sons of the Clergy (NRO: Map 2837). The site is shown approximately in yellow

The site in 1773 was mapped as part of a survey of the estates of the Corporation of the Sons of the Clergy (Fig 8; NRO: Map 2837).

At that date the site is divided into three parts:

- 112 Home Close (Glebe); 1 acre 1 rod 12 perches
- 114 House and Close; 0 acres 3 rods 31 perches
- 116 Dovecote Close; 4 acres 1 rod 27 perches

At this point the site is more divided up than it ever appears again. To the east lies 115 (House and Yard) but these buildings are clearly predecessors to the cottages which stand there today. The plot 132 is called Stone Pit Close (17a 2r 2p), bisected by the northerly track (now a road) which survives today and leads to the Watling Street.

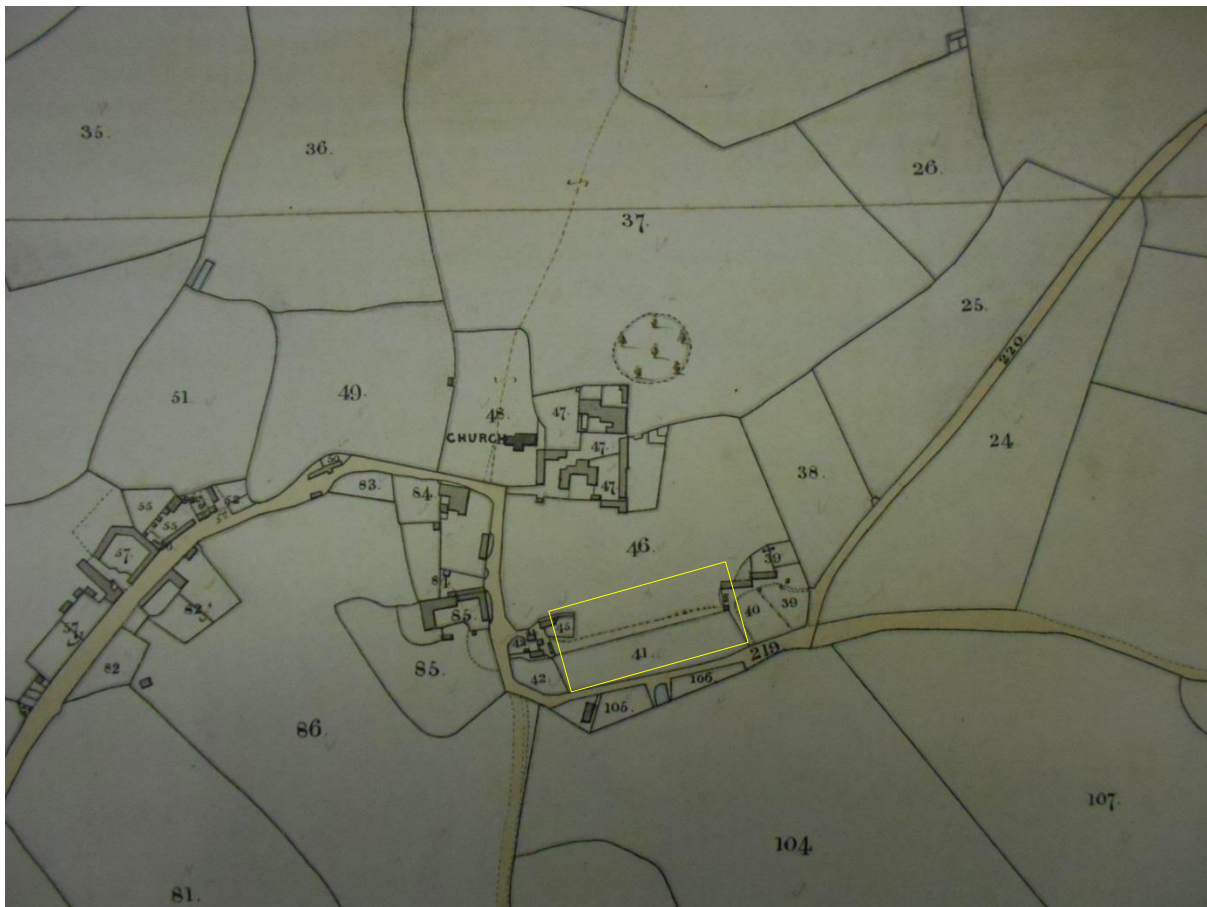
Fig 9: The site mapped for the 1839 Tithe Apportionment (NRO: Map T10). Site shown approximately in yellow. Nearby 24 was *Stone Pit Close*, while 38 was *Little Stone Pit Close*

In 1839 the parish was mapped for the tithe apportionment and the Tithe Map of that year records an altered layout to the site in which a whole plot has been lost (no 114 in 1773; Fig 9).

41 Pound Close (pasture) - Glebe -1 acre 1 rod 12 perches

46 Dovecote Close (pasture) – Sons of Clergy – 4 acres 3 rods, 5 perches

Between the two plots lies a causeway, for east-west access, fenced or hedged on the south side (NRO: Map T10).

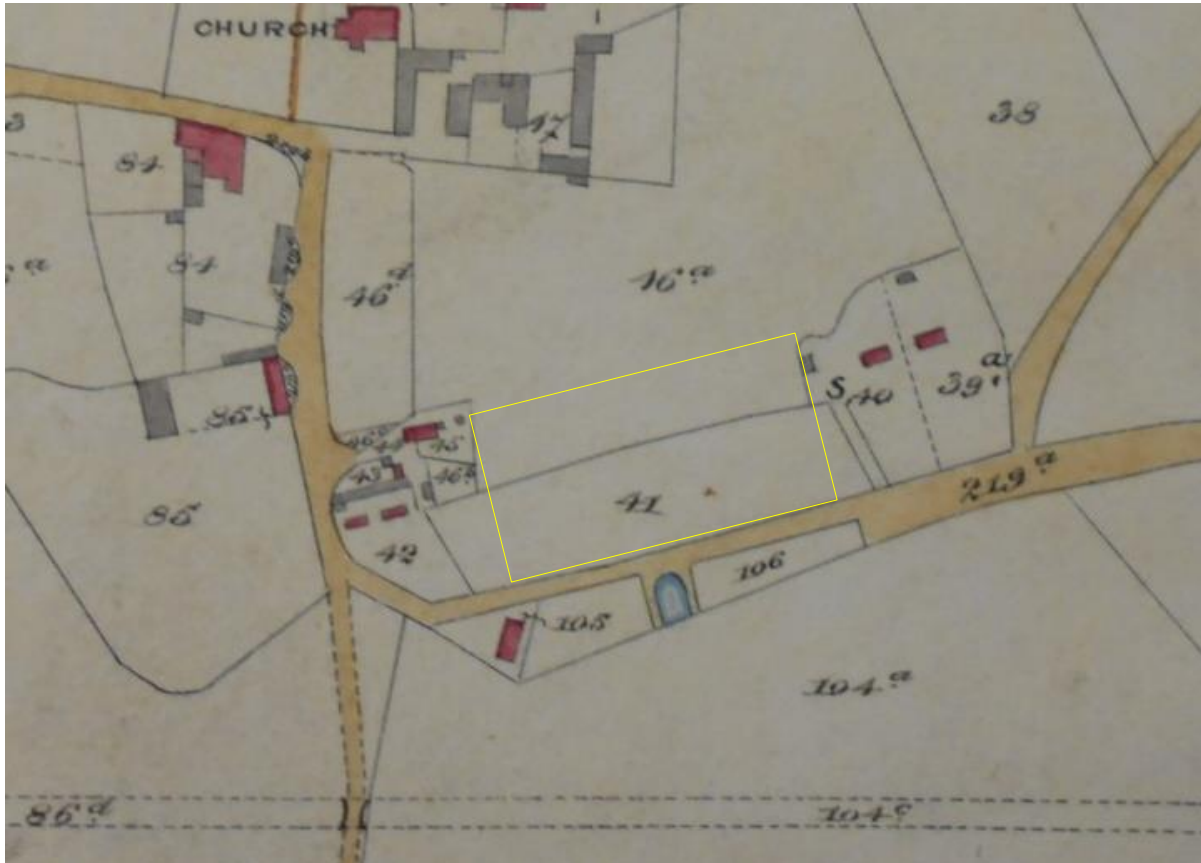
Fig 11: The site mapped in 1862 (NRO T175). The site is shown approximately in yellow. Note the new mineral tramway south of the site and the Heyford Road (86d/104a).

The title apportionment was reappraised in 1862 and a fresh map and schedule produced (NRO Map T175; Fig 11). Dove House Close was listed as pasture and measured 3a 3r 37p. Pound Close (41) was also pasture, owned by the Corporation of the Sons of the Clergy (not Glebe) and measured 1a 1r 12p. The small Main Street frontage site 46d was also called Dove House Close and measured 0a 3r 0p. As will be seen this is a key plot and crops up later on.

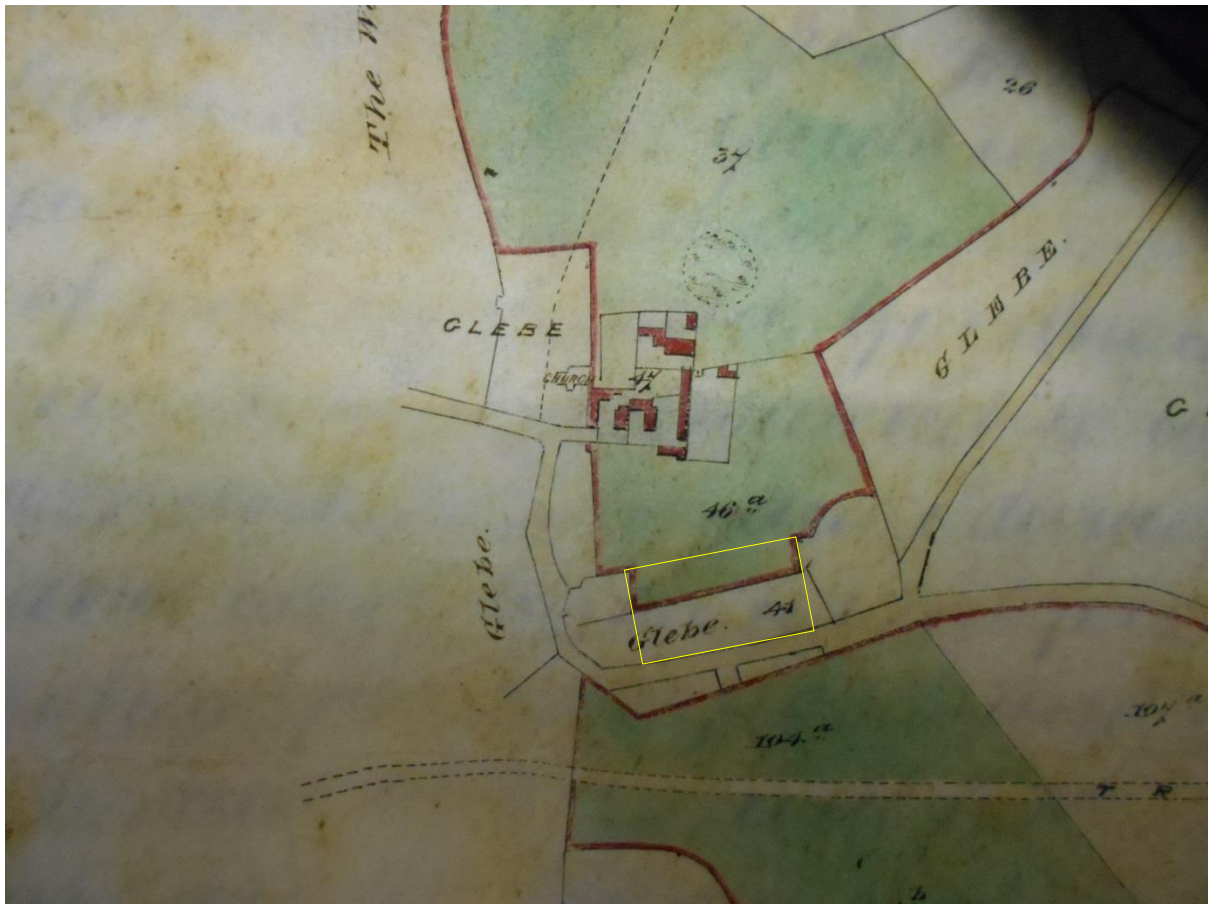
Fig 12: The site mapped for the lease of the Manor House Farm 1868 (NRO: YZ 7948). Site shown approximately in yellow.

In 1868 part of the estate of the Corporation of the Sons of the Clergy was mapped again, in order to lease out Manor Farm (Fig 12; NRO: YZ 7948). The site is shown as divided as it was previously in 1853, but by then it had apparently lost the causeway access from west to east. The northern portion of the site was part of Dovecote Close (no 46a) and which amounted to 5 acres 3 rods 37 perches in area, bigger than it had ever previously been. The southern portion (44) remained Glebe land, in the hands of the Vicar and was known as Pound Close, 1 acre 1 rod and 12 perches of pasture. Later correspondence from the vicar shows that this was the village animal pound.
