Iain Soden Heritage Services Ltd

**Level 3 Building Recording at the former Unity Works
and Vittoria Works, Vittoria Street, Birmingham, 2016**

Summary

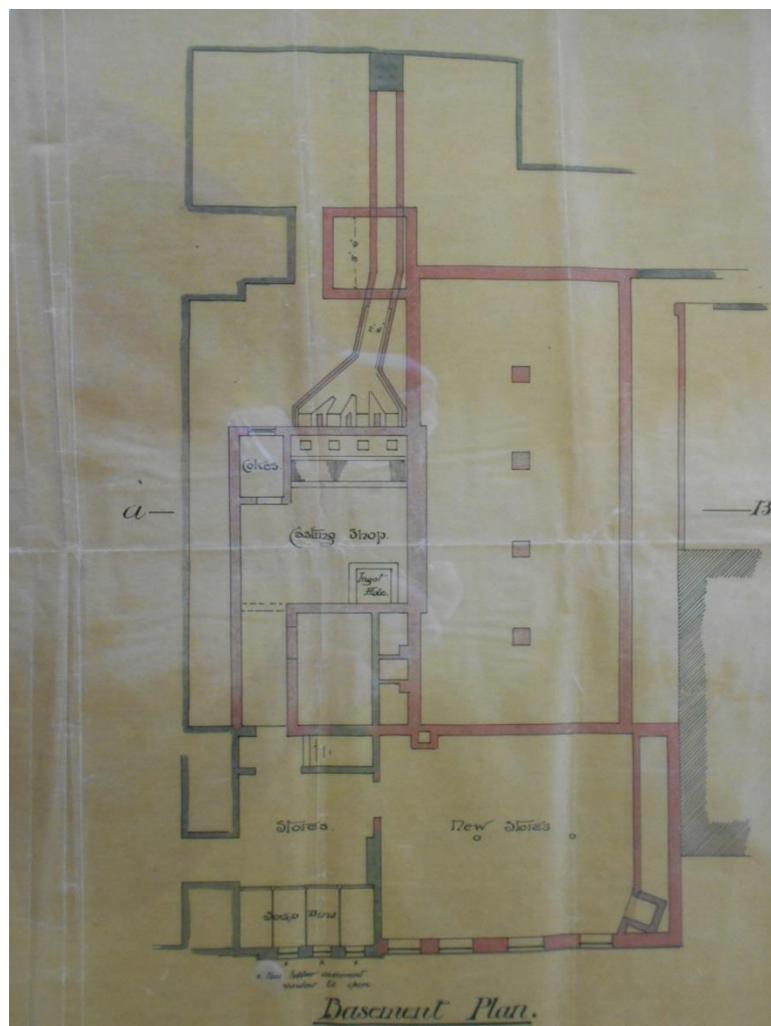
Fig 3: The new Unity Works basements of 1897 and the foundations of the new three-storey shopping (BA: BBP 13597). Cattell *et al*'s (2002) comments relate mainly to this plan.

As will be seen below, much of the 1897 proposals were carried out, although the furnaces and flues cannot currently be confirmed due to the restrictions of the existing access.

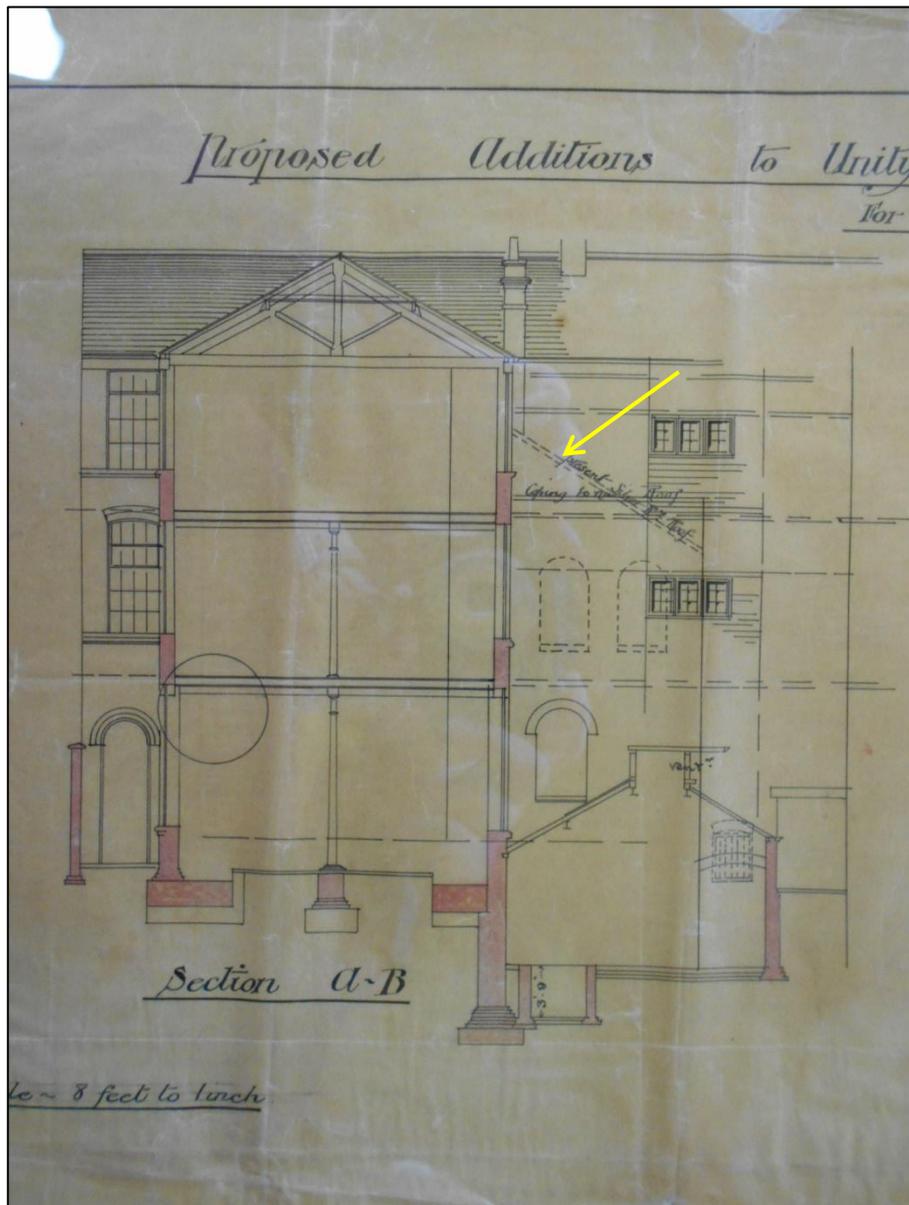
Fig 7: Sectional elevation of the new 1897 Unity Works shopping, looking east, with detail beyond the cutting plane. Note the basement-level casting shop, but also the location of the roof-line of a pre-existing two-storey short range of shopping, which was lost in this construction programme (arrowed). That was shown on the 1887 Ordnance Survey map.

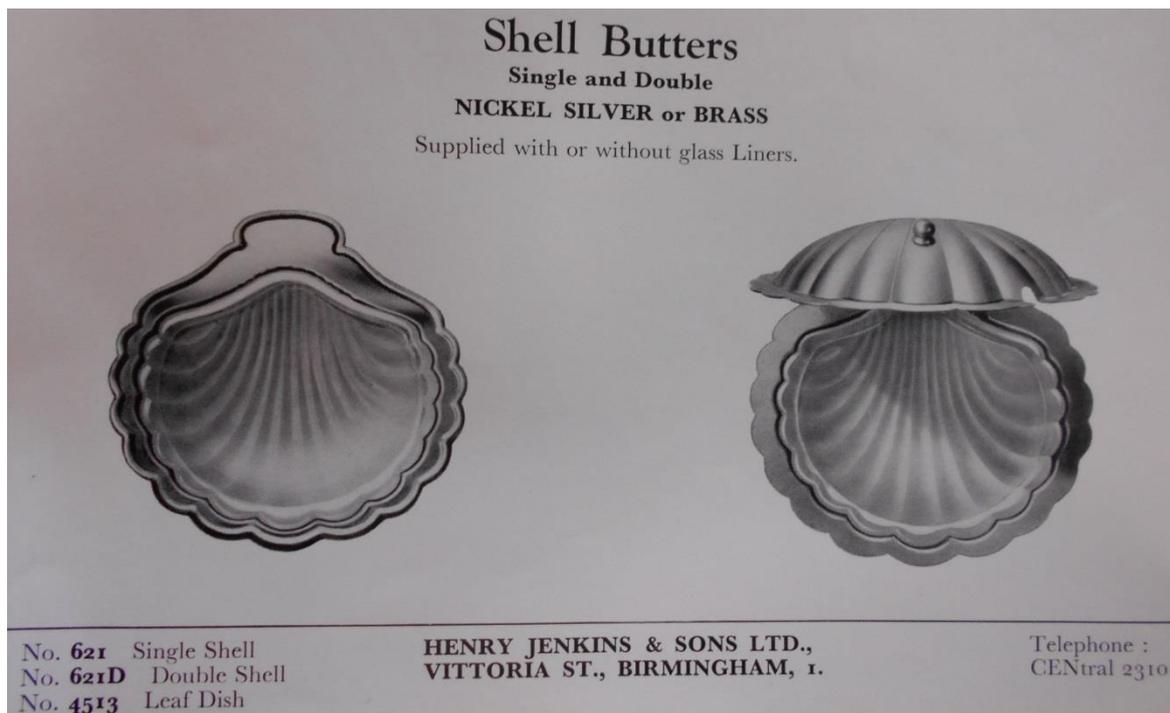
Fig 14: Shell Butters (butter dishes), available from at least 1958- c1971 (**BA: LS10/A/7/1**). Henry Jenkins and Son Ltd could supply replacement glass liners at a price of 97 pence (19s 6d) per dozen in 1971. Already 13 years old in 1971, clearly even then there was dwindling call for either new butter dishes or their liners, since hundreds still lie in 1958 East Lancashire newspaper wrappings in Room EG31.

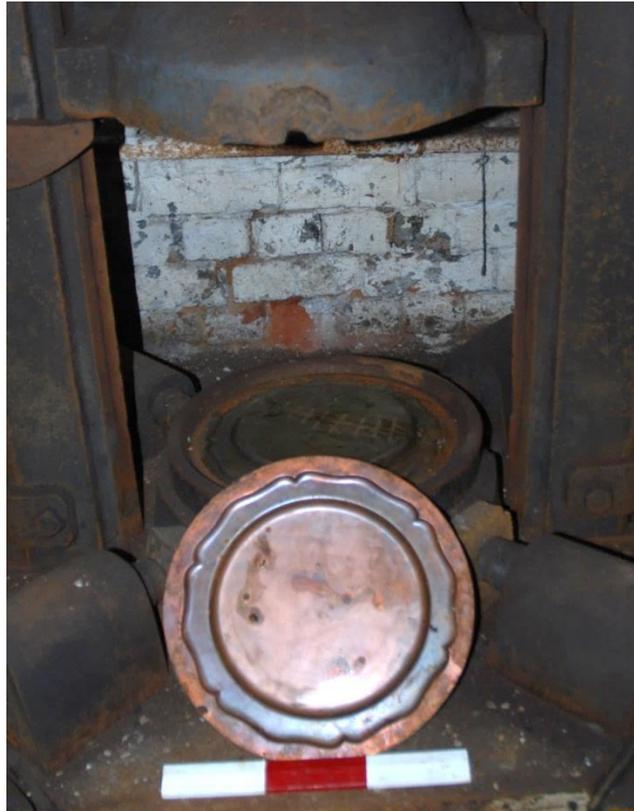
In another example from the catalogue an advert portrayed copper or nickel silver section trays or dinner plates in sizes of 6½", 8", 10", 12" or 14". The stamp for one of the 10" examples is still in position in one of the rooms, with one of the last examples ever produced lying beside the press.

Fig 16: The 10" copper or nickel silver tray and its die stamp, still set for production; scale 30cm

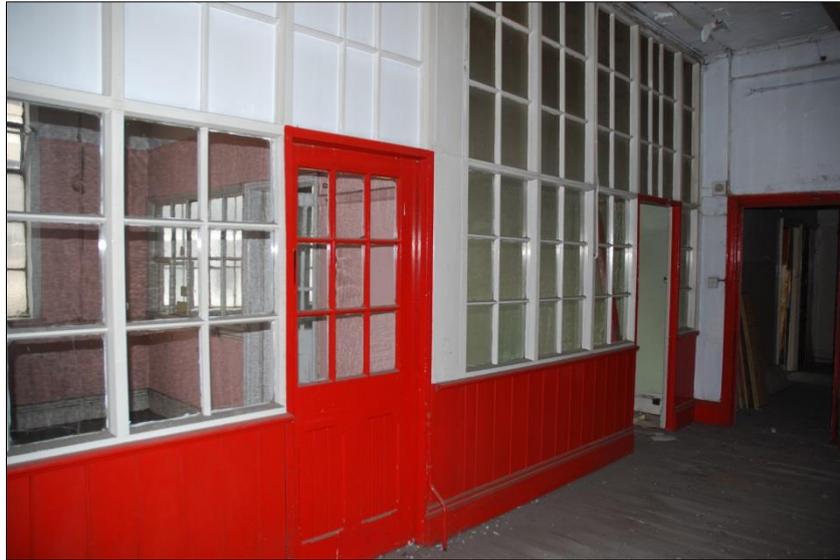
Fig 17: The Beverley Hall Ltd offices EF62 and EF63, looking south-east across EF61

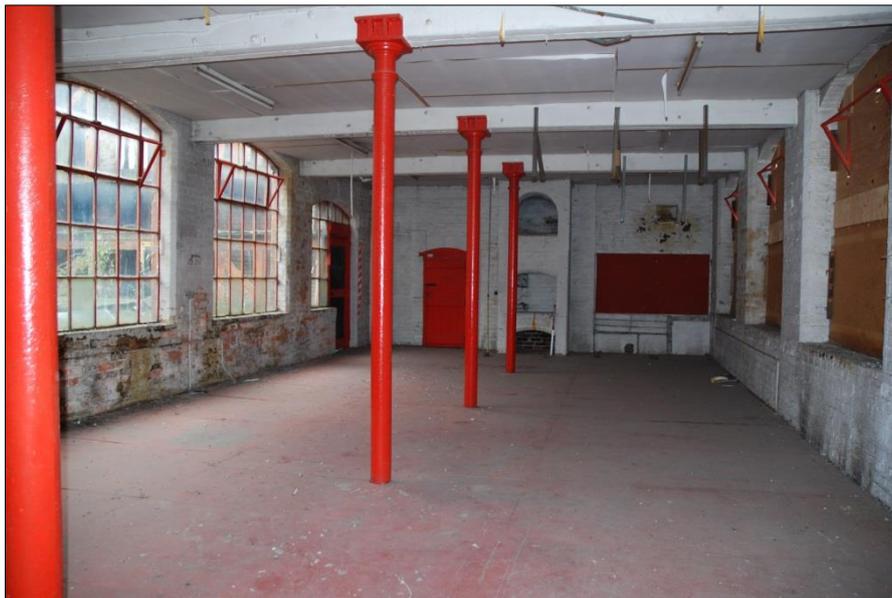
Fig 18: The first floor production space EF59 in the bright Beverley Hall Ltd livery

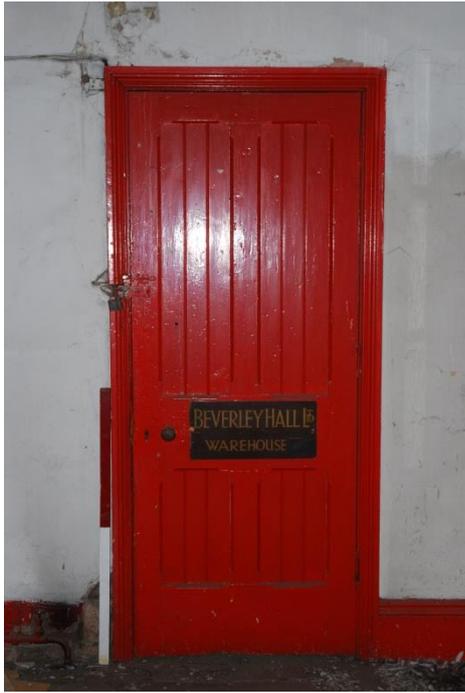
Fig19: The door to EF64, the Beverley Hall Ltd warehouse; scale 1m

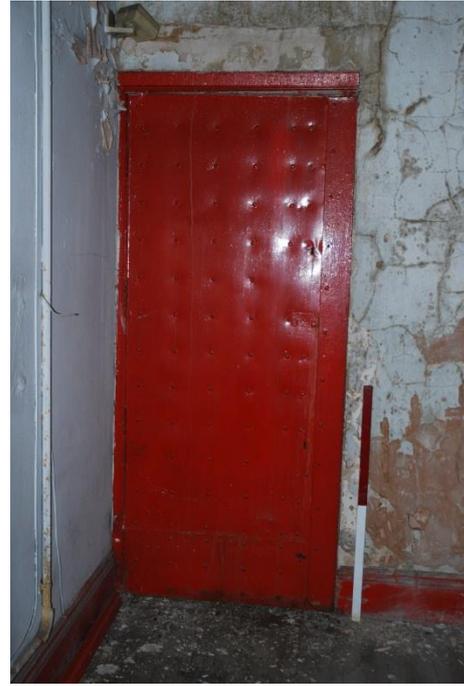
Fig 20: The strong-room door in EF61; scale 1m

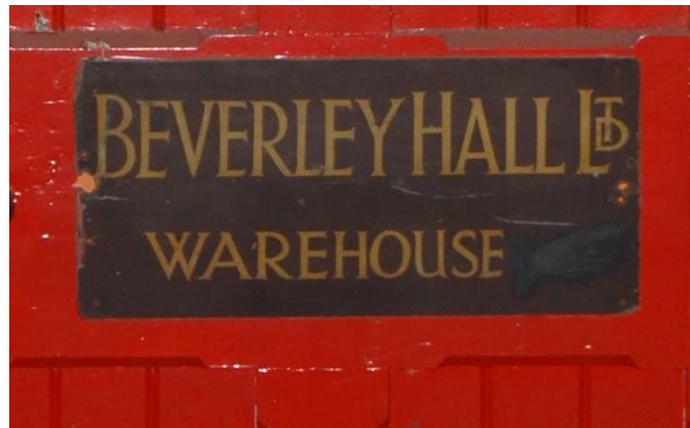
That said one of the most interesting features of the typeface is vertical stroke on the U in Warehouse. It has a stem at the bottom which not many fonts do. It's reminiscent of the font [Albertus](#). This dates from the early thirties. It also has a late Arts & Crafts feel like Eric Gill's [Perpetua](#). That was late 20s. It is plausible therefore that the sign dates from the early 1930s.'

Fig 21: The sign on the door to EF64 in Fig 19 (above). The distinctive lettering face suggests it was created in the early 1930s.

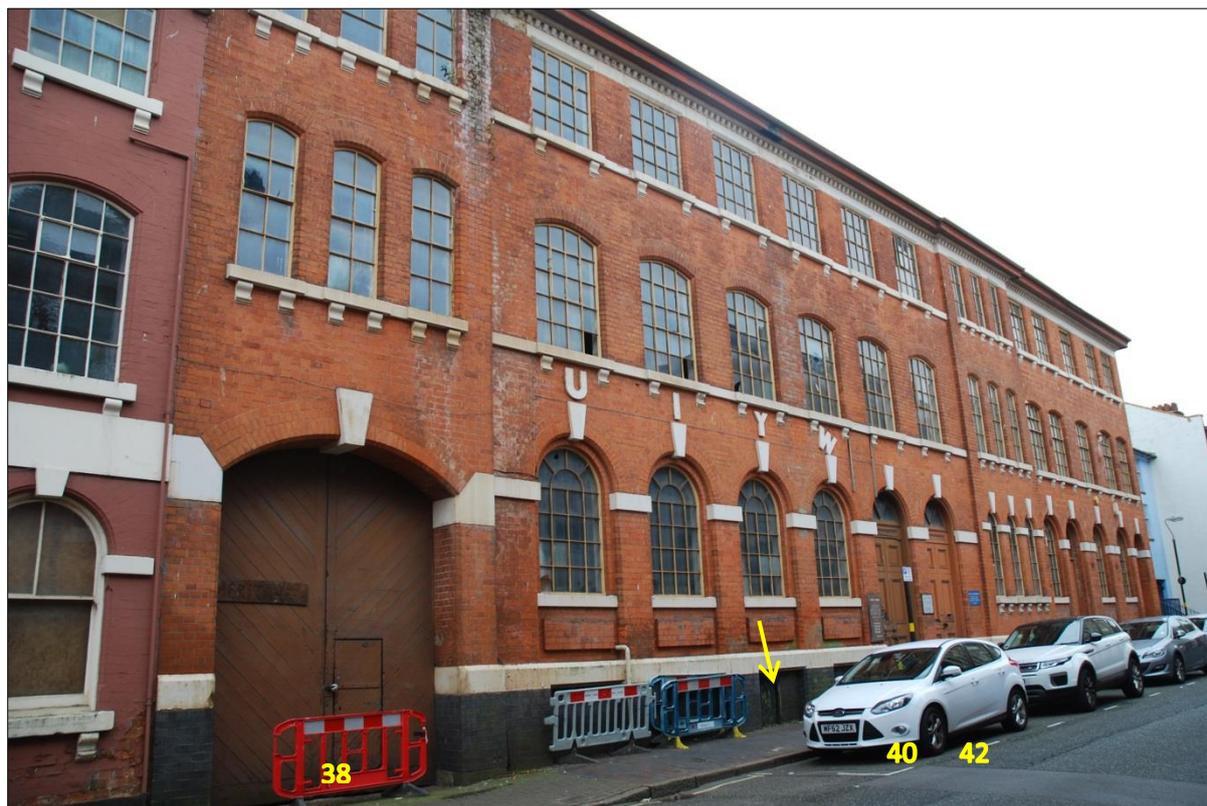
Fig 22: Unity Works street frontage with surviving street numbering

Some considerable alterations have been carried out to the frontage at street level. The plinth of Staffordshire Blue Engineering Brick is largely either a full replacement at its northern half or a major alteration at the southern half. This was to block up (and in the northern half externally at least almost visually remove) the row of basement windows, possibly with integral pavement light-wells. These brick blockings are all visible on the inside. Externally the blue brick plinth would have been totally rebuilt along its northern half, leaving only the stone lintel chamfers of the plinth offset. Along the southern portion the former openings remained visibly blocked, all but one, which retained a timber door (arrowed yellow in Fig 22).

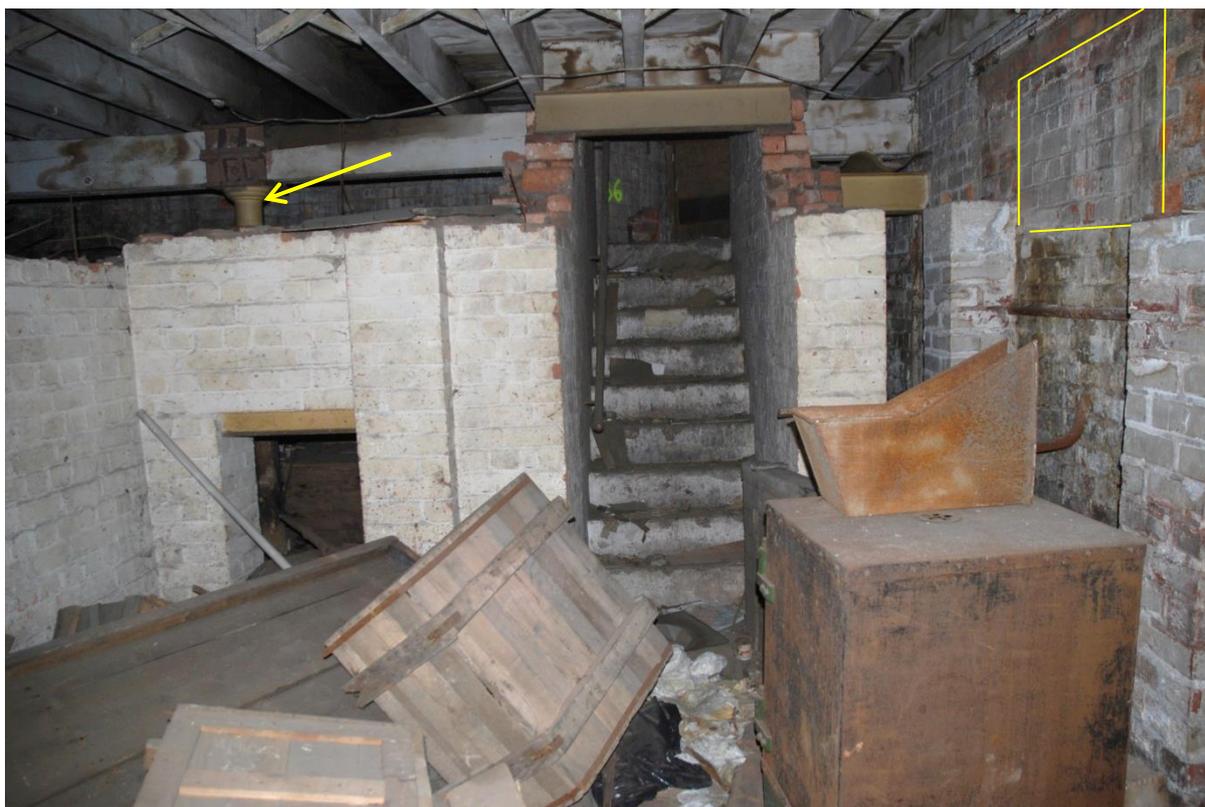
Fig 23: Basement view, looking north in room EB16, with blocked basement light (yellow) on right, with lintel *in situ*. Note the original ground floor timbers supported on a cast-iron column (arrowed) and almost hidden behind the extensive whitewashed (probably 1940s) Fletton inserts (see below)

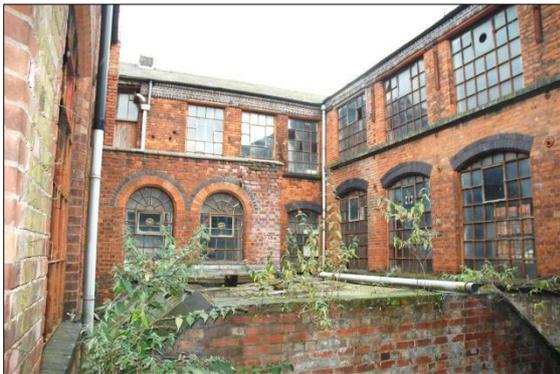
Fig 24: View from EF59 doorway to EF52 east across across roof of the Polishing shop and toilets (flat roofs) showing rear of frontage range and north face of EF47 and ES29

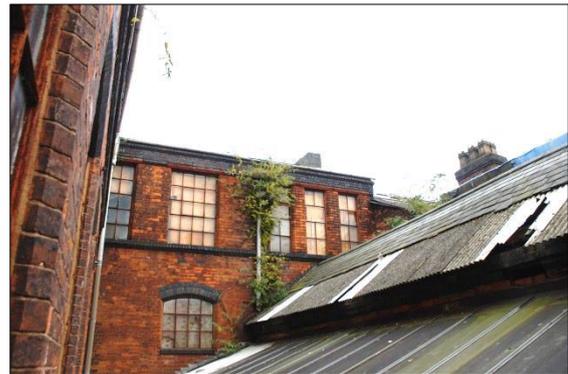
Fig 25: View from south window in EF47 looking east across covered yard showing rear window of EF37 and second floor windows of ES27.

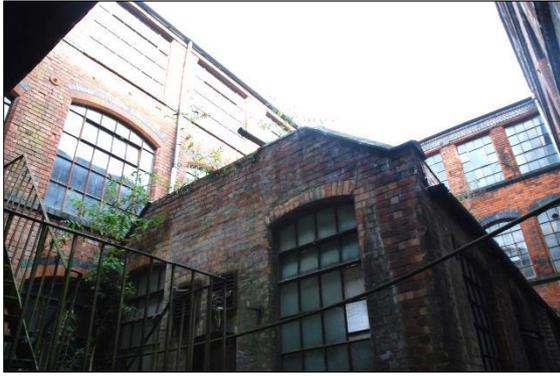
Fig 26: View up over the Polishing shop to the exterior of EF59 and ES39 (top left)

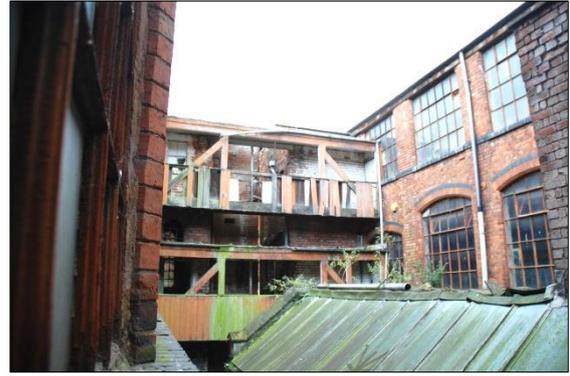
Fig 27: View west over Polishing shop of the two-floor timber link walkways between the two principal workshop ranges. EF59 and ES39 to right

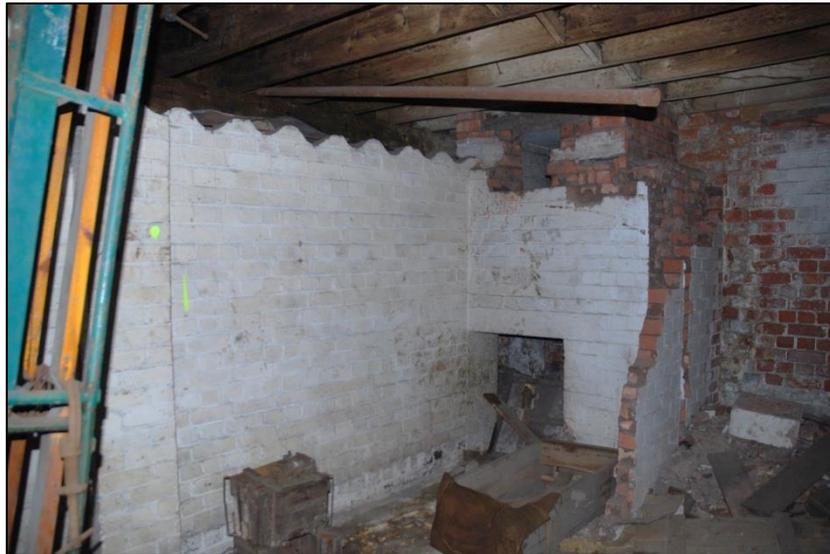
The whole basement along the frontage at its greatest extent has been extensively fitted out with a lavishly-buttressed inner skin of Fletton brick in the relatively-strong English Bond (alternate courses of headers and stretchers). This represents the well-documented creation of an extensive Air Raid Shelter from March 1940, even before the Midlands (or any other English urban centres) had been targeted.

Fig 28: Dividing wall in basement room EB10 (looking East) entirely of Flettons in English Bond with corrugations denoting former inserted roof line under the ground floor joists of EG31

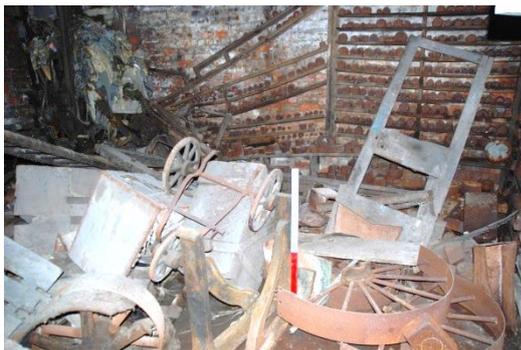
This rear basement is littered with early debris, including drive-wheels, belts and shaft-apparatus, while the walls are lined with hundreds of steel former die-stamps on shelves. This basement space, still largely inaccessible, contains a considerable body of production material and the awkward access created by the insertion of the Fletton Air Raid Shelter suggests it may have been largely undisturbed since c1940. It was designed as a new Casting Shop in 1897 and contained furnaces and flues.

Fig 29: Dumped debris

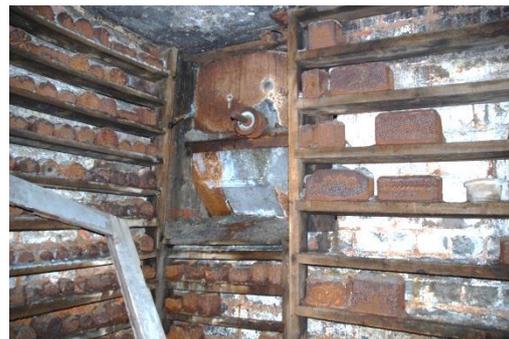
Fig 30: Stored stamps

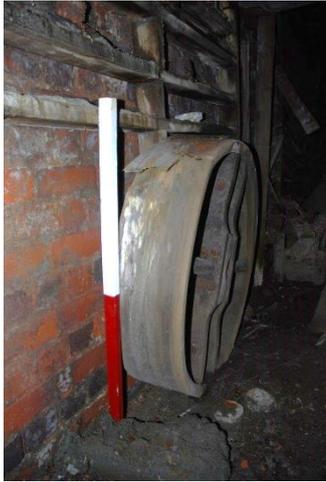
Fig 31: A laminated (and delaminating) wooden drive wheel in corridor

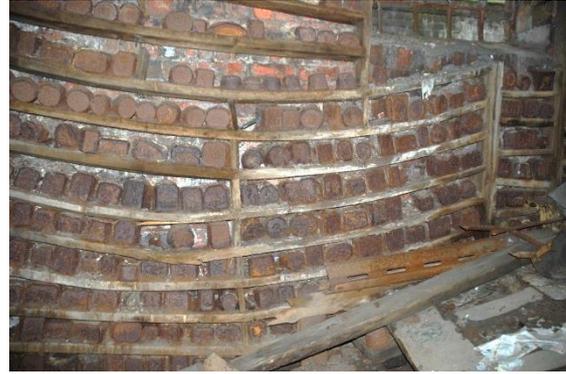
Fig 32: Stored stamps, rotting shelves buckling under their weight

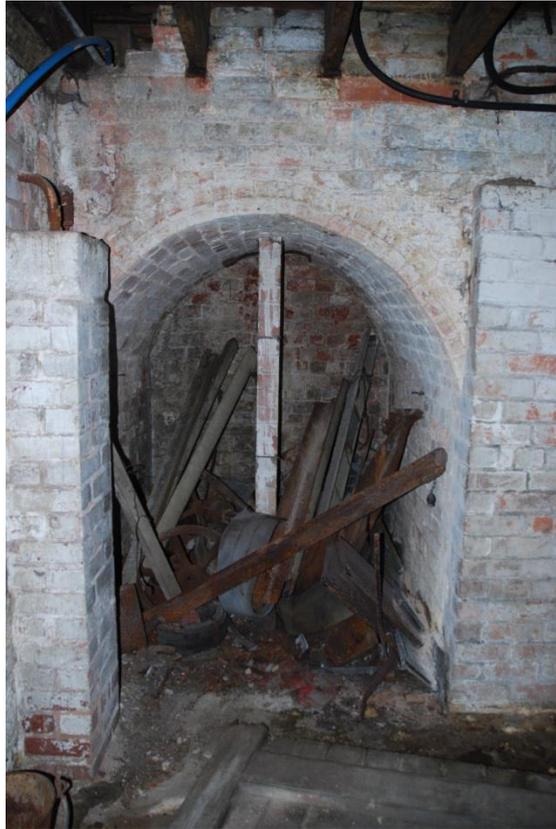
Fig 33: Arched alcove in north-west corner of EB11, containing a collection of cast-iron wheels from a drive-shaft. The arch supported the stairs above, while to both left and right stand two World-War II Fletton-brick buttresses. Most of the basements are highly cluttered like this.

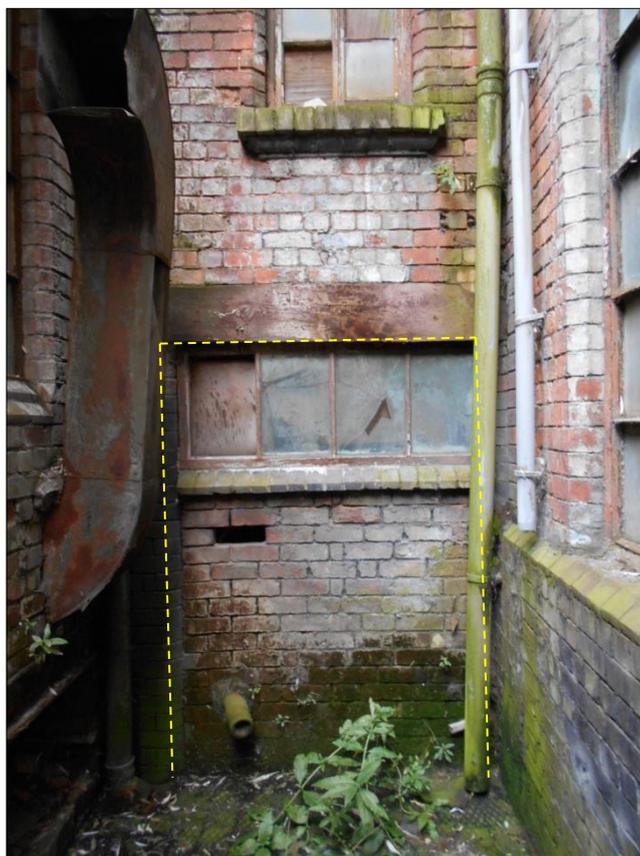
Fig 34: The former main corridor entrance from Vittoria Street to the rear yard and workshops (marked yellow). The small window above once lit a stair quarter-landing

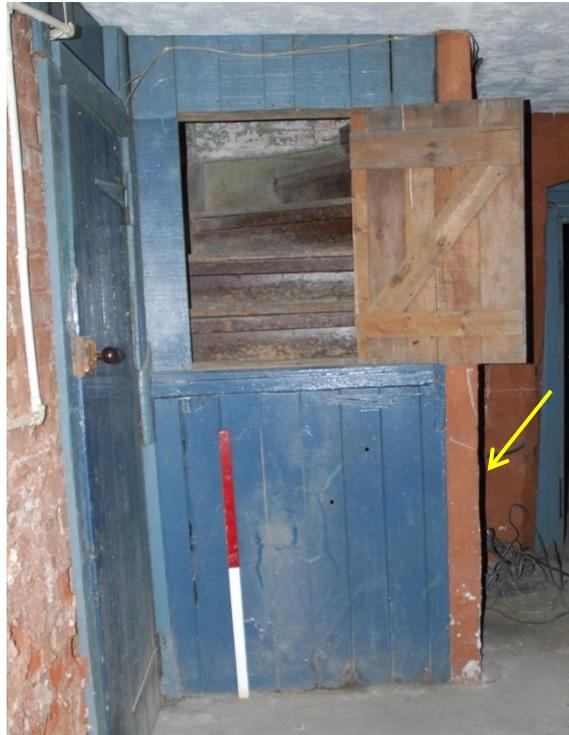
In a lobby to the rear of the office stands a winding set of blanked-off stairs (EG39). Their *raison d'être* has been entirely lost as they have been severed both above and below (EF42 and EB14, respectively). These form the former stairs serving the northern half of the frontage range.

Fig 35: Blanked off and boxed-in stairs in EG 39, looking north towards the winding flight up, once to EF42. The arrow shows the location of the winder downwards in the side-face, once to EB14; Scale 1m

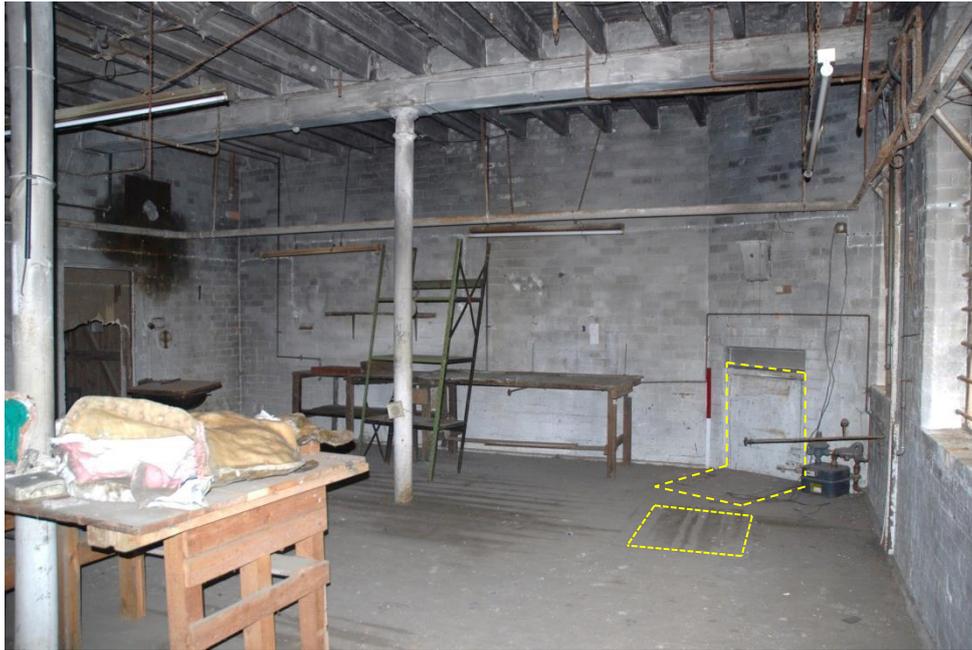
Fig 36: Room EG40, possibly formerly dispatch but built in 1897 as a 'New Stock Shop'. View north from in front of the pavement loading doors, looking north; scale 1m. Note the low-level doorway and hatch to the basement stairs; a second, vertical hatch lies nearby.

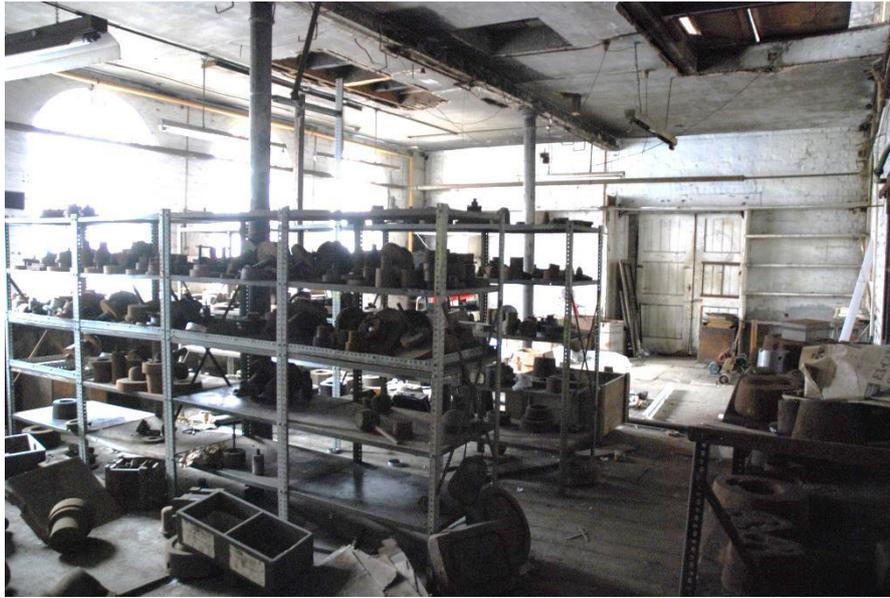
The southern room on the ground floor frontage (EG31) is today a place of storage for hundreds of rusty stamps and dies from the former workshops. These litter the room and some are also more sensibly placed on modern Dexion-type shelving. This storage function is probably a relatively recent introduction, since the room is unusually provided with a plastered ceiling, suggesting it may once have housed workers whose comparatively sedentary jobs required warmer surroundings. The single principal beam runs north-south, in contrast to EG40. The benches along the east wall also contain settings for fly-presses, so some production has also gone on here.

Fig 37: Room EG31, looking south, with the shelf-stored array of dies and stamps. Note the double doors in the far, south wall which open at chest-level in the adjacent road-access.

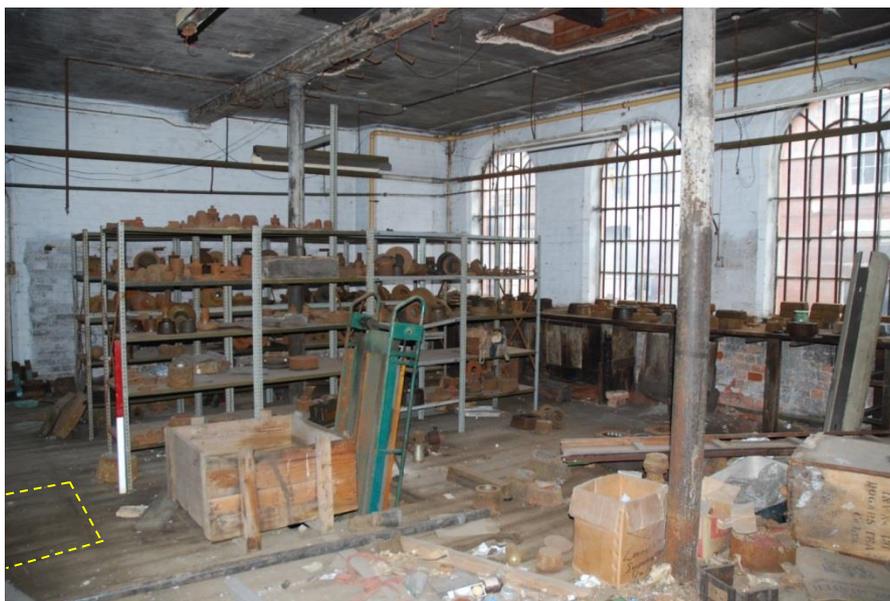
Fig 38: Room EG31, looking North-east. Note the covered-in ceiling. Both the bench and the shelves are full of stamps and dies. The turquoise coloured cellar hoist through an open floor-hatch can also be seen from below in Fig 28 (above). Another closed hatch is marked in yellow. Scale 1m.

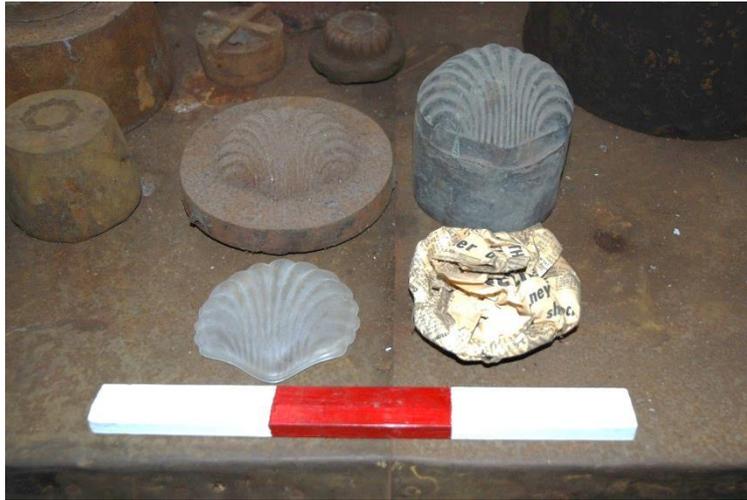
The room also contained a collection of tea-chests with items connected to production in the post-World War II period. A number of cartons contained (still packed) unused glass inserts for ashtrays, while a tea-chest contained hundreds of scallop-shaped glass inserts for butter-dishes. These remain wrapped in their newspaper packaging, which is dominated by East Lancashire local newspapers of 1958. Nearby are a selection of matching scallop-shell stamps and dies for the related dishes.

Fig 39: Room EG 31 -Stamps, glass scallop-insert, the same wrapped, two of hundreds; scale 30cm

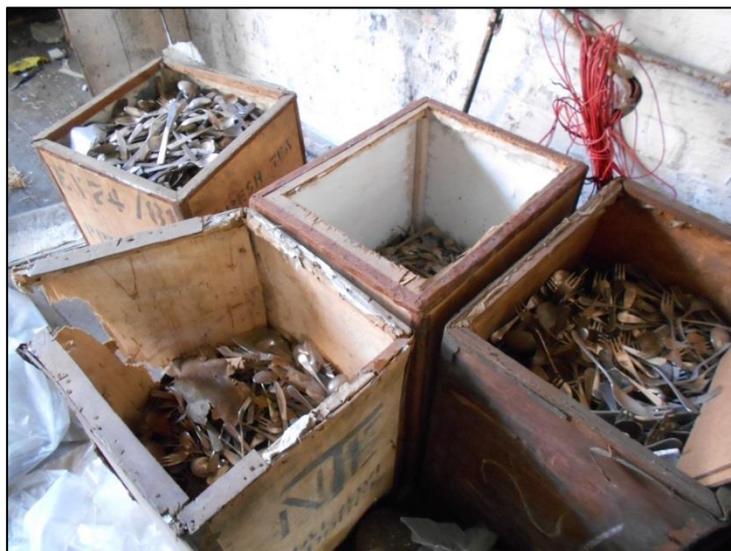
A number of assorted tea-chests contain thousands of 1960s-70s EPNS pieces of cutlery sent back perhaps for re-plating. They bear monograms of disparate hotels, airlines and other corporate identities.

Fig 40: Tea-chests full of EPNS cutlery, possibly sent in for re-plating

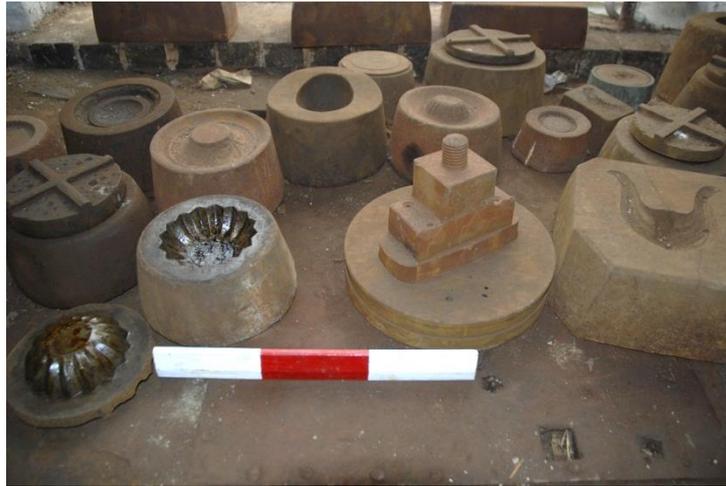
Fig 41: Stamps and dies stored on benches in EG31, a frontage window onto Vittoria Street behind. The stamp to the far right is one half of a pair of tea-pot spouts. The gouges in the bench-top at bottom right show that in a former room-use fly-presses were formerly located here; scale 30cm.

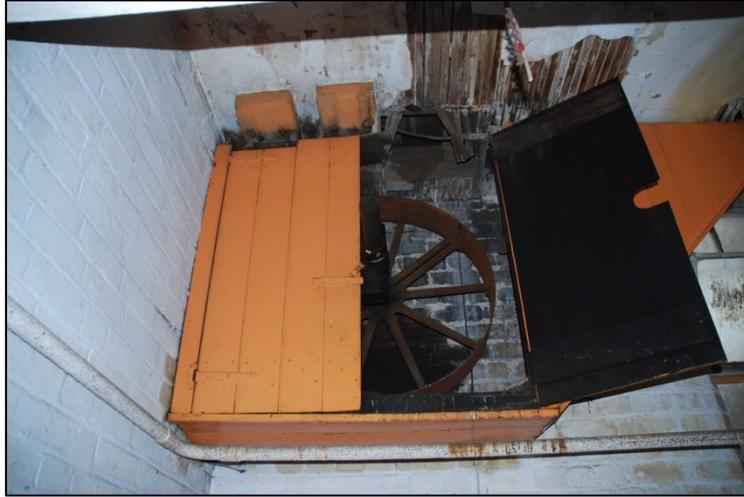
Of particular note, however, is the truncated end of a former drive shaft in EF64, which once ran the length of an adjacent workshop (EF59). When the drive shaft was taken out, leaving just the cradle and bearings in the walls, the far end -with a single wheel- in EF64 was left in situ. The wheel may suggest that there was at one time a driven machine in EF64, but latterly this function was dispensed with. Instead the wheel and shaft-stump were boxed in, presumably to lessen and noise through the wall with the workshop, but also to stop any spray of grease and oil from the bearings. This may have been done when the room became the Beverly Hall Warehouse as the distinctive sign indicates, perhaps around 1930.

Fig 42: High in the west wall of room EF64, the Beverley Hall Ltd Warehouse, but built as a 'New Silver Room' in 1897. The boxed-in wheel and drive shaft, cut off on the far side of the wall in EF59

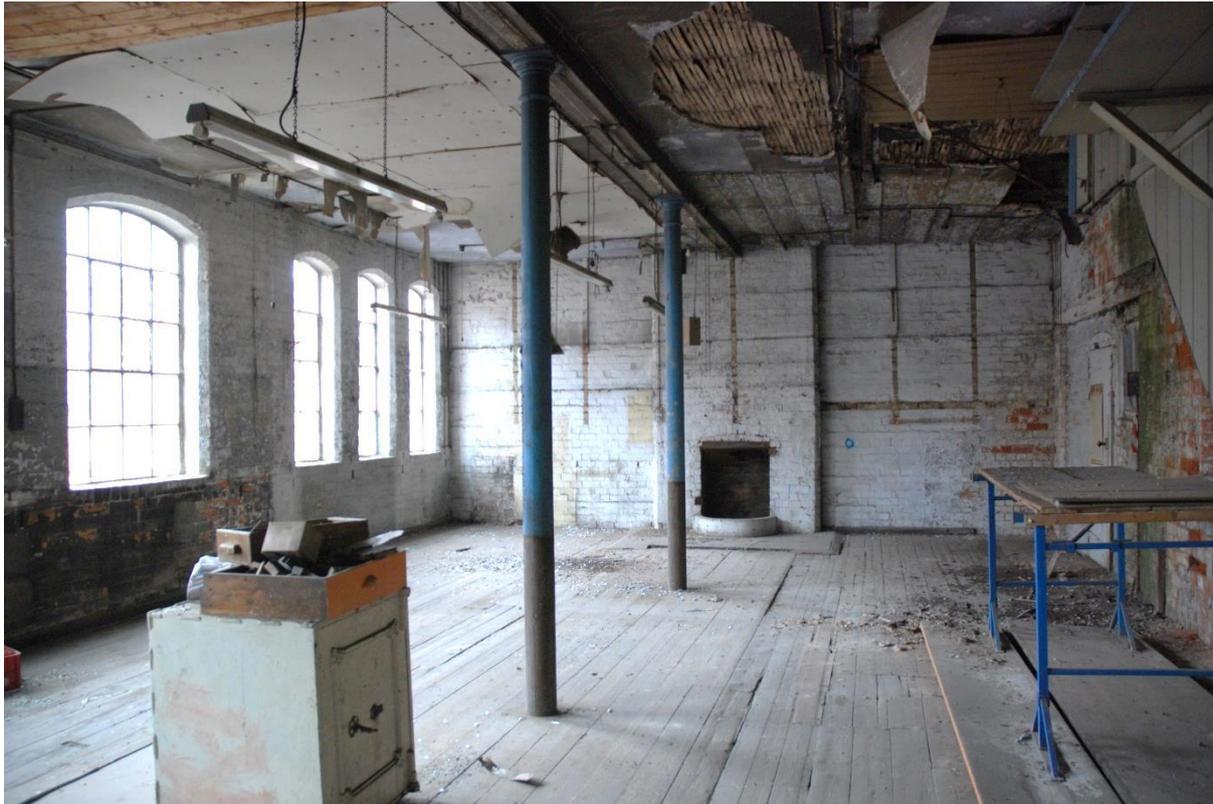
Fig 43: Room EF37 looking south. Note the fireplace in the end gable (with 1m scale adjacent), and the trio of tall, narrow windows in contrast to the bigger frontage aspect windows. The corporate livery is a notable light blue. Stair at far right.

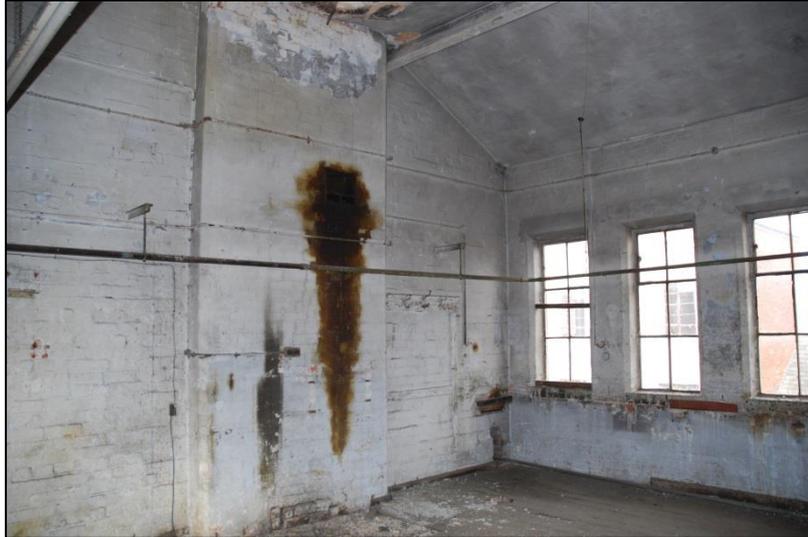
Fig 44: Room ES41. The grease mark from a wall-mounted drive shaft bearing (one of a set of four) the only room at second floor level to contain them. It is unclear where the drive came from, although a discrete electric motor mounted on the second floor seems likely. Note the blocked fireplace and hearth with kerb in the gable.

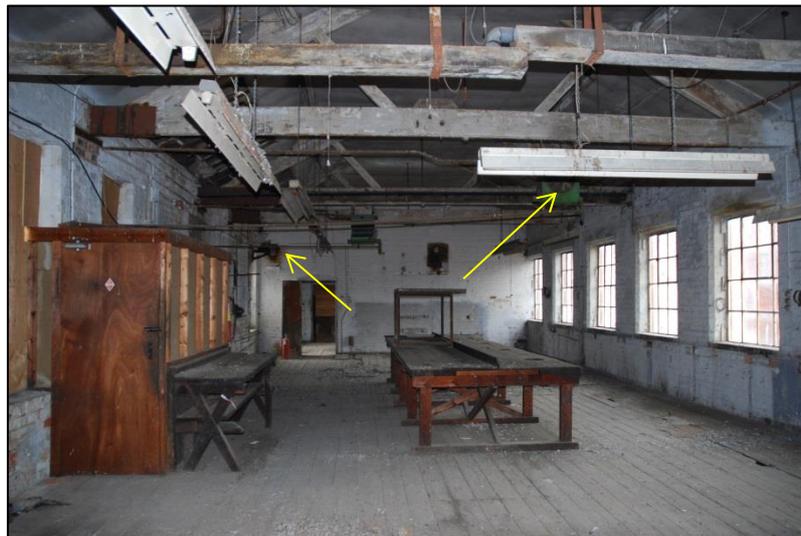
Fig 45: Room ES27, looking north, with boxed-in stair to left. At this level all the windows are square-headed to both front and rear, unlike the arched examples further down the building. The queen-post trusses of the frontage roof are exposed and there is evidence in a number of fitch-plates that the roof trusses have previously had to be extensively-repaired. A variety of side and centre-line benches and work-stations may be inferred from wear patterns on the floor. Any early lighting has been lost to post-war strip lights. Tannoy-type speakers are arrowed.

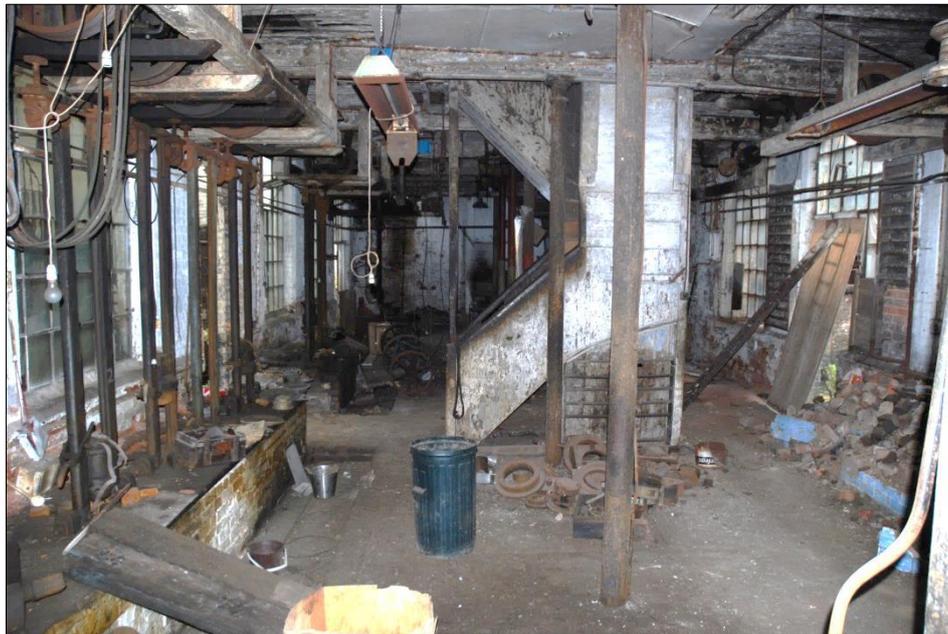
At each gable end, there is an annealing hearth or furnace (for softening more malleable metals, and particularly to form the 'force' – the softer, positive part of a die); some of these hearths have been blocked up, others not. Along each wall, lit by maximum natural light, is a secondary brick bench with integral concrete, shock-absorbing 'anvils' built in. The benches are now discontinuous and most lost or very damaged, but one length is substantially complete, standing against the south wall, with a battery of four intact presses. Its work-top is formed by wide, thick baulks of timber into which have been coach-screwed or coach-bolted the fixings for the dies and the poppets (inclined bolts) for holding the stamps.

Fig 46: View of EG49, from EG30, looking west. Along both sides lay the brick and concrete benches on which stood the presses, and of which a battery still survives. Heated channels in the floor were intended to provide the working position for the press-setter and operators, while drive was provided through the shafts and belt-driven wheels mounted on substantial timber cradles suspended from the ceiling. The central stair runs up through the whole building.

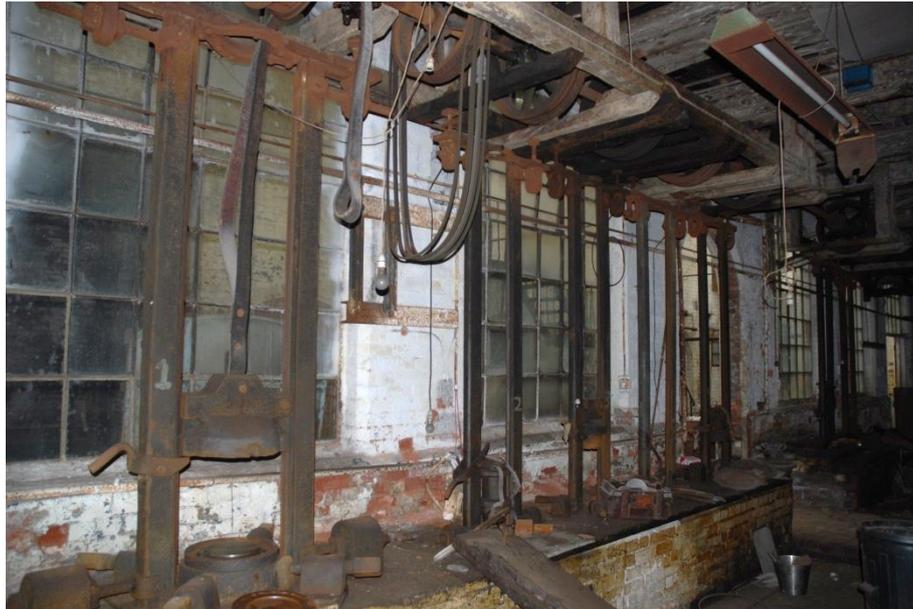
Fig 47: View showing the bench, surviving battery of presses, and timber cradle with driven wheels on a spindle or shaft. The nearest press (also shown in the figure below) has been left with a manual pull-belt for individual stamps for engaging the power, carefully and slowly.

Above the presses are the vertical iron guide-rails, each with a manual brake or lock. At the bottom these are fixed into the bench, while at the top they are fixed to the same timber cradle which supports or from which hangs the drive-shaft and wheels for each press. A number of redundant wheels make it clear how many pieces of machinery are missing which once stood here too.

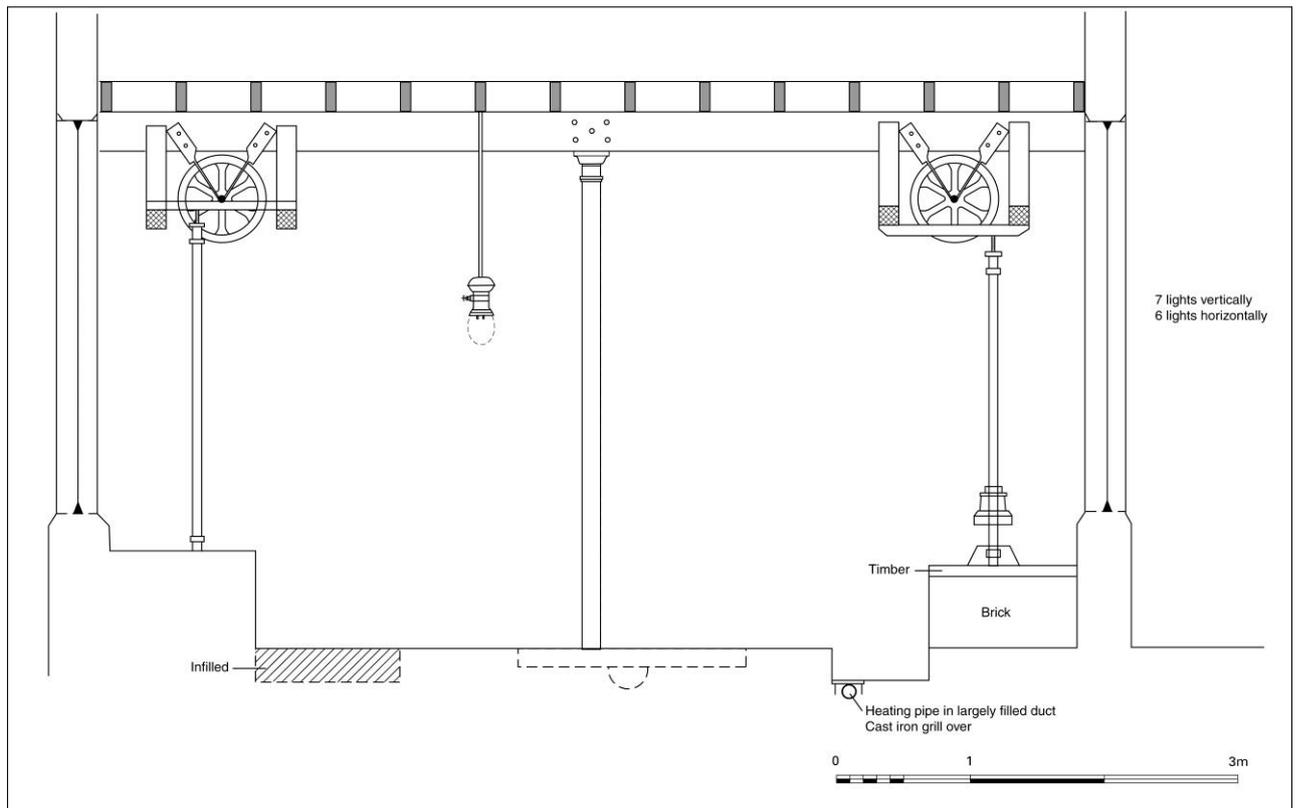
Fig 48: Cross-section of Room EG49 across the remaining stamping battery. Note the slight variation in the mounting of the timber cradle for the line shafting. Gas lantern on conduit from ceiling joist (Andy Isham).

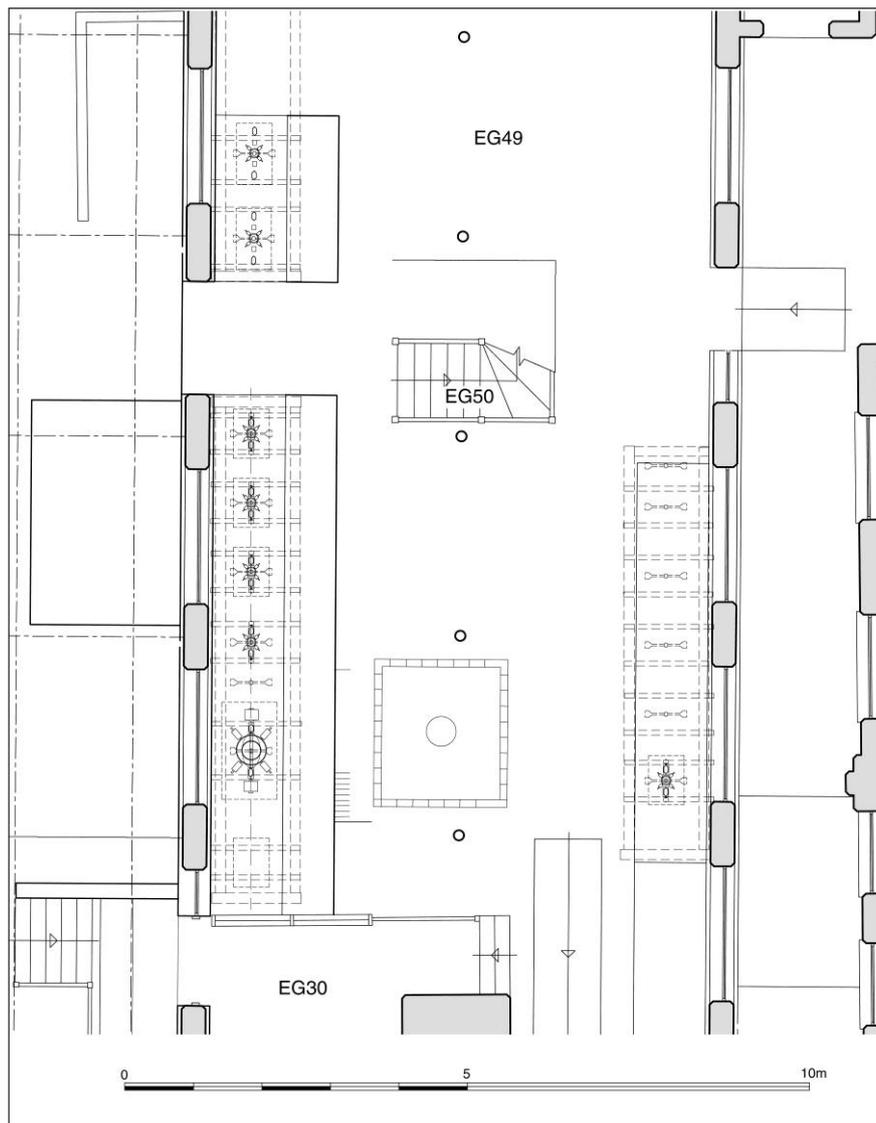
Fig 49: The surviving stamp battery in EG49
