Iain Soden Heritage Services Ltd

**Level 3 Building Recording at the former Unity Works
and Vittoria Works, Vittoria Street, Birmingham, 2016**

Summary

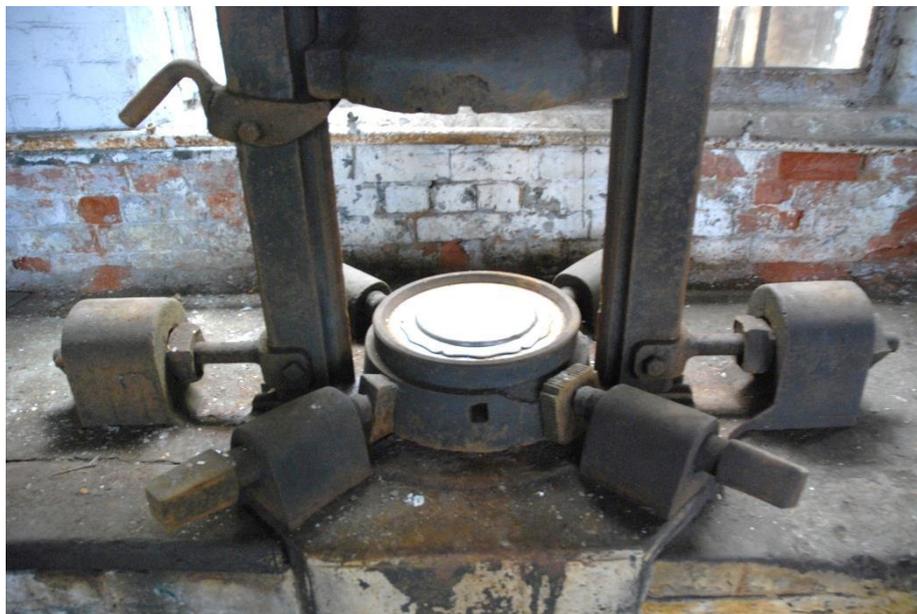
Fig 50: The biggest surviving press with stamp for a hollow-ware 10" plate or tray, held in place by a ring of four inclined bolts, called 'poppets'. Note the polygonal shock-absorbing iron 'anvil' within the brick and timber-topped bench. This prevented the bricks in the bench from shattering under repeated impacts. Note the manual brake lever on the left

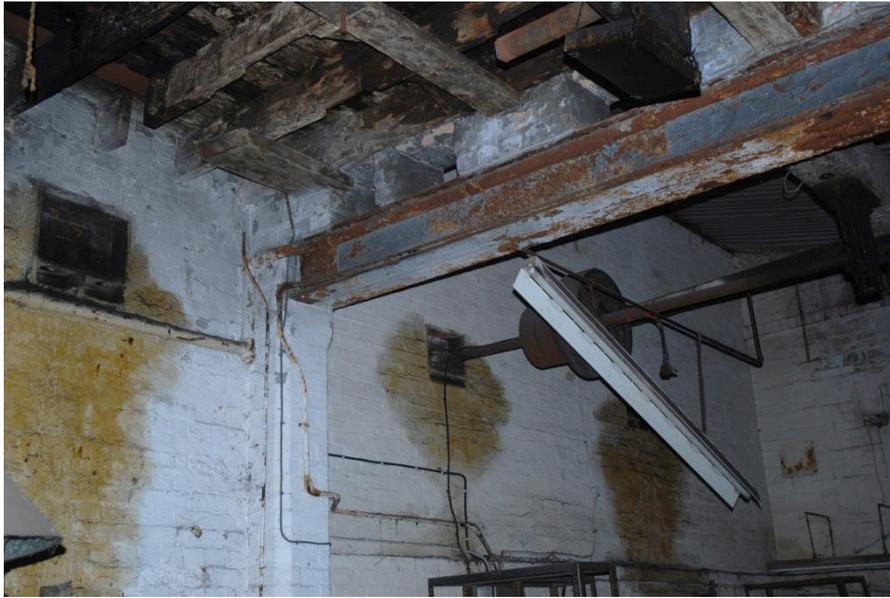
Fig 51: View around the western end of EG49 looking north-west into what was originally the Blacksmith's Shop until at least c1897. The bearing-ends and grease-marks on the wall of three former driven shafts can be seen (with one left in situ). Above the RSJ in the ceiling can be seen a series of slots, through which the drive and relay-belts passed unhindered.

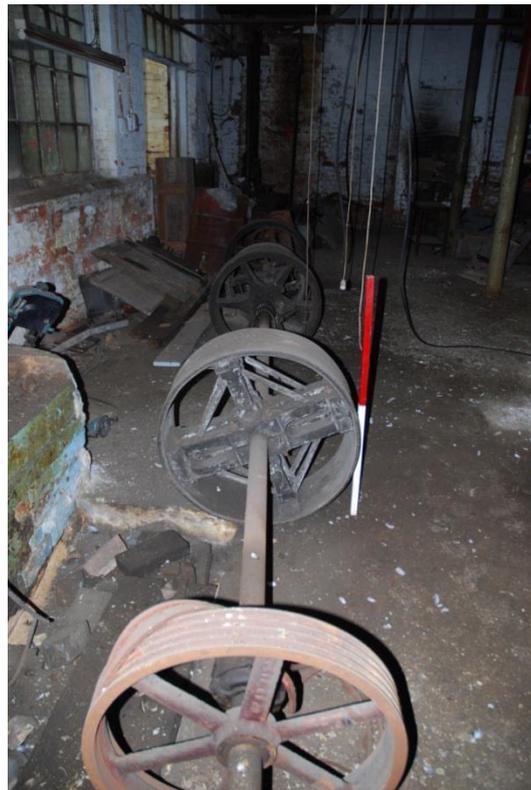
Fig 52: A former drive shaft and drive wheel, *ex situ*; scale 1m. The drive wheels are in laminated wood to prevent the belts slipping. Secondary, iron wheels were often grooved for rubber belts (that in the foreground for four) or flanged to prevent slack or angled belts from sliding off.

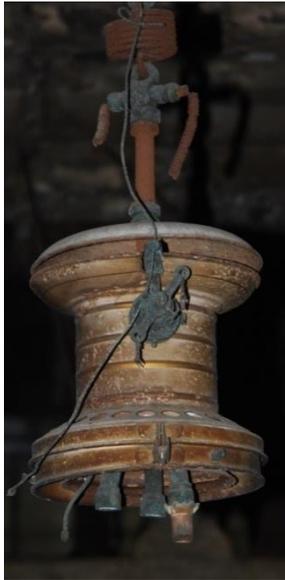
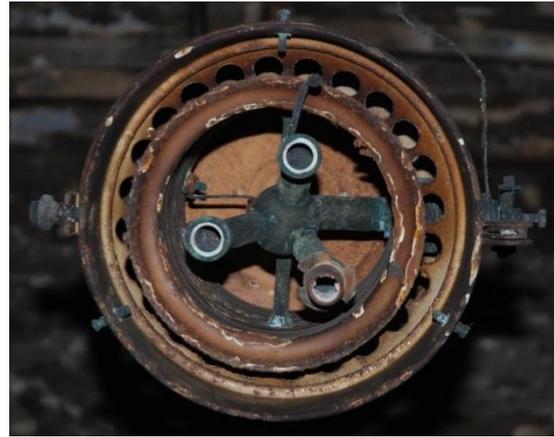
Fig 53: Two views of surviving 19th-century gas lamp on a rigid suspension from the ceiling in EG49.

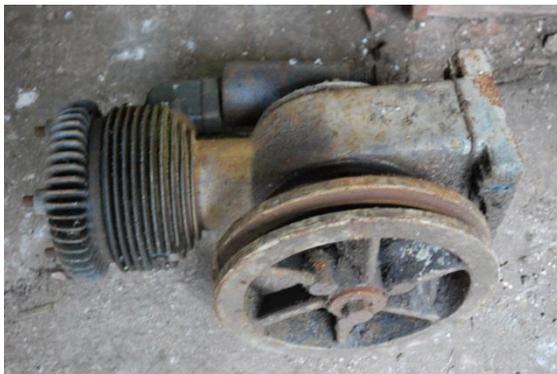
Fig 54: Discarded early electric motor with drive wheel fitted with a belt-groove

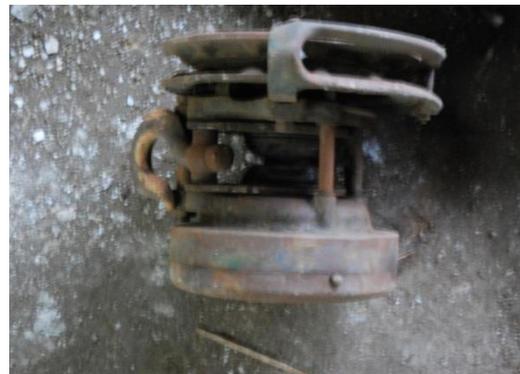
Fig 55: Half-ton chain hoist by Yale 'Triple geared block'

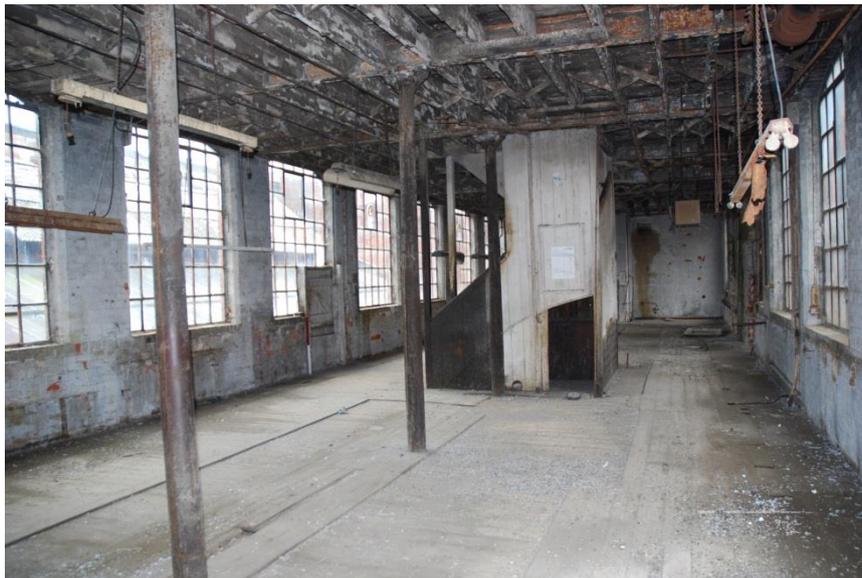
Fig 56: Room EF47 (Spinning Shop) looking west. Note a bearing grease mark on the end wall.

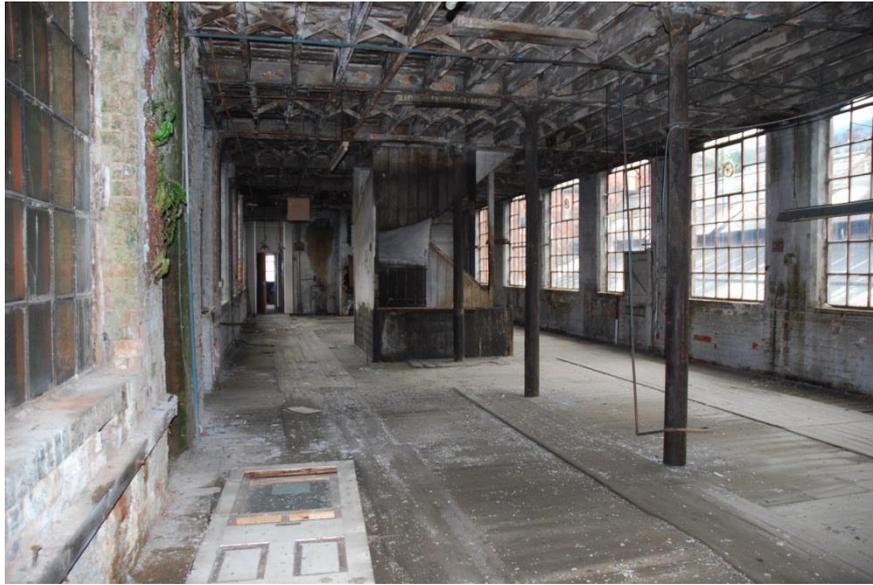
Fig 57: Room EF47 (Spinning Shop) looking east. Note the slightly raised walkways with thickened reinforced timber.

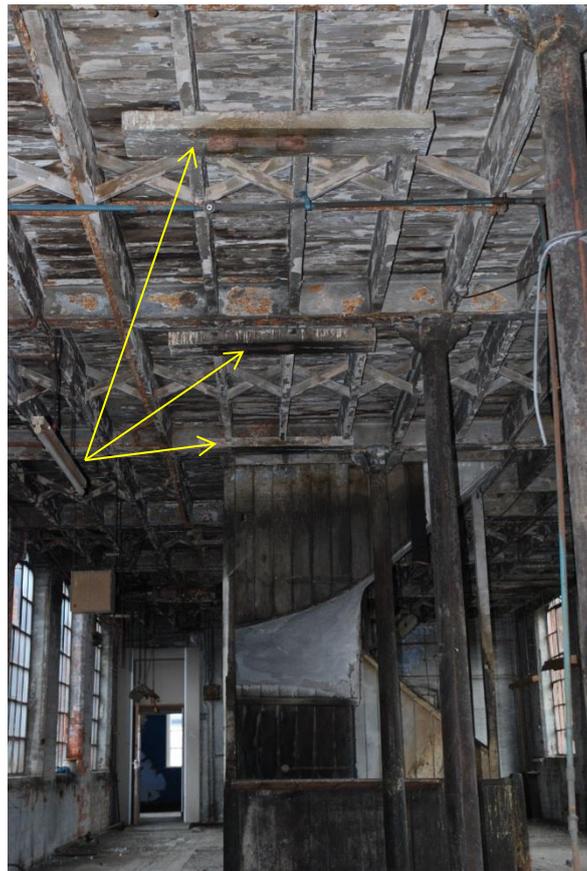
Fig 58: EF47 Drive shaft cradle remains (arrowed) showing how the inner ends of the shafts must have terminated either side of the stairs.

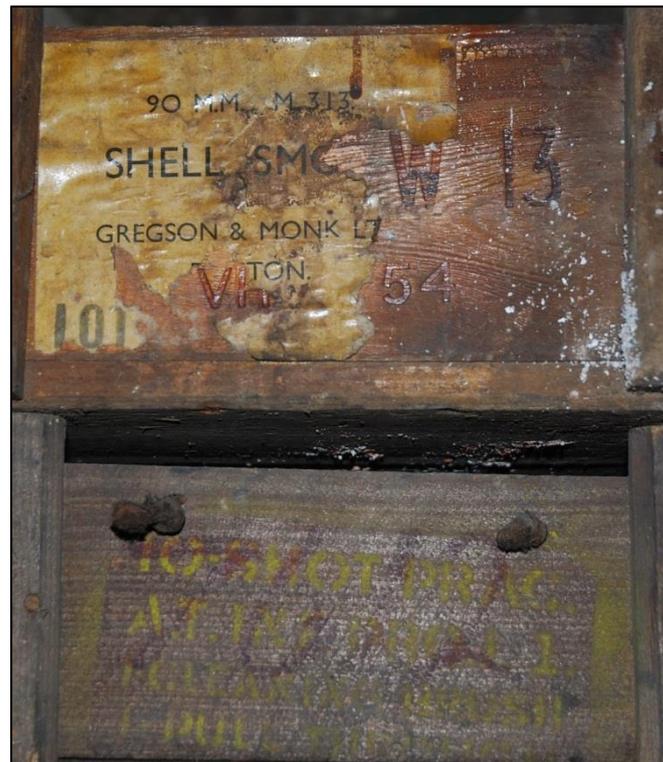
Benches surviving along one side of the room are littered with an assortment of dies and stamps which were presumably related to the items once produced in the room. Also present are hundreds of copper printing blocks for the production of trade catalogues. A collection of Second World War ammunition boxes also suggest some of the items which may have been put together here, although it may also be the case that the crates were bought for general workshop use as War-Surplus; the evidence is equivocal. The crate labels here and elsewhere in the building are as follows:

Fig 59: Ammunition crate labels throughout the building - shells, fuse caps; evidence of war work?

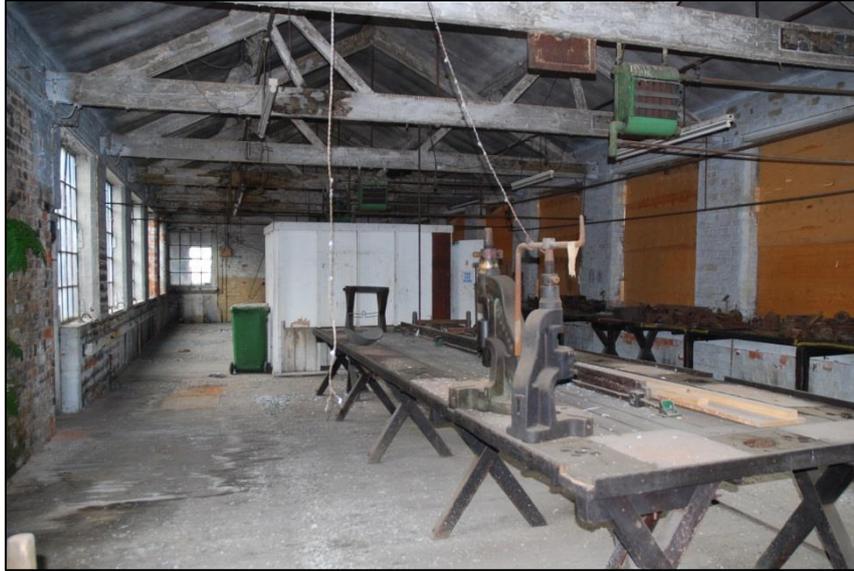
Fig 60: ES29 west end looking east to the stair. The centre benches all have fly-press fixing holes. All work-stations along the walls and the centre benches were provided with electricity and a fixing for an angle-poise lamp, style icon of the 1940s and uniform at a date when war work meant national investment at the end of a decade of economic depression.

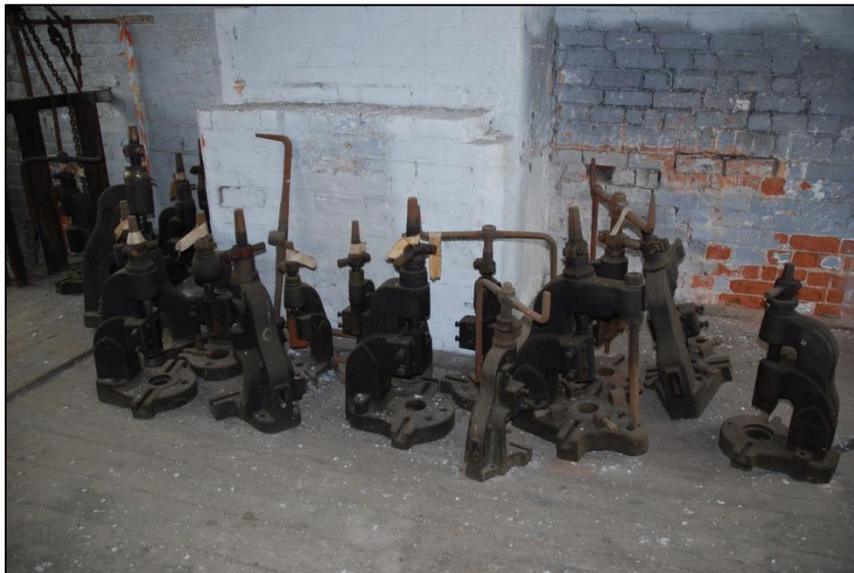
Fig 61: ES29 – a collection of dismantled fly-presses of different types and sizes, such as the Denbigh or the Norton no1, no 38 and no 58, mostly by Sweeney and Blocksidge, Saltley, Birmingham, but some by Hazelwood and Dent, Birmingham. The latter company was established in 1885, but its premises were severely damaged by fire in 1928.

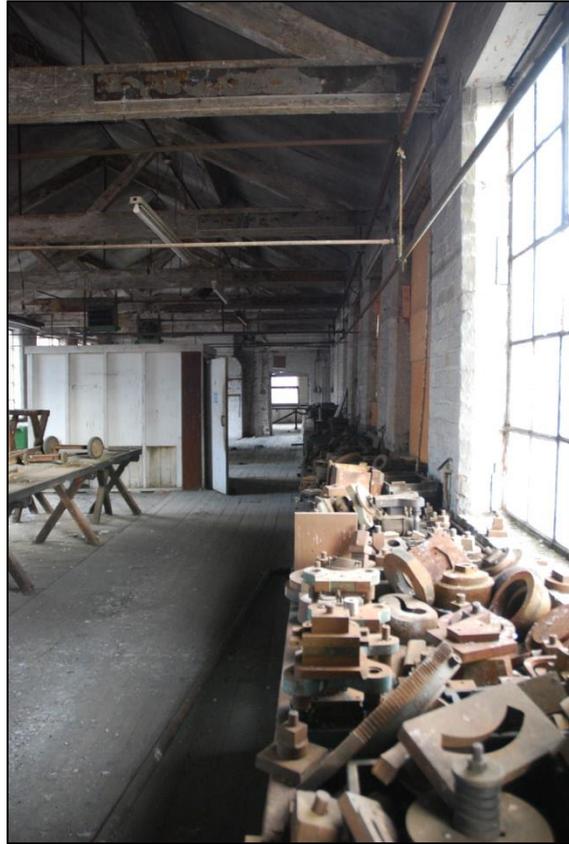
Fig 62: ES29 looking east. Stacked press fittings.

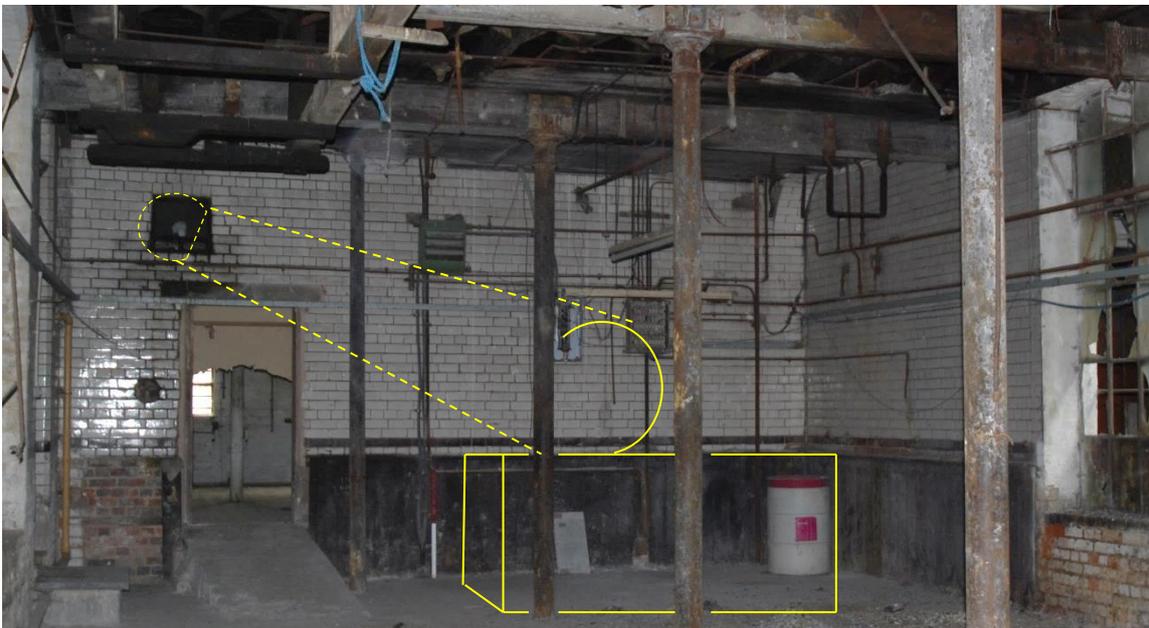
Fig 64: The distinctive wall-finish of the 1897 Engine House at the east end of EG41. The engine location is marked, while the bearing housing for the main drive shaft is at top left with the hangers for the shafting cradle spaced towards the camera. The chimney elbow is at the top right hand corner of the room.

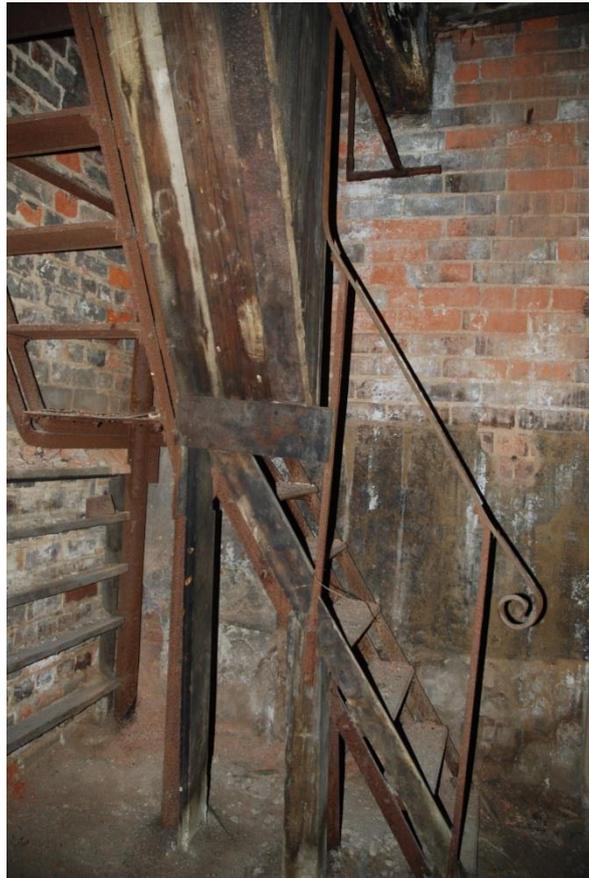
Fig 65: The steep cast iron stair in EG54. Probably the prime staircase in the 1897 rear shopping

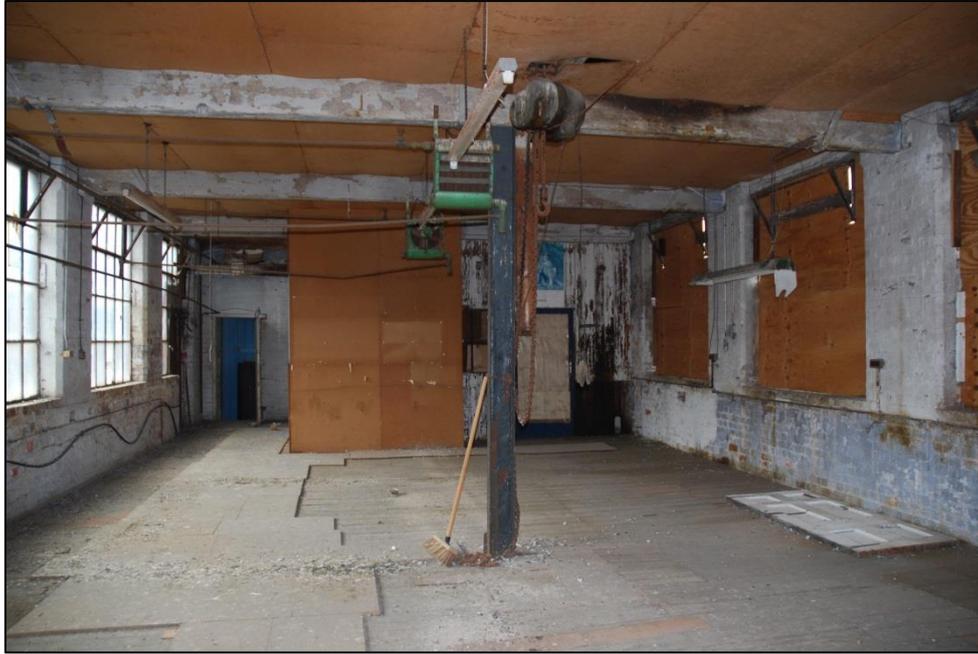
Fig 66: Room ES39 looking west, the end partitioned in modern times to provide an office space. A chain-hoist is fixed next to the supporting post.

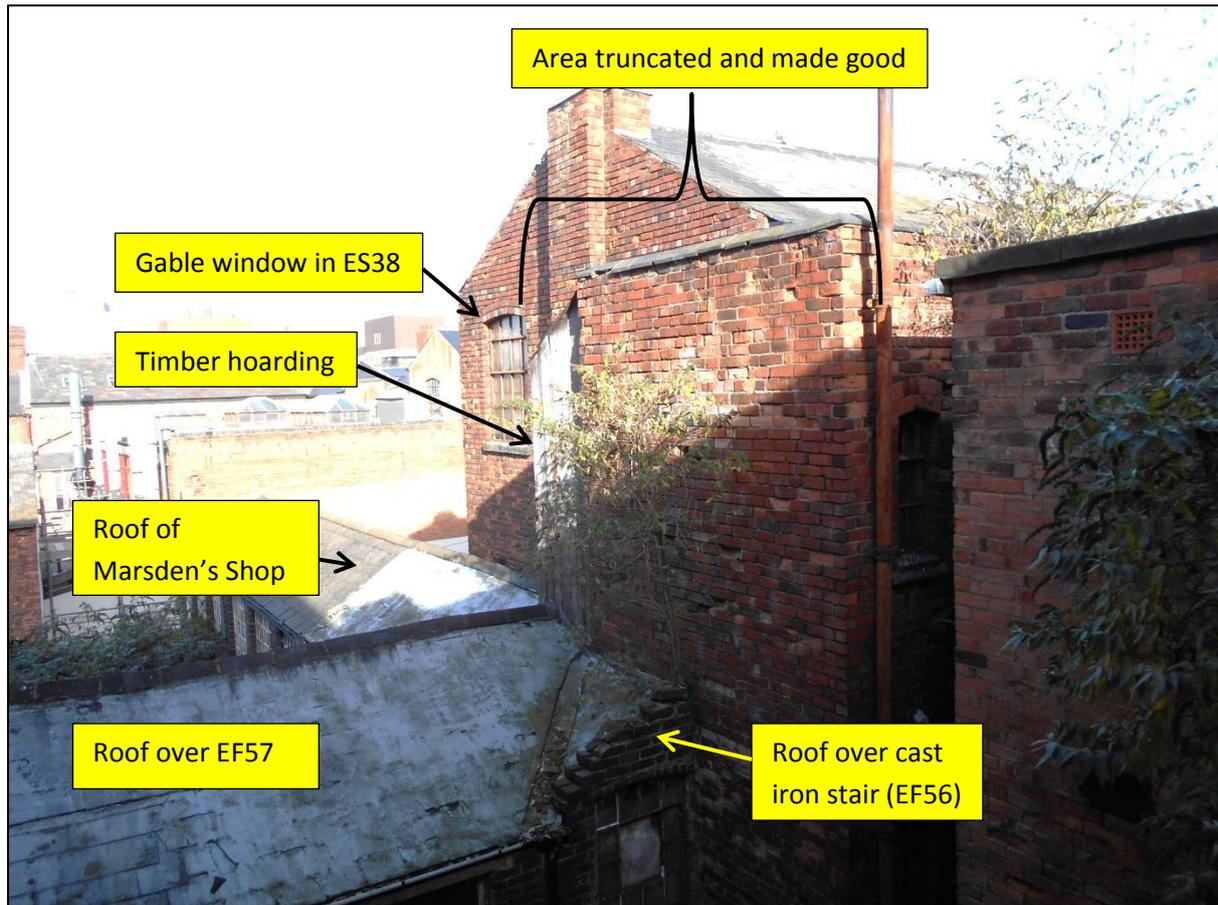
Fig 67: The truncated building end between the second floor rear shopping (ES39) and the earlier buildings to the rear, looking north out of ES29. A scar up the end wall of the plot shows that these were once taller, while the brickwork above the cast iron stair has clearly been truncated and made good, if rather haphazardly. The blank end wall and blue brick coping over the end of the toilet block may indicate a massive brick sticking-plaster.

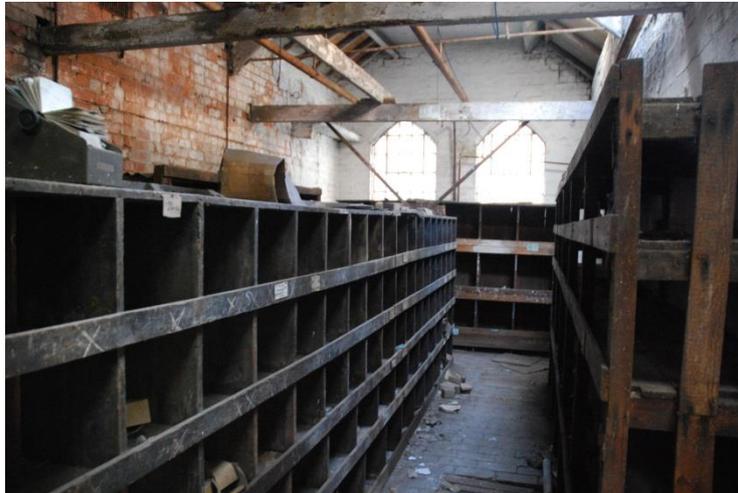
Fig 69: Room EF34 Pattern/Stock Store, looking west. The end gable walls retain line-shaft bearings.

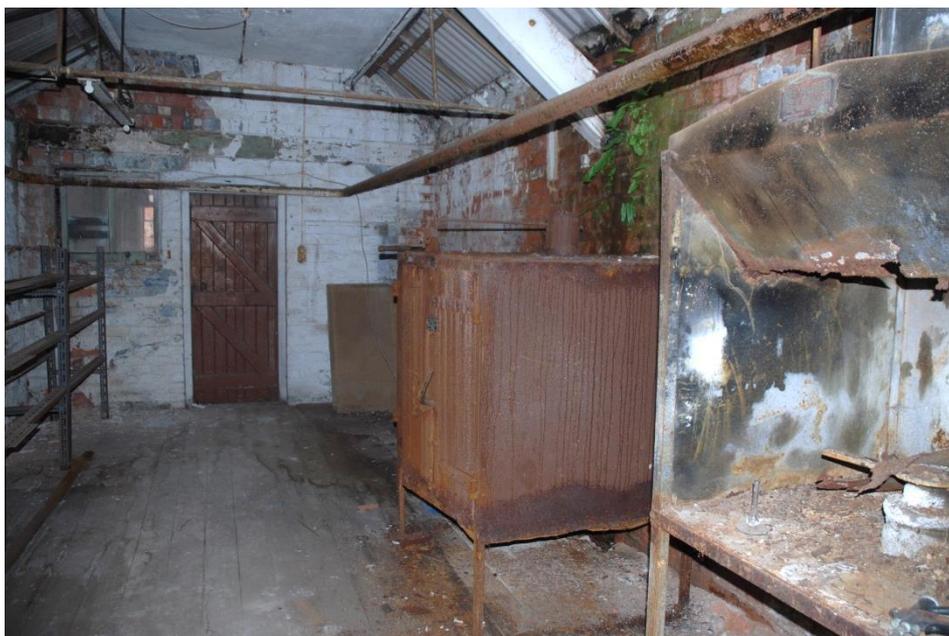
Fig 70: Kiln room EF36, possibly for enamelling (centre) and lacquering (right). The doorway at the end connects directly into EF37 and is secondary.

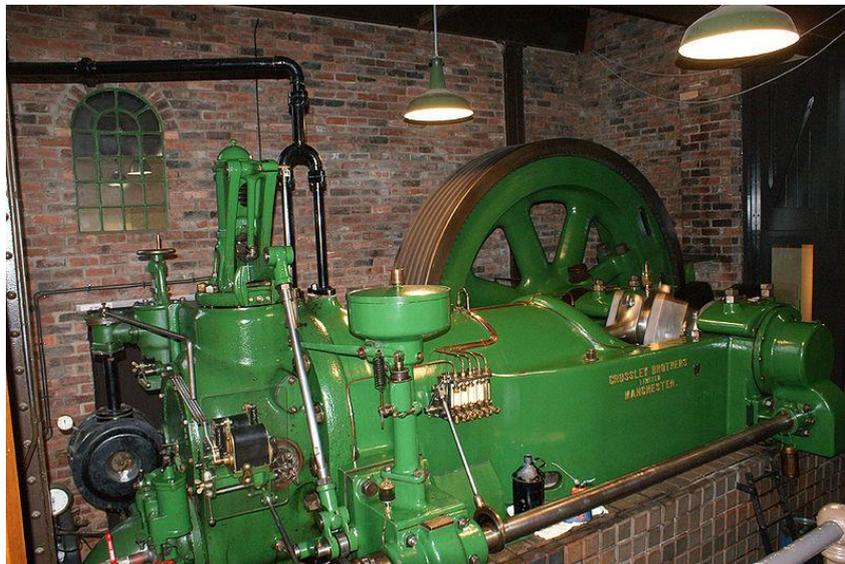
Following the use of steam, an intermediate engine was probably driven by town gas, from the turn of the 19th-20th century. The location for this engine was the unnumbered space to the north of the chimney and last boiler, and here the evidence is clearer. The room was divided up in the period 1930-60 by the insertion of a wall of Fletton bricks, which would protect the workshops from a boiler blow-out of the last (current) gas-fired boiler. Before its insertion, however, the space was continuous at ground floor level, and a concrete-filled slot in the floor, close to the east wall, may be a filled-in fly-wheel pit.

Fig 71: A typical (large) Crossley Gas Engine (Kelham Island Industrial Museum) - pre-First World War

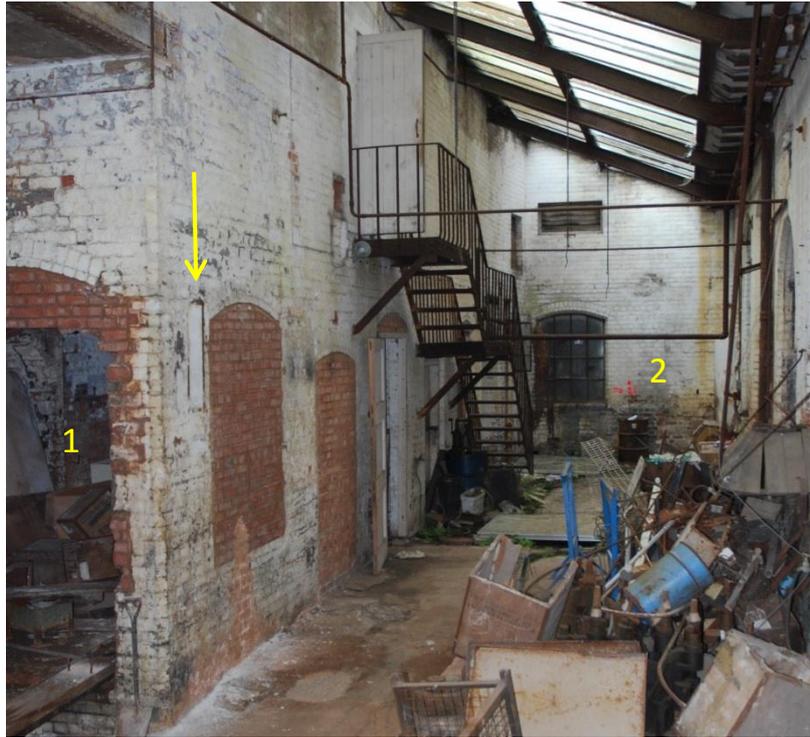
Fig 72: Two boiler houses and engine locations (steam to left (1), gas (2) at the end). Note the large drive-belt slot (arrowed).

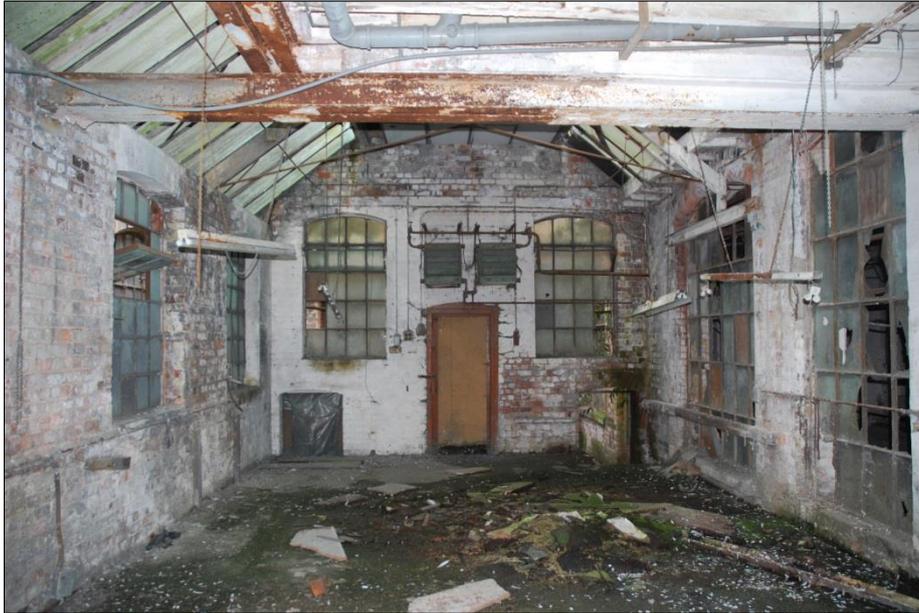
Fig 73: The interior of EG42, what was the polishing shop from the 1940s

This building is named on the B/cast Plan only (Fig 9) and as a late addition to the buildings ensemble it may have been built as such (Room EG42) although its single-storey construction and extractors may also be redolent of a plating function. It is of single storey brick, with concrete lintels and sills of Staffordshire blue engineering brick laid at an angle on edge, and is provided with numerous electrical points inside. In the former yard it stands off-centre in order to retain for the time-being the street-entry through the building (EG35/EG34) [although this was later lost]. Its concrete-screeded floor overlies a partially-collapsed rear basement which was entered and recorded by lamplight (see above). The building was added to the side of the most northerly range of 1897-8, from which it stole three bays of natural lighting, and with which it was forced to share an internal gutter as a result. Those blinded windows were left *in situ*, and were provided with only a flimsy rail for protection. While it had metal-framed windows to the south and the west, natural light was limited in these areas so the building was provided with extensive skylights. The roof is of timber combined with RSJs to form a part-flat, with no central ridge, although this may be a haphazard modification as the end gable appears to contain two truncated parapets. Two extractors were fitted in the gable end.

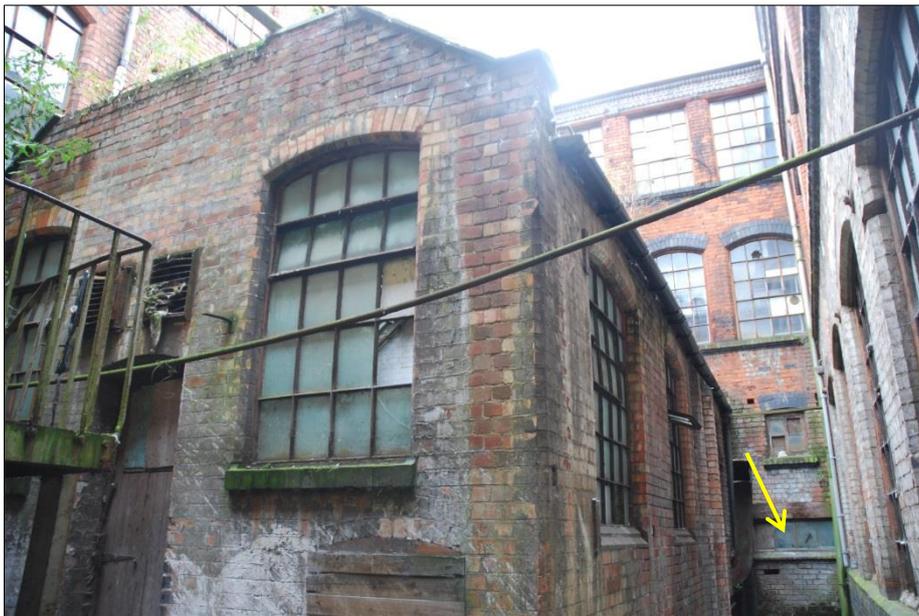
Fig 74: Polishing shop from the yard. To the bottom right of the picture (arrowed) is the former access through to and from the street.

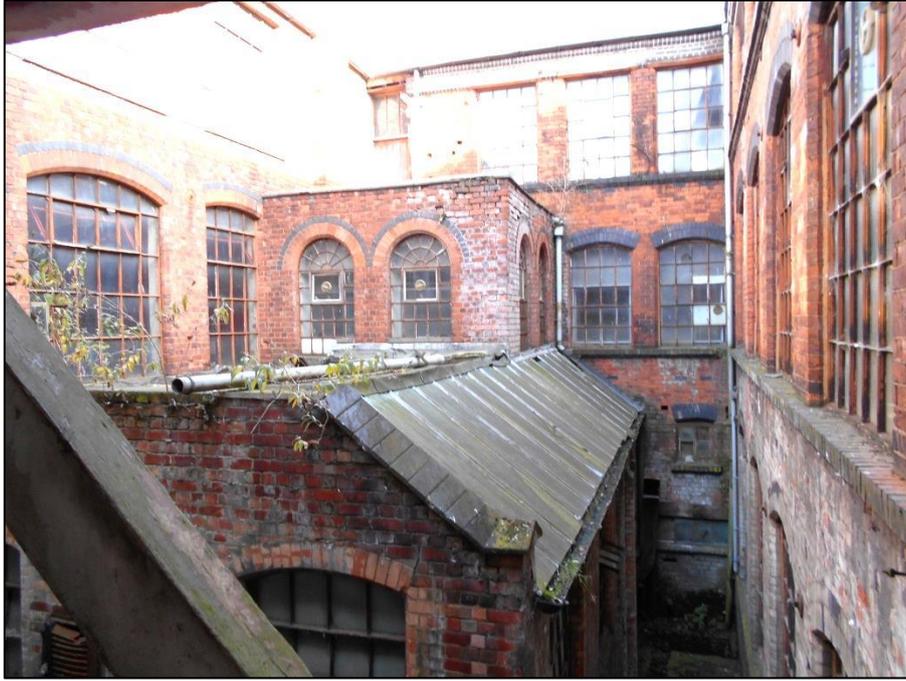
Fig 75: Another view of the polishing shop with its peculiar roofline. Note the truncated parapets surmounting the gable, which possibly indicate a former ridge and fully pitched roof.

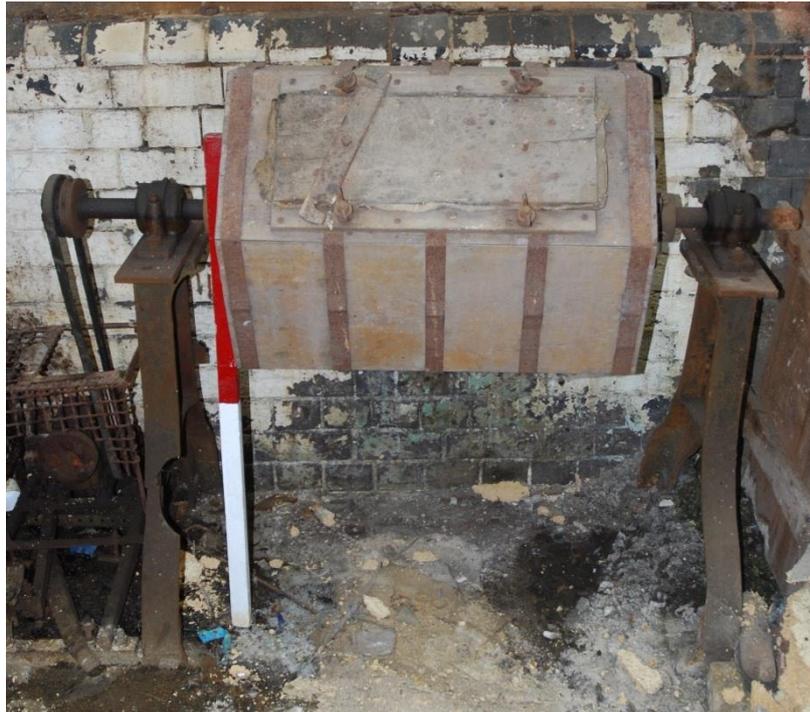
Fig 76: belt-driven tumbler drum for polishing, so called 'barrelling', discarded in the covered yard; note the belt and drive low down to the left; scale 1m

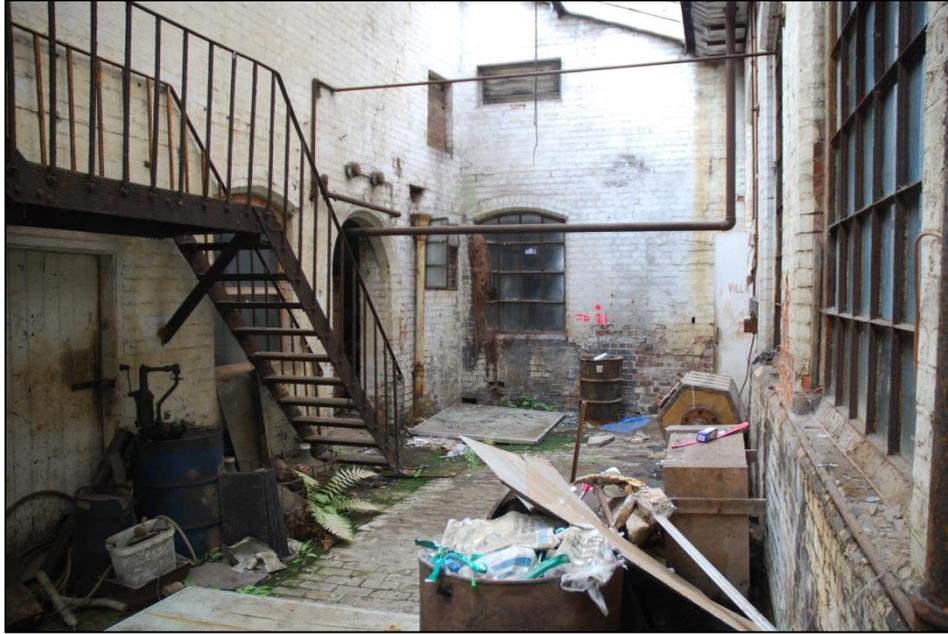
Fig 77: The covered yard EG29, looking west towards the rebuilt gas-engine house. Note the mains gas pipe crossing the yard from right to left. This was traced back all the way to the frontage.

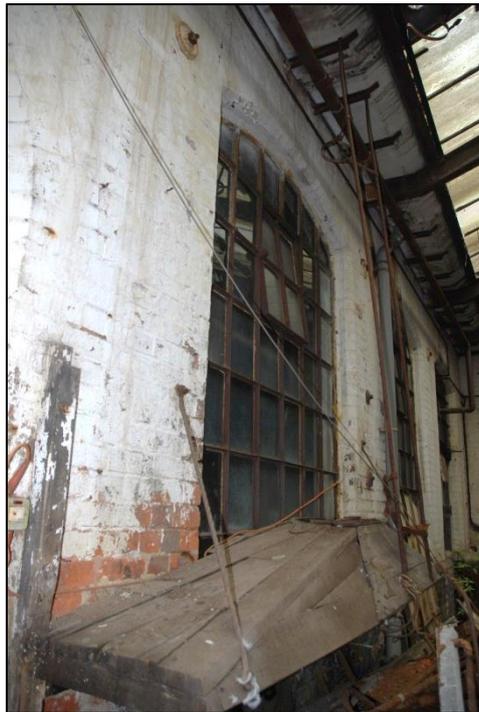
Fig 78: The shaped wooden fume-hood at shoulder-height; an exit pipe to the roof is missing.

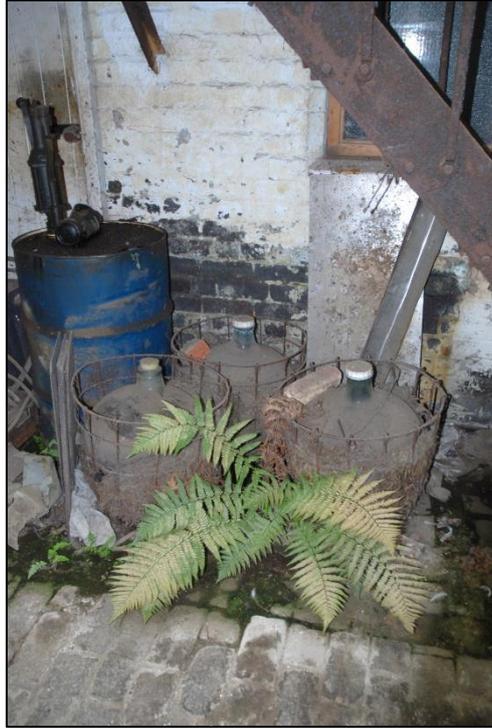
Fig 79: A group of carboys for acid storage in Yard EG29, beneath the exterior stairs to EF34.

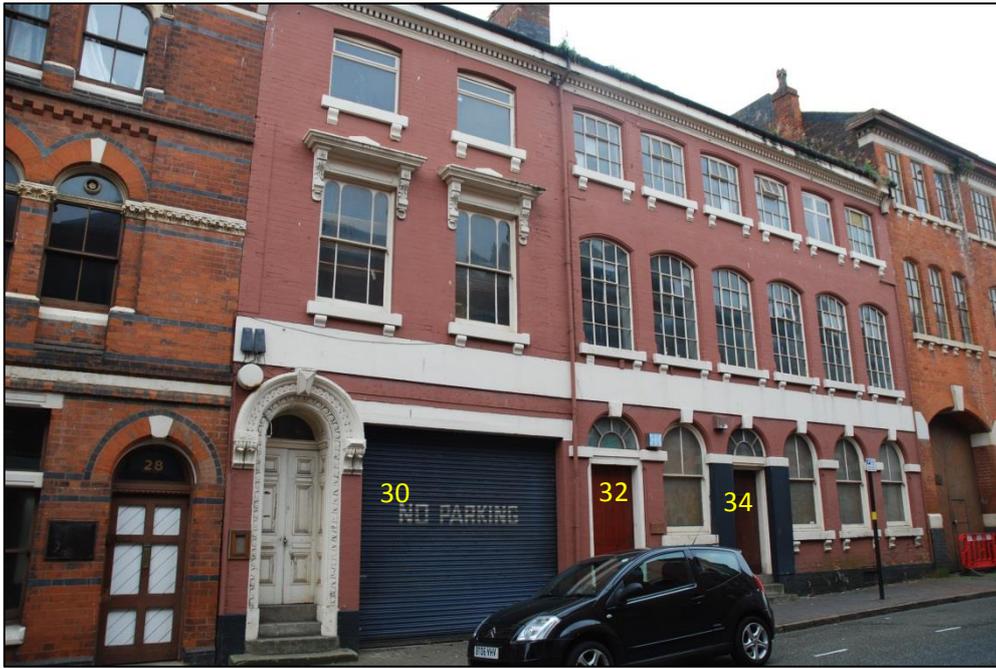
Fig 80: The Vittoria Works frontage of the Listing Description, with street-numbering

The frontage façade has been very succinctly described in its Listing Description (see above). However, the monumentality of the façade gives no hint at the domestic scale and intimate surroundings of the Vittoria Works frontage buildings inside. They are a relative warren of small, interconnecting rooms and a collection of short flights of stairs, many of which have long since been blanked off or truncated as redundant. There is every suggestion that the buildings which formerly occupied the frontage here (and which presumably enjoyed the early, defunct street numbering before 1884) were as much domestic houses as domestic-scale workshops for skilled craftsmen.

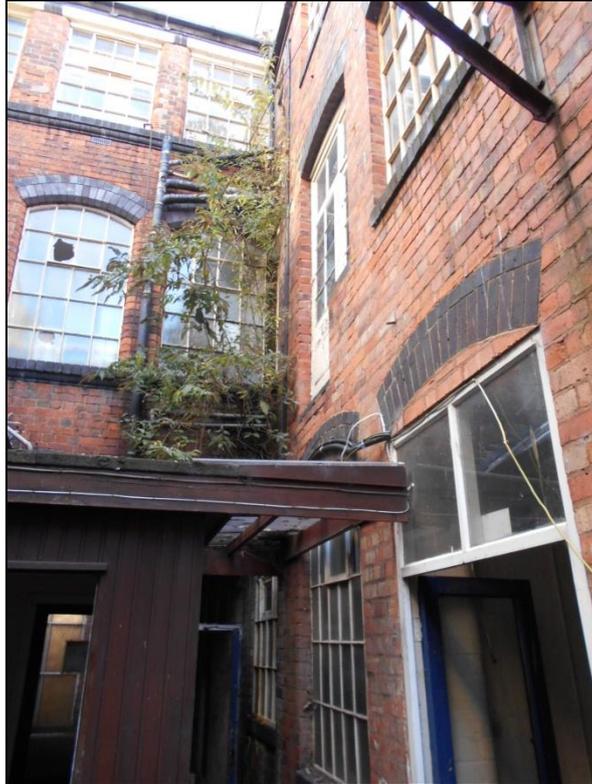
Fig 81: The tiny visible portion of the frontage visible from the rear yard. Note how the southern range of shopping (right) cuts across the edge of a rear-facing window.

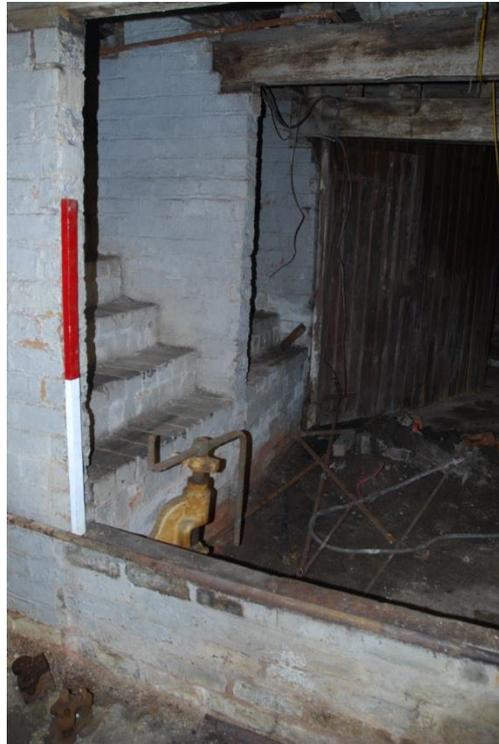
Fig 82: A pair of truncated brick steps (EB05), the lowest two treads and risers removed. 1m scale stands on a bund wall, built to keep an oil spillage in from an adjacent tank.

which stood over these basements (which was still in existence in 1896 as seen on (BA: BBP 11584). The rear two may once have had chutes down from the entryway, where subsequently the wall has been removed between them, allowing a permanent connection across from one pair to the other. Originally all four would have been discrete basements, divided by the entryway spine and a single-thick brick wall between the two pairs of steps.

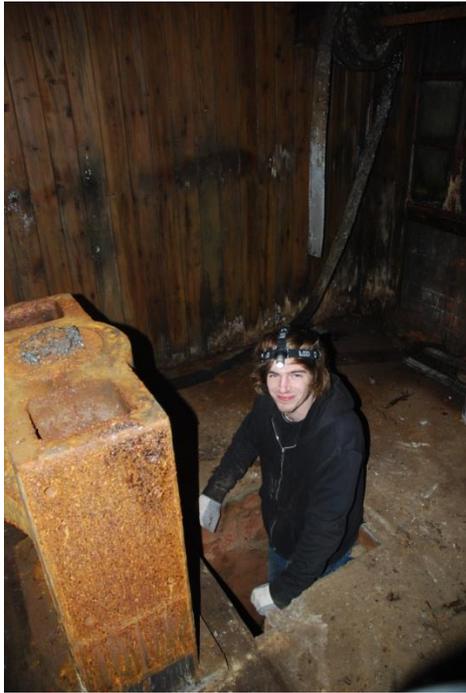
Fig 83: The pit emptied to show the press-operator's working position

The most interesting basement is EB04 which is partitioned off in timber (which unfortunately has what looks like dry-rot). It contains a deep working pit with a large wheel-turned press made by Taylor and Challen of Birmingham ([http://www.gracesguide.co.uk/Taylor and Challen](http://www.gracesguide.co.uk/Taylor_and_Challen)). It dates no earlier than 1875/80. The screw remains intact but the immensely heavy wheel lies to one side, having been removed by an acetylene cutter or similar.

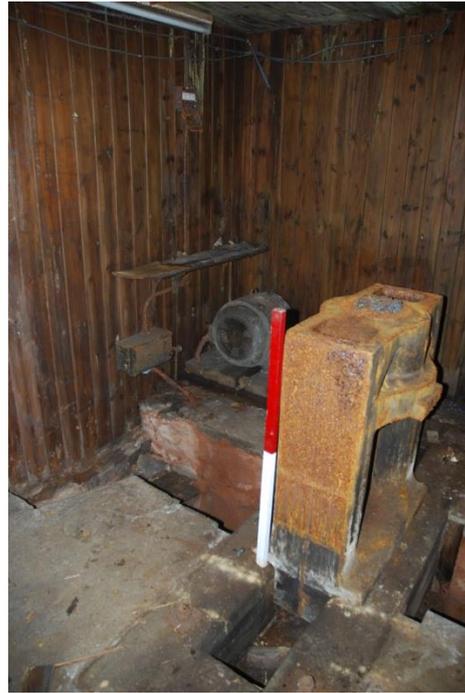
Fig 84: The press; scale 1m. Note the small electric motor behind

A small early 20th-century electric motor lies in one corner, opposite an *in-situ* drive shaft which once transferred power to a room above. The belt is still attached to the drive-wheel. Access to the four basements is now only by an inserted common timber stair down into EB08.

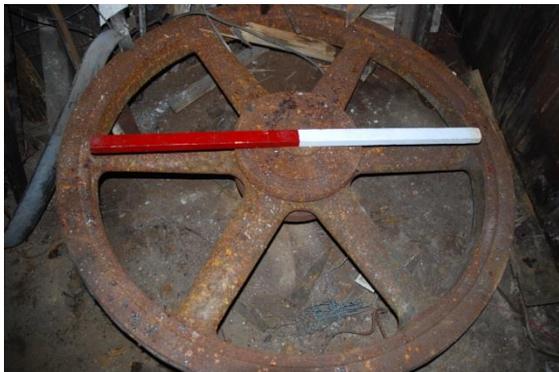
Fig 85: The cut-off press-wheel in EB04; scale 1m

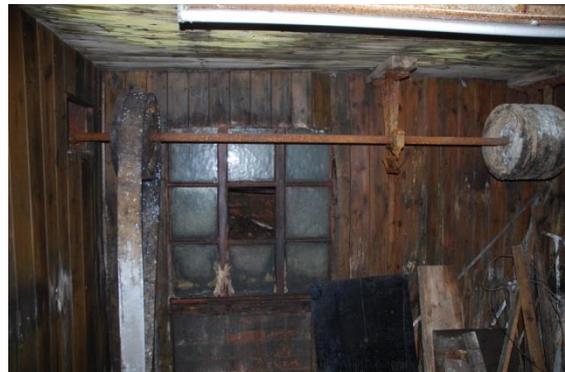
Fig 86: The surviving basement light well in west wall of EB04, with drive shaft and drive-wheel (top left), with belt still attached

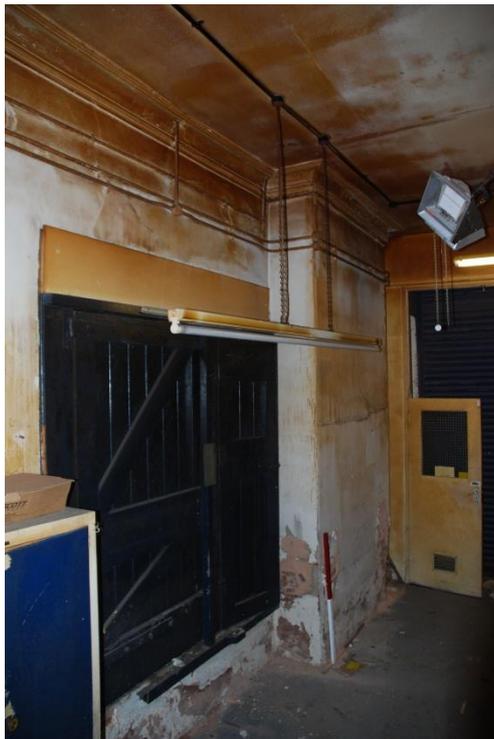
Fig 87: Room EG01, north wall with blocked fireplace; scale 1m

The ornate entranceway of no 30 actually leads directly to a set of stairs and has no connection with the ground floor whatsoever. This once ensured that visitors were guided to upstairs offices and show rooms, while the business of the works went on with separate access via the entryway. Despite its floor having been lowered to create direct access to the street via a modern roller-shutter, room EG01 retains a high and now slightly bizarre-looking plaster cornice and picture rail, suggesting this was once a principal reception room or office. In the north wall is a blocked fireplace.

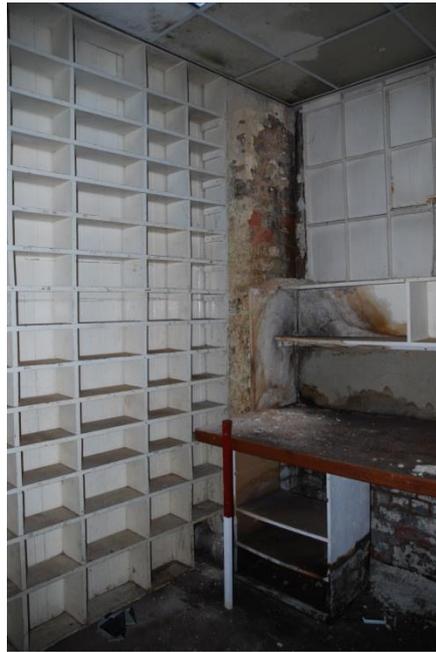
Fig 88: Room EG27 with stamp-shelves on east wall; scale 1m

Room EG27 is the only room in the building to retain shelves put up for storing metal stamps, such as are found in numerous places through the adjacent Unity works. However all are empty. This and the adjacent EG28 were probably used as office space serving the rear shopping (EG25)

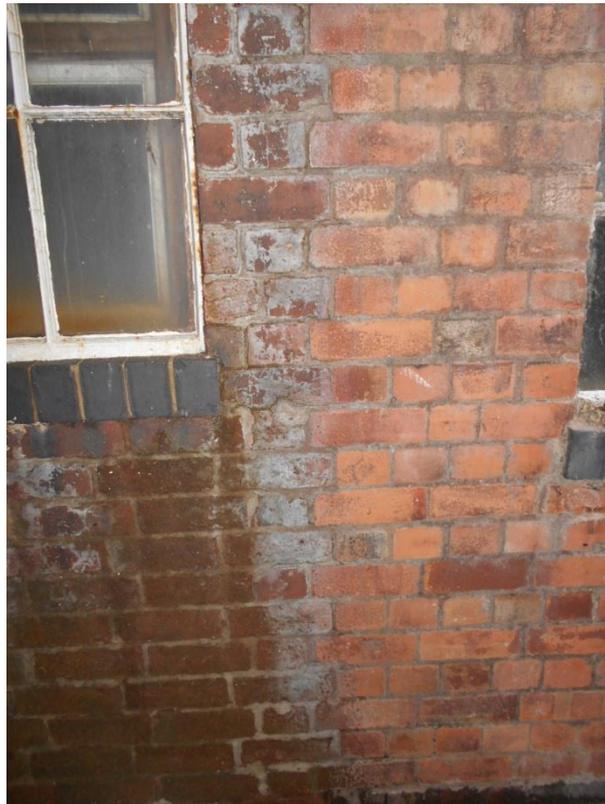
Fig 90: The major change in brickwork from no 30's frontage (Left) to the rear shopping (Right)

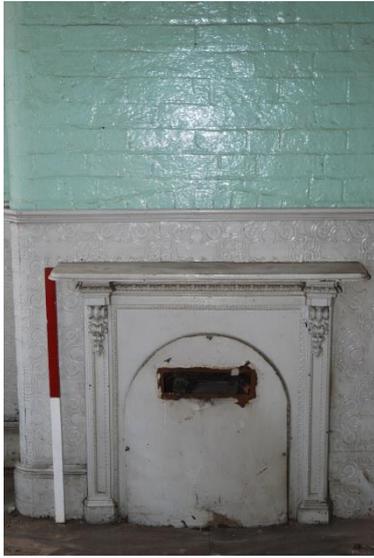
Fig 91: Room EF03 fireplace; scale 1m

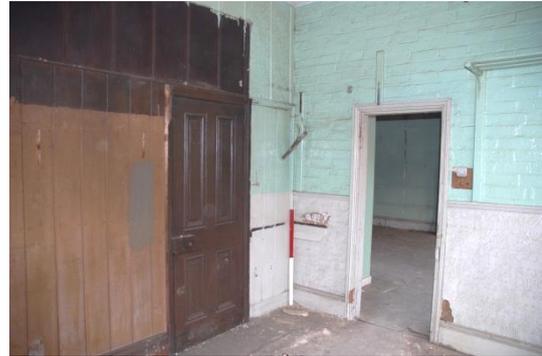
Fig 92: Room EF03 view of panelling and anaglypta wall-covering; scale 1m

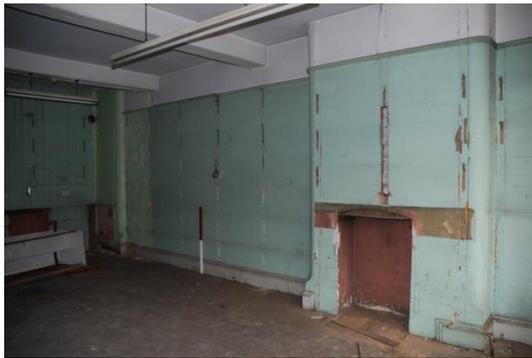
Fig 93: Room EF07, looking north-west;
scale 1m

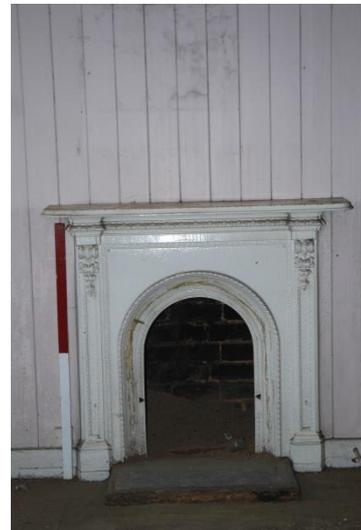
Fig 94: Room EF09 fireplace and panelling;
scale 1m

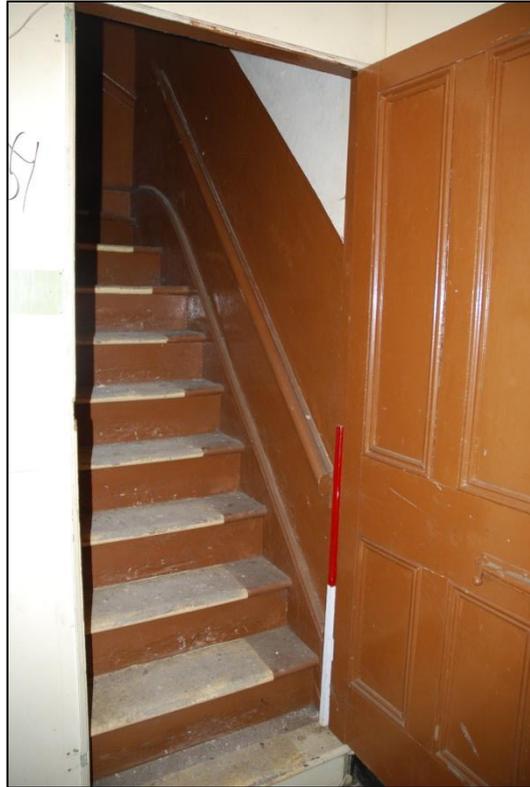
Fig 95: Staircase from Room EF04, is part of the Victorian/Edwardian ensemble and the door matches the one in EF03; scale 1m.
