Iain Soden Heritage Services Ltd

**Level 3 Building Recording at the former Unity Works
and Vittoria Works, Vittoria Street, Birmingham, 2016**

Summary

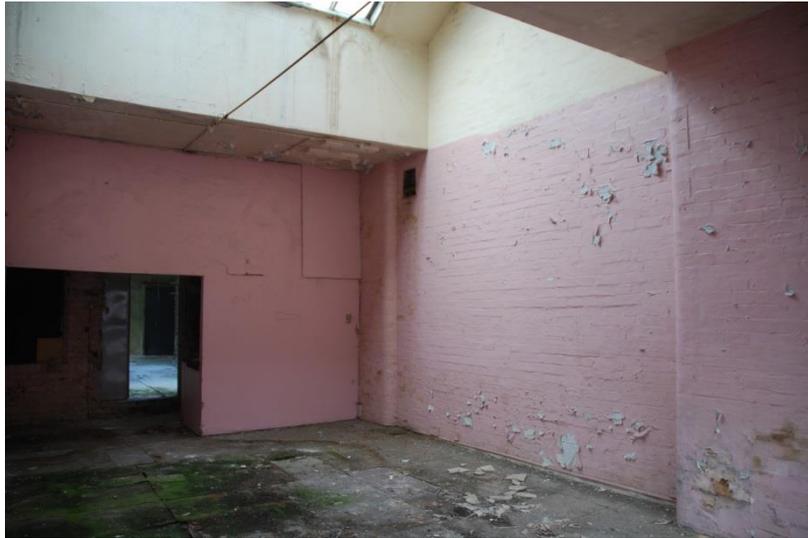
Fig 96: Rom ES21. Note the natural light from above.

In the northern block a single room (ES21) has a long, west-facing roof-light, which affords a good source of natural lighting. This is probably designed as a drawing office but there is nothing to confirm it. The room is otherwise devoid of historic features.

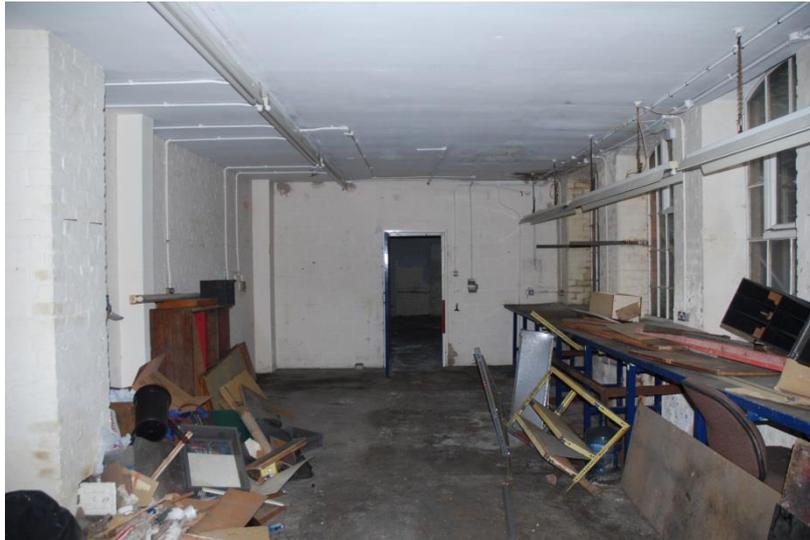
Fig 100: Room EG19 looking west. There was formerly probably an annealing hearth on the left against the wall

The interior at Ground Floor level retains nothing of its former use and it has been fitted out with benches under the windows and a suspended ceiling. The range includes a modern partition at its mid-point. A WC has been added to the outside wall when the range was extended westwards.

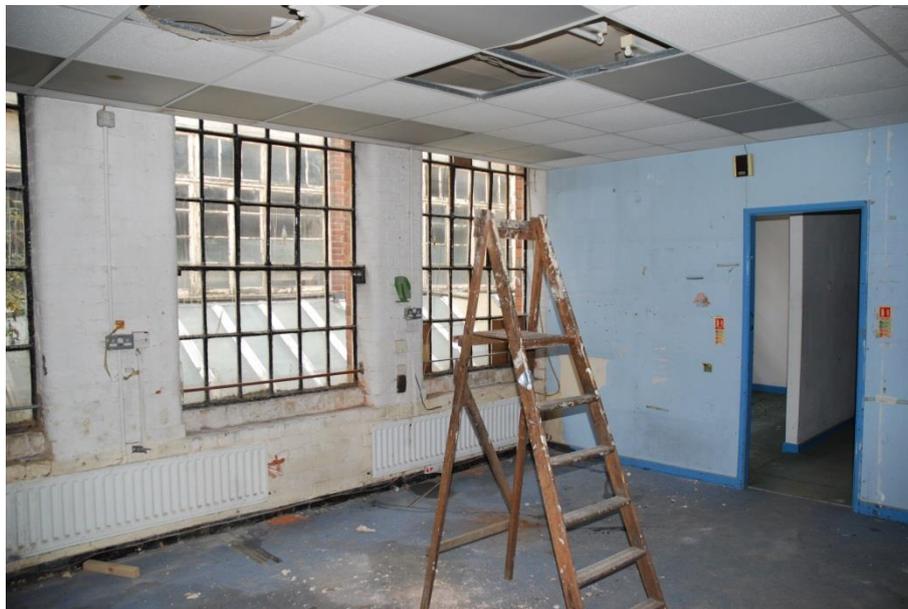
Fig 101: First floor room EF19 looking north-east into the yard (through the iron-framed windows) and room EF18 beyond the partition

The First Floor of the range is almost identical to the Ground Floor, with the exception that in modern times it has been even more divided up with partitions and a suspended ceiling. The interior is unremarkable and there is little instructive historic fabric to be seen.

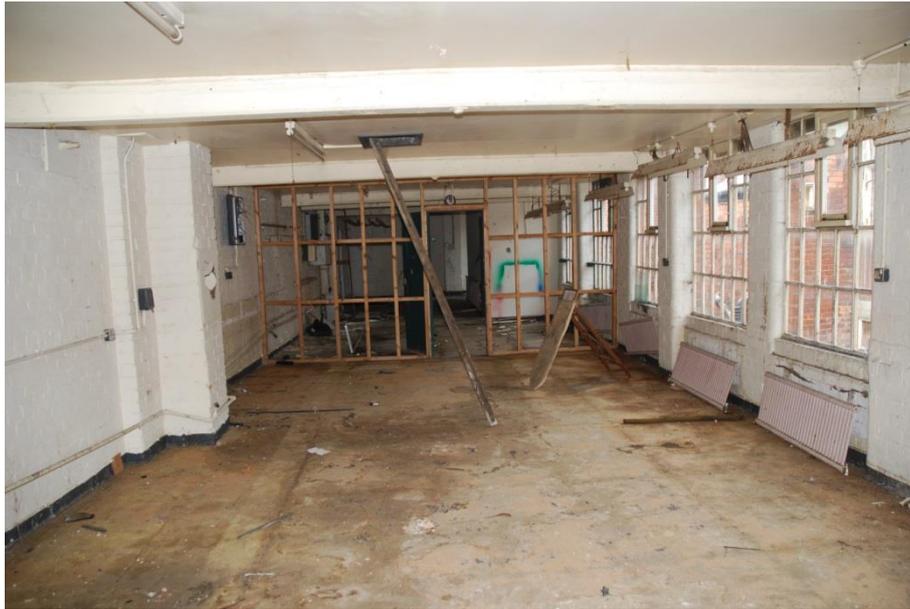
Fig 102: Room ES09 looking west into ES10. The roof is glimpsed through the ceiling hatch (note ladder for location).

Similar to the floors below, the second floor is devoid of historic features, but access is afforded to the roof structure via a ceiling hatch. At this level the former chimney in the south wall is probably without alteration, being the collector-flue for the rooms below.

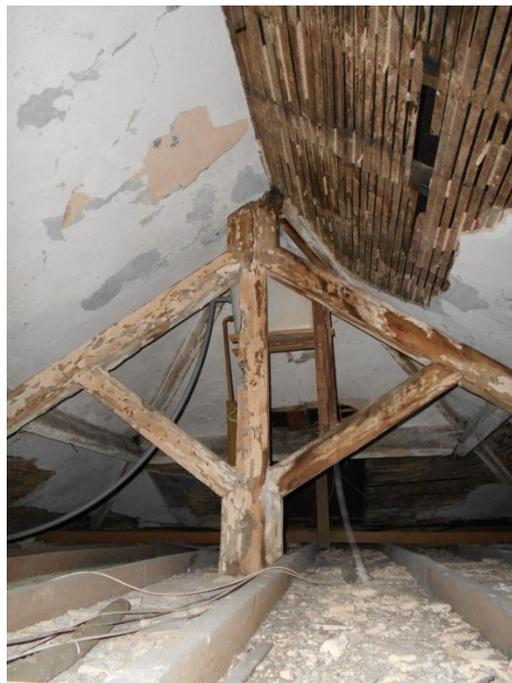
Fig 103: The roof space and truss structure above ES09. A plastered pitch and underside to the rafters show that the present second floor ceiling is an afterthought.

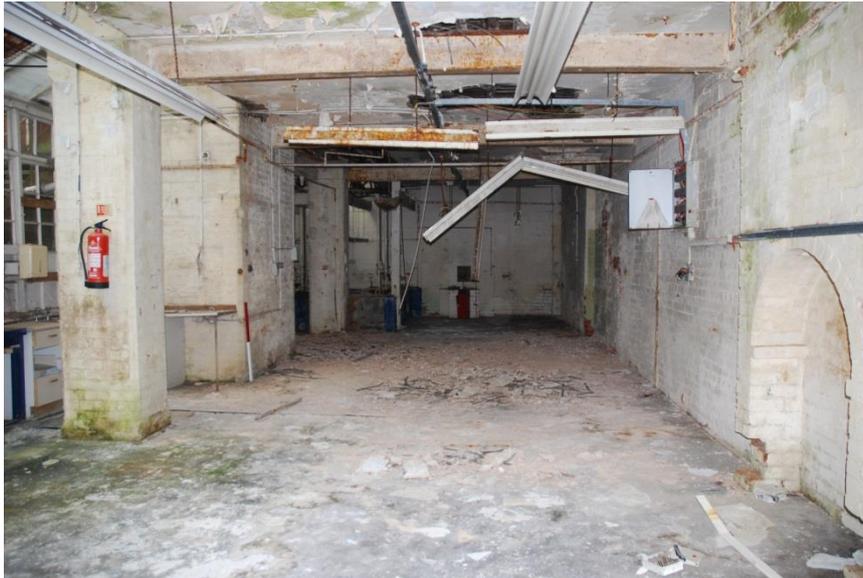
Fig 104: Room EG25 looking west towards a stamp battery in far left behind the WC block, verandah to far left; scale 1m

At the far, west end of the space is an intact stamping battery, actually more complete than that in the Unity Works, and comprising six drop-stamps with line shafting in cradles overhead, and a small electric motor for power. Their overall condition suggests they are not as old as the ones in Unity, and they are certainly somewhat smaller.

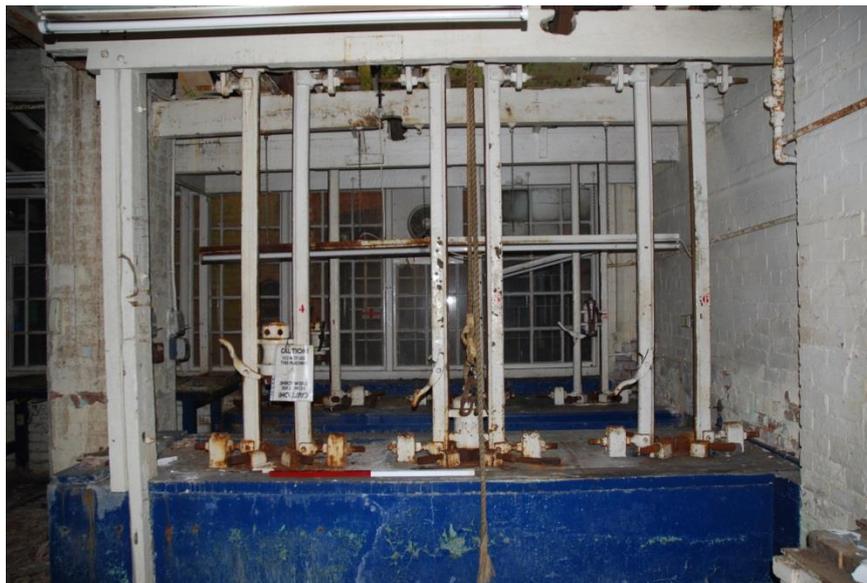
Fig 105: Surviving stamp battery in Room EG25, looking south; scale 1m. The only surviving historic features in the entire works. The blue painted areas are the brick and concrete anvil-benches.

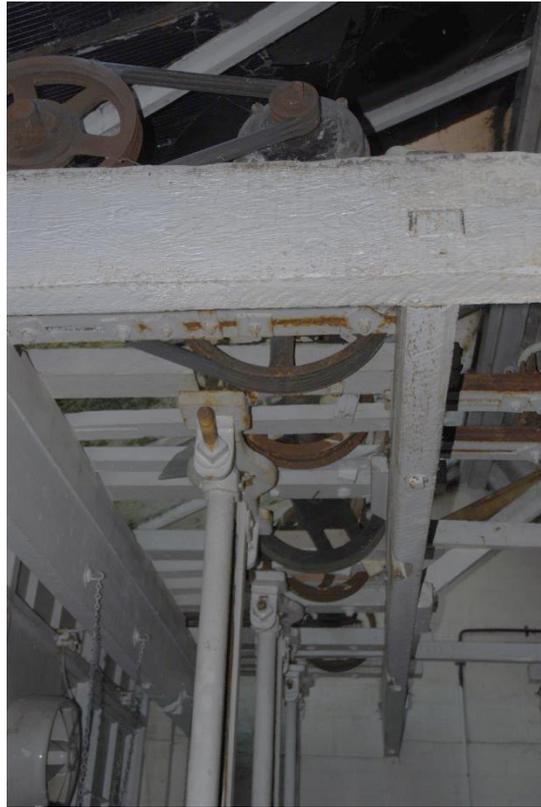
Fig 106: The timber cradle for the line-shafting of the stamp battery in EG25. The drive wheel and belt is at the top left corner (motor out of picture). Note the cast iron brackets to which are fixed the drop-press guide runners.

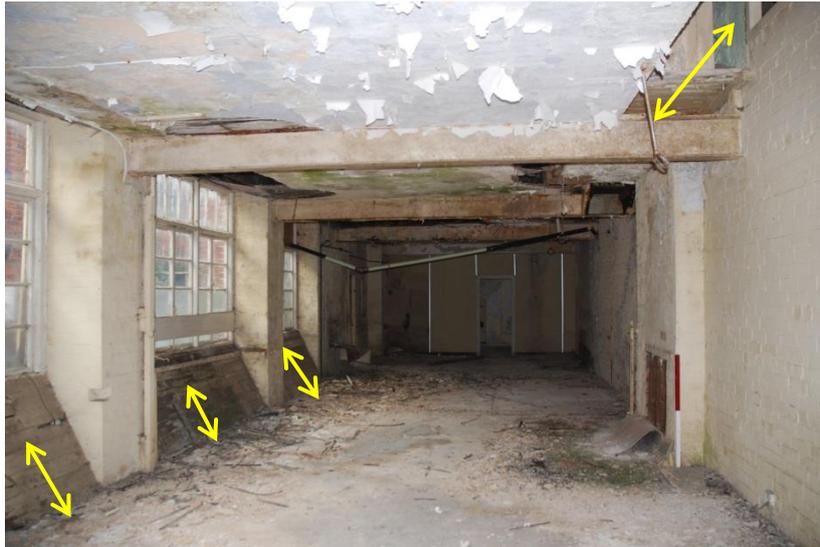
Fig 107: Room EF32 looking east. Note the window-protection and additional natural light afforded by the ceiling gaps and angled boards (arrowed). The steel frame is very clear. Note the bottom corner of the second-floor window (top right), which added light into the first floor from under the benches above

The simple open space of the first floor contains no detail, other than to note the angled boards placed so as to protect the windows from feet, probably when workers were sat at benches along the wall. Feet and debris would otherwise compromise the lower portion of the windows. The use of overly deep windows in this way was not an oversight in ordering materials, but rather this lower portion could shed its light from second floor level, to the darker first floor, which (like the ground floor) could take no benefit of light through the dividing wall with Unity. An attempt had been made to do the same above the verandah from first- to ground-floor on the south side, but it may have been insufficient, requiring the verandah as belt-and braces.

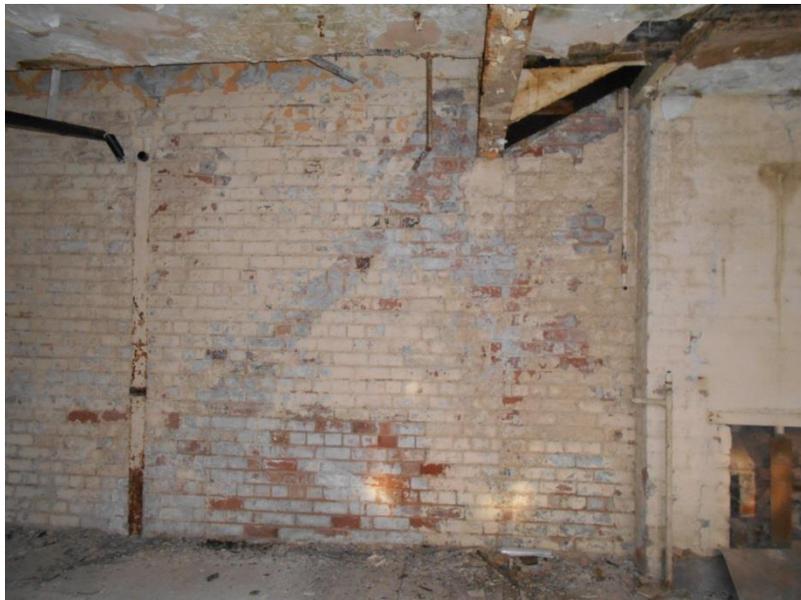
Fig 108: The scar of the former staircase, lost from the north wall of room EF32 up to the second floor

Against the rear wall is the scar of a former stair which once led up to the second floor. Since there is no similar stair from Ground to First floor, it is reasonable to suggest that the range was divided in such a way that the ground floor was differently tenanted from the top two floors, or that the processes differed between the two so markedly that communication was discouraged.

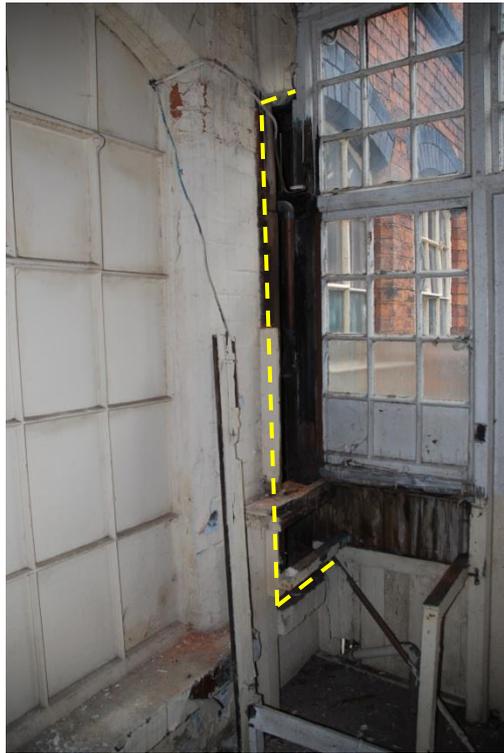
Fig 109: View from EF33. Note the loss of 1¼ rear-facing windows. An earlier range clearly left this as courtyard, as the block-plan of 1896 shows.

The range makes an awkward joint with the back of the frontage block, and a number of windows facing into EF32, EF33 and the yard, have been rendered useless by its construction. It seems that the upsurge in demand, which drove the factory expansion, was little – anticipated at the end of the 19th century.

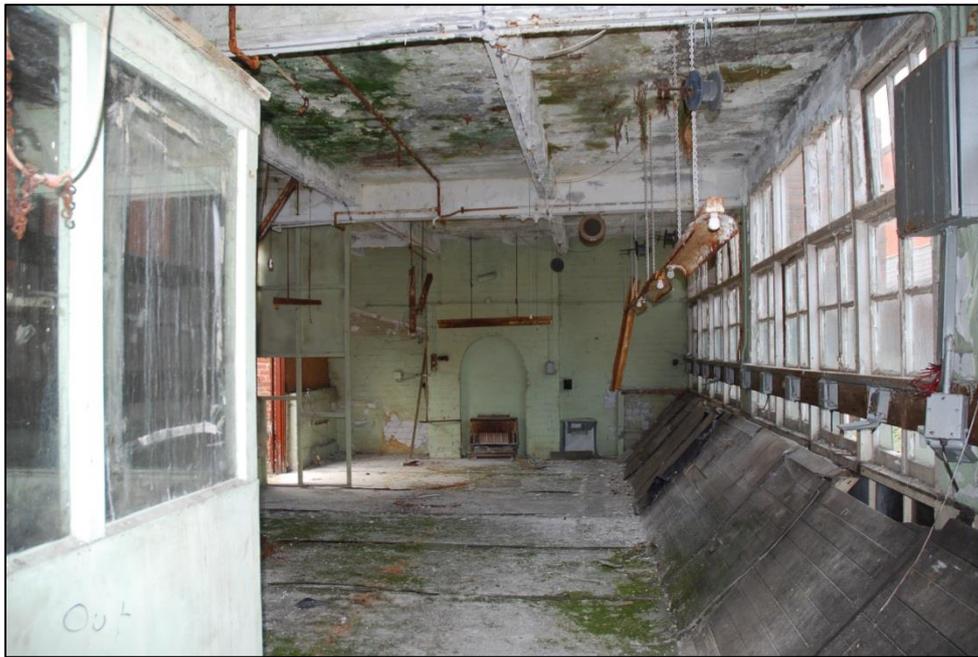
Fig 110: Room ES14 looking west, with annealing hearth at the end. The angled boards protect the lower third of the blinded windows from feet and from dropped materials and tools from the benches, now gone. They also made sure the floor below benefited from their light. On the applied mid-rail are mounted numerous electrical points. Note the circular tannoy-type speaker on the ceiling.

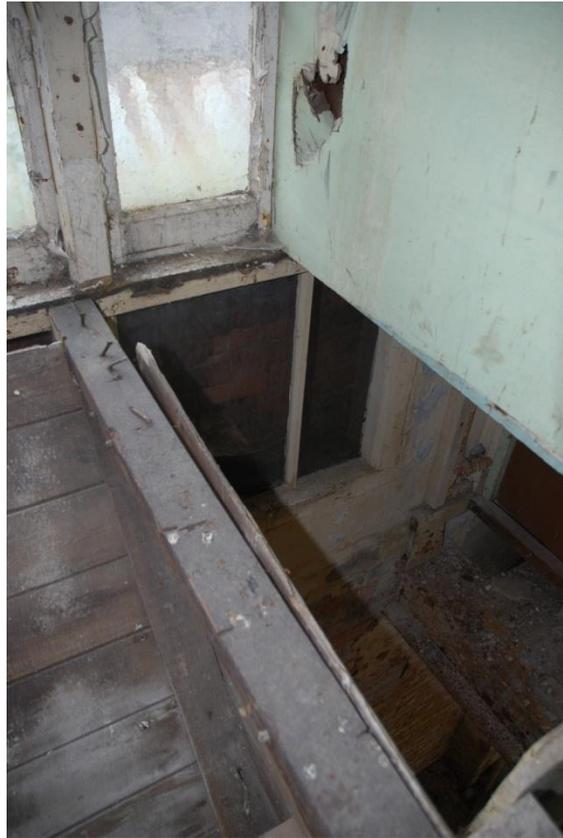
Fig 111: The truncated end of the stair up from the First Floor where it emerges in ES14. Note the lower portion of the huge window, which sits behind the angled protective boards.

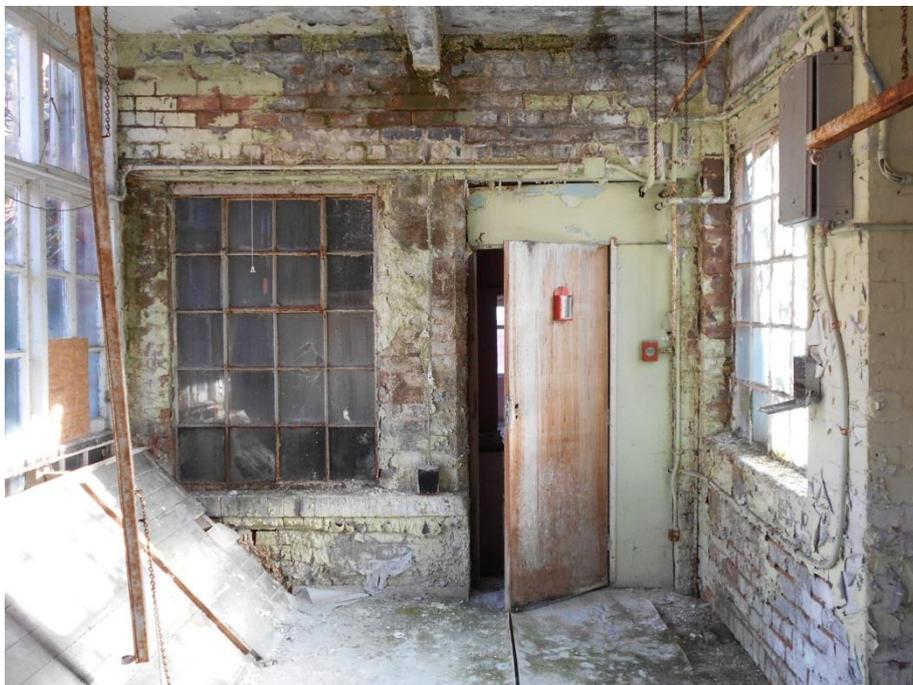
Fig 112: Room ES18, looking east into ES19 and ES20. Note the blinded rear-facing frontage windows (one subsequently converted to a doorway) which show that the earlier range was shorter, and had an open yard between it and the frontage.

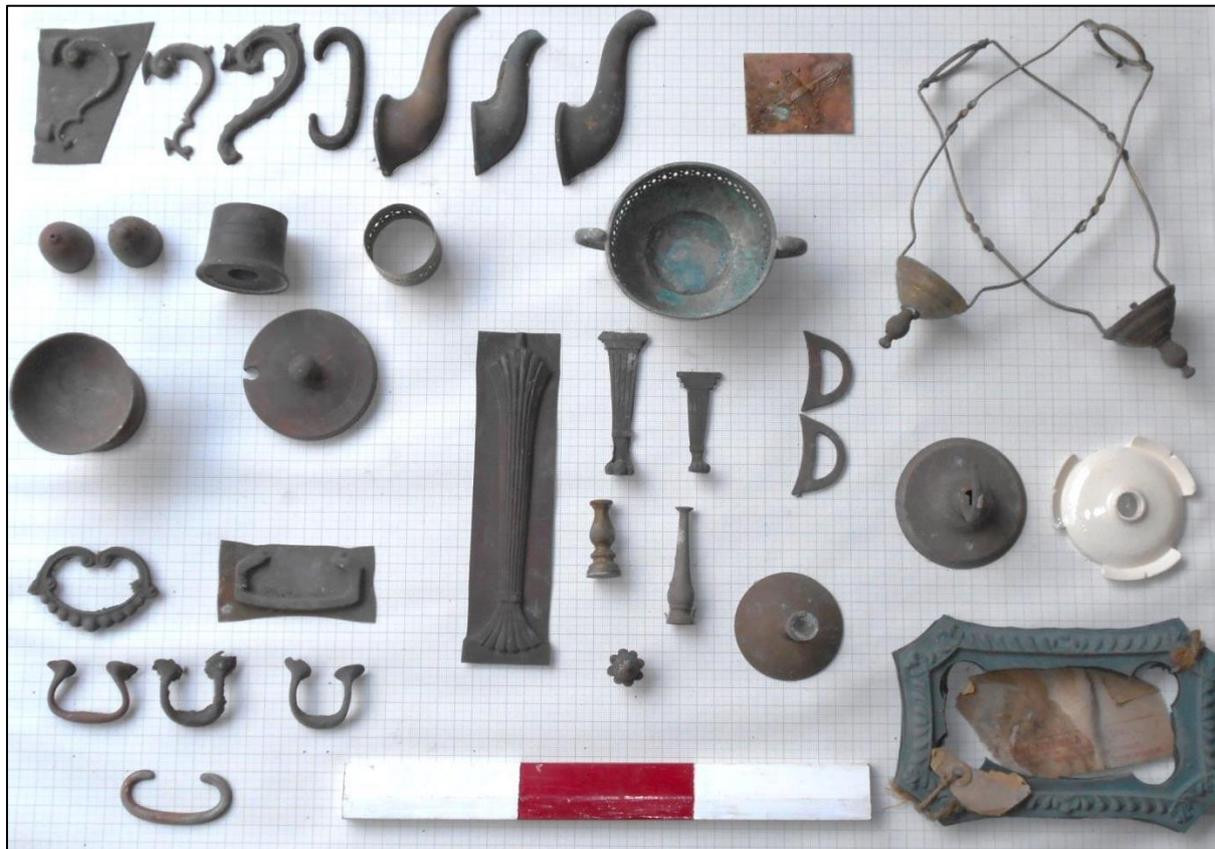
Fig 113: Finished and part-finished cast or stamped artefacts found in profusion around the ground and first floor of Unity Works (principally EG 49 and 51 and EF34): handles, spouts, salt and pepper pots (pattern as described in report above), matching mustard pot, bowls, lids, knops, stems, feet, light fittings, regimental badge (The Parachute Regiment); scale 30cm and photographed against 1cm graph-paper background.

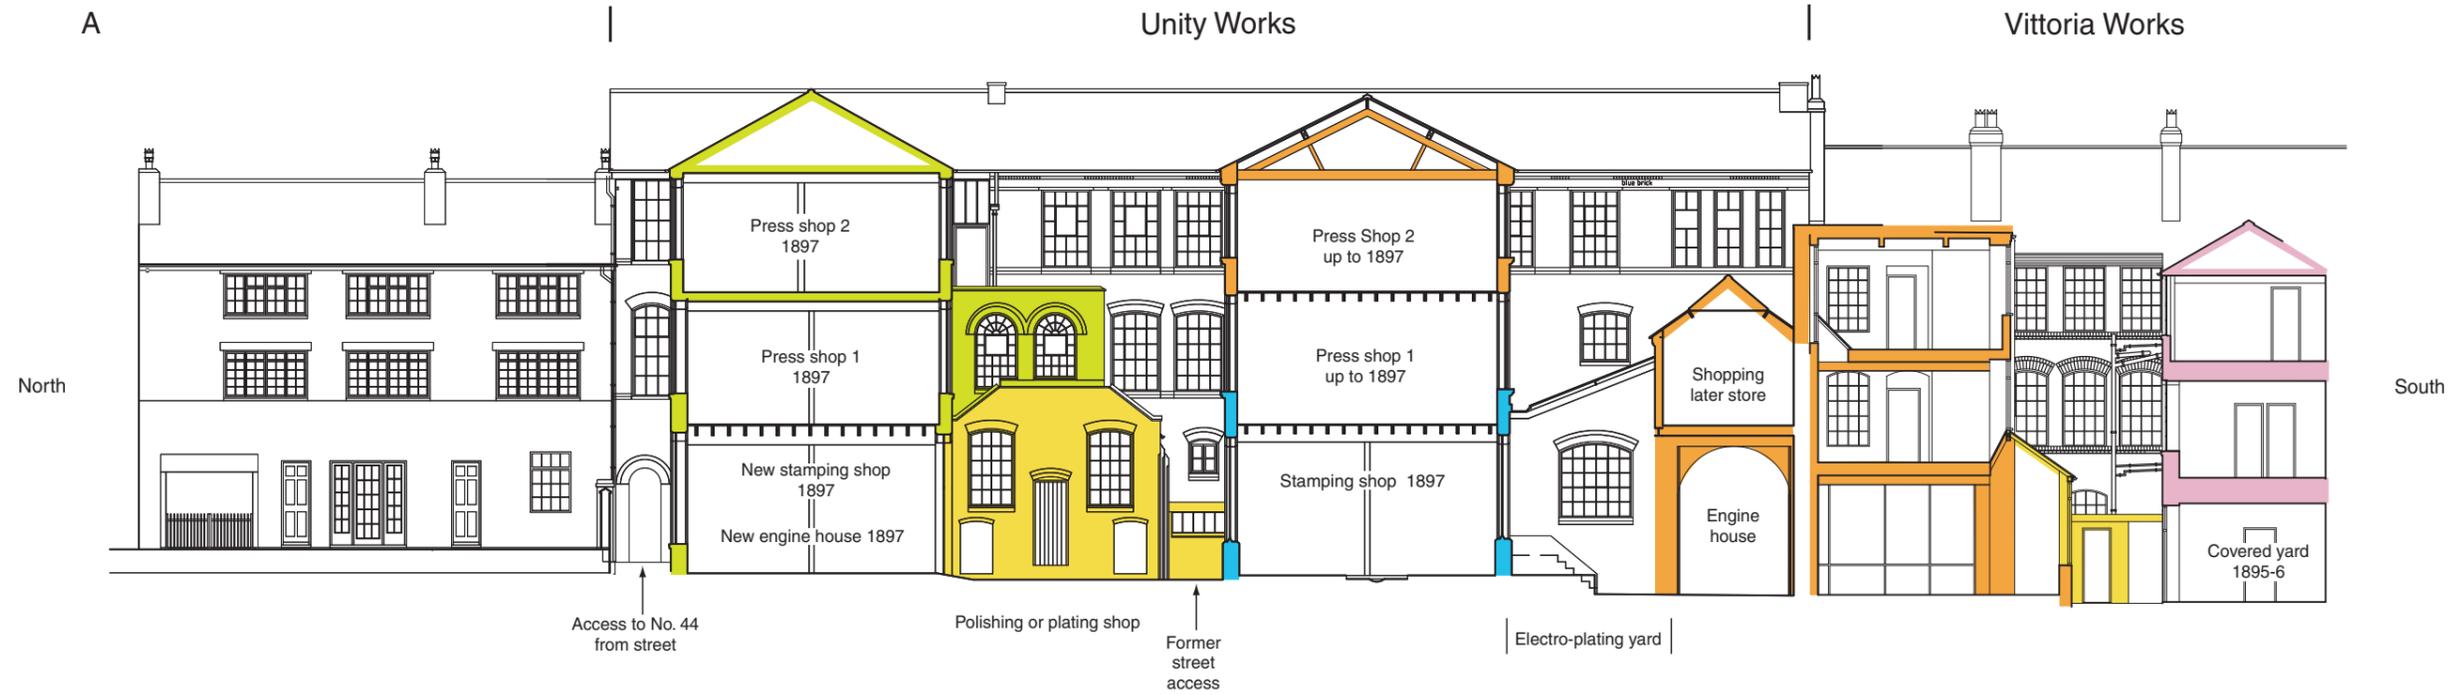
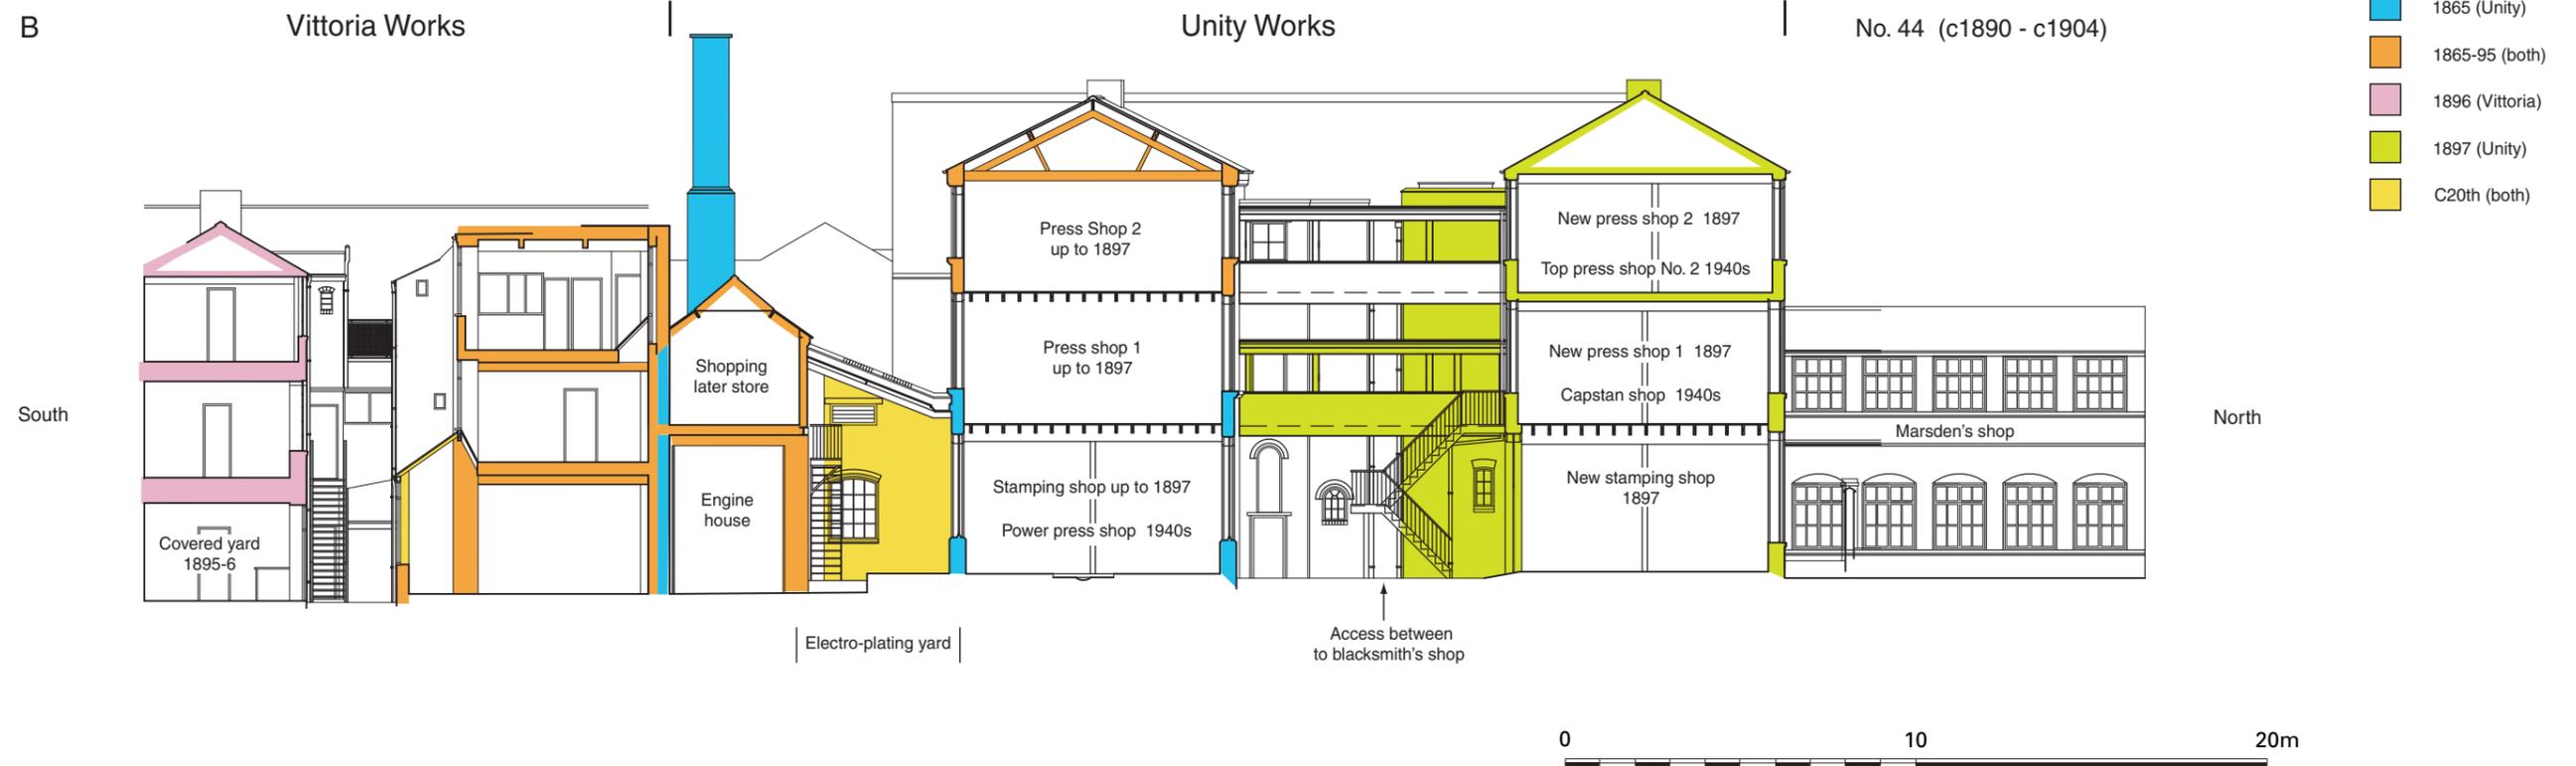
SECTIONAL ELEVATIONS

Phased and dated sectional elevations at AA and BB (Andy Isham/PCPT Architects)
