An Archaeological Evaluation on a development site at 24-32 Gold Street, Wellingborough

Summary

Archaeological trial trenches indicate that remains of a potentially 17th-century frontage survive directly below a surface car park at 24-32 Gold Street, Wellingborough, but that the rear of the former plot has been probably extensively quarried in the 19th century.

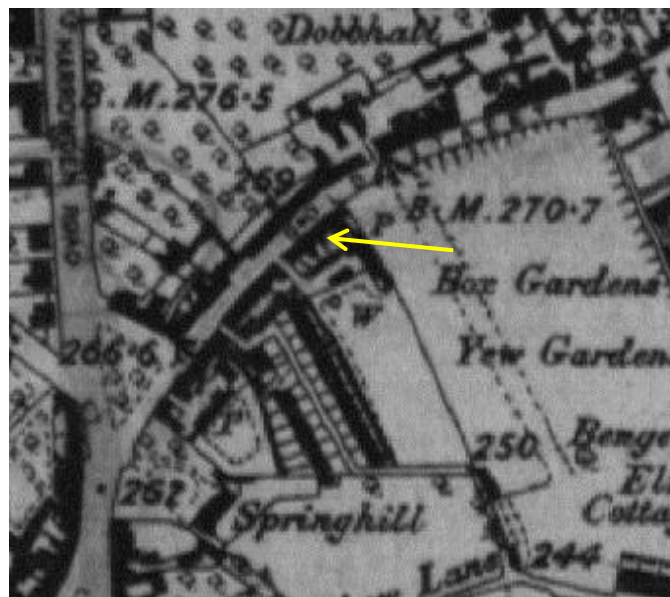
Fig 3: 1886 first edition Ordnance Survey; sheet 39 NE. The site is arrowed

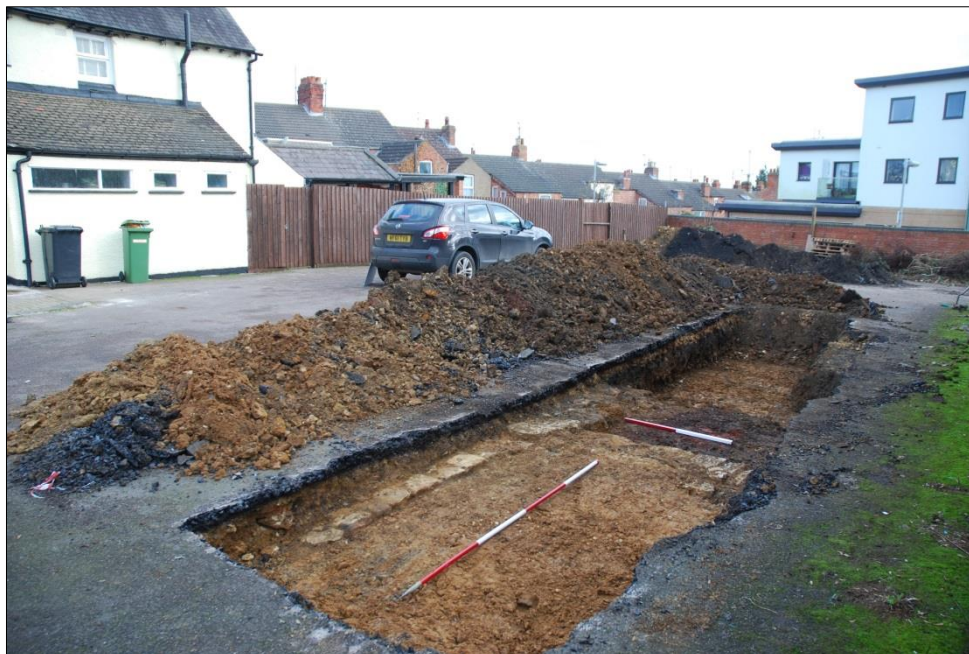
Fig 5: View looking south-east across Trench 1 (foreground) and Trench 2 (background); scales 2m and 1m

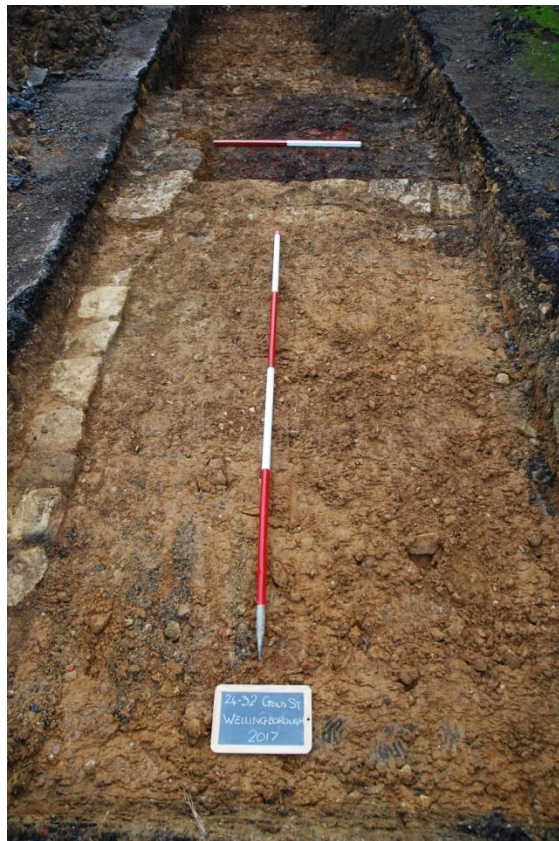
In the angle of two of the foundations, at the frontage, was natural or re-deposited natural sand and gravel at a level of 81.55m above Ordnance Datum. However, in the angle of the other two of the wall foundations lay a 150mm-thick deposit of dark soils with concentrations of ash and burnt material, some quite intensely scorched. None appeared to have been burnt *in situ*, however, and it could represent the rakings-out from a hearth or oven. No pottery or other dating material was present. The material petered out close to the end of the stone foundations and appeared to lie on an edge of natural clay which angled down sharply towards the south-west.

The southern half of the trench comprised a dark clayey soil with numerous mixed clay lumps and ironstone pieces. Amongst it lay a single line of brick, perhaps demarking a path edge or a horticultural order. The soil here was reduced by machine and was noted to become stickier with clay content, but was equally mixed at depth. The machining stopped at 0.8m depth without the layer showing any signs of further change. It produced a number of sherds of 19th-century pottery throughout (not retained). This area is considered to comprise a poor-quality garden soil, making use of earlier quarry backfill, all of the 19th century.

Fig 7: Trench 1, looking south. Note burning in the angle of two of the foundations; scales 2m and 1m

Trench 1 shows that there is at least the outline of the historic frontage surviving directly below the car park tarmac and road-stone sub-base, as high as 81.67m above Ordnance Datum. Exact dating was not forthcoming but it is likely to be the same frontage as was mapped in 1803 and shares a common origin with that of the 17th- to 18th-century Fox and Hounds next door.

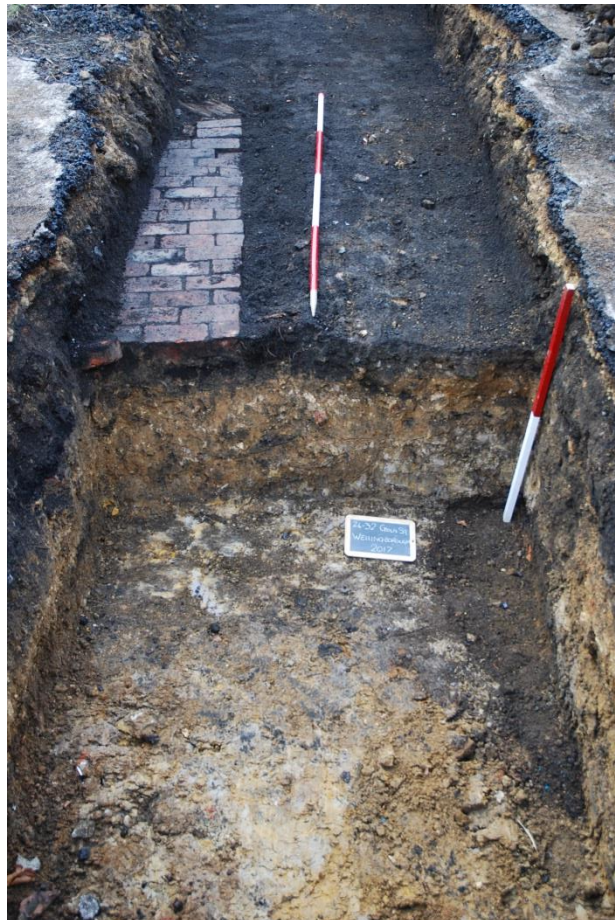
Under the tarmac and road-stone the trench contained a 200mm-thick spread of very hard industrial slag, which comprised siliceous lumps from the base of a furnace, typical of steam engines. This overlay a discrete un-mortared brick floor or hard-standing which extended beyond the trench. The whole lay at a height of c81m above Ordnance Datum.

Alongside the brick floor was an unbroken 200mm-thick deposit of coal-ash and cinders which appeared to form a wider hard-standing. This contained 19th-20th-century pottery and a ceramic electrical socket fitting (not retained).

At one end of the trench a machine-dug sondage was cut to a depth of 1m below the modern ground surface to test the underlying stratification. This was found to comprise successive layers of clay, rubble and topsoils tipping down in a south-easterly direction. These are confidently interpreted as imported quarry-fills, which have been noted elsewhere in the near vicinity behind Gold Street.

The basal layer of the fills, where tested at 1m below the modern ground surface, still contained 19th-century pottery and clay tobacco-pipe stem pieces in some numbers, a not uncommon find on former public house sites. None of the finds were retained.

Fig 8: Trench 2, looking west; scales 2m (horizontal) and 1m (vertical). Note the dark soil at 1m depth, which produced 19th century pottery and clay tobacco pipe.

Trench 2 shows that considerable quantities of 19th-century quarry backfill has made up the rear portion of the site which had been previously reduced. It is felt to have no potential to contain stratified earlier material.
