Iain Soden Heritage Services Ltd

Archaeological observation and recording at Brackley Town Hall, 2017

Iain Soden BA MCI(A)

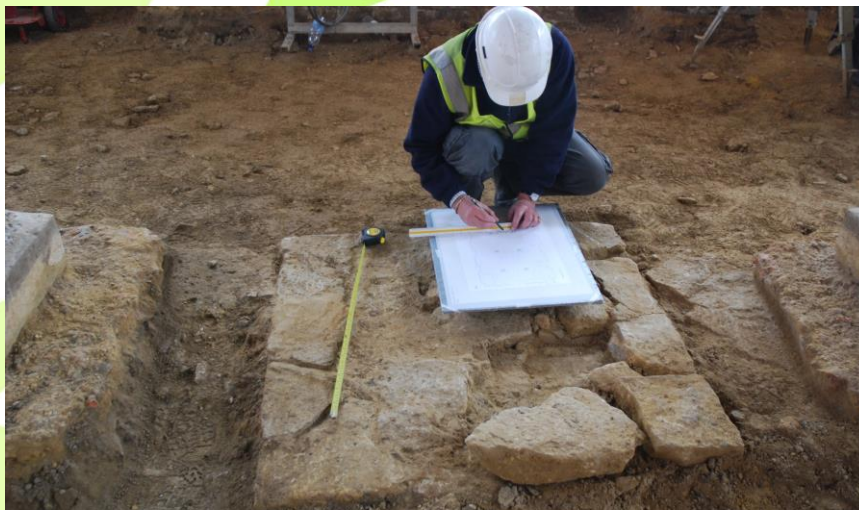
Recording an early 18th century pier base during ground reduction

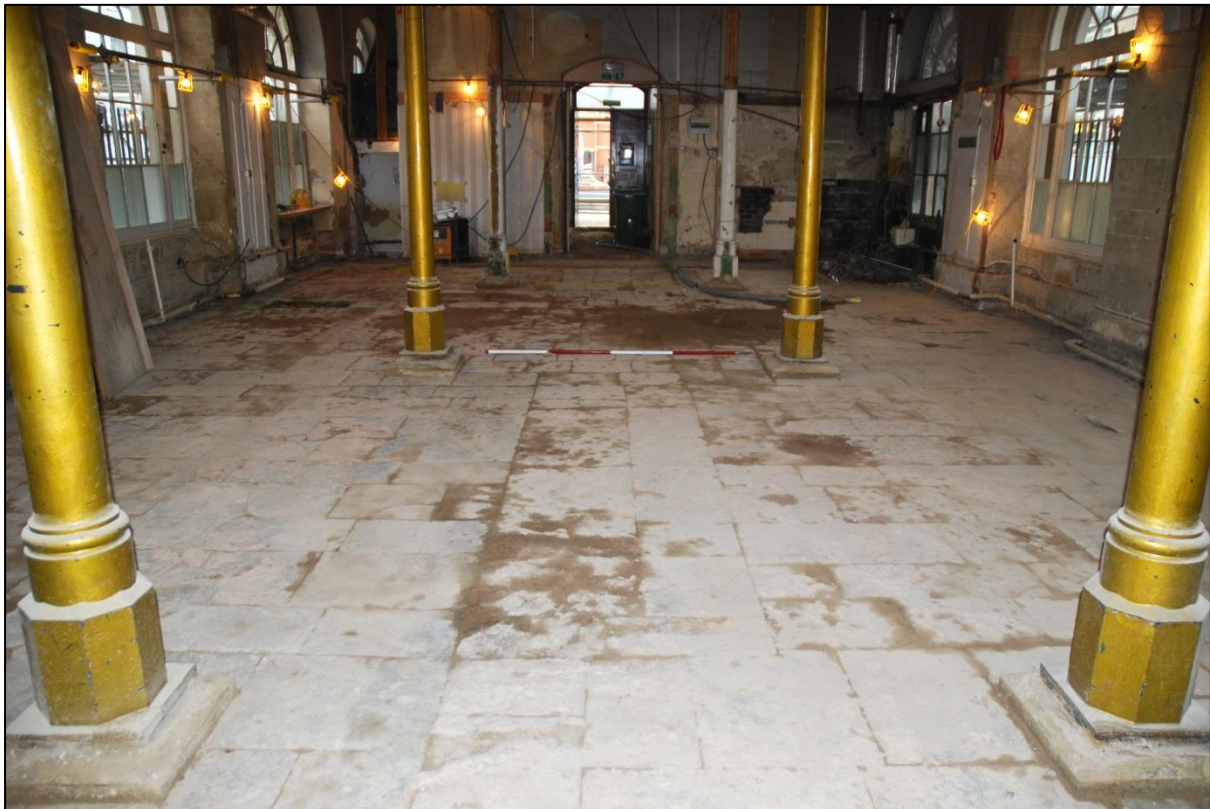
Visually the flagged floor cleaned up very well, although it was found that some half of all the flagstones had been cracked or broken before the concrete screed was put down. The flags neatly abutted the upper portions of the bases for the cast iron columns, clearly showing they deliberately respected the new layout. They also fitted neatly into the former arched doorways which had once characterised the open ground floor of the market hall, but also stopped neatly at each blocking wall, showing that the flagged floor was part of an enclosed hall from that date.

Fig 2: View looking north across the newly-uncovered 1883 stone-flagged floor; Scale 2m

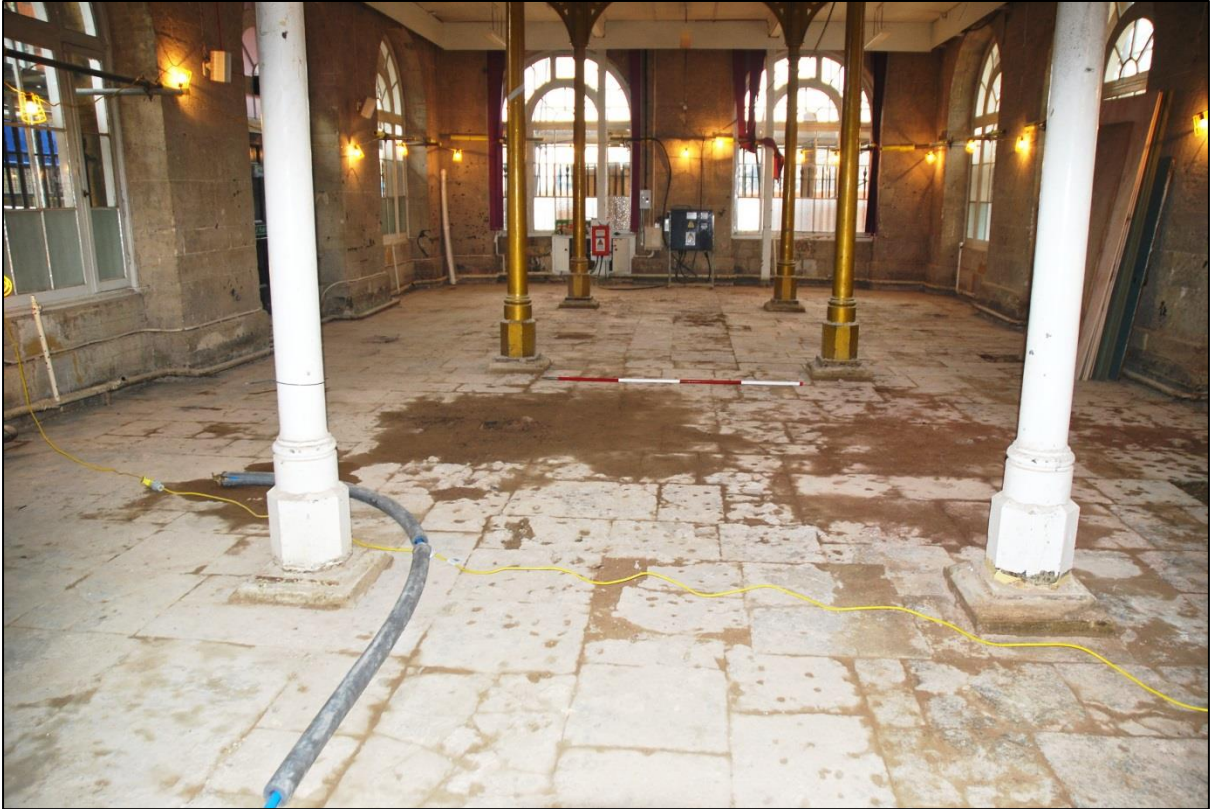
Fig 3: View looking south across the newly-uncovered 1883 stone-flagged floor; Scale 2m

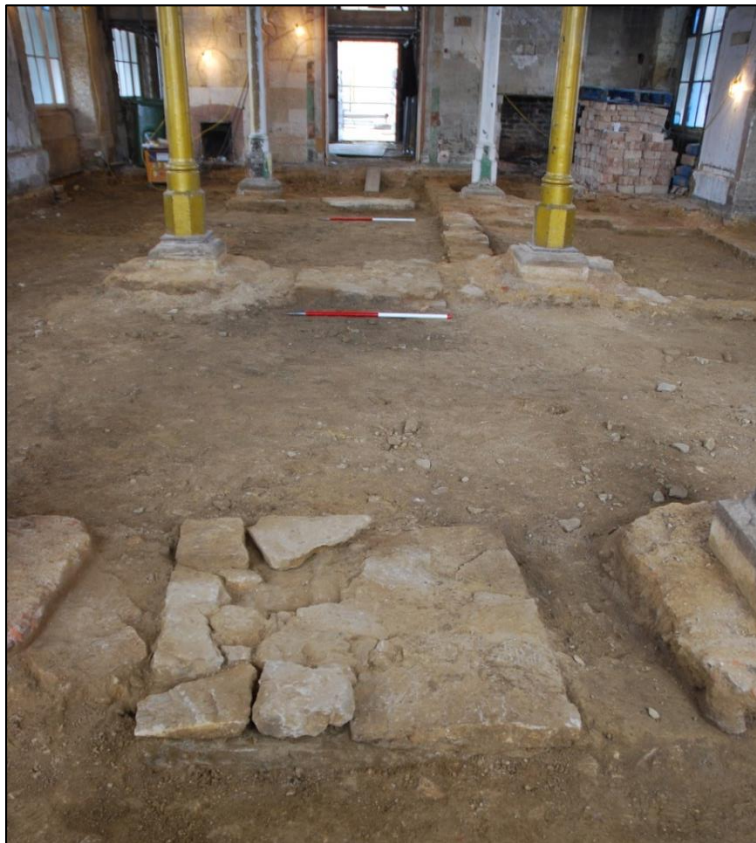
Down the centre-line of the hall lay a row of square limestone pier-bases- all that remained of the supports for the original open market-hall ceiling.

Fig 5: View looking north along the row of reduced pier-bases left over from the market hall as first built;
Scales 1m

The southerly and the middle pier base were composites, constructed mainly from roughly-coursed limestone pieces with occasional ironstone fragments (an otherwise unknown inclusion in this building). The northerly example, however, comprised a single slab of limestone on which a mortar ghosting pattern suggested the size and square shape of the pillar which once surmounted it –or at least the lowest of the pillar courses which would have been visible. Each base was a little over 1m square in plan.

Although axial to the long centre-line of the original building, it was notable that the northerly and southerly piers projected further north and south (respectively) than the pairs of cast iron pillars which replaced them. Thus they were not quite central to the two bays they each served. This suggests that the original hall may have loaded its first floor differently, or that the piers which supported the early outer arcade were once different and have been modified to the arrangement which has pertained since 1883.

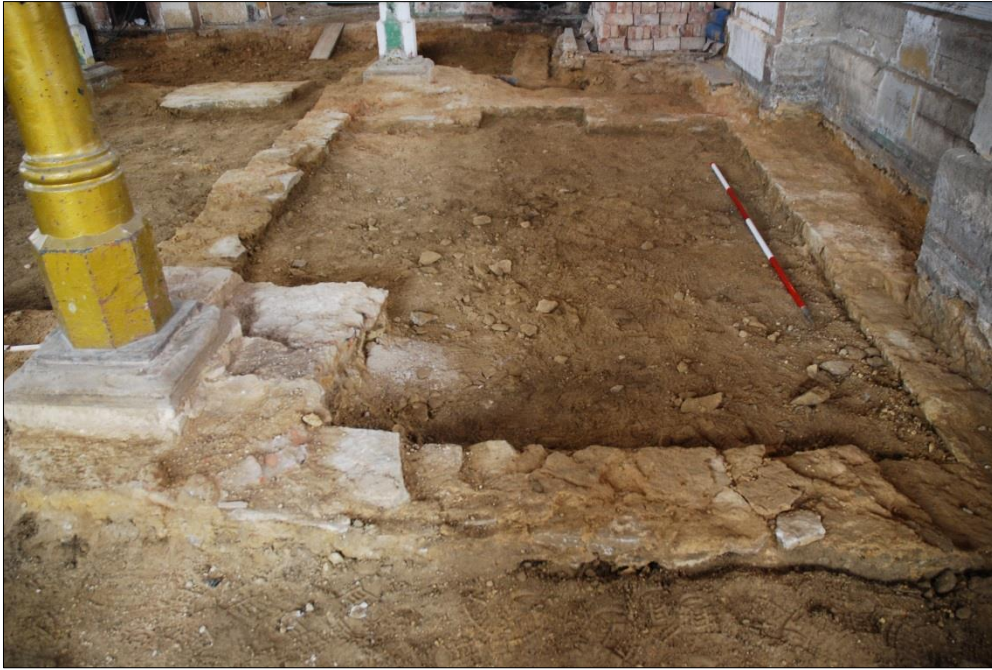
In the north-east quadrant of the hall lay the reduced foundations of some internal structures. They were built of limestone, but impressions in mortar on their upper surface showed that they once carried walls of brick construction. The foundation on the east side suggests that the structure was in place while the market hall still had open sides, prior to the current infilled arcade.

The biggest space, the constable's room, appears to have had a fireplace in its northern wall (Figs 6 and 9). The dimensions of the fireplace match exactly that in the north wall of the present hall space so the jambs and lintel may be a direct re-use from this location.

The whole internal structure must have been demolished for the 1883 re-ordering since two of the cast iron columns stand squarely on top of the reduced foundations. When in place there would have been very little gap between the central row of columns and the wall of the room through which to squeeze.

Fig 6: View looking north along the inserted 'Constable's room' of c1838; Scale 2m

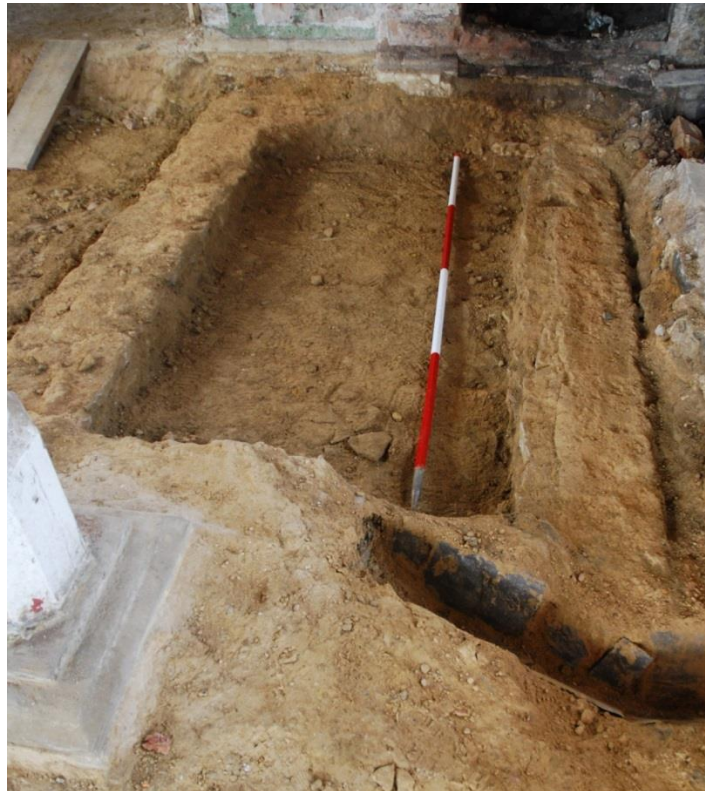
The northern portion of the internal structure comprised two prison cells of very restricted space. Each was just over 2m long and this included a slate-lined V-shaped drain for a urinal at the southern (inner end). The doors to these cells must have been on the northern, outer end of the structure. One of the cells had been all but destroyed by construction of the modern plant room.

Fig 7: View north along one of the two cells of the 'lock-up'. Note the slate-lined urinal drain in the foreground; Scale 2m

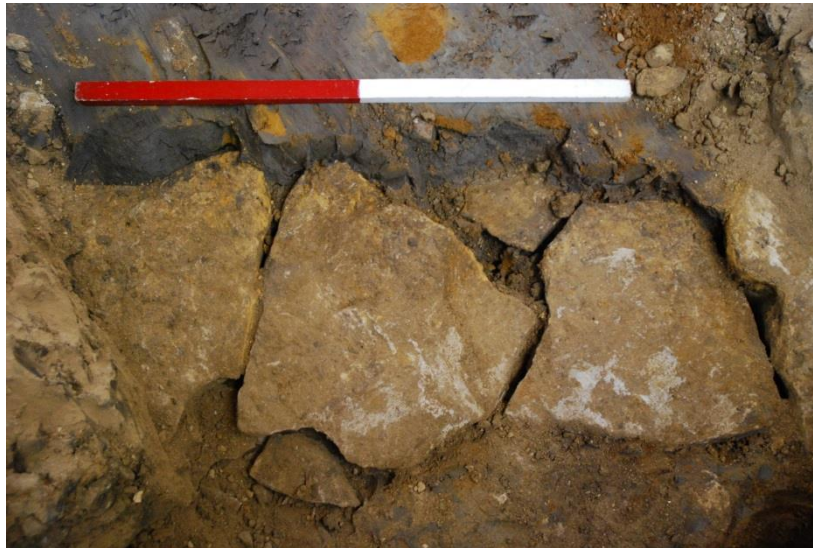
Underneath the constable's room digging continued to insert new services. An area in the eastern third of the hall was therefore further reduced (this time by hand) under archaeological scrutiny. At a depth of about a further 600mm two limestone-lined and limestone-capped drains were uncovered (Figs 9, 10 and 11). These were set into lias clay and one at least was still conducting groundwater.

Fig 10: Vertical view of a stone lined drain below the Constable's room; scale 1m. North to right.

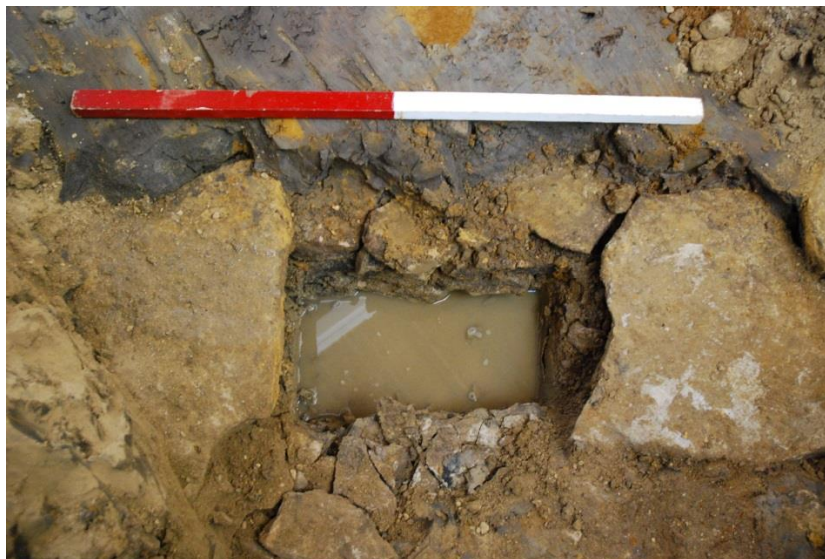
Fig 11: Same view as above, stone capping removed, the drain still doing its work; scale 1m. North to right.
