## Lyveden Old Build – an archaeological appraisal of the building and its former built environs

Joe Prentice and Iain Soden

## **Lyveden Old Build – an archaeological appraisal of the building and its former built environs**

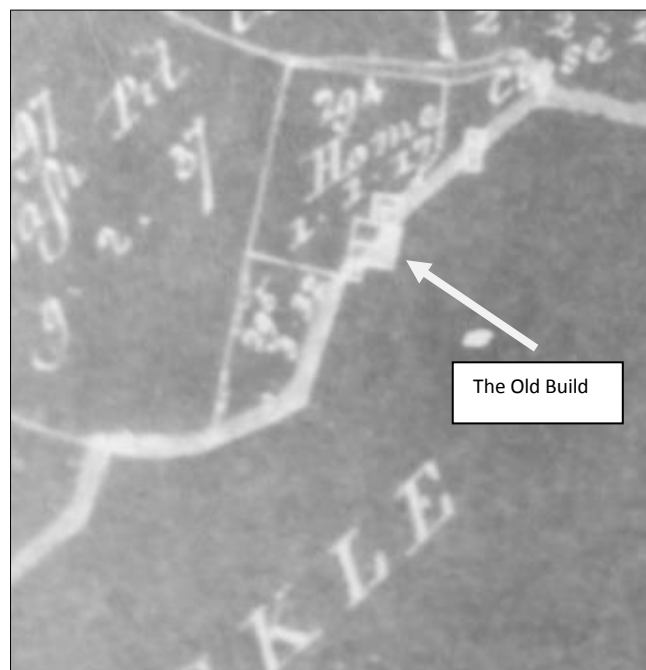
Fig 3: Inclosure map of 1824, extract (NRO: map 2885a). North to top.

By the time of the first large scale example of mapping the building appears to have changed shape significantly and is perhaps the first reliable representation of the standing building (Fig 3, Inclosure map of Benefield, 1824 - NRO map 2885a, black and white Photostat).

The Old Build lies on the parish boundary between Aldwinckle, Benefield and Pilton and the quality of the copy is relatively poor but appears to show an L-shaped building with to the north a probable

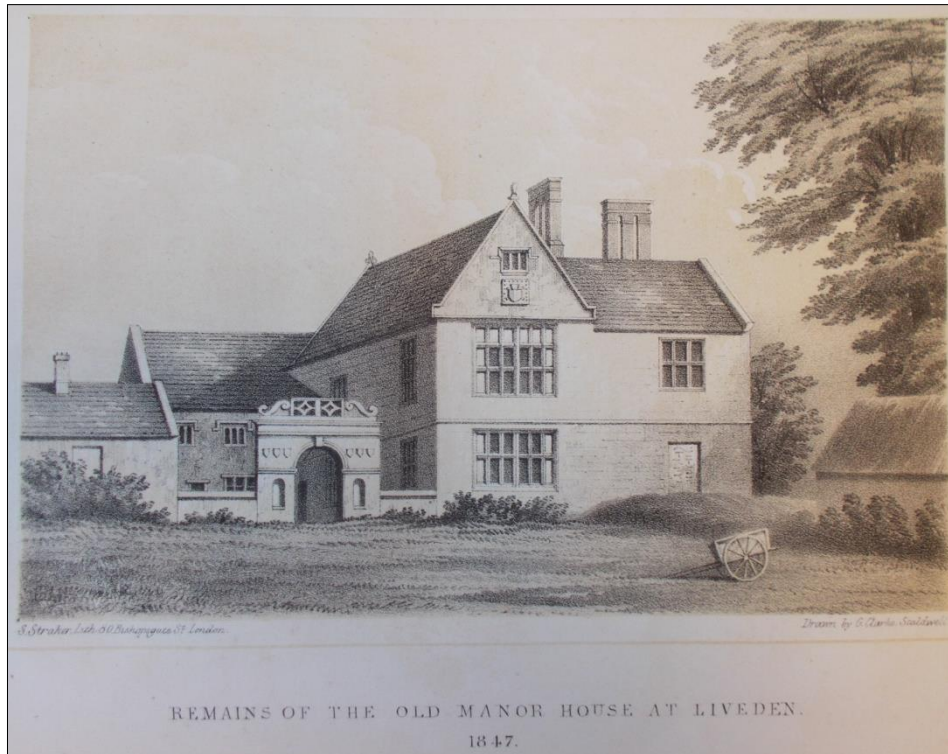
Fig 5: Drawing by G Clark from 'The Ruins of Lyveden' by T Bell, 1847, looking south-east.

The engraving shows the Old Build from the west or north-west with the arched gateway, flanking niches and screen walls to the courtyard along with the now demolished east and north ranges. The arch and flanking walls exist today but were removed in the nineteenth-century to Fermyn Woods. On the far right of the view is a low building, presumably for service or agricultural use.

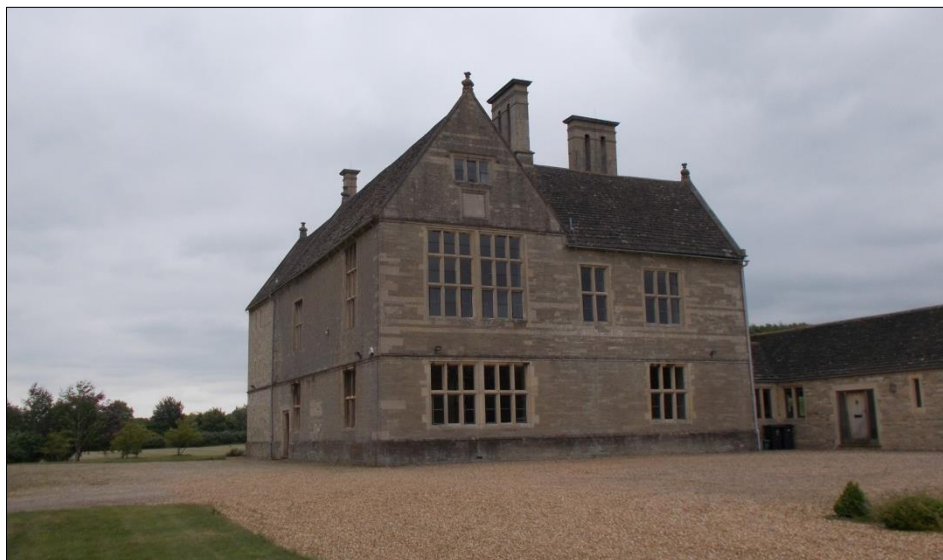
Fig 6: The same view as Fig 5 today. Former East range lost to left

There are a number of significant differences between the two views.

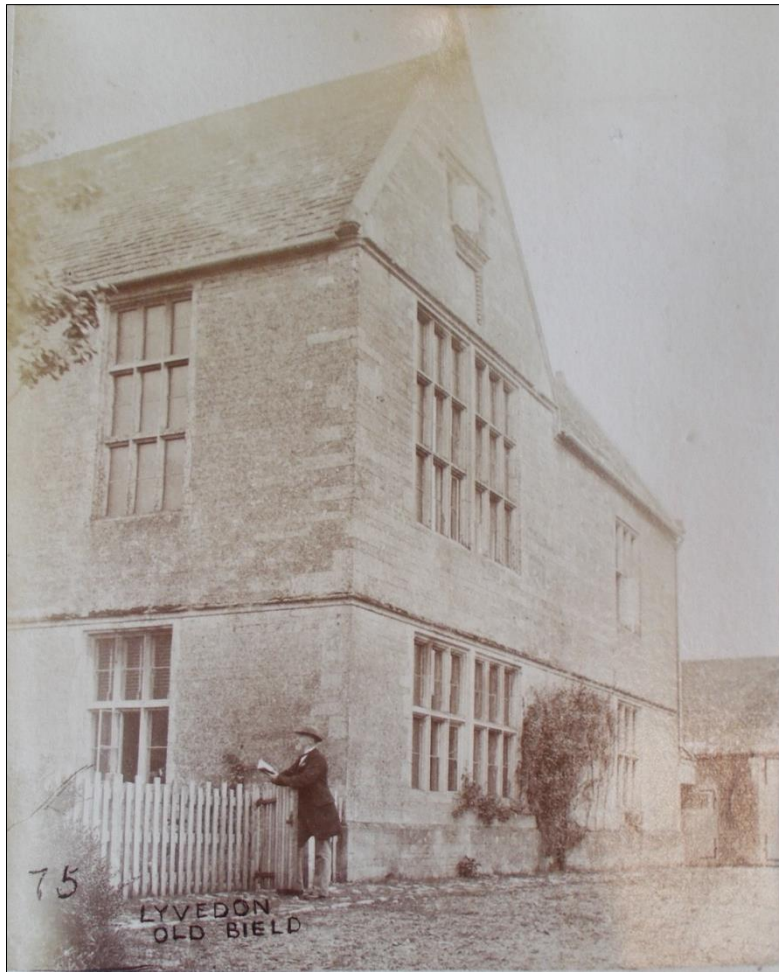
Fig 7: Photograph of 1882 showing the Old Build from the north-west (NRO: TBF277).

The first photograph found dates from 1882 (NRO: TBF 277; Fig 7). It was apparently taken by John L Robinson on an excursion of the Architectural Association. Unfortunately it shows only a small section of the building although the detail is surprisingly good and reveals some interesting points.

At ground floor level the former doorway is now replaced by a window which remains to this day, a replacement which took place therefore between 1847 and 1882.

In the single storey east-west range two doors are shown in the north elevation (Fig 7). That to the west is lower whilst the one partly visible on the far right of the photograph reaches to the level of the eaves, perhaps indicating that it was a carriage-house door. Both appear to be painted white, or at least a pale colour, and are fitted with black or dark-painted HL hinges. The single storey range appears to have been linked to the main building by a covered section but whether this was an entirely closed space or was simply a covered alley is uncertain.

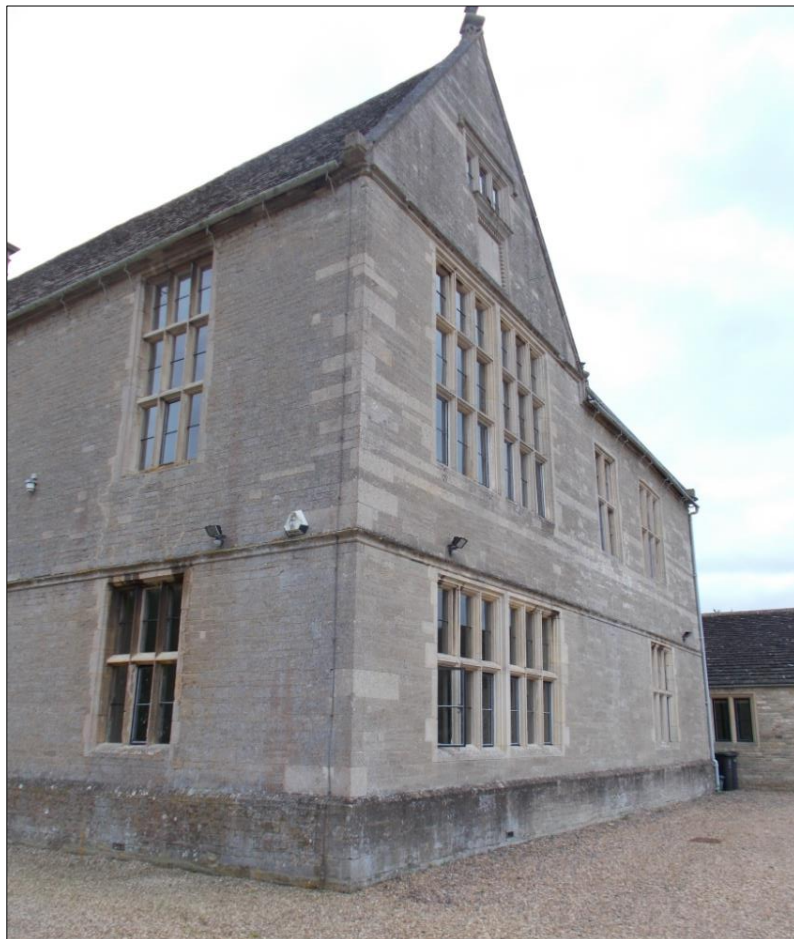
Fig 8: The building taken from the same viewpoint as Fig 7 today.

This section of the building appears to remain much the same today though with some minor differences (Fig 8). The coats of arms, formerly in the recessed panel at attic level, are clearly no longer present.

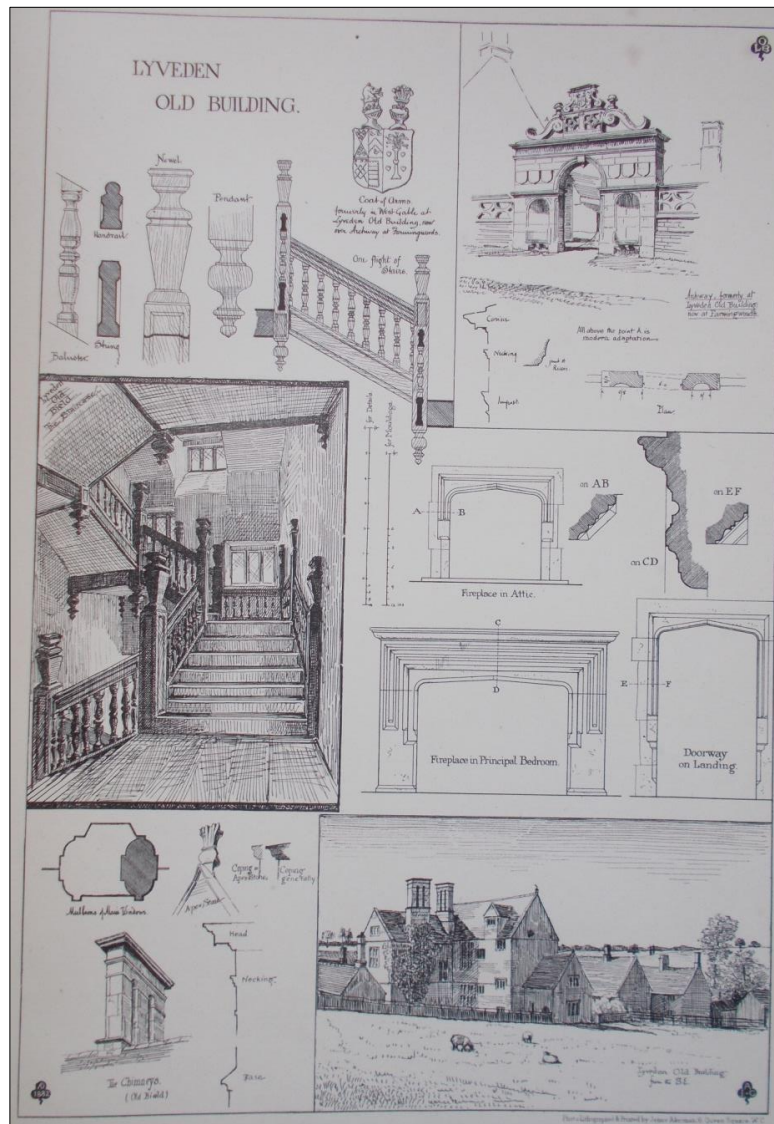
Fig 9: The plate showing the Old Build from Gotch 1883.

From left, Gotch shows the single storey east-west range with another building further to the west behind it. The south range appears to be as it survives today although there is no indication of the two light window at the north end of the east wall close to the junction with the north range; this may in fact be due to the presence of a fence line which obscures the lower part of that wall rather than an actual change.

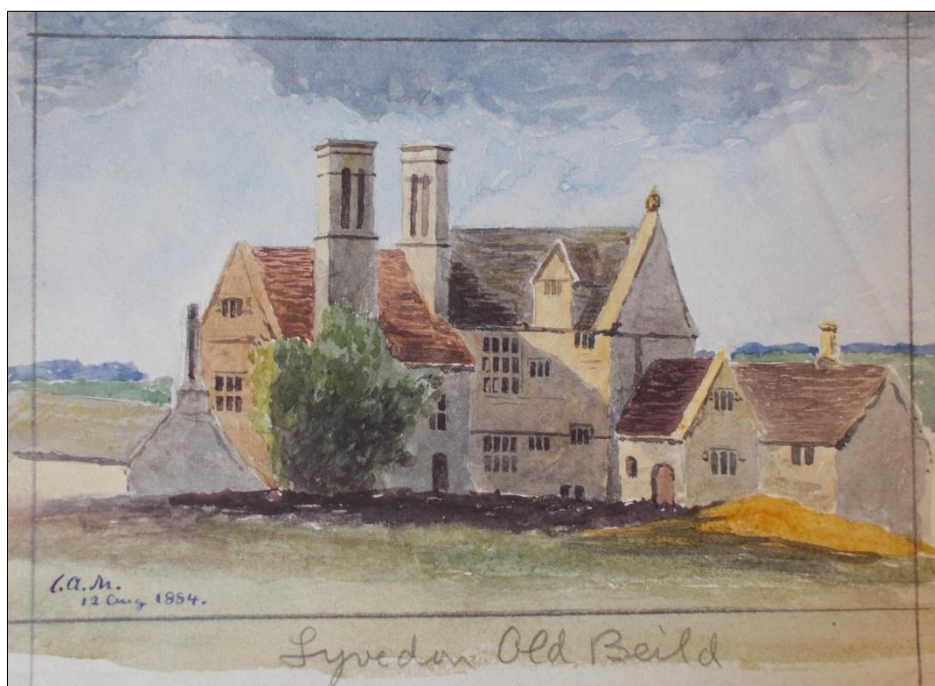
Fig 10: 1884 watercolour by C A Markham looking north-west (NRO: CAM 993).

The main building appears to be essentially the same as in the Gotch engraving (Fig 9) and much as it remains today (Fig 11). However, the Markham watercolour shows what appear to be two windows set very low down in the wall on the south side of the staircase hall. If correct their position implies cellar windows since their lintels lie well below the level of the sill of the large eight-light window to the west (see also reference to 'underground passage' in 1957 sale catalogue, below). Otherwise the view shows the same detail as Gotch but does not include the northernmost of the two ranges on the north side of the main building.

In both of these views the most significant losses are the replacement of the single storey building against the east gable wall by the modern three storey addition and the detached northern ranges.

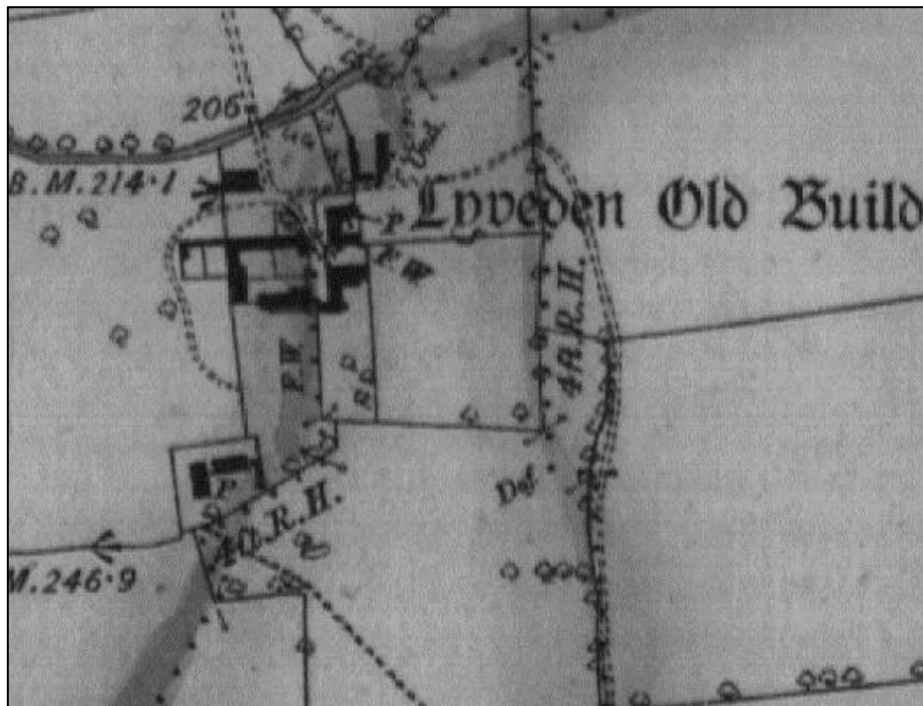
Fig 12: The 1880s Ordnance Survey map (18 SE) showing the Old Build complex. This layout was unchanged into the 1950s.

The first Ordnance Survey map appeared in the early 1880s and shows a complex of buildings significantly more extensive than that which remains today (Fig 12).

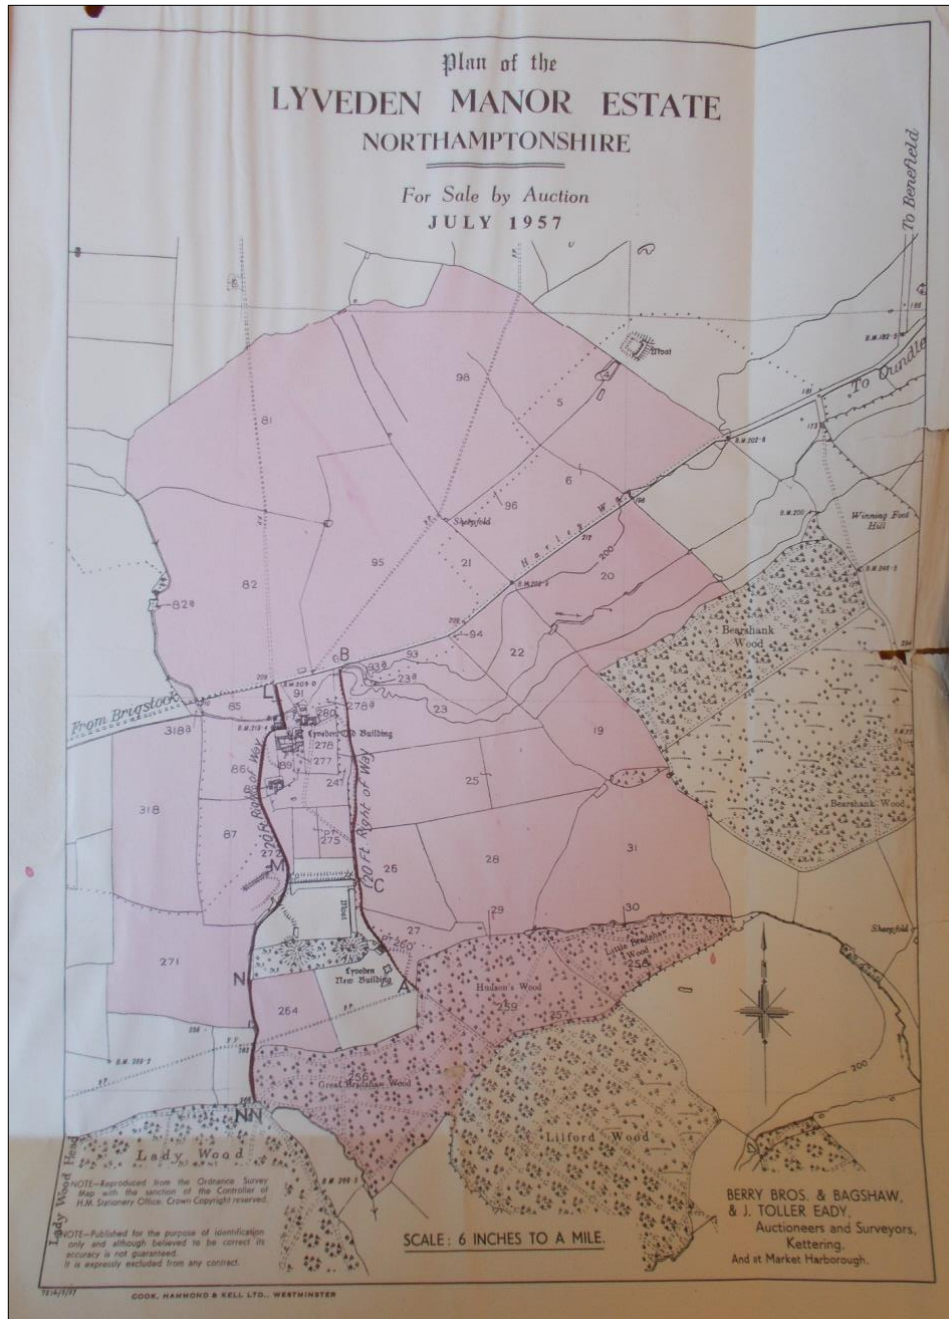
Fig 13: The plan attached to the 1957 sale catalogue showing extent of property for sale.

Note that the New Build and the area of land around it, including the Moated Orchard, is not included since this had been acquired by the National Trust in 1922.

(divided into two cottages) four bungalow cottages and an ample range of farm buildings along with just over 624 acres. It was to be sold by Berry Bros and Bagshaw and J Toller Eady at the George Hotel, Kettering on Friday 12 July 1957 on behalf of Ian Irvine Boswell of Crawley Grange, Buckinghamshire (Fig 13). It is not known when Boswell purchased the Old Build but notes that the New Build is owned by the National Trust.

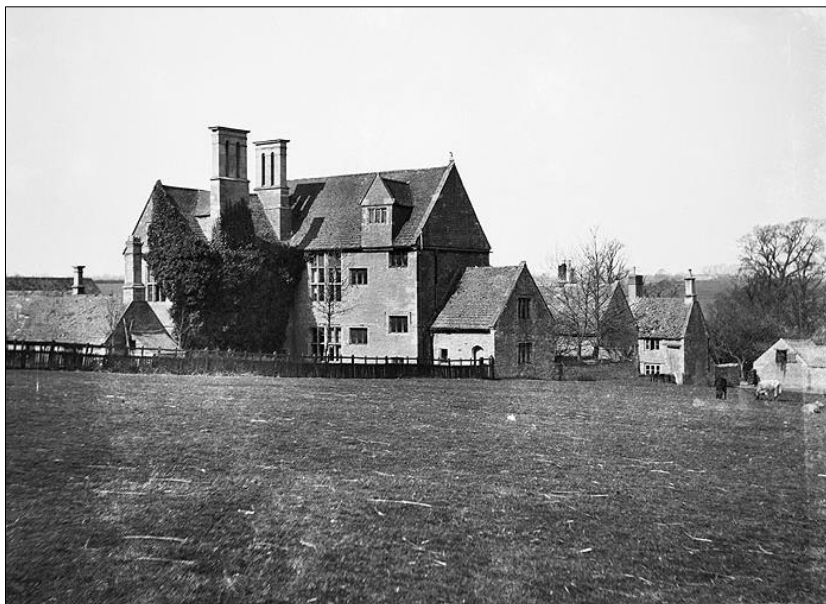
Fig 15: The house looking north-west, 1907. HEA image bb44\_01106.

A view of the house and ancillary buildings to the north, looking northwest across a pasture field (Fig 15).

Beyond lies a detached building which looks like a barn. It has a gable facing south with a second range aligned east-west at the southern end. At first floor level of the south gable a hayloft door is open suggesting the storage of fodder. No other detail can be observed.

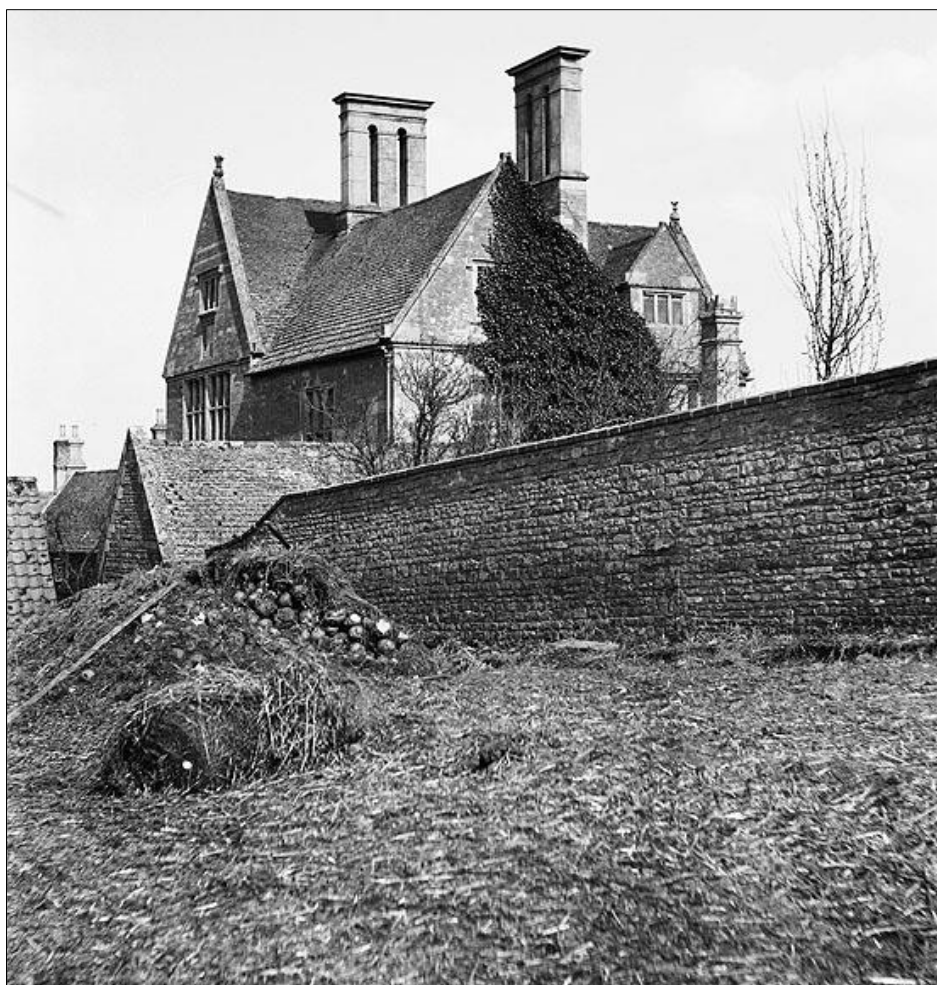
Fig 16: The house looking north-east. HEA image bb44\_01108.

Due to the angle from which the image is taken only the upper floors of the main house can be seen (behind a terrace wall which has since been demolished). On the west gable ridge the decorative finial is present at this date; it had gone by 1947 (see Figs 18 and 19). The middle window at first floor level is not present at this date. Much of the south gable wall of the south range is obscured by ivy growth even to the extent that the window in the attic level is only just visible. The south side of the staircase hall wall is partly visible and it can just be seen that the top three-light window in the dormer is fitted with leaded lights of small diamond panes.

In the foreground there is a winter earth clamp of root vegetables, possibly turnips or mangel wurzels for use as animal feed (OED 1950- Mangel wurzel: A variety of beet, with a root larger than the garden beet, cultivated as a food for cattle).

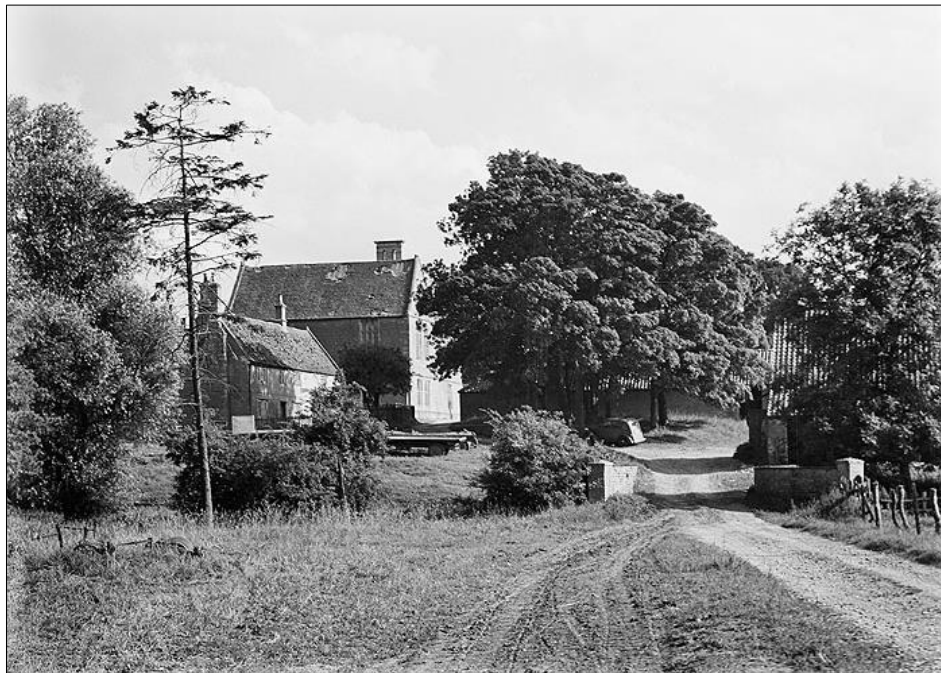
Fig 17: The house and other buildings, looking south. HEA image aa48\_03663.

This image shows a large number of now lost buildings though the view is much obscured by trees. Of the main house little detail can be observed apart from the roof which is better seen in image aa48\_03664 (see Fig 18).

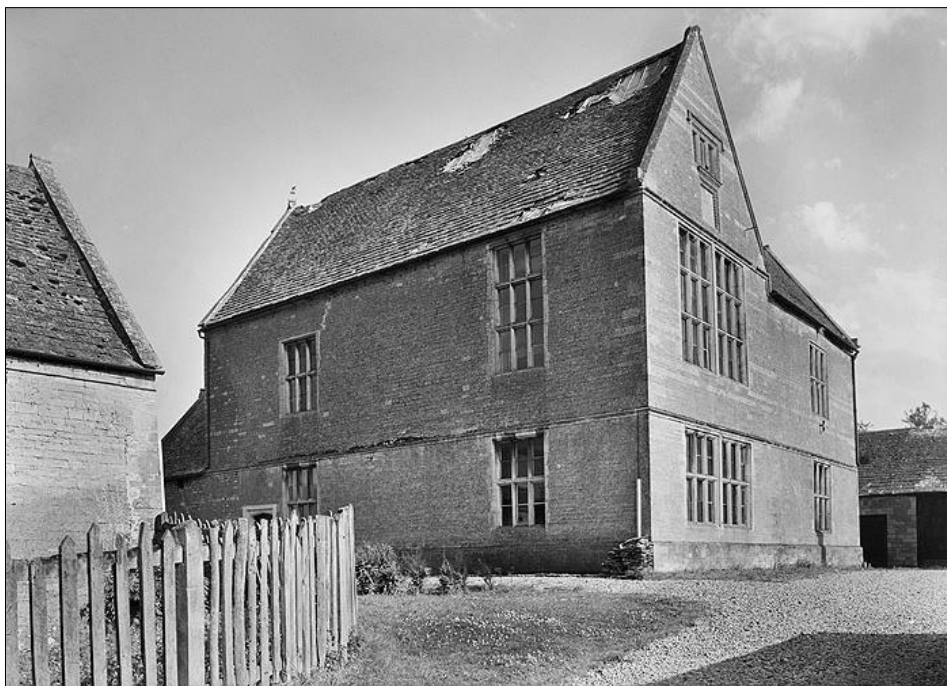
Fig 18: The house looking south-east in 1947. HEA image number aa48\_03664.

At the east end of the north range the roof of the single storey (with attic) building can be seen but no other detail can be observed.

In the west elevation at ground floor level there is no change to what can be observed today but at first floor it can be seen that the four-light window situated between the large great chamber window and that to the south has not yet been inserted. It is assumed that this window was created

to light the 'back stairs' in the south range after the removal of the principal staircase to allow more light to those secondary stairs since they became the only form of access to the upper floors. There is something attached to the wall between the south ground and first floor windows but the detail is insufficient to determine what that object is. The decorative finial on the west gable ridge is missing, whilst one is present on the east gable ridge.

The condition of the roof of the main house is poor, with patches of Collyweston slate missing, the losses covered with what appears to be roofing felt held down by battens.

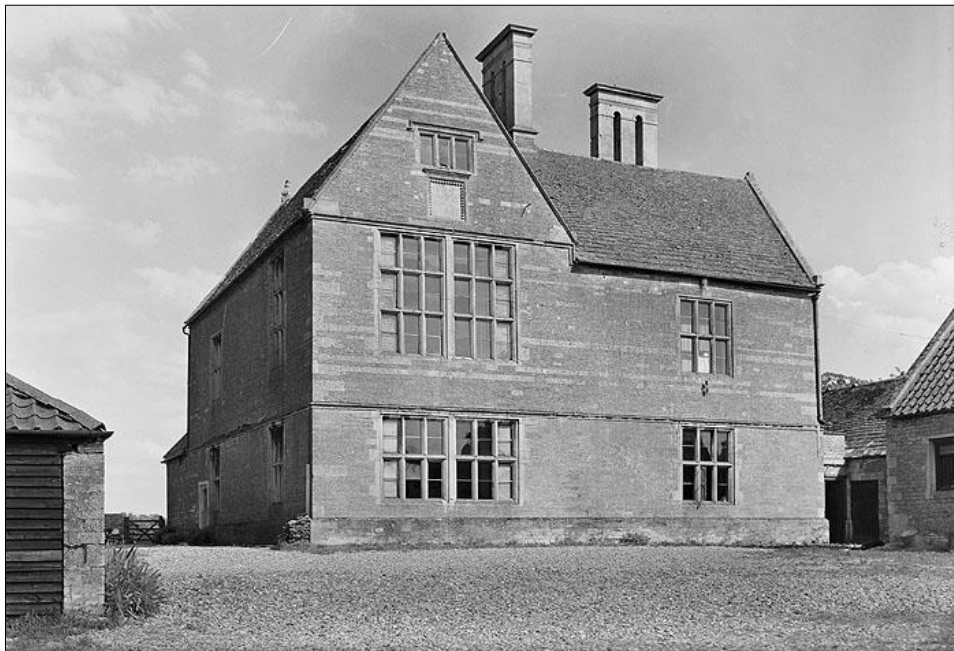
Fig 19: The house looking east-south-east in 1947. HEA image aa48\_03665.

The single storey south service range shows that the eastern end has a lower roof line than the western section and that the covering is of different materials. The east end has Collyweston stone slate whilst the western has clay pan tiles. There is a coped gable between the two roof lines. The western section also projects slightly to the north and in this image conceals the full height cart door of the eastern end as well as containing a window with a slatted lower part and a glazed upper part. This might suggest that it was a stable, as slatted windows are commonly found in such buildings for ventilation and to prevent the horses from damaging themselves on the glazed sections. A probably flat-roofed link connects the service range to the south gable wall of the south range.

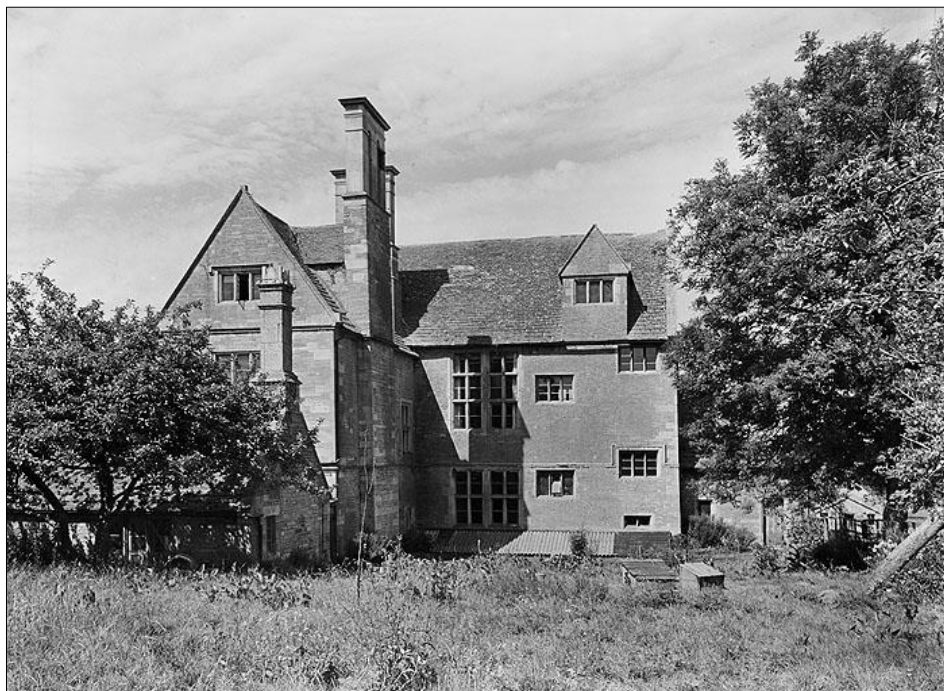
Fig 20: The house looking almost due north. HEA image aa48\_03666.

On the ground floor the store, reputed (without evidence) to have been a chapel, has been replaced by the modern three storey addition on the east end of the Old Build. The staircase hall, described as 'entrance hall' in the catalogue remains, although now furnished with a reproduction of the original staircase based on measurements taken from the original. It is unclear where the bathroom and WC were located. Curiously, none of the measurements given for either the sitting room or dining room can be reconciled with the present measurements of either of the two ground floor rooms which currently contain stone fireplaces, but can broadly be equated with the illustration included in another (1996) description of the building (Heward and Taylor 1996, fig 367). In their plan of the ground floor as surveyed, the now large single room which occupies the west end of the north range is divided into two with a corridor located on the north side of the eastern room leading from the staircase hall. Presumably the kitchen and larder were located within the south range although if this is the case, where was the dining room described as also having a stone fireplace? This fits better with the 'scullery and cellar reached via a 'covered way' perhaps an earlier incarnation of the linking structure positioned against the south gable wall of the south range. Perhaps the most curious description is of the 'Conservatory, recently converted from underground passage'. This appears to have been located against the south wall of the north range where a long horizontal flaunching scar, filled sockets for joists as well as an angled flaunching scar on the east wall of the south range can still be seen (see below). If it was formerly an underground passage the question arises, where did it lead? Was it to the possible cellar windows indicated on the 1884 watercolour which suggests a cellar beneath the staircase hall? The roof of the passage can be seen in a 1947 photograph (Fig 20).

The heavy ivy growth visible in the 1907 images has been cleared and the walls are now clearly visible. The south gable wall of the south range shows that it remains the same today and no changes can be observed.

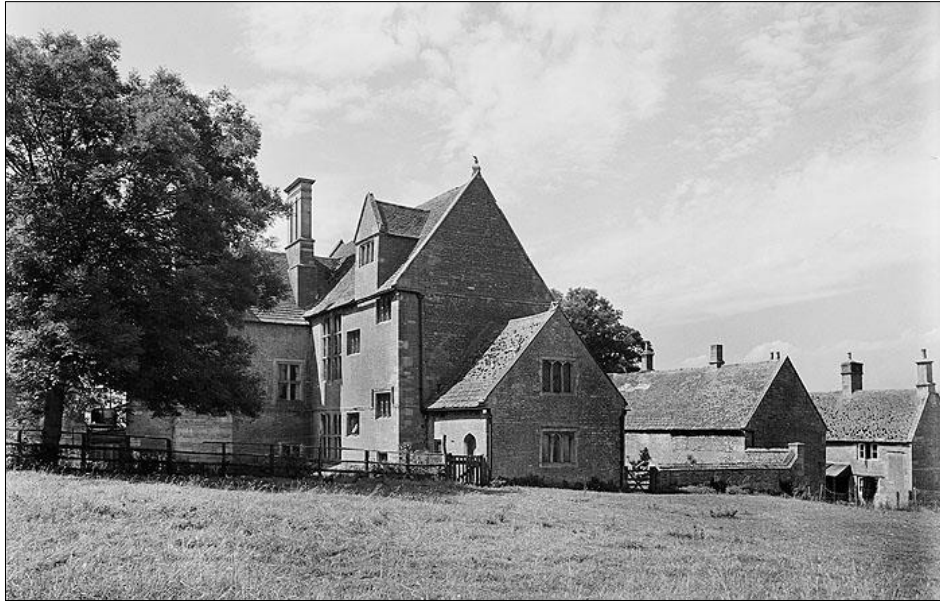
Fig 21: The main house looking north-west. HEA image aa48\_03667.

A similar viewpoint to the 1907 images, but of greater clarity. The house appears to be essentially unchanged but this image is taken from a slightly closer viewpoint and the earlier picket fence has been replaced by a post and rail example. This allows more of the lower part of the house walls to be seen and the low, sloping, roof of the underground passage can just be seen in this image. Unfortunately just at the point where it abuts the east elevation of the south range there is some vegetation so the junction between the two cannot be seen.

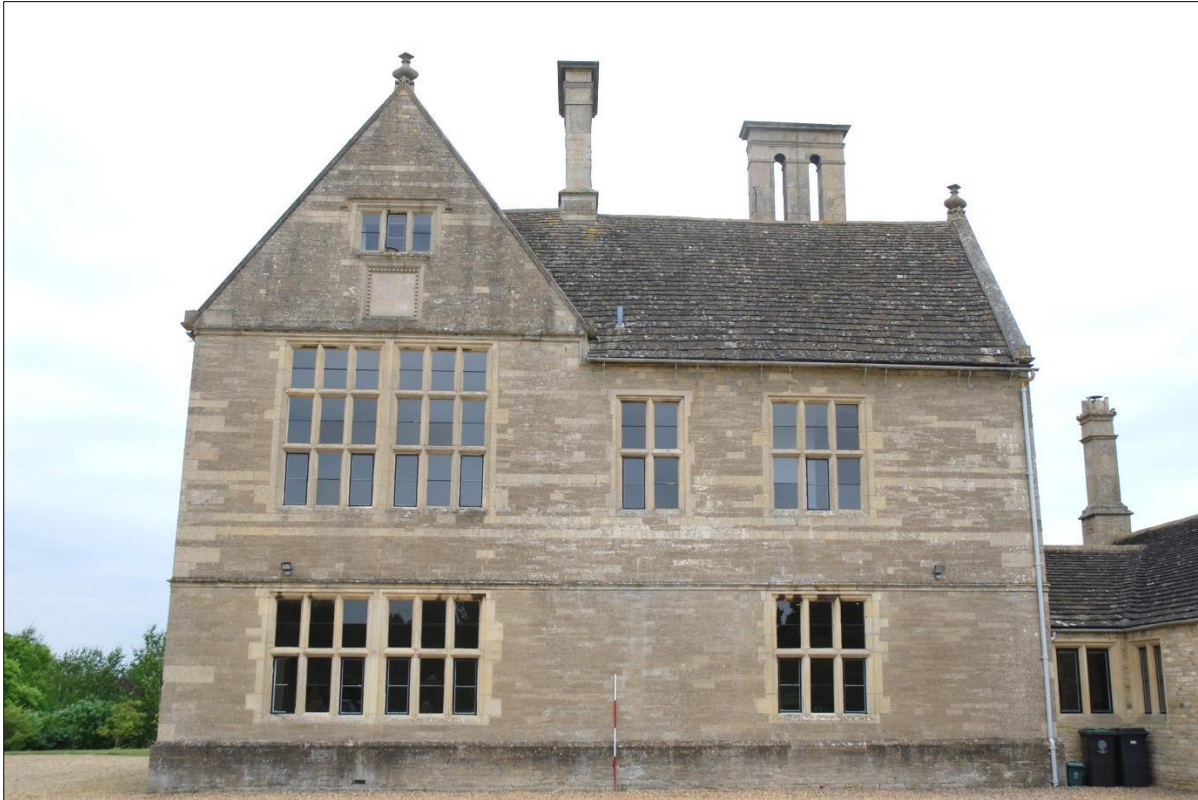
Fig 22: The west elevation. 2m scale.

Constructed of finely dressed limestone with occasional large quoins at both the north and south corners, the quality of the stonework is particularly fine (Fig 22). All of the stones are crisply cut with sharp arrisses and the mortar joints between the individual blocks being often no more than 1-2mm. It is likely that some of the larger quoins might be some of those described by Sir Thomas in his 1604 letter to George Levens (see above) in which he requests two and three feet long quoins for the New Build. Measurement of some of the quoins shows them to be exactly three feet long. It is possible that these were carved, but never used, for the New Build and so made their way into this building when it was constructed by his second son, Lewis Tresham. It is also possible that the quoins, if re-used from the stone cut for the New Build, retain a religious connotation (see below, Discussion). The whole elevation is set upon a simple chamfered plinth of surprising plainness.

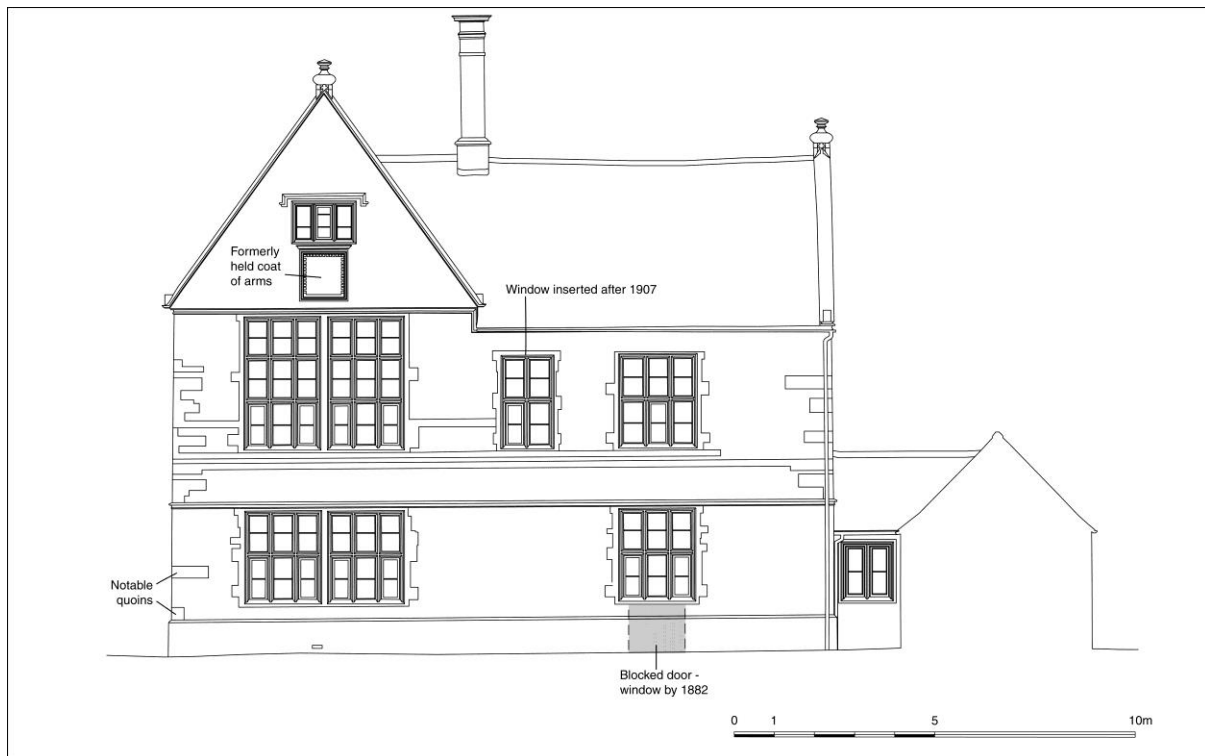
Fig 24: West elevation drawing showing alterations (Andy Isham).

To the south, in the west wall of the south range there is a further window of the same moulding and comprising six lights. The glazing is identical to that in the window previously described. This window was inserted after 1847 but before 1882 when it is present on the photograph of that date (see Figs 5, 7 and 24). It replaced an earlier door shown on the 1847 Clark drawing, the width of which can be seen in the stonework beneath the present window. Prior to the replacement of the door by the window the room within the south range must have been particularly dark since there is no indication of any other windows at all lighting that space. The only possibility is that the opening in the south gable wall, now a doorway, was formerly a window. Since both the internal, and formerly external, surfaces are currently covered by plaster it is not possible to clarify this.

Between the ground and first floor is a continuous string course of a similar moulding as that commonly used on hood moulds. Apart from some sections of obvious repair and chopping-out for former vertical features such as rainwater goods this remains largely intact.

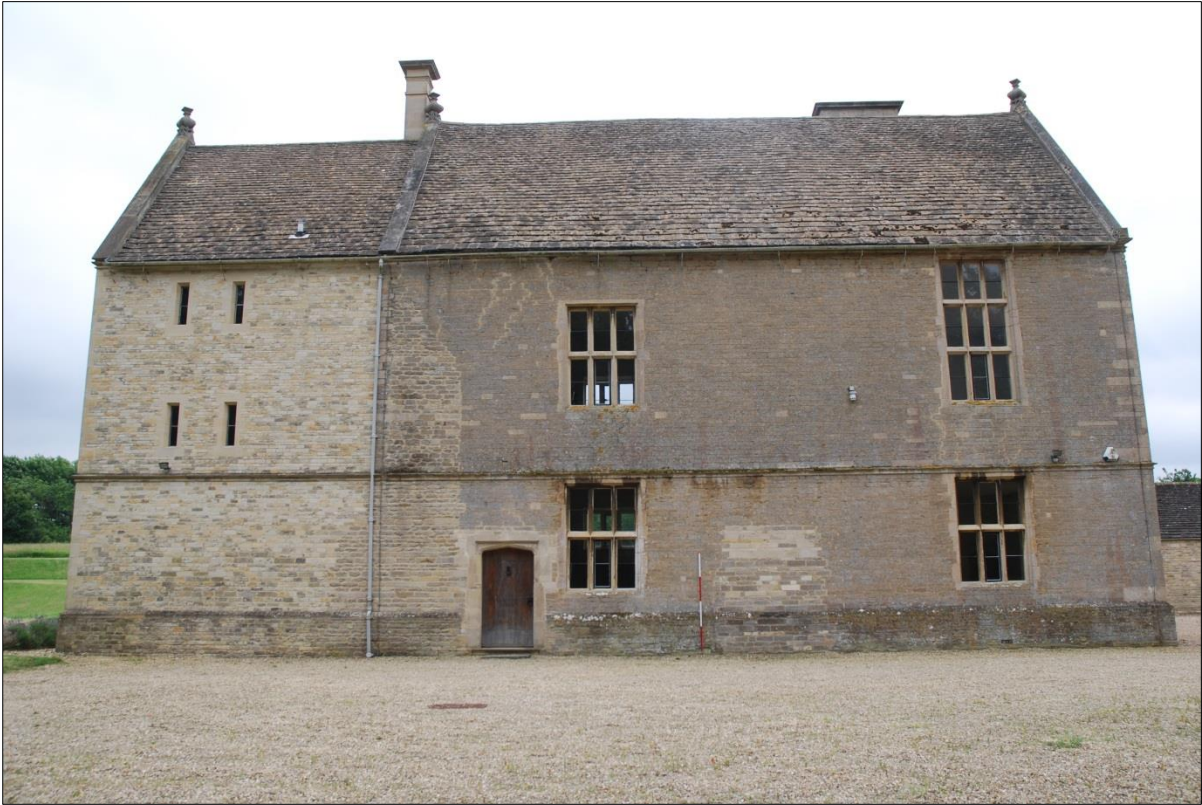
Fig 25: The north elevation. 2m scale.

Constructed of coursed dressed limestone above a plinth which continues at the same level as, and with the same profile, that on the west elevation (Fig 25). The stonework, whilst good, is certainly not of the same quality as that used on the more prominent west front, this can be most clearly observed from the north-west when viewing that corner so that both wall surfaces can be seen together. The mortar courses on this elevation are wider than those on the west elevation. The separation of the ground and first floor is defined by the string course used on the west elevation. Where the upper string course in the west gable continues onto this elevation it is positioned directly beneath the eaves.

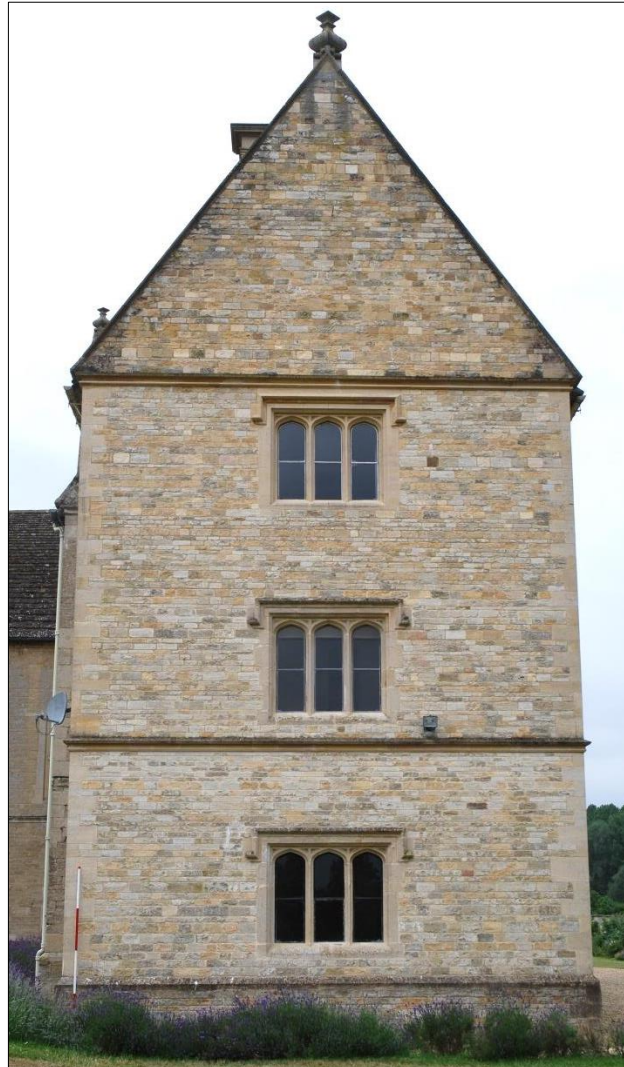
Fig 28: The east gable elevation. 2m scale.

The two sets of three-light arched-head windows with hood moulds were re-set into the present extension. Each has cavetto-moulded mullions with an external ogee moulding continuing the moulding to the external wall plane as is present on the north range ground floor windows (Fig 28). These appear to be the only surviving elements of its demolished predecessor.

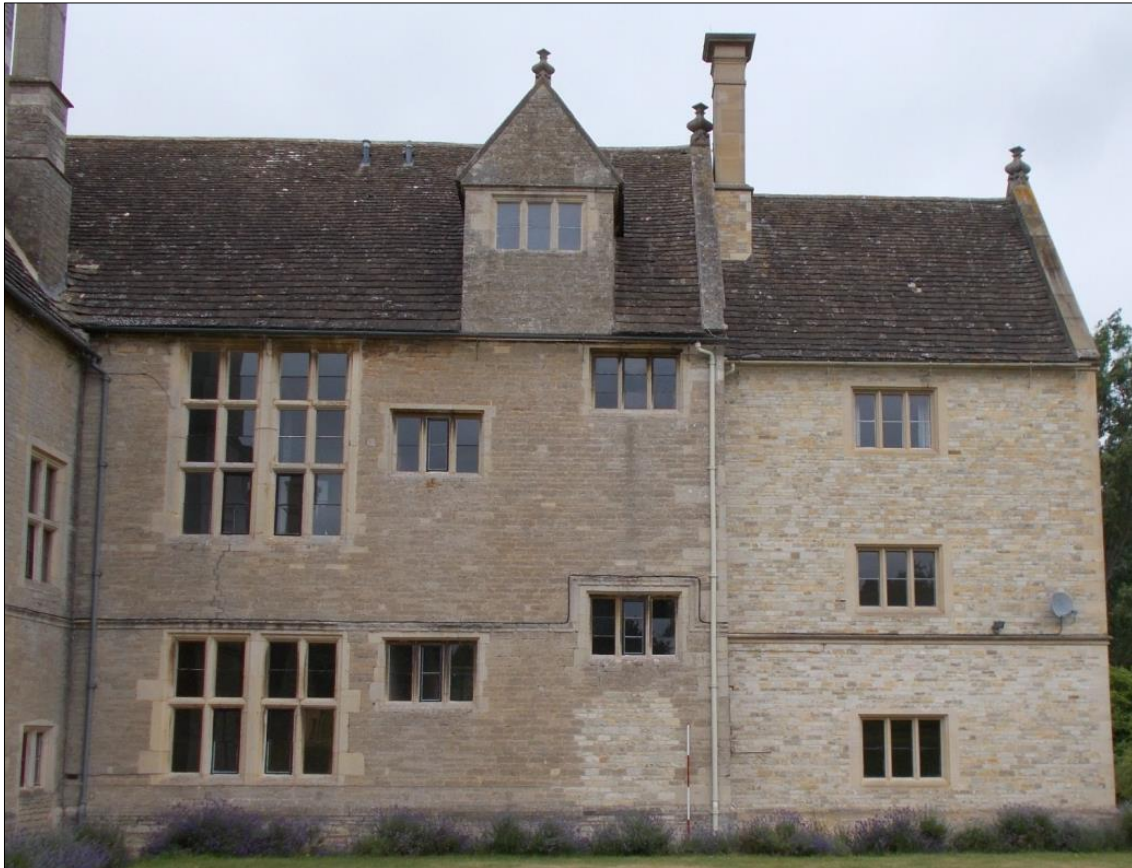
Fig 29: The south elevation. 2m scale.

Constructed of the same materials, prepared and laid in the same way as the north elevation, this face of the building contains the same elements, but configured in a different way (Fig 29). This includes the plinth and two levels of strings courses along with a combination of cavetto and ovolo moulded window lights of the same profiles as those previously recorded.

The eastern end of this range contained the three storey oak staircase which is now in America but which has recently been replaced by a modern copy. Four three-light windows formerly lit, and now again light, the various quarter landings of the open-well staircase. Each has cavetto moulded mullions and the lights are currently fitted with two panes each of plate glass. The Gotch drawing of the staircase from the interior shows them to be glazed with diamond panes, this same configuration can be seen on the 1947 HEA photograph (Figs 9 and 20). Above the level of the eaves a stone dormer with a further three-light window provides further light to the top flights. Interestingly, the mouldings of the dormer mullions are ovolo perhaps suggesting that it was a later addition. It was certainly present in 1883 when Gotch drew the interior of the staircase.

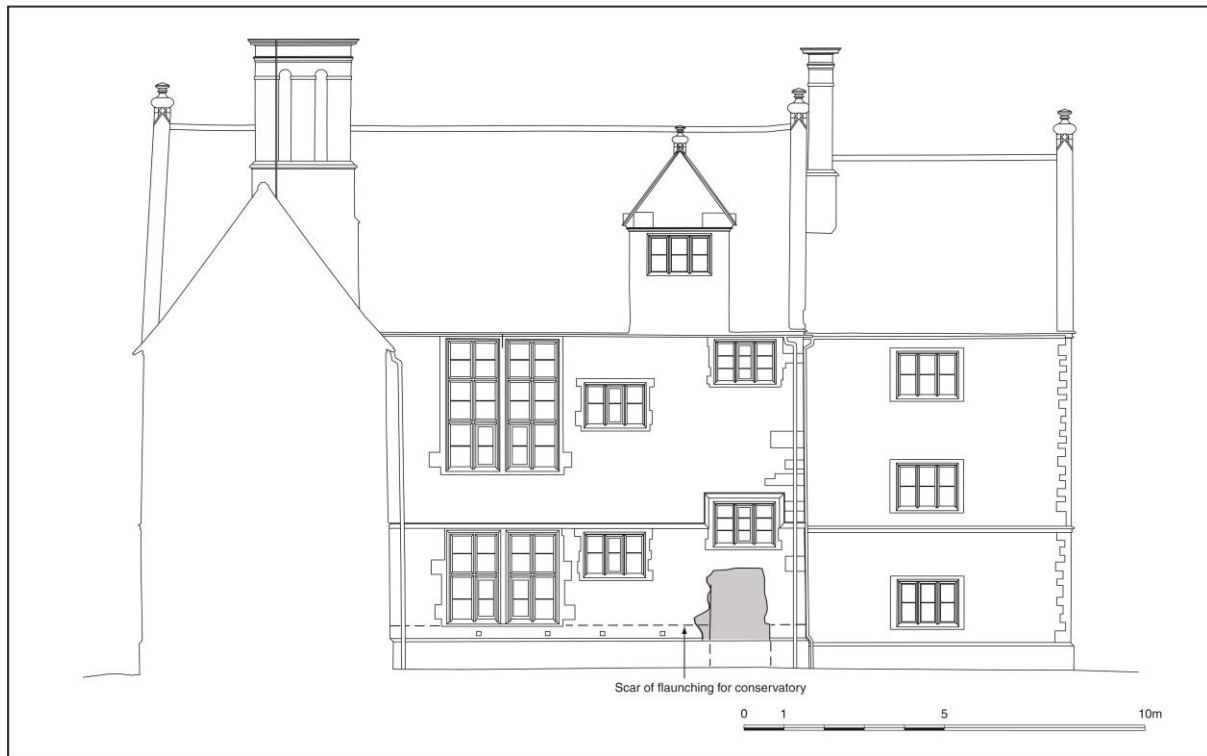
Fig 30: South elevation drawing showing alterations (Andy Isham)

Immediately below the ground floor parlour window, and extending almost the entire length of the south elevation as far as the original south-east corner, is a band of hard grey cement infilling a widened mortar course (Fig 30).

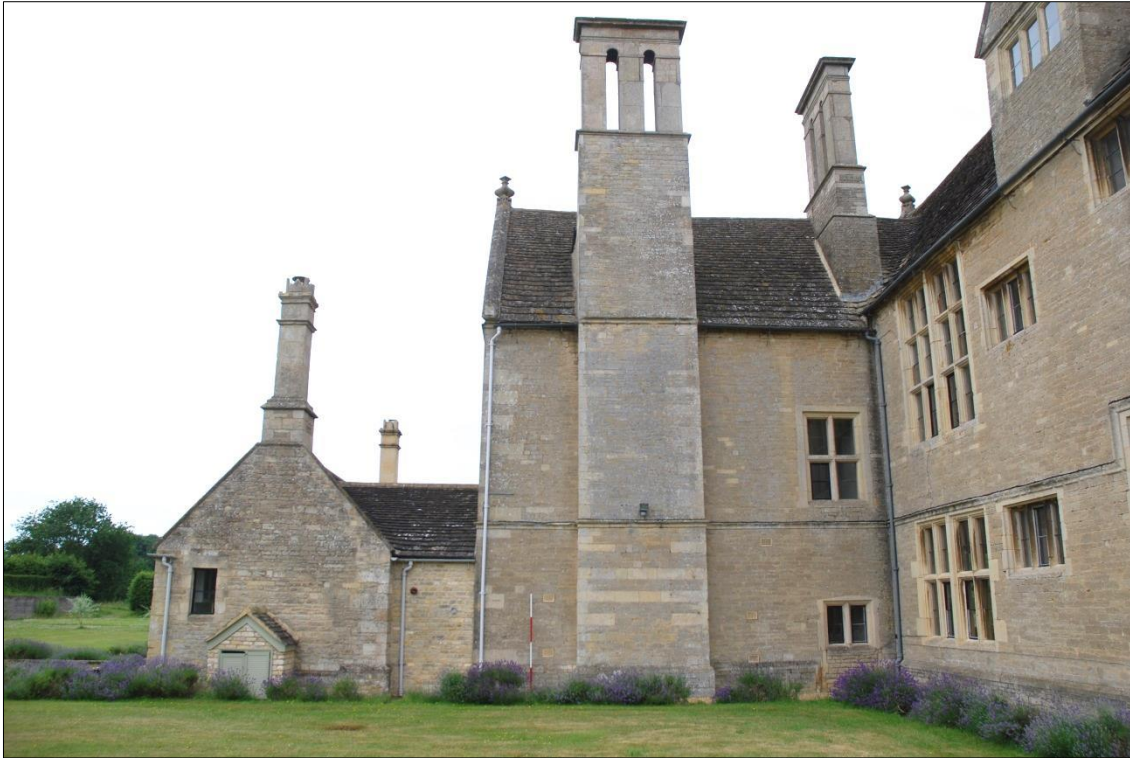
Fig 31: The east elevation of the south range. 2m scale.

round arches below the necking and capping. There are only two windows in the flanking elevation, both tucked into the re-entrant angle between the south and north ranges.
