## Lyveden Old Build – an archaeological appraisal of the building and its former built environs

Joe Prentice and Iain Soden

## **Lyveden Old Build – an archaeological appraisal of the building and its former built environs**

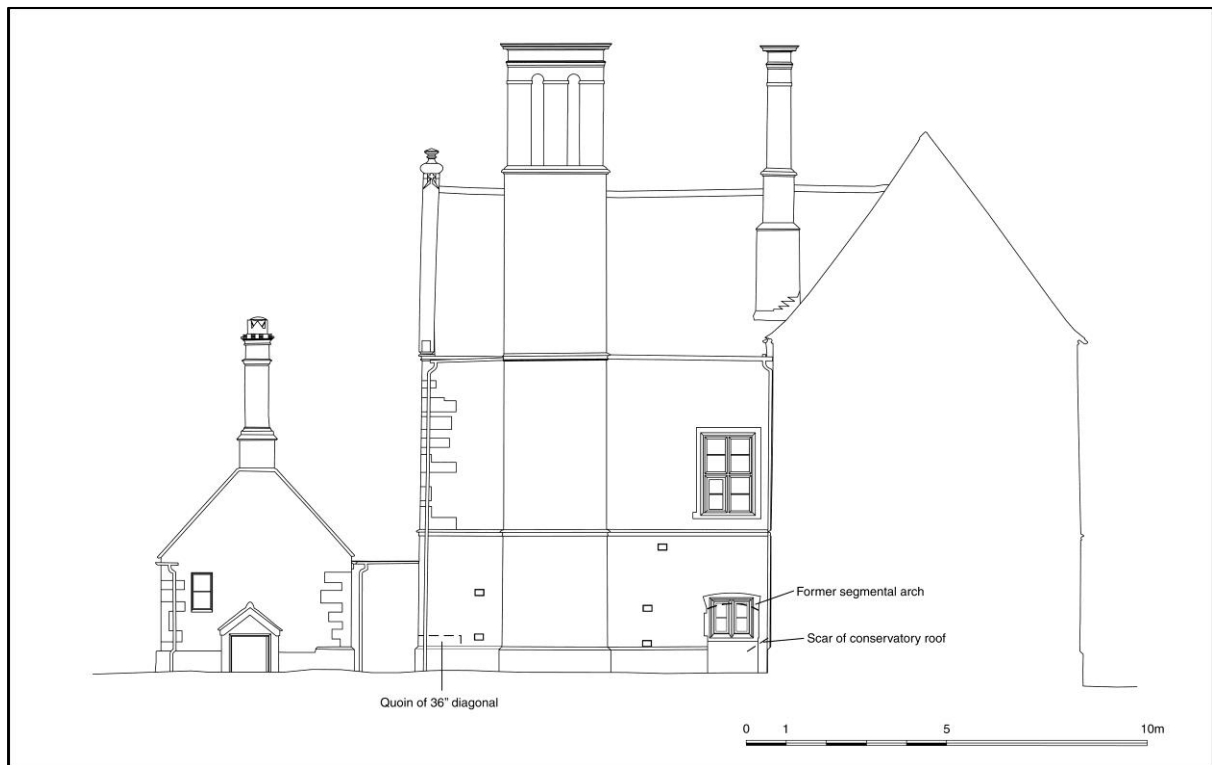
Fig 32: Drawing of east elevation of the south range showing alterations (Andy Isham).

On the north side of the blocked doorway, above plinth level, is a narrow remnant of hard grey cement flaunching which must relate to the conservatory roof line constructed from the underground passage mentioned in the 1957 sale catalogue (Fig 32). The angle of the flaunching suggests that the former roof line projected no further than the south side of the former doorway, now a window.

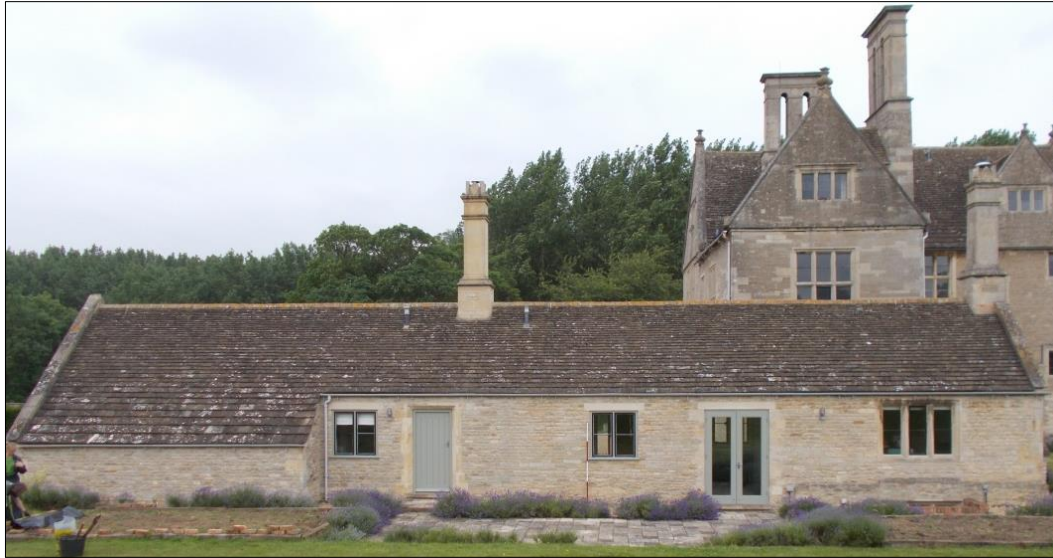
Fig 33: The south gable wall of the south range with single story range to foreground. 2m scale.

The ground floor section of the gable wall is now obscured by the short link which connects the single storey south service range to the south range (Fig 33). It is assumed that the stonework of that obscured section would have been the same as the section above which can still be observed. It is the same as that on the west elevation i.e. made of finely cut rectangular blocks with fine mortar joints rather than the coursed dressed stonework in coarser mortar courses of the remaining elevations. Again, the distinction between the south and east elevations of this range can most clearly be seen when the two elevations are observed together from the south-east corner.

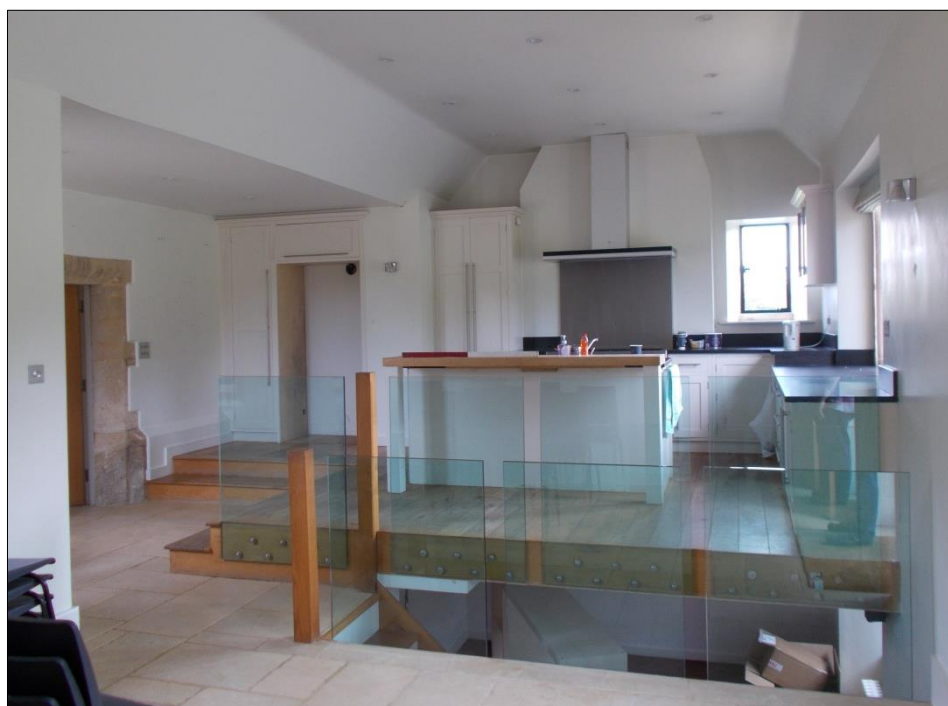
Fig 35: Room G1 looking east. Note stairs in foreground leading down to B1; scale 1m.

Occupying the eastern end of the nineteenth-century single storey range this space has been entirely re-furnished during the twenty-first century alterations (Figs 27 and 35). On the north side of the room the doorway leading into the ground floor room of the south range of the main building has had the limestone quoins and lintel of the doorcase exposed along with part of the plinth for decorative purposes. A three-light mullioned window lights the room on the south side with a single window in the east gable wall. The chimney stack is visible as a projecting section of wall surface but retains no visible fireplace opening. All wall and ceiling surfaces are covered with modern plaster and painted; the floor is of modern stone slabs. No other details are visible.

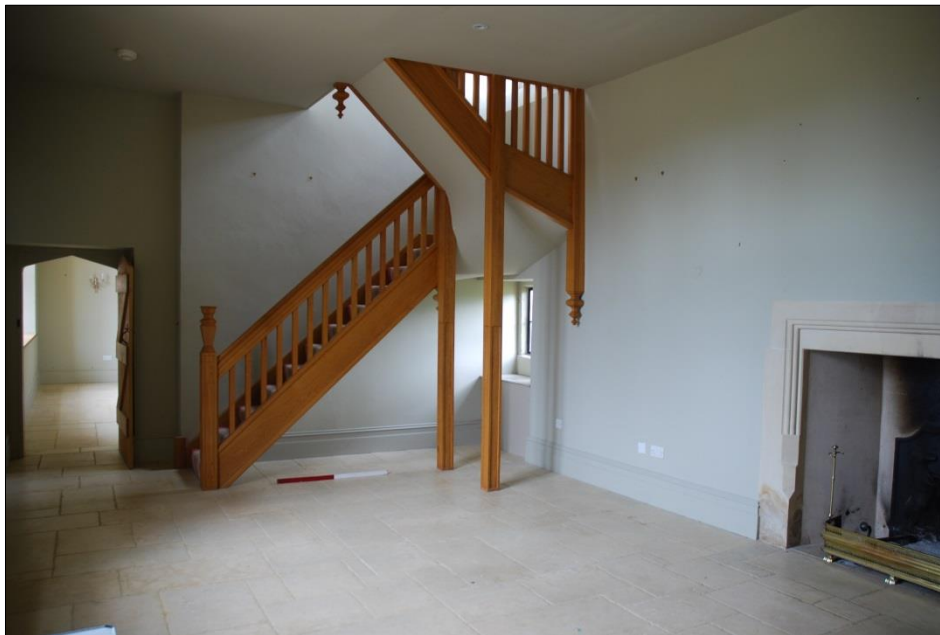
Fig 36: Room G3 looking north-east; scale 1m.

The east wall contains a modern stone fireplace and against the north wall is a modern oak staircase adjacent to a door leading into G4 (Fig 36). It is not known if the present staircase is a replica of the previous structure or is an entirely modern interpretation.

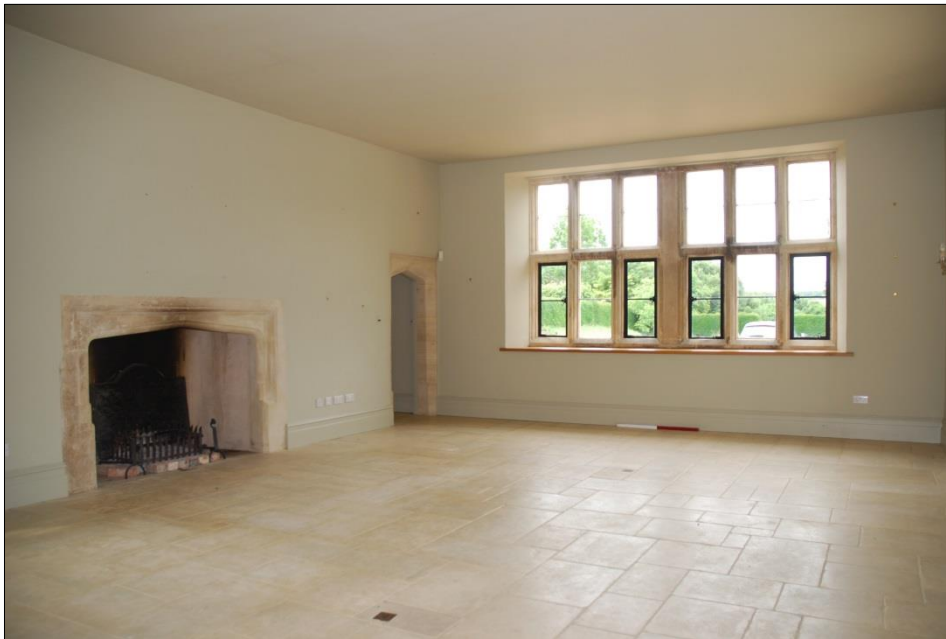
Fig 37: Room G4 looking south-west; scale1m

The south wall contains a partly re-made and re-set fireplace, on the 1996 plan it is shown located further to the west due to the presence of a dividing wall which separated the space into three (see Fig 27 for previous layout). The left-hand side of the fireplace is original stonework and there is a mason's mark on the lintel. This is identical to those on the jambs of the doorcases leading into this room and the room above from the staircase hall (see below, Fig 39).

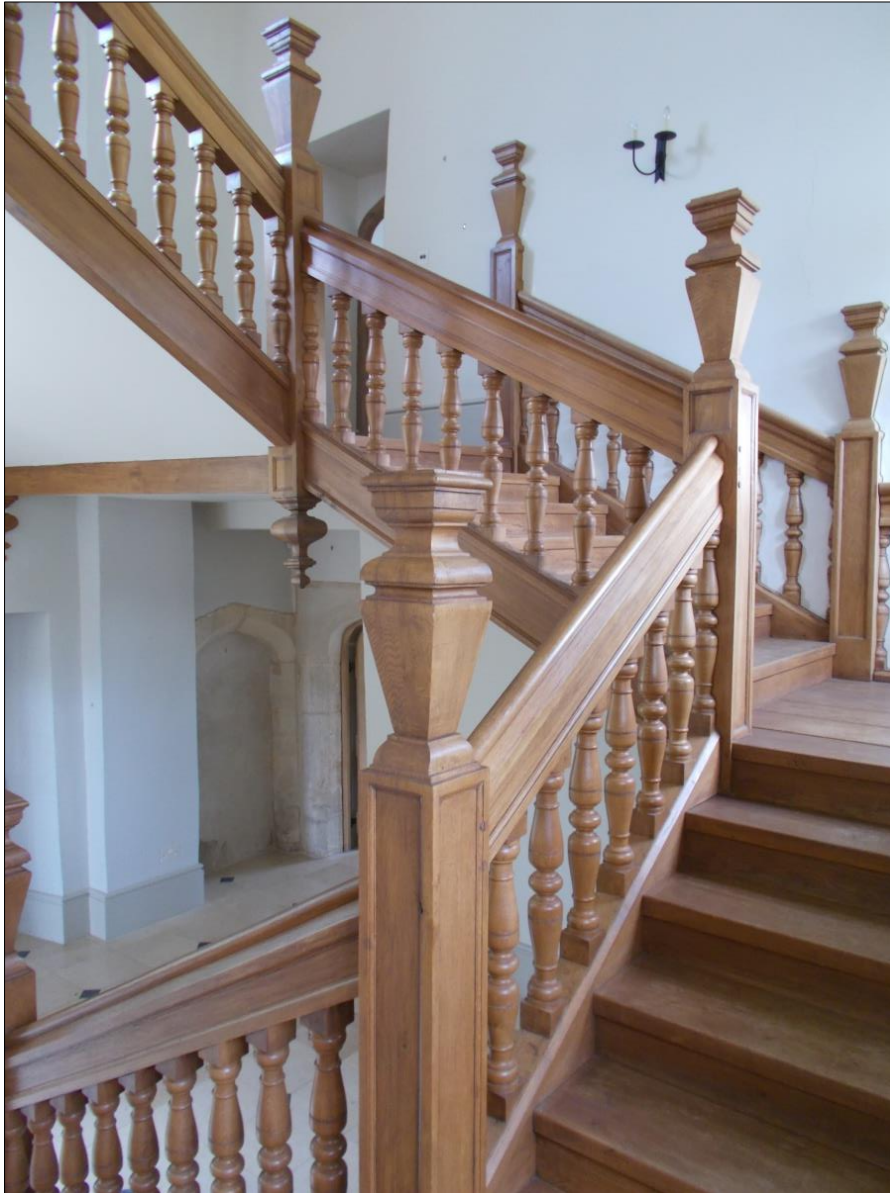
Fig 38: Room G5, the staircase hall looking north-east from the first quarter landing.

Roughly square in plan this space rises to occupy the full height of the east end of the north range and is now filled by a faithful modern copy in oak of the original stair (Fig 38).

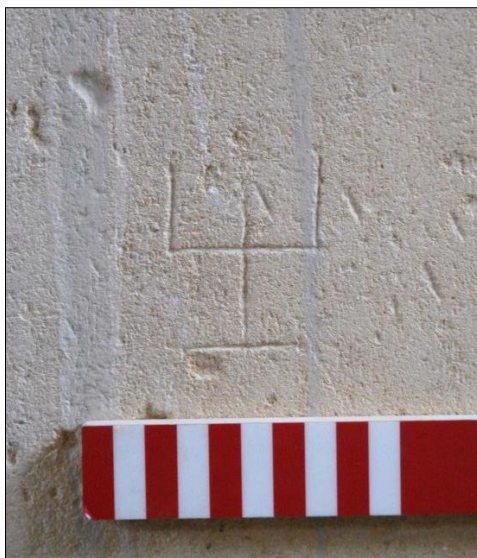
Fig 39: The mason's mark on the door-case leading from G5 into G4. Scale 1cm divisions.

On the south jamb of the door-case leading into room G4 is a mason's mark (Fig 39). This is identical to that present on the original section of the fireplace surround in that room.

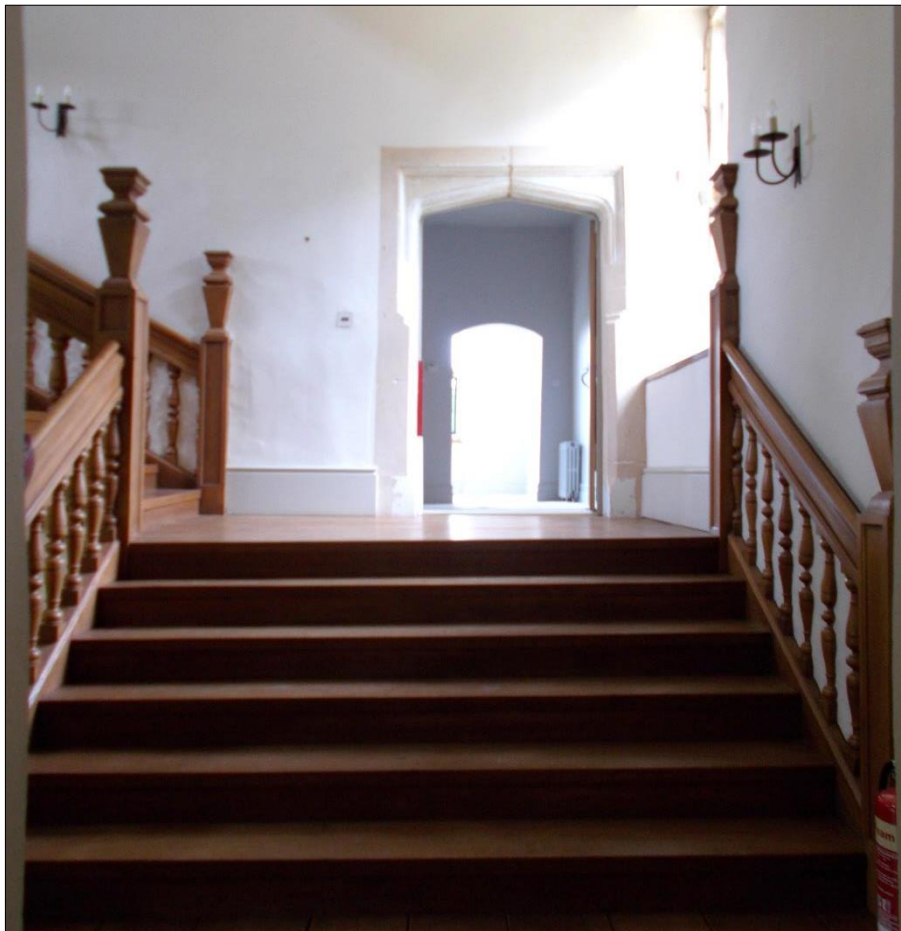
Fig 41: The wider staircase and landing leading to F1, looking west; scale 1m.

The staircase and landing at the first floor level are significantly wider than the staircase above or below, a deliberate widening to afford greater significance to the room to which it leads (Fig 41).

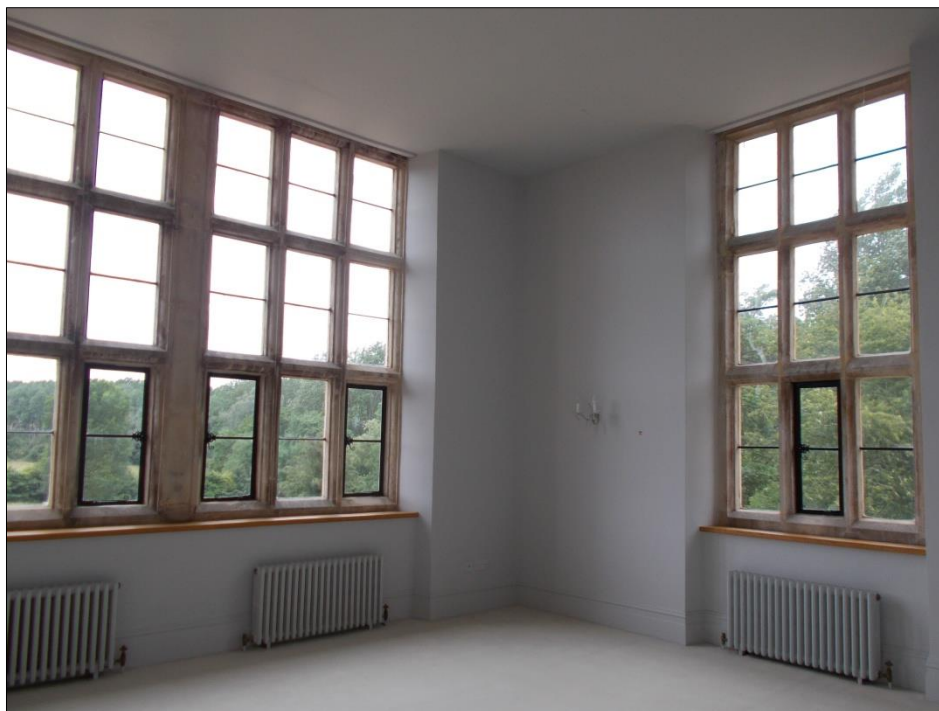
Fig 42: Room F4 with the west and north windows, looking north-west.

single window in the building present in the west wall, with a second close by in the north wall (Fig 42).

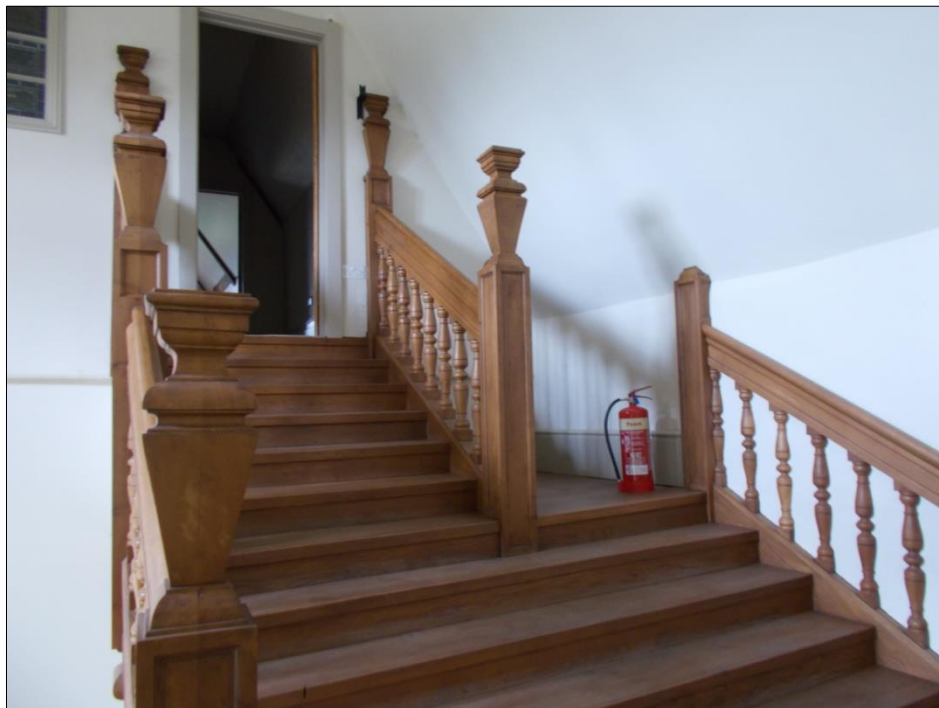
Fig 44: The second floor landing, looking west.

The upper landings of the staircase hall and access to the modern second floor rooms of the twenty-first century addition (S7, Figs 43 and 44).

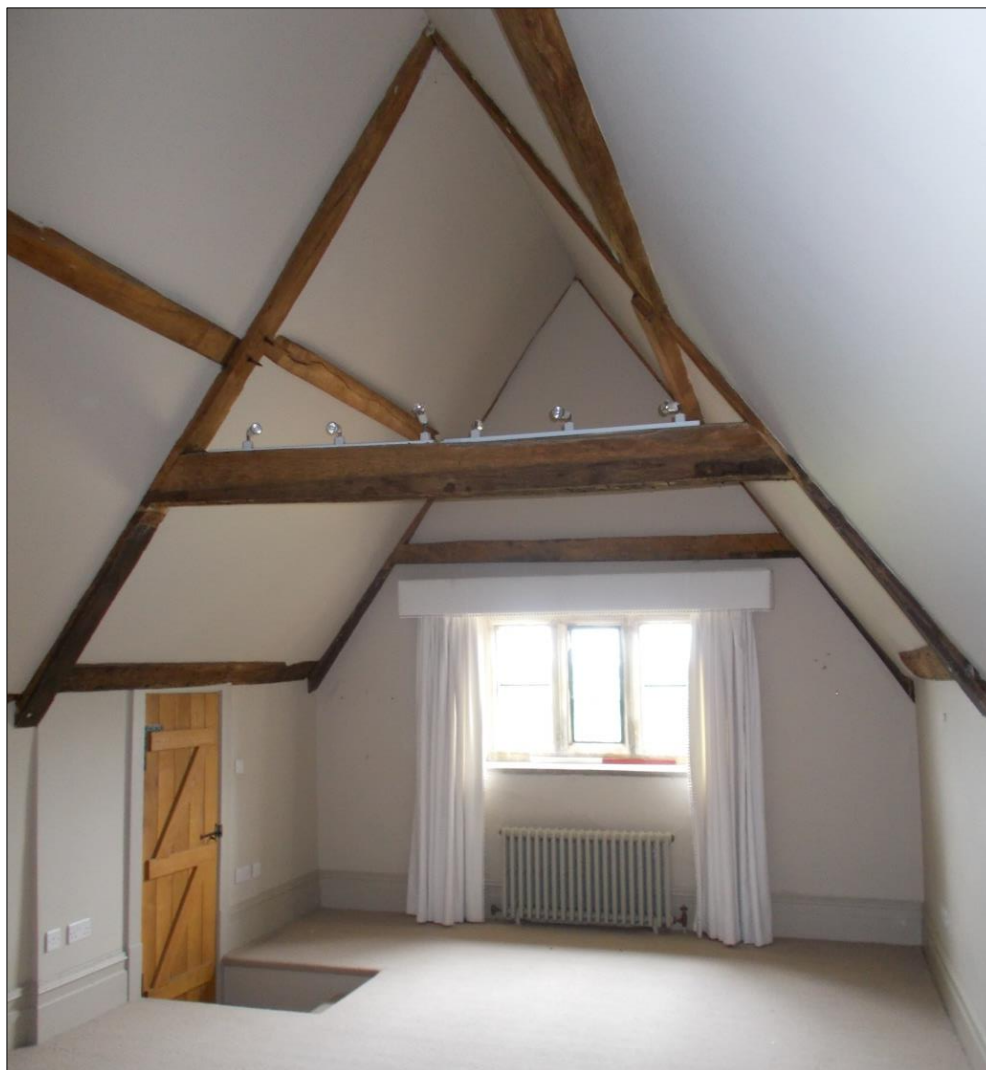
Fig 45: Room S4, looking west.

Beyond, in the western end of the north range is a bedroom lit by a window in the west gable wall (Figs 43 and 45).

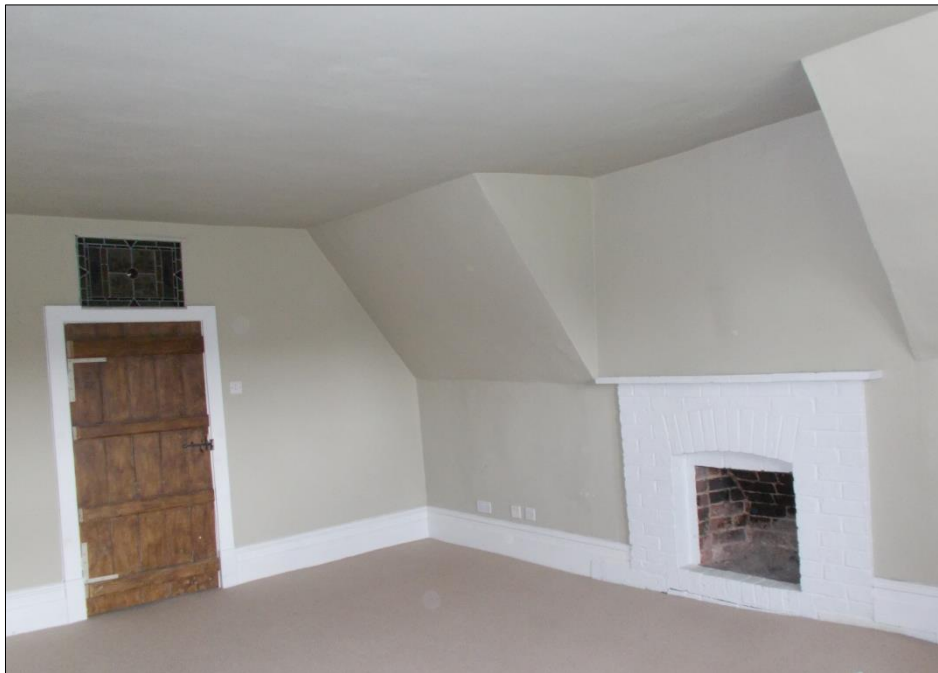
Fig 46: Room S6, looking north-east showing twenty-first fireplace and door to S5.

A bedroom occupying the majority of the south range attic (Fig 43). It is lit by a three-light window in the south gable wall and retains a fireplace against the east wall which is a twentieth-century replacement of the one illustrated in Gotch (1883, Figs 9 and 46).
