**Archaeological observations ahead of construction of
two houses on King Street, Maidford,
Northamptonshire**

Archaeological observations ahead of construction of two houses on King Street, Maidford, Northamptonshire

Summary

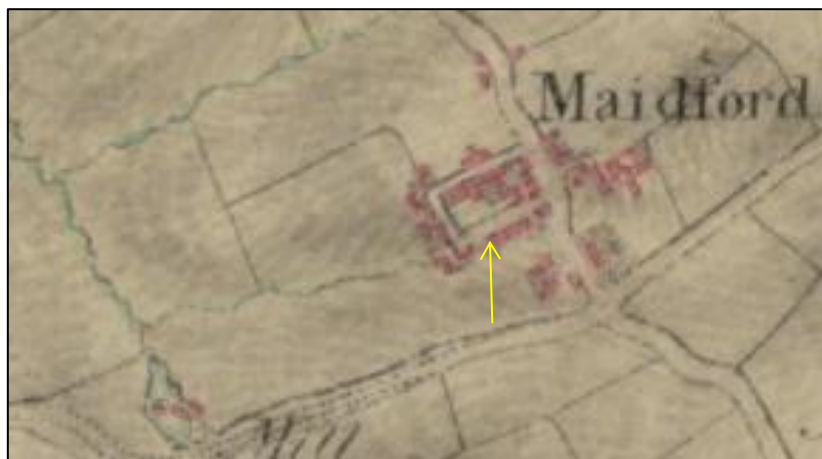
Fig 2: The village layout in 1810 (Ordnance Survey Surveyor's edition, sheet 228). Note the watermill site at bottom left. The current site location is arrowed although the frontage lacks detail.

Both historic maps consulted, the first edition Ordnance Survey of 1886 (1:2500 scale) and the foregoing 2-inch Ordnance Survey Surveyors map of c1810, suggest that the frontage of the application site contained a small cottage sitting directly onto King Street. On the 1950 Ordnance Survey, the previously-depicted frontage was still in existence (Sheet SP65). Demolition seems to have taken place in the 1950s or 1960s leaving an open-fronted site. On the 1886 map the outbuilding can also be noted, as can the larger houses to the east with their distinctive orientations and layouts (Westholme and Brook House), helping to locate the site exactly (Fig 4).

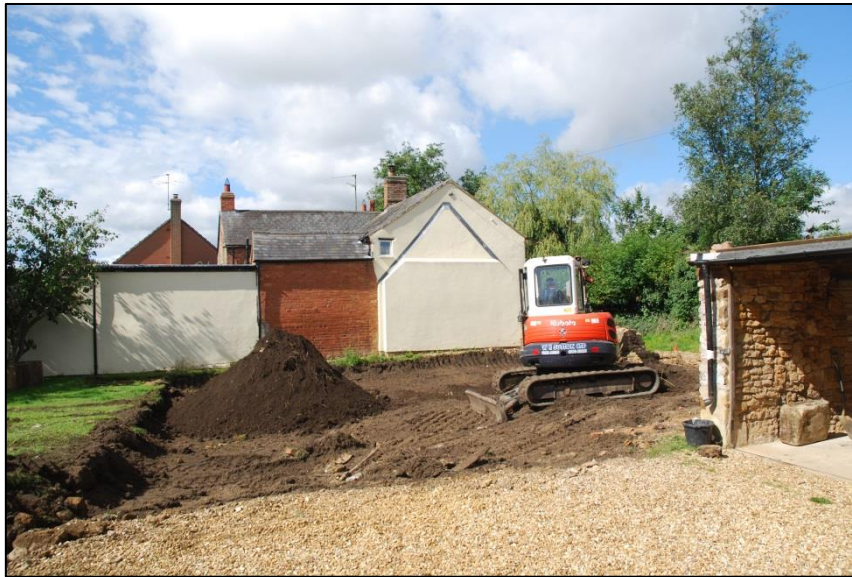
Fig 5: The site looking west during machining of the topsoil; garage building to right

The footprint of the new houses, two semi-detached homes, was stripped using a 5-ton 360-degree excavator fitted with a 1.6m-wide toothless ditching bucket. The work took place under archaeological scrutiny and control where requested. This exposed the natural substrate or any archaeology as appropriate.

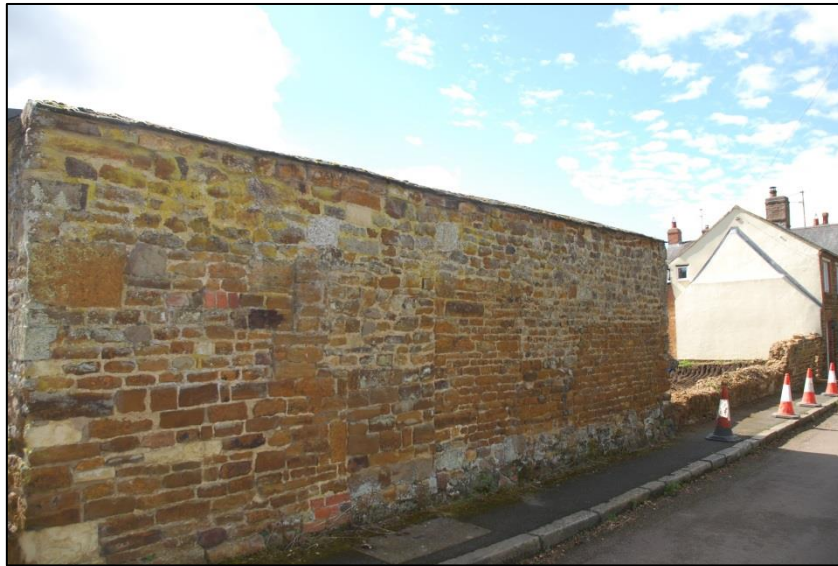
Fig 6: Adjacent garages with former cottage front wall with blocked doorway and window. These are being reused in the new development

While one half of the frontage comprised a former boundary wall, which was being reduced for the construction of the new houses, the other half comprised a garage-building which was to be retained and re-used in the new development as garages serving the two new houses. The extant front and side walls are of ironstone and preserved within the front wall are the blocked former openings of a door and a window, relating to a previous, probably domestic cottage, use.

Of the former cottage, the front edge appears once to have occupied the back of pavement and its front wall has more recently been mimicked by the now-demolished roadside wall (Figs 6 and 7). The cottage gable end is still visible made-good against next the door cottage (the 19th century Brook Cottage- Fig 8).

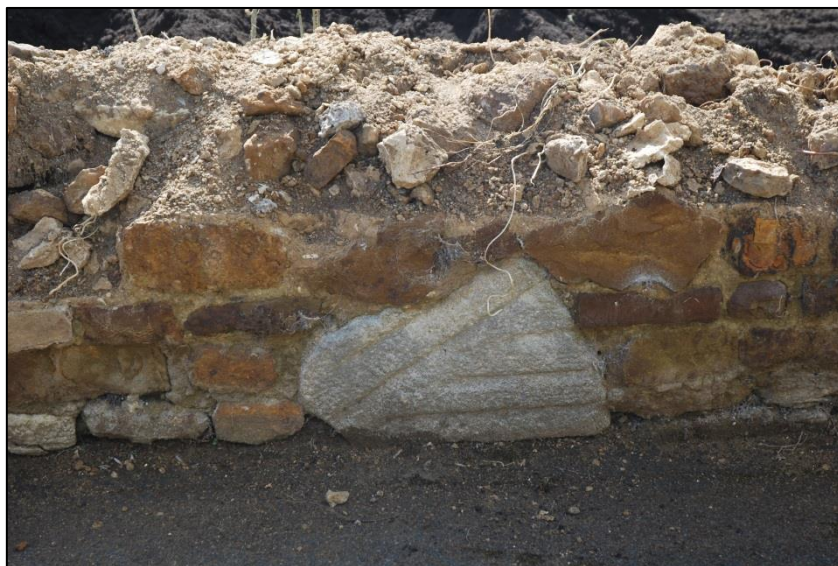
Fig 7: Broken piece of millstone re-used in the existing frontage wall

The boundary wall being demolished where the new houses are being constructed is an unremarkable ironstone wall about 1.2m high and 0.5m wide. It butted up against the modern render of the adjacent cottage and was thus patently modern in date. It retained at ground level a broken fragment of a former millstone as a feature. It has been noted above that on maps of 1810 and 1886 the former Maidford watermill stood not far away.

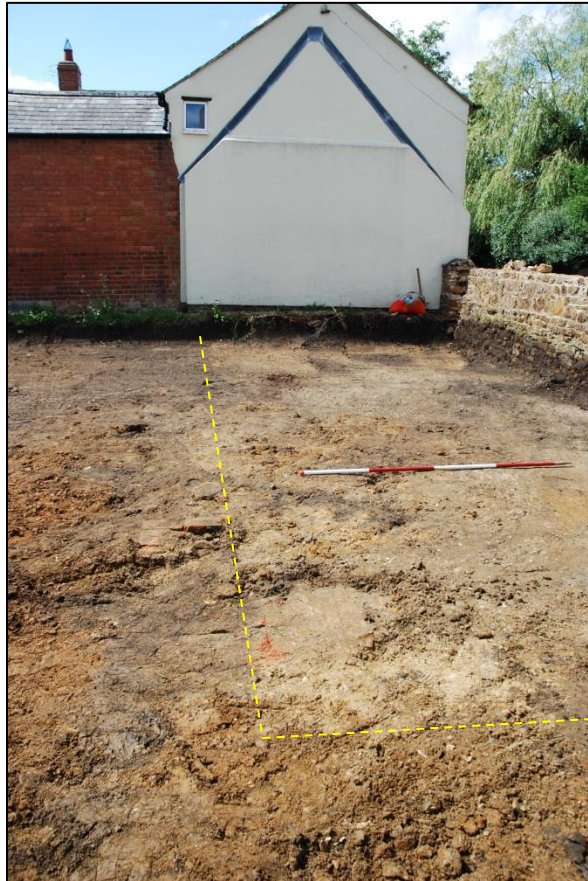
Fig 8: Looking west to the preserved former gable. The former cottage footprint is outlined; scale 2m

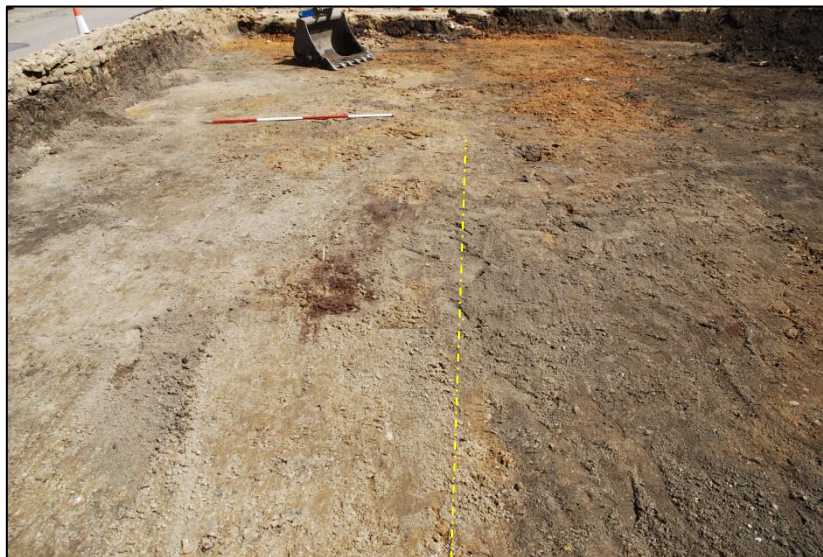
Fig 9: The site following machining, looking east. The stark difference along the dashed line is a 'mortary smudge'- all that remained of the cottage demolition (left) and clean subsoil (right). At top is exposed natural ironstone; scale 2m

Beneath the stripped topsoil, one third of the frontage comprised exposed clean solid geology (fragmented ironstone), while two thirds comprised demolition and disturbance into the same (from removal of the mapped and demolished cottage, of which the straight back edge was visible).

The cottage foundations seem to have been grubbed up at time of demolition – leaving nothing bigger than a half-brick or an ironstone fragment for the most part. The site seems to have been very professionally cleared in the post-War period, leaving only the most ephemeral ‘mortary smudge’ of the former cottage’s rectangular footprint. The cottage itself appears to have removed any earlier evidence, or it is possible that the site was previously not built-upon.
