A Level 2 Building Record of Adstone Wesleyan Chapel

An early 19th century agricultural building was converted in 1849 into a Wesleyan Chapel. It is now about to be converted and extended to become a home. Built of ironstone under a slate roof, the building survives as a shell, and there are few architectural details. It is however, testament to the simplicity of surroundings in a Wesleyan Methodist chapel in the 19th and 20th centuries.

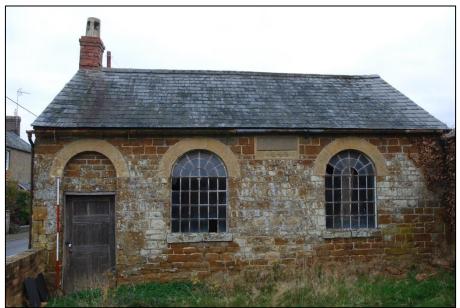
The front of the building is coursed Northampton Sand with Ironstone, the wall pierced by two round-arched windows above ironstone sills. A third round arch with plain coursed stone tympanum sits above a Victorian six-panel front door. The brick wall leading to the outer door-jamb is a modern replacement for a taller ironstone example photographed in 1986 which swept up to almost head-height to keep the wind and rain off the front door (ibid, 135).

Between the two windows is a date-stone of 1849 formed apparently in mortar, but with a top half previously defaced and not legible.

The roof is of Welsh Slate with Staffordshire Blue ridge tiles. The north end is surmounted by a squat brick chimney and pot.

Fig 4: The front face of the chapel (scale 2m). the dated 1849 wall abuts a brick farm building on the right.

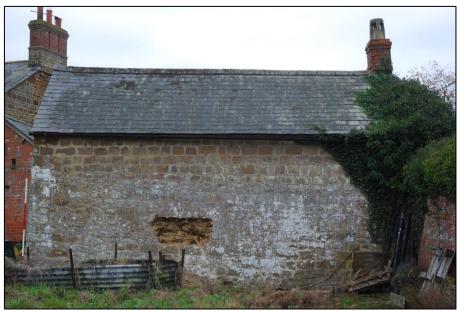
The rear wall is plain and has no piercings at all, but for a patch where the walling has fallen out. However, it is in slightly different ironstone with different bedding planes and a different finish – it is far more lichen-covered; the coursing is far more haphazard than the front and there is a break at about two thirds of the way up. Above that the same coursing as is seen on the front takes up the remainder of the way to the eaves.

Fig 5: The rear face of the chapel (scale 2m). Note the change in coursing two thirds of the way up.

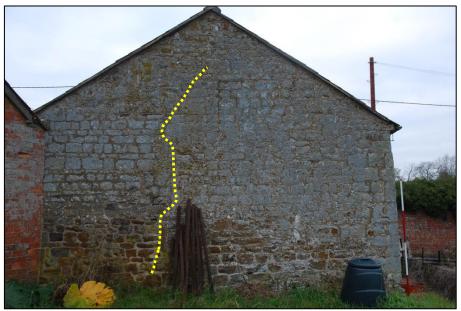
The southern gable is instructive. Here the more haphazard coursing of the back wall is carried around towards the front. At c1.2m from the front wall, there is a jagged join in the stonework, where the front of the building has been built onto an earlier rear.

Fig 6: The south gable (scale 2m). The join of two stonework types is outlined.

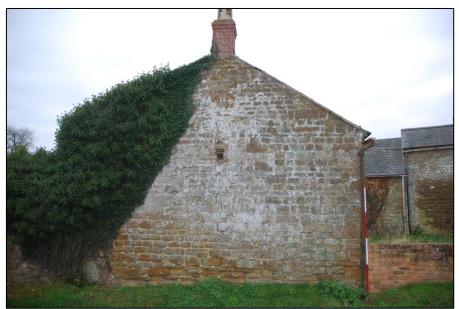
The roadside (north) gable is partly covered in ivy. The same join as the south gable is not apparent. It is likely that the join at this end took place at the back of the gable (behind ivy), and the gable was a complete rebuild. A hole centrally placed high in the wall is a rodding point for a stove-pipe exiting the chapel and leading to the brick chimney within the gable wall thickness.

Fig 7: The north, roadside gable (scale 2m)

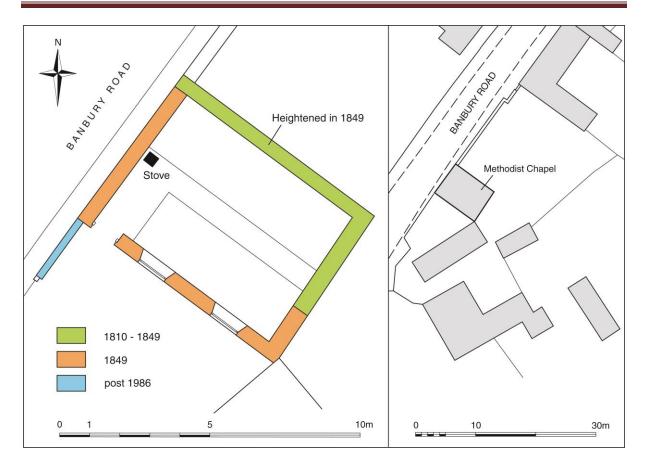
Fig 8: Phased plan of the building with the plot layout (Andy Isham after Roger Coy Partnership)

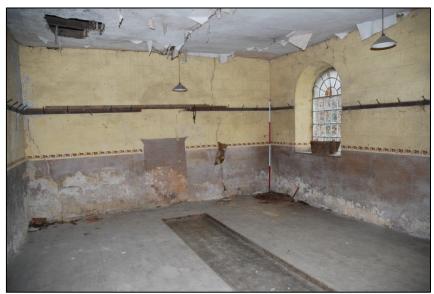
Inside the chapel is a single small room, measuring c8m x c6m. Lit only along the west side, I is simply decorated with plaster scribed with false jointing to mimic ashlar stone. The plaster is undecorated below 1m (waist height) and it is considered that from floor to 1m was probably formerly tongue and groove panelling. A modern dado stencil then highlights the junction with the top half of the walls which are painted a pastel yellow. There are previous traces of a light blue colur scheme showing through. At head-height is a continuous wooden rail holding regularly-spaced coat and hat pegs, broken only by the doorway and (formerly) by whatever stood against the south end gable wall. This was possibly a lectern or some sort of tabernacle. It had been taken out some time ago, and the rail had subsequently infilled the space.

Fig 9: The interior, looking south, scale 2m

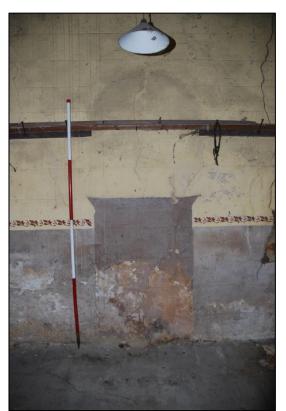
Fig 10: Marks indicating the former presence of a lectern or tabernacle against the south wall (scale 2m). Later the space was infilled with a modification to the coat rail.

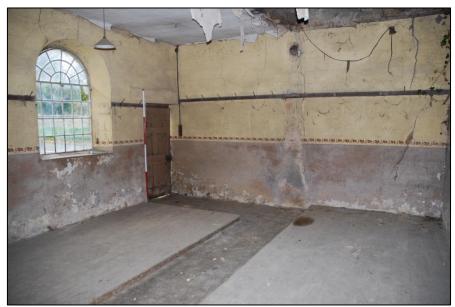
The floor is mostly boarded out for chairs, but with a tiled walkway up the central axis, and a tiled area at the north end just inside the doorway. At that end there once stood a heating stove, which would have vented its gases through a hole half way up the gable wall into the chimney flue.

Fig 11: The interior looking north-west towards the door (scale 2m). Note former stove position and stovepipe exit above. A piano may have once stood in the far right corner of the room
