Archaeological investigation of the putative lower garden terraces at Lyveden, Northamptonshire 2017

Joe Prentice and Iain Soden

On behalf of The National Trust

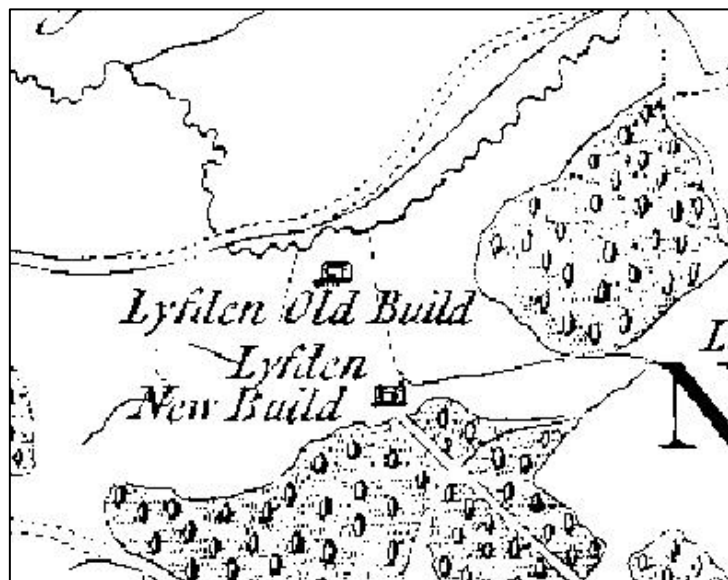
Fig 2a: Map of Northamptonshire by Thomas Eyre 1771

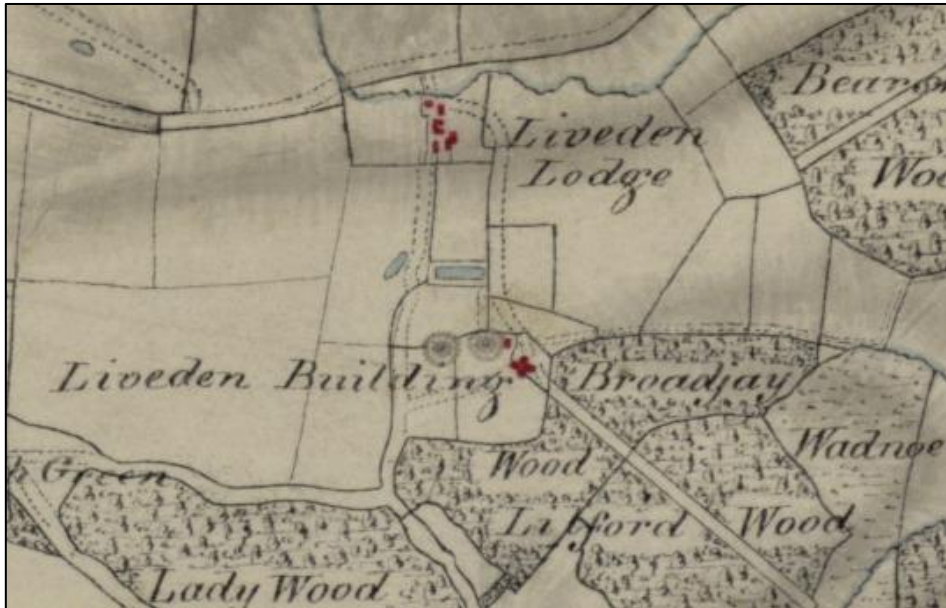
Fig 2b: The Ordnance Survey Surveyors' preparatory map c1810. North to top.

To the north of that point there is a separate enclosure within which the group of buildings including the Old Build (on the map called Liveden Lodge) is shown as blocks of red. To either side of the long rectangular field are apparently two tracks shown by dotted lines, one each to the east and west, both aligned north-south.

None of the historic maps, including the series of Ordnance Survey maps published from the 1880's, shows any indication of lower garden earthworks or layout. Of the earlier maps there is little to comment upon as none show anything in the area occupied by the Lower Garden. The earliest that shows the site at a usable scale is the Eyres map of 1771 but not even field boundaries are indicated in the area (Fig 2a). Similarly, the c1810 Ordnance Survey preparatory map shows little apart from a single long rectangular field extending from the north side of the northern moat terrace almost as far as the Old Build but clearly separated from the latter by a boundary aligned east-west across the slope (Fig 2b).

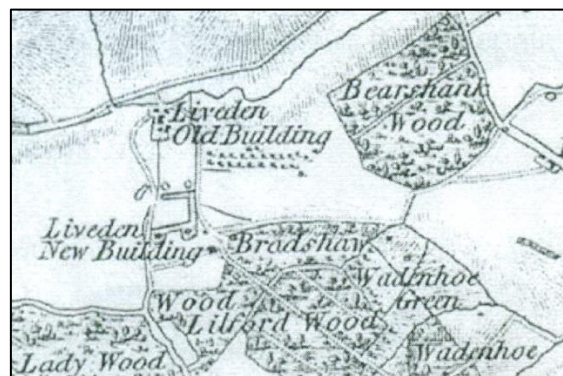
Fig 2c: 1834 Old Series OS depiction.

A broadly similar layout is depicted on the 1834 Old Series Ordnance Survey map (Fig 2c). One curious feature shown on that image is an apparent avenue of trees extending east-west to the south-east of the Old Build. However, whether or not it actually existed is unclear. It is not shown c1810, nor is it present on the First Edition Ordnance Survey map c1880 (Fig 3b). At this time the property was owned by the Fitzpatrick family and subsequently by Robert Smith Vernon (see above). It is possible that the ladies Fitzpatrick may have felt inclined to plant an avenue, but one has to ask would they bother when the property is thought to have been tenanted and why in that location? It neither leads to or from the Old or New Buildings but rather awkwardly lies between the two. It apparently starts on the east side of the track which leads from the Old Build to the New Build and then stops abruptly in the middle of a field, short of Bearshank Wood through which there is not even a ride.

If an avenue is planted, the usual route is leading to the main property to add grandeur to the approach, or radiates outwards from it, either singly or often as one of three (known as a *patte d'oie* or goose foot) leading the eye into the wider landscape, perhaps terminating in a distant folly or another feature such as the spire of a church. The avenue shown here does none of those things and sits uncomfortably on the slope. Nothing can be seen on the aerial photograph (Fig 6) either indicating a track or the planting pits associated with the avenue. Given that much earlier planting pits can be seen showing the layout of fruit trees in the orchard, this casts doubt on the entire representation. Unless other evidence is found it might be appropriate to consider the existence of an avenue as doubtful.

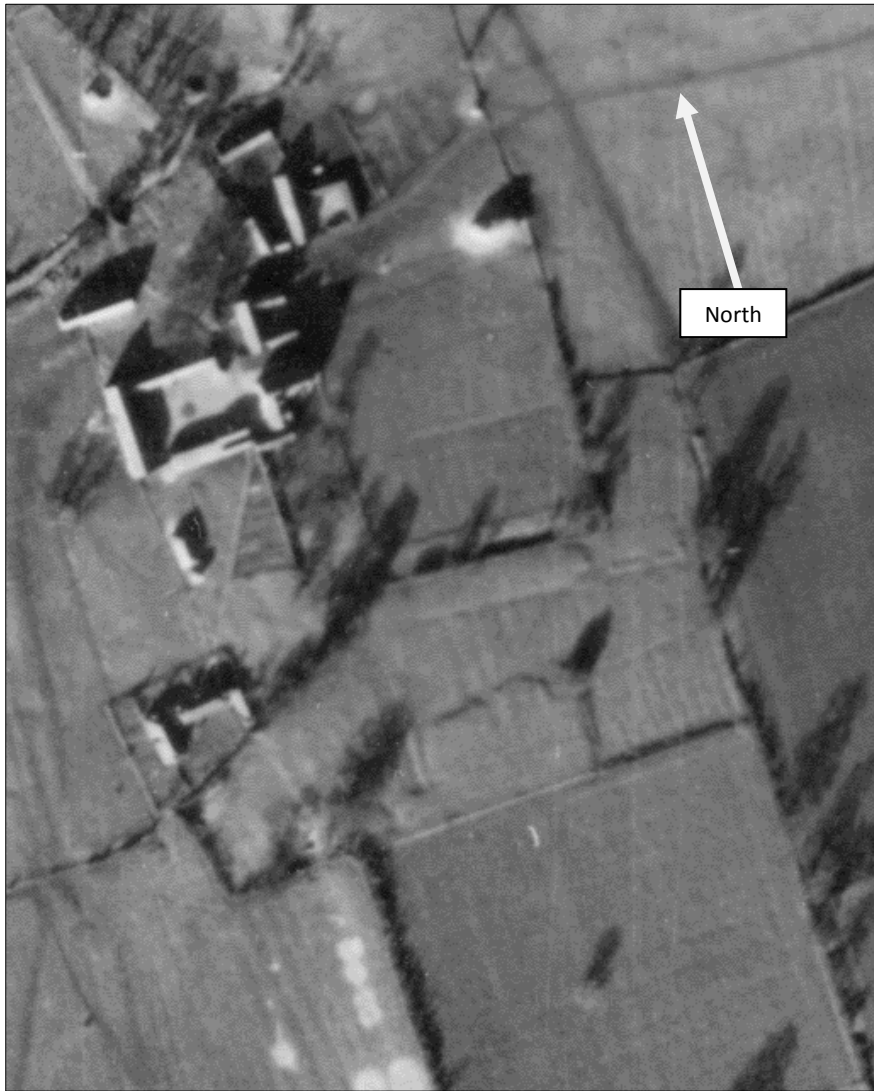
Fig 6: Detail of the c 1944 (USAF) aerial photograph of Lyveden.

Recent, closer examination of the K C brown plan throws this interpretation into doubt. The interpretation of the earthworks visible on aerial photographs appears, on this evidence, to have been somewhat creative, perhaps relying overly on the eye of faith. Indeed if the lines of the lower garden 'terraces' are overlaid onto an image of the site which shows them it can be seen that they are not as parallel to each other, or the remainder of the garden earthworks of the upper gardens, as the Brown and Taylor plan suggests (compare Figs 5, 6, and Fig 7).

(see Fig 7, outlined in blue, compare with Fig 6).

Three evaluation trenches were opened between 25 and 29 September, 2017. Trench 1, measuring 94m long x 1.5m wide, was positioned to investigate the large rectangular terrace with its central projecting platform at the southern end of the lower garden area and the two adjacent 'terraces' (Fig 6). Nothing further north could be assessed since it had been lost entirely to earthmoving for the recent cricket pitch created by the last private owners.

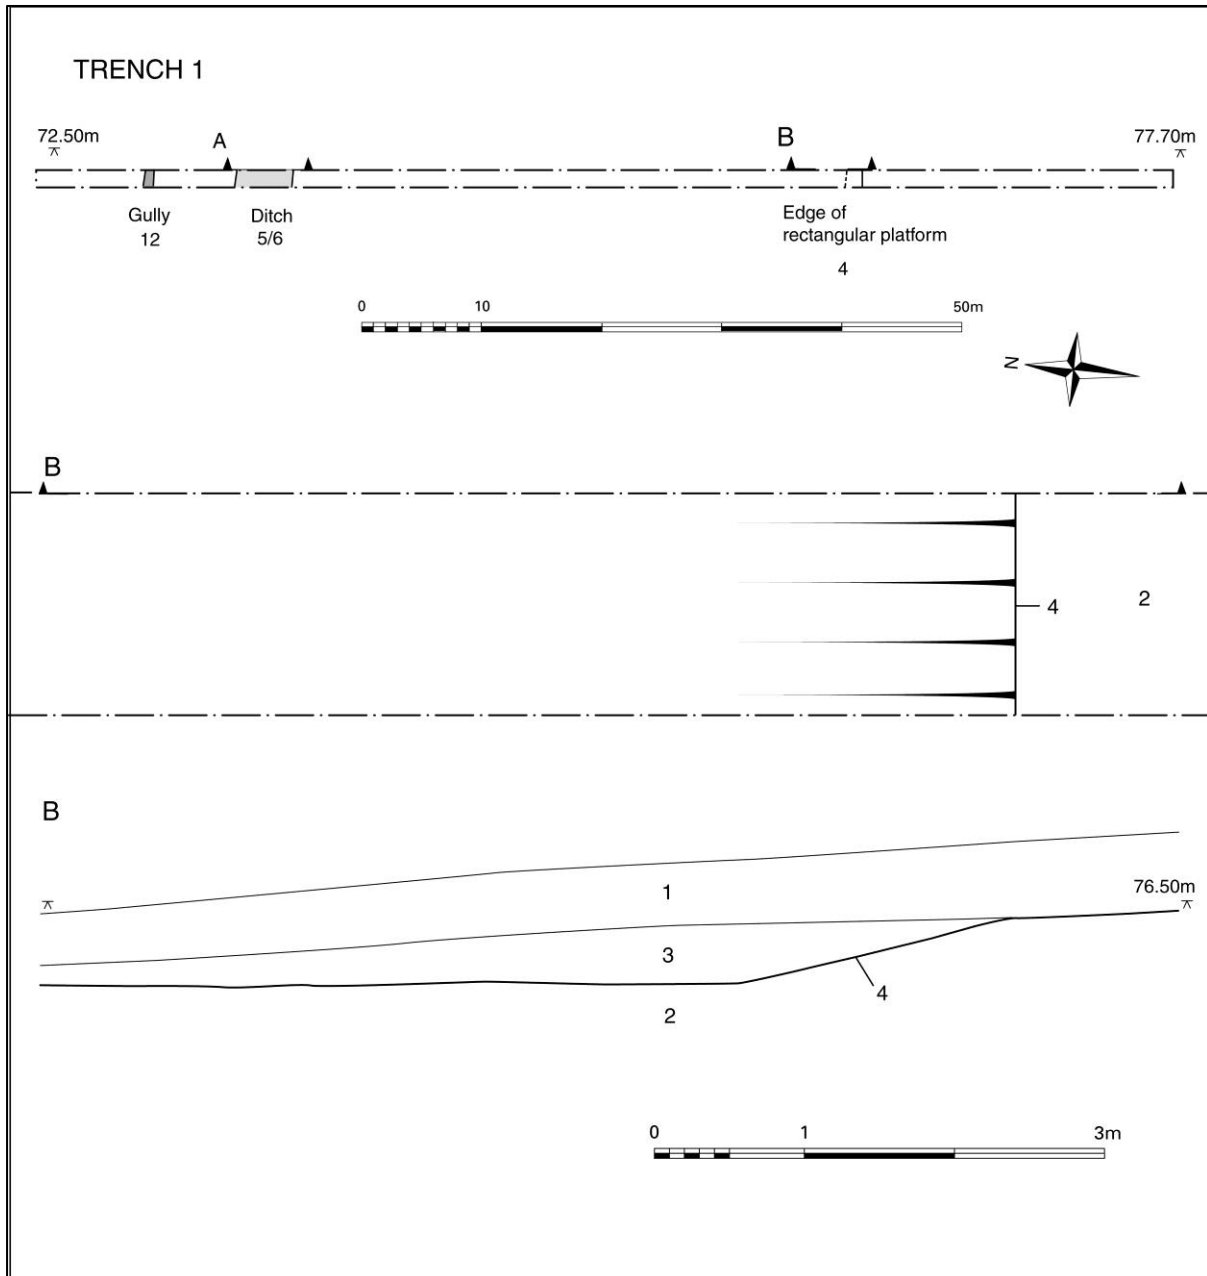
Fig 9: Trench 1 plan with detail showing plan and section of the rectangular platform edge [4]. See photograph (Fig 10) (Andy Isham)

Cutting into the natural clay 24m north from the southern limit of the trench was a distinct upper edge of a steeper slope which appears to represent the upper edge of the rectangular projecting platform [4] (Figs 9 and 10). This feature was noted by both Col Brown and Brown & Taylor. The slope only survived for 1.5m at which point it continued almost perfectly horizontally for another 5.5-6m when the gentle downward slope to the north truncated this flat platform. This very slight break of slope could just be made out on the ground before trenching began but it is almost imperceptible to the untrained eye.

Beyond this remnant of the rectangular terrace platform the trench continued down the slope with only the same topsoil layer lying directly above the natural clay for a distance of 72.5m from the south end of the trench (Fig 9).

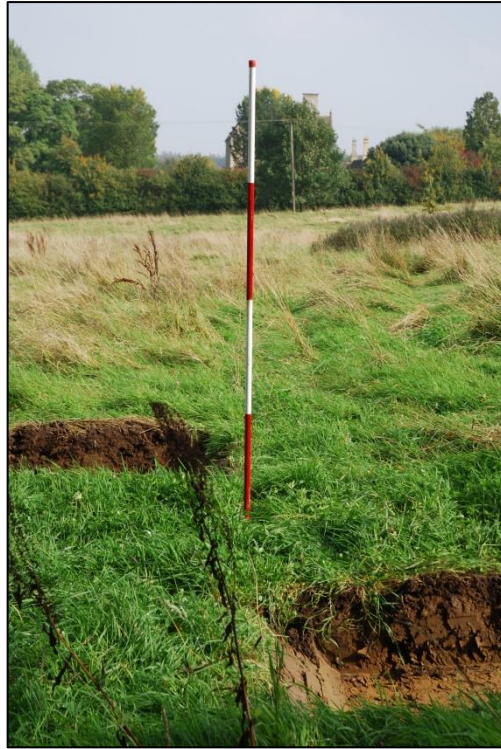
Fig 14: The view from trenches 2 and 3 looking east towards the Old Build. Scale 2m

There were no features of any kind in these two trenches. There was no evidence present of the purported former western approach at this point.

Trench 3 measured 5m N-S x 1.5m wide, and the land here fell from 67.2m to 66.7m. Natural clay geology lay at 66.9m in the centre of the trench.
