Iain Soden Heritage Services Ltd

**Archaeological monitoring, excavation, building
recording and analysis at Delapré Abbey,
Northampton 2014-19**

Archaeological monitoring, excavation, building recording and analysis at Delapré Abbey, Northampton 2014-19

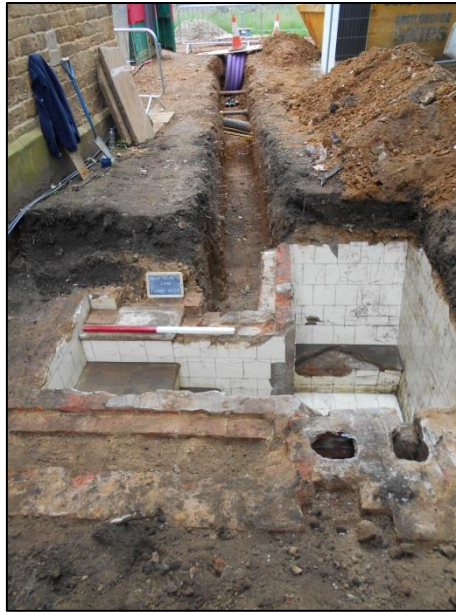
Fig 6: Typical monitoring conditions outside the north range - on this occasion the conduit trench which discovered the Victorian plunge bath

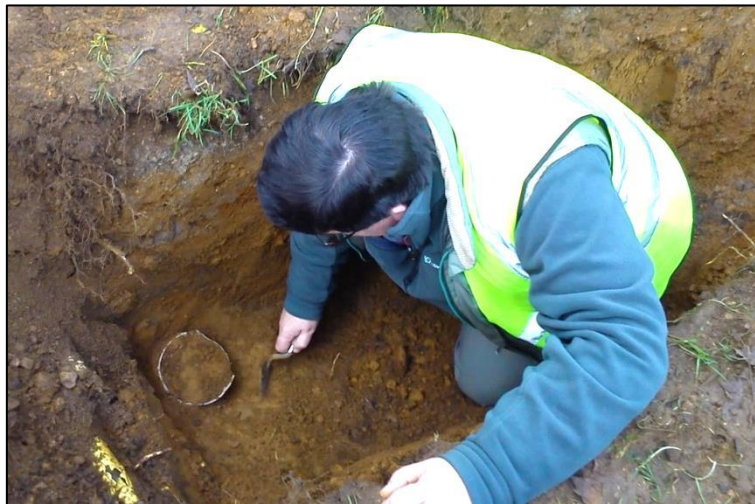
Fig 7: Initial discovery of the flagon (see below), its top half scattered.

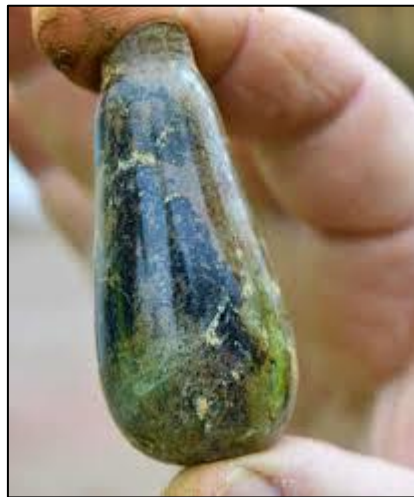
Fig 9: The glass phial soon after excavation (Photo by Craig Forsyth, NBC)

- In addition to the pottery vessels most of a pale blue glass phial was recovered. It was sadly missing its neck and rim but the surviving bulbous lower part was 54mm tall and 26mm maximum diameter tapering to 14mm just at the base of the neck which would have been about 12mm diameter as indicated at the break. Vessels of this form are known from Colchester where they are seen at their peak in the first century after 60AD and at St Albans similar vessels are assigned a first or second century date (Cool et al 1995, 85; Charlesworth 1972, 206-7).

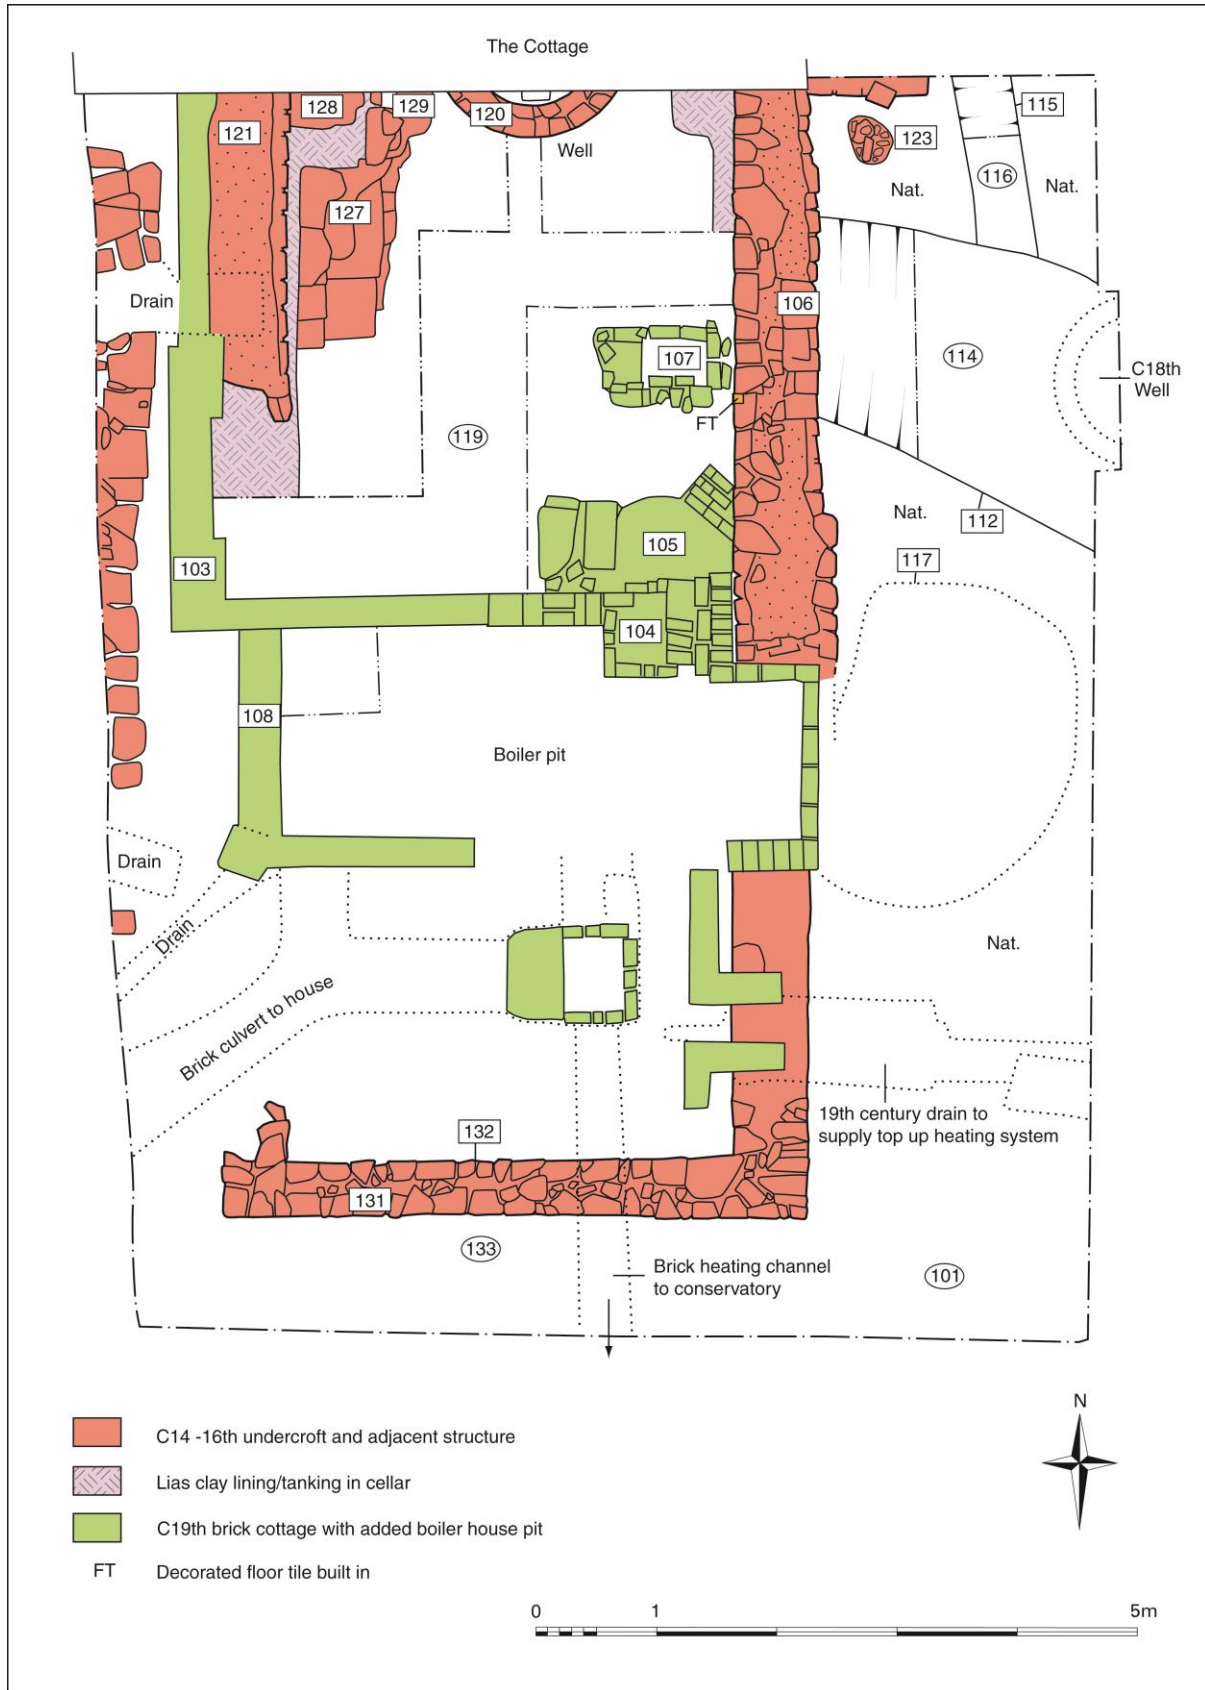
Fig 10: Plan of the undercroft with tanking, steps and well (Andy Isham)

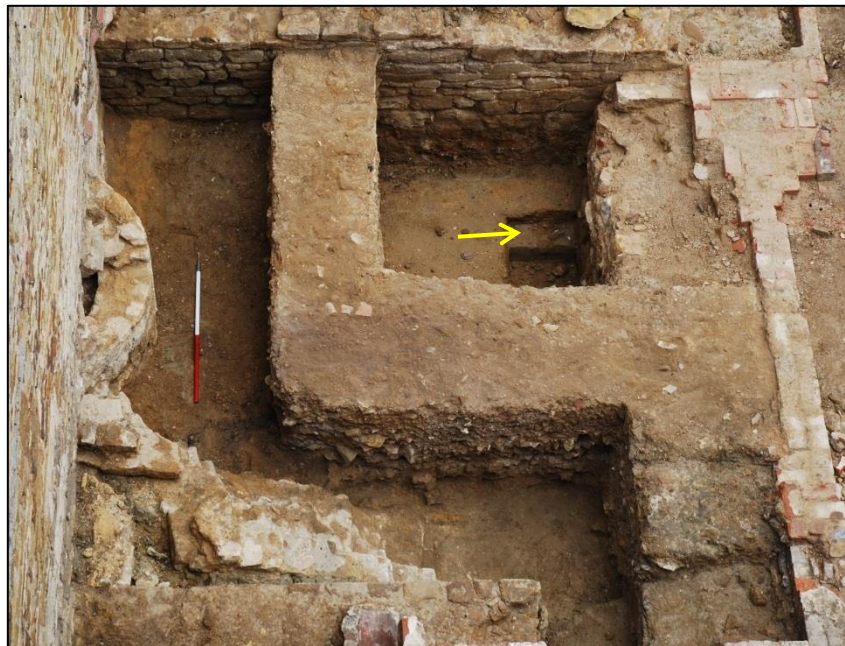
Fig 11: The undercroft, partly emptied. The east (top) and west (bottom) walls can be seen, with the well (far left centre) and robbed stair bedded in clay (bottom left). A sondage at top right centre has been cut through the sandy floor and basal tanking layer (arrowed), which stretched at least 1m up the sides; scale 1m. North to left

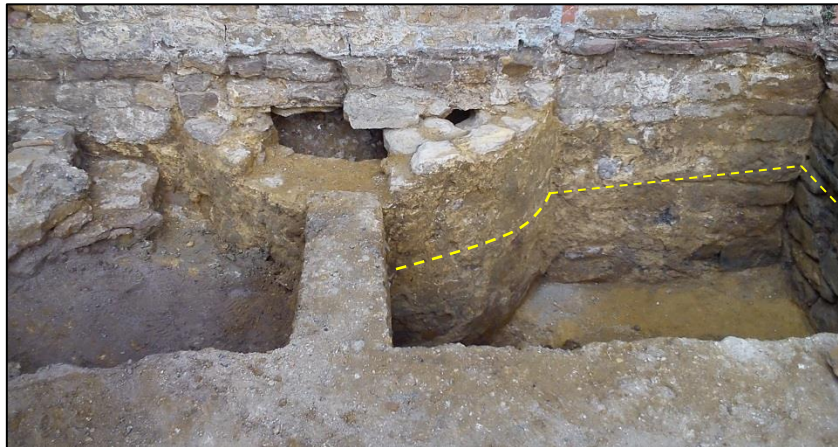
Fig 13: Early in the excavation, the Blue Lias-clay tanking can be seen up the left side of the plastered well shaft; it has been removed in the right half but rain-water is still seen ponding on its truncated base. The dashed line shows its former extent. View looking north

The tanking of the room, high up on the free-draining ironstone-based geology, is surely an effort to keep in the liquid contents of the room, while also preventing damp from spreading up walls and into the next basement room (although it would not address any natural damp from under or outside the building from creeping up. While damp is a characteristic which might be applied to many undercrofts, the tanking effectively means that this room, with direct stone-stair access, became simply a huge wet-room (in modern parlance), in which natural drainage (normally a requirement) was discouraged and very probably was entirely unintended. By blocking-in either side of the well, adding the stairs afterwards, the entirety of the water-seal was maintained for this end of the building.

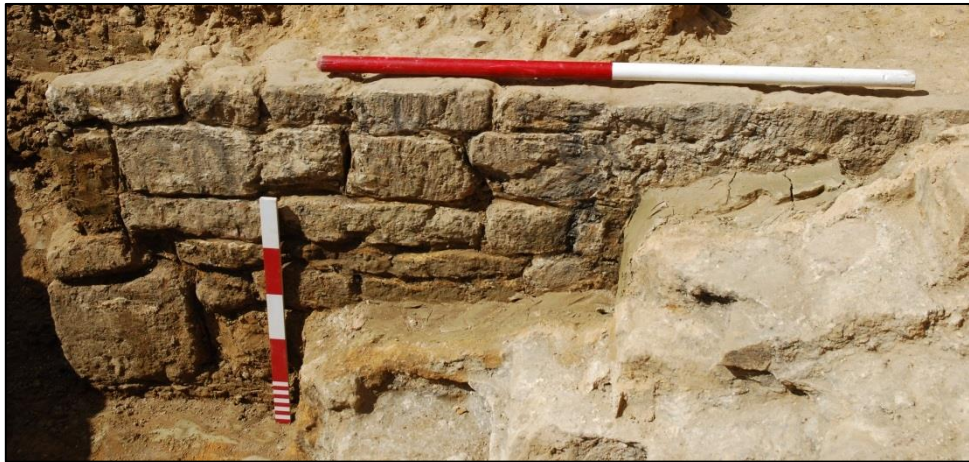
Fig 14: Undercroft west wall rear [121], robbed stair [127] foreground and c100mm of lias clay tanking between, looking west; scales 1m and 50cm

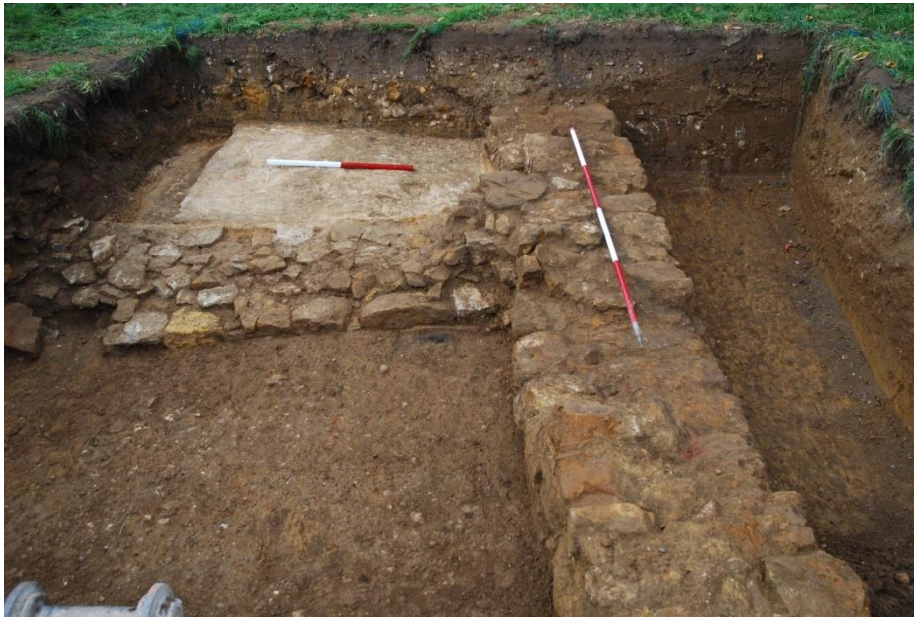
Fig 15: View of the west range in the aborted 45000L tank trench, looking north (Abbey to the right); scales 2m and 1m. Some 1.1m of deep soils lie outside the building to its east (right).

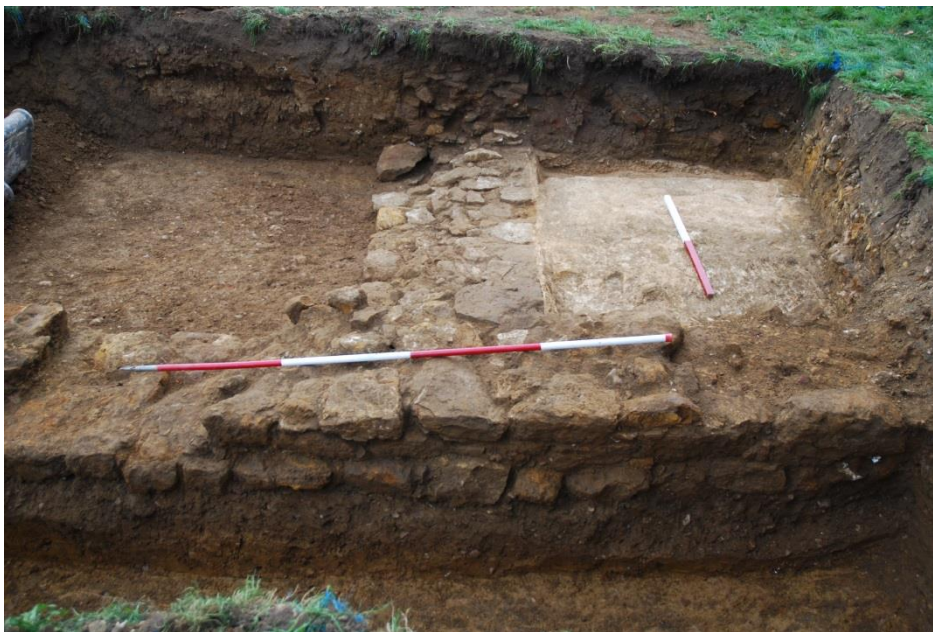
Fig 16: View of the west range in the aborted 45000L tank trench, looking west (Abbey behind camera); scales 2m and 1m. Note how the wall in the foreground has been bedded on rammed soil.

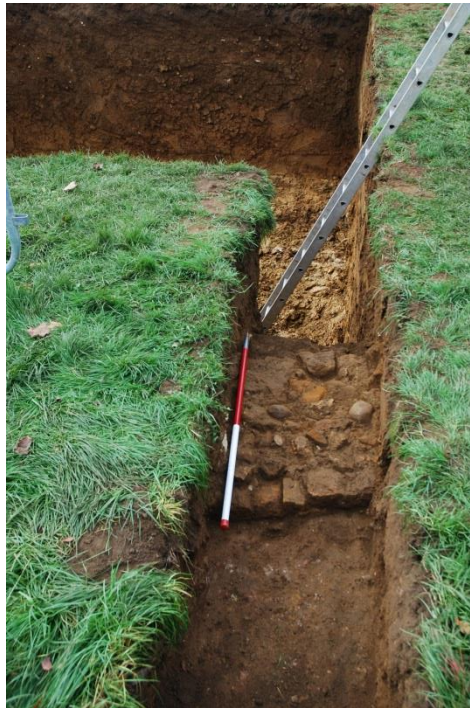
Fig 17: The west wall of the west range, adjacent to the successful 45000L Tank Trench 2 beyond, looking west (Abbey behind camera and slightly to left); scale 1m. The tank trench was c6m x 6m in plan, and 5m deep.

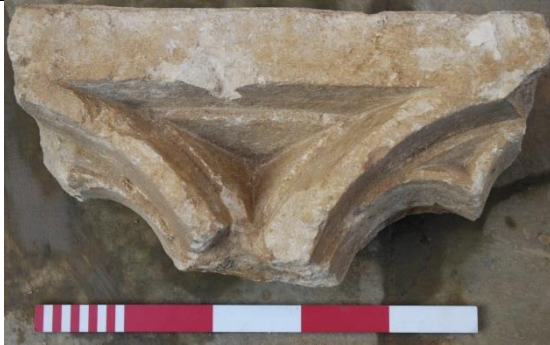
19.2	<p>Fragment of straight 15th-century window mullion in fine-grained Blisworth limestone with cavetto moulding one side of a glazing groove with roll-moulding projection on the other. Dimensions (475mm) long x 213mm wide x 114mm deep. From beneath conservatory. Scale 50cm</p>

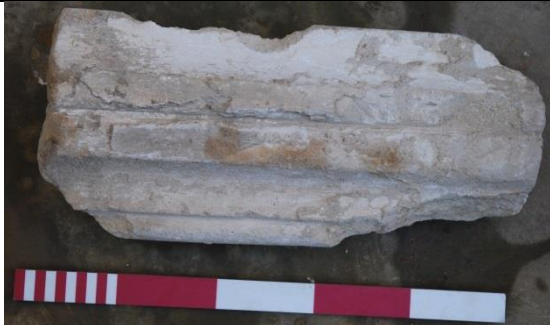
19.3	<p>Two fragments of substantial plain very shelly limestone cavetto moulding, possibly from a 14th- century vault rib. Dimensions 200mm x 210mm x 240mm and (140mm) x 210mm x 240mm. From beneath conservatory. Scale 50cm</p>

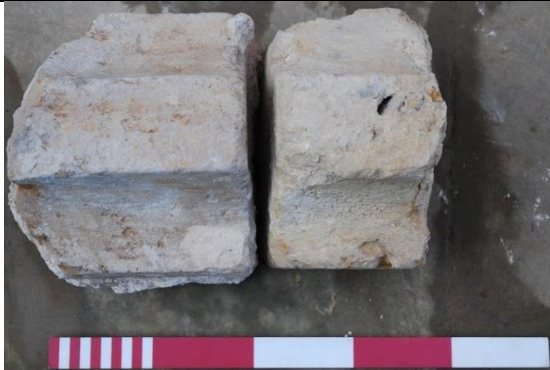
19.4	<p>Fine-grained Blisworth Limestone fragment from a junction between an arch and a possible jamb. Medieval but may have been reused before the Dissolution. Dimensions 303mm x 320mm x 158mm. Scale 50cm</p>

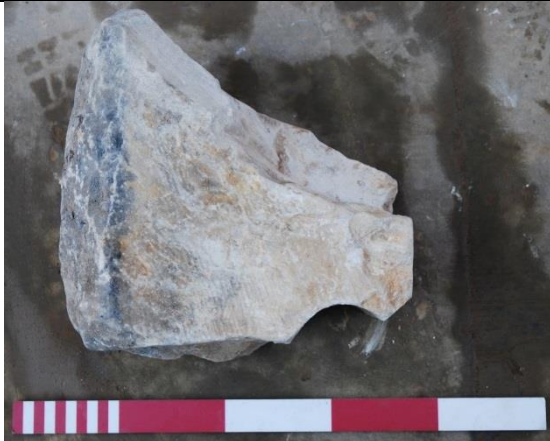
19.5	Small, fine-grained Blisworth limestone fragment from a window arch. Dimensions 300mm x (140mm) x 123mm). From North wall of B11, cutting for new door. Scale 50cm

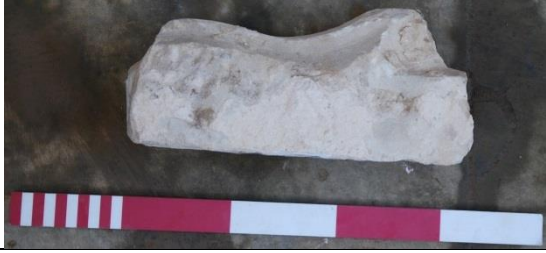
19.6 a	A small capital in (slightly scorched) Northampton Sand Ironstone from on top of a (probably disengaged) shaft from between two bays of blind arcade, or sedilia. Groove at rear of roll-moulding may mark former depth of wall setting. From excavations for new Kitchen (DA15 K 123) on site of what is thought to be the former monastic bath-house. Dimensions 152mm x 120mm x 100mm. Side-view opposite; scale 30cm

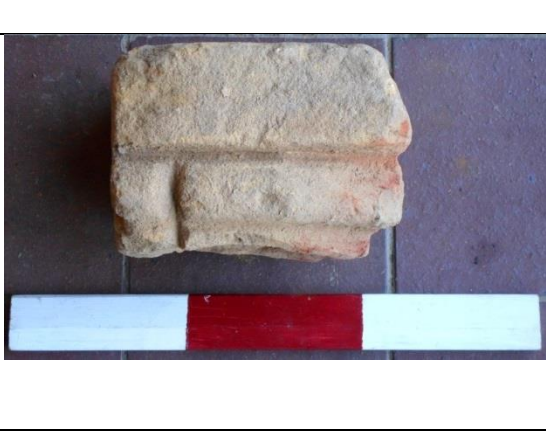
19.6 b	End-view of 6 above; scale 30cm An exact parallel for this stone can be seen as a capital to each of the shafts between the sedilia in the 14 th -century chancel at St Lawrence's Church, Long Buckby, Northamptonshire (c, below).

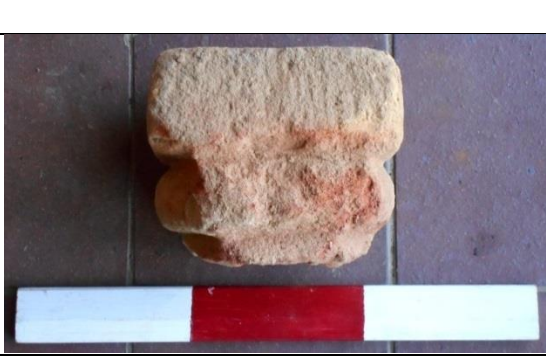
19.6 c	Example of 6. in use in 14 th -century chancel sedilia at St Lawrence's Church, Long Buckby, Northamptonshire

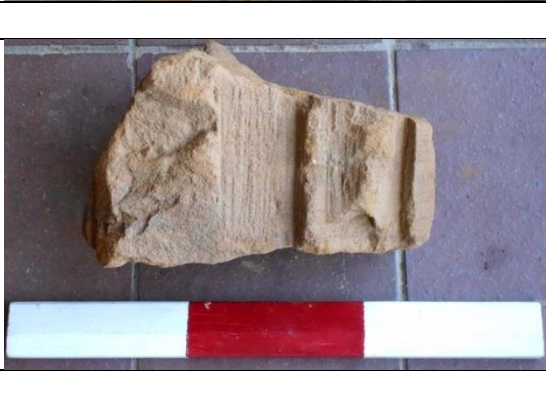
19.7 b	Profile view of 7 opposite; scale 30cm

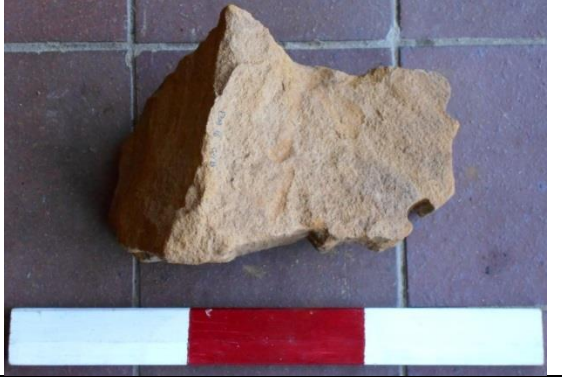
19.8	Fragment of Blisworth Limestone from a trefoil cross-section shaft. Dimensions (110mm) long x 115mm across two trefoil lobes. From floor reduction in Basement B13; scale 30cm

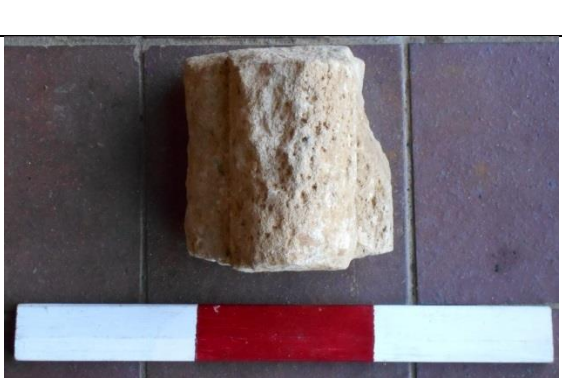
19.9	Fragment of Blisworth Limestone, very similar to 19.8, but less well-preserved. (130mm x 110mm). From excavations for new Kitchen (DA15 K 133) on site of the former monastic bath-house. View here shows the profile as the better-preserved of the two; scale 30cm

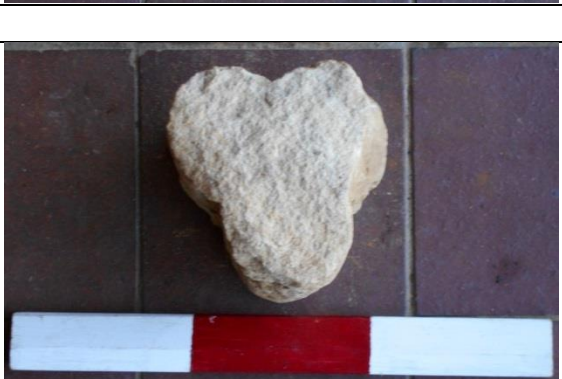
19.10	Fragment of Blisworth Limestone from an octagonal shaft with upstanding roll-moulding around all faces. Possibly a fragment of cross-shaft. Dimensions (155mm) x 115mm diameter across roll-moulding/astragal. From below floor of stables in room G59. Scale 30cm

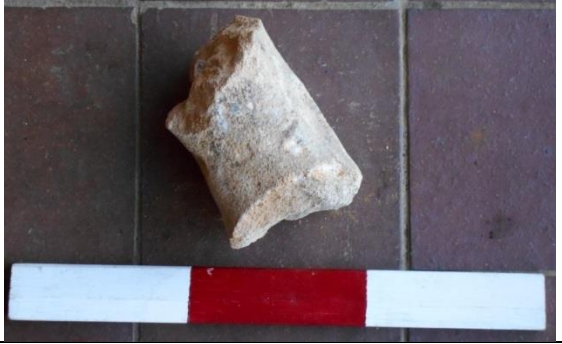
19.12	<p>Fragment in Blisworth Limestone of a regular octagonal shaft. Dimensions (140mm long) x 90mm diam. From 1.4m depth in deep soils of south soakaway; unstratified. Scale 30cm.</p>

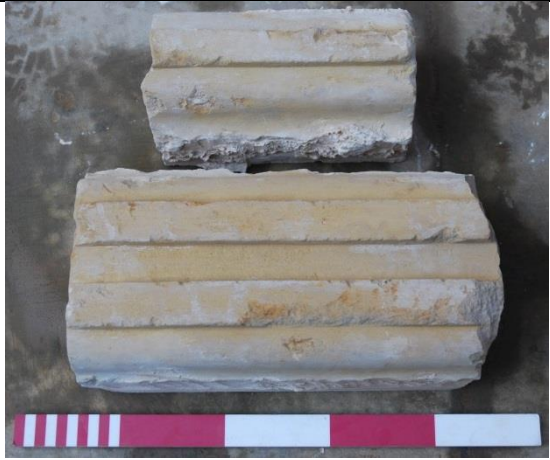
19.15	Fragment of Northampton Sand Ironstone 17 th -century mullion with glazing groove and integral jamb splay, from at-depth in DA14 Evaluation test-pit G2. Dimensions 310mm x (200mm x 200mm). Assumed therefore to derive from the former South Range. Scale 30cm

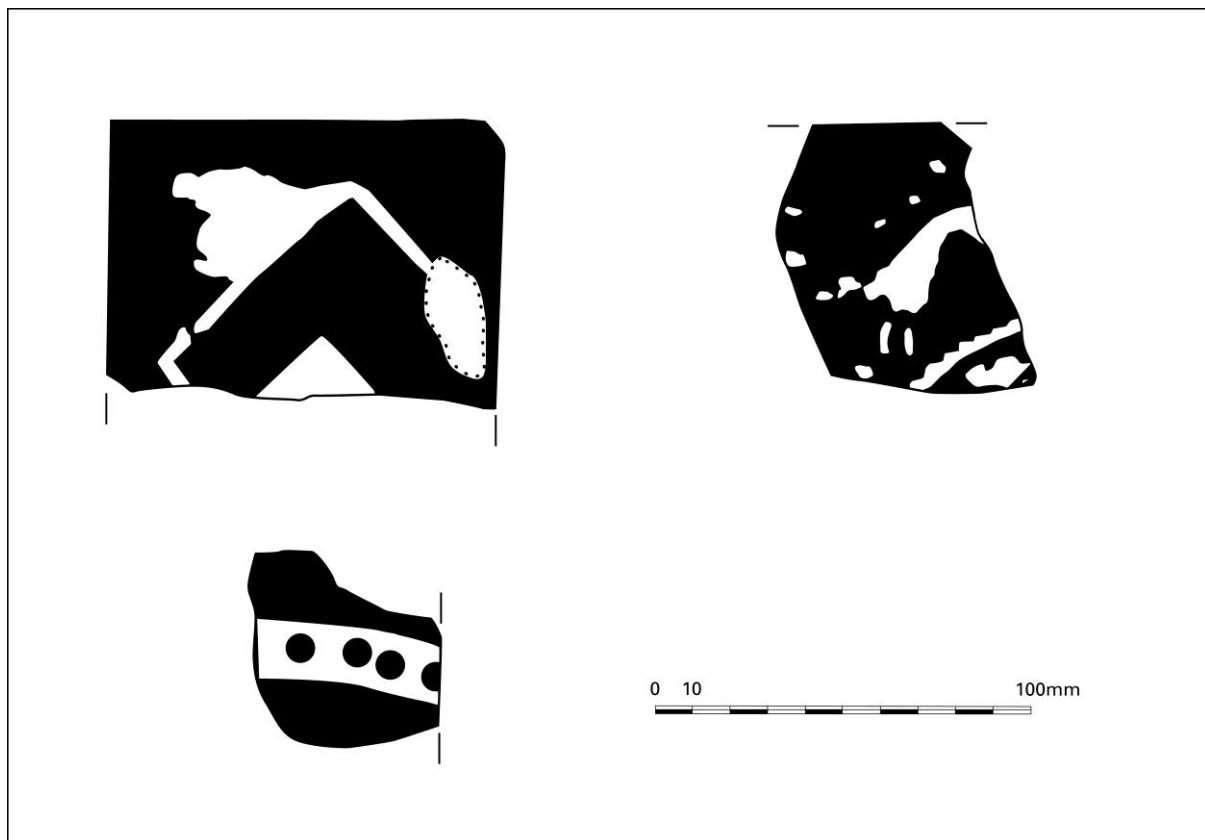
Fig 20: The decorated medieval floor tiles-1 (top left); 2 (top right); 3 (bottom left). (Andy Isham)

1. Half of possibly a multiple-tile design with armorial bearings comprising a printed shield border with an indistinct motif, and an equally indistinct decorative element outside. DA15 K 106 (Built into the east wall of the east-range undercroft). No parallels found. Its location is of note since it is structural dating for the construction of the undercroft.

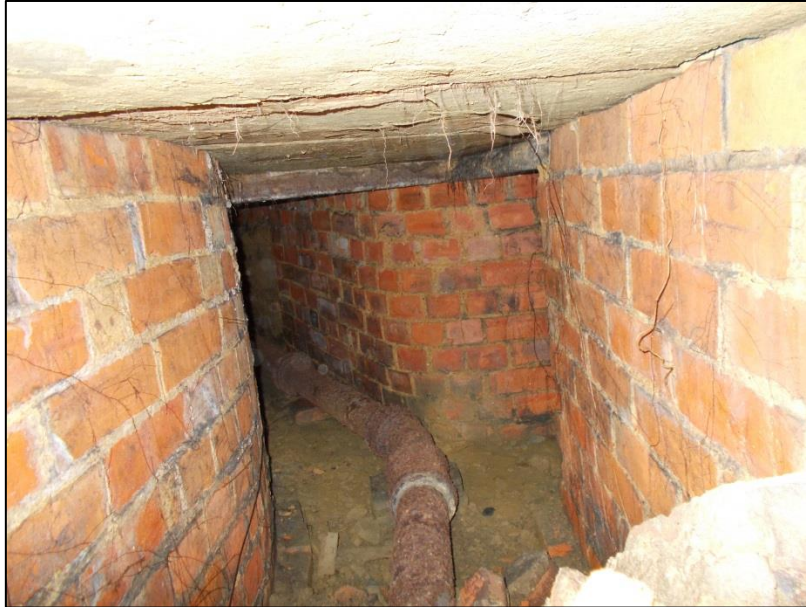
Fig 21: A snatched view along the buried brick culvert from the boiler house to the house, entering under the back door (to G5). This view was only possible by placing head and shoulders in the former maintenance pit.

Thus, heated via a fire-box to the north, the hot water from the boiler was initially fed at high level under the conservatory's north wall, where heat was most important, and then channelled via 5-inch cast iron pipes, east to the billiard room or west to the dining room and drawing room, before cooling as it found its way back to the boiler pit.

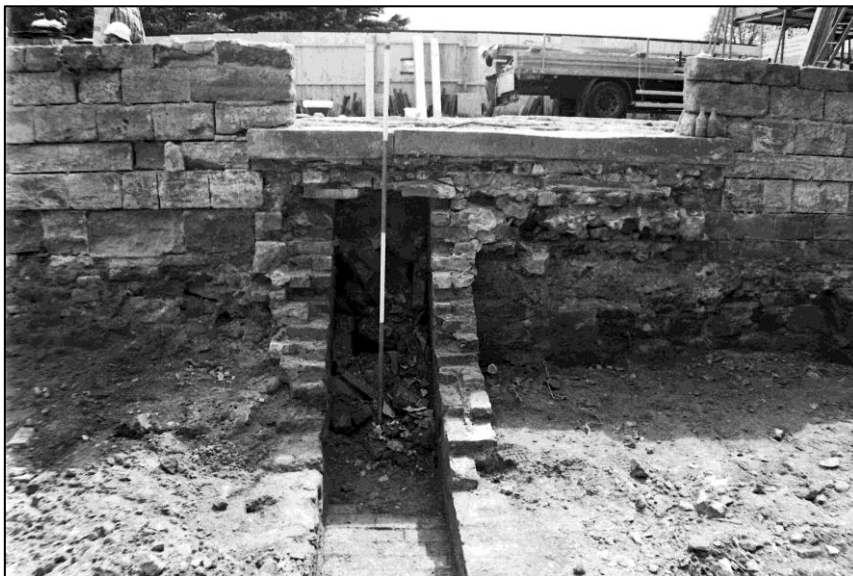
Fig 22: View south from the boiler pit along the heating channel which fed the former Conservatory with hot water. The base of the channel was 1.6m below the conservatory floor. This view is directly south from the inspection chamber adjacent to the boiler pit. Following the loss of the conservatory, the whole was later truncated by a set of steps (and that incremental truncation is visible in the rising brick courses; scale 2m
(Scanned from B&W negative in site archive)

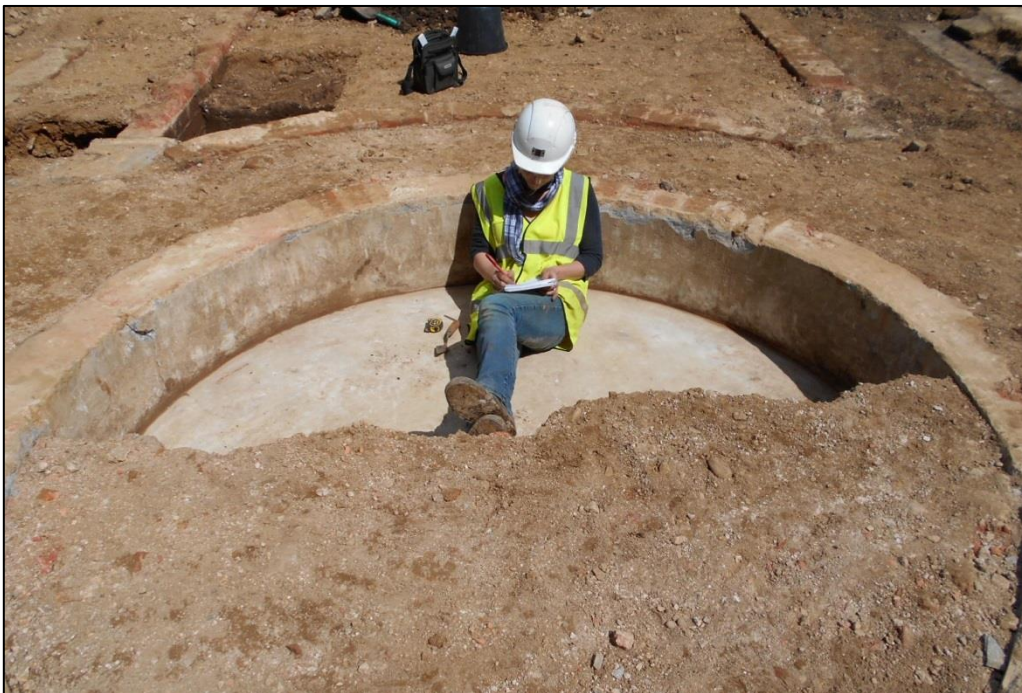
Fig 24: Charlotte recording the central pool, looking east.

The pool was constructed of red brick and rendered internally with hard, grey, cement. In the centre was the truncated stump of the water inlet pipe which almost certainly held the brass fountain rose or spigot (see below). In the base of the pool, on the north side, was the water outlet hole which would have been fitted with a bung or plug until such a time as the pool required cleaning and emptying. During general use there must have been an overflow since at this period there were no circulating pumps and the fountain must have simply been gravity fed which means that as water came in and produced the fountain, water must have been let out otherwise the pool would have overflowed. This was the standard format of the period which meant that mostly the fountains only played for short periods since they would have been supplied by header tanks which usually held relatively small supplies of water.

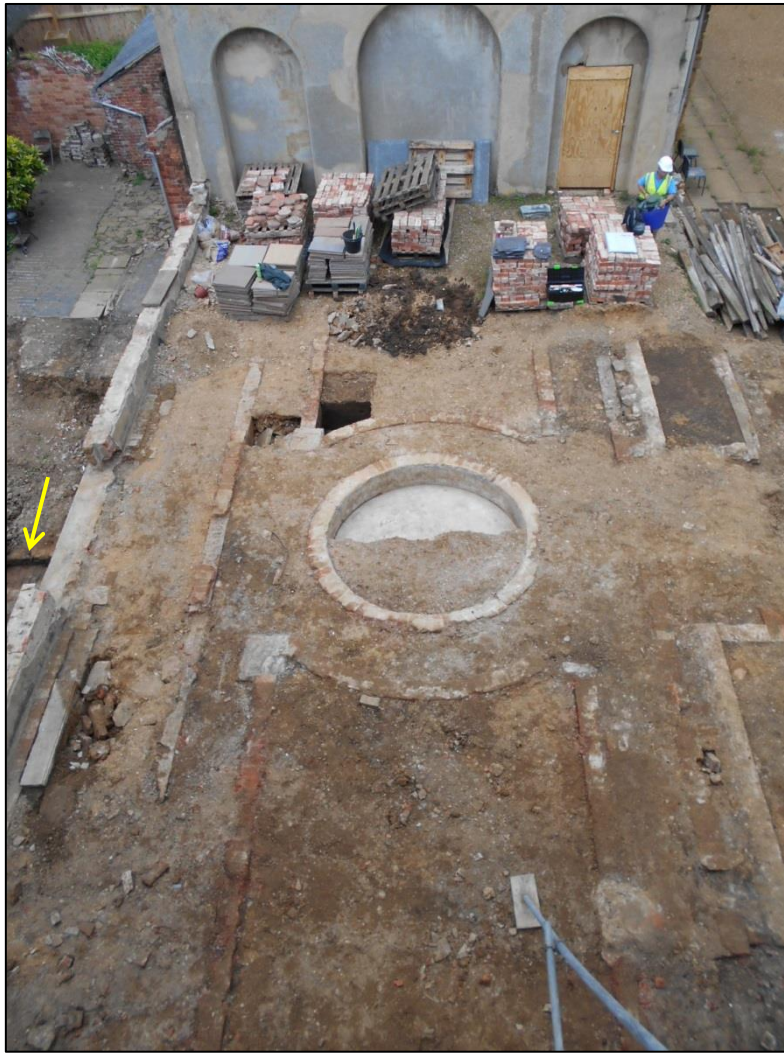
Fig 25: Photograph of the Conservatory during excavations, taken from the roof of the South Range. Note the brick heating source channel from the boiler house glimpsed at far left (arrowed)

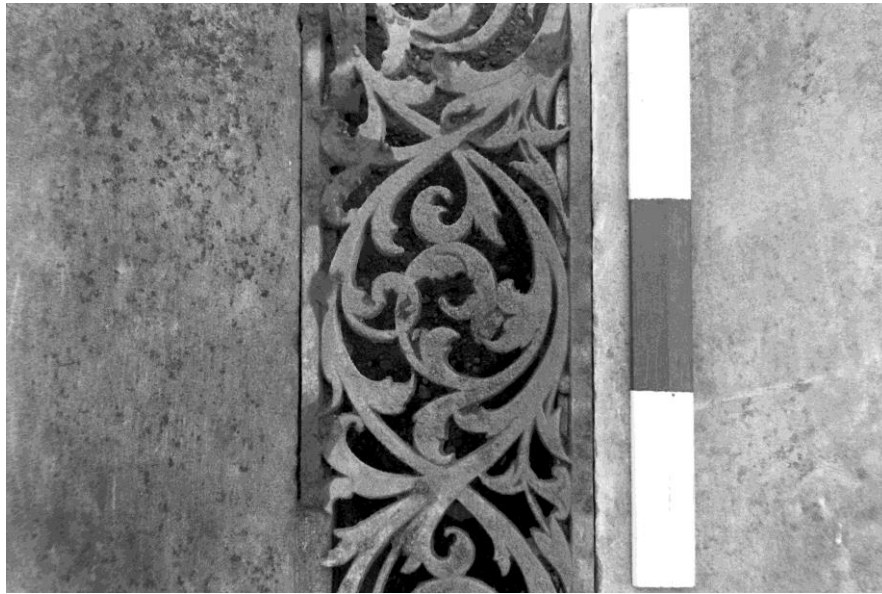
Fig 26: The elaborate cast iron grille repositioned in its rebates on broken limestone paving blocks as it would have lain in the floor over the heating pipes before demolition; scale 30cm. (Scanned from B&W negative in site archive)

The ducts which held the heating pipes are located not only around the perimeter as would be expected but appear to also wrap around the central pool. However, no clear evidence for this was found in the form of elaborate pierced grille covers where only straight sections were found. Since all of the ducting voids had been rubble-filled it may be that the section which lay around the pool was otherwise filled and had no grille.

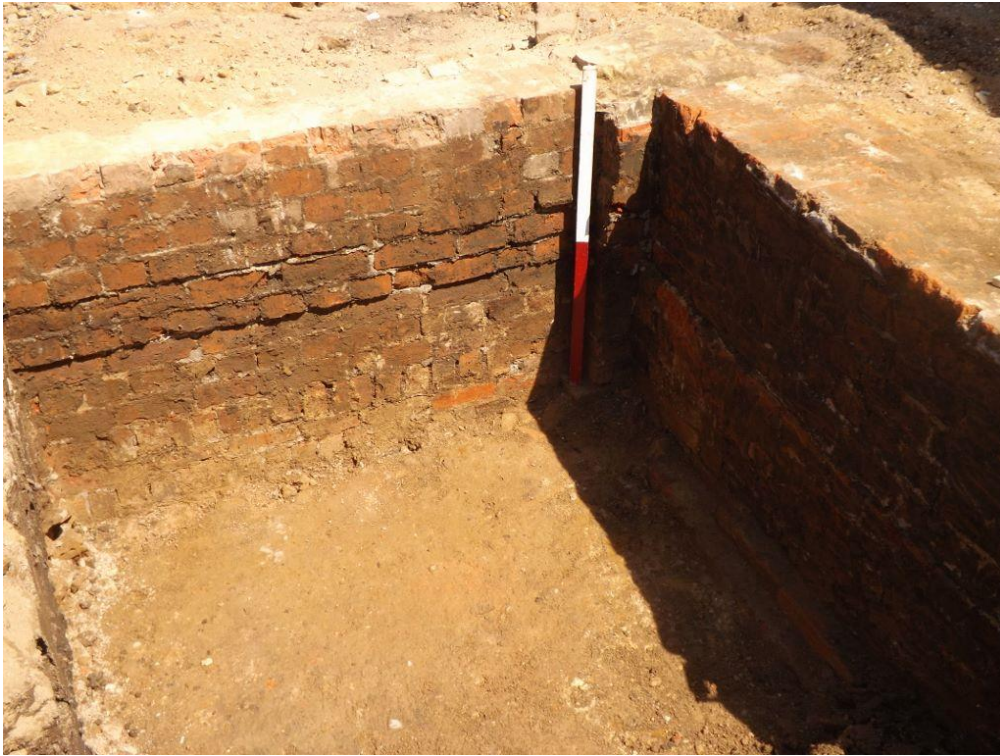
Fig 27: A 13 brick-courses deep sondage into the eastern planting bed. Bottomed on a sloping bed of white limestone fragments, it was filled with thick black humus. At the rear is a brick plinth supporting one of the columns; scale 1m

The planting beds contained deposits of dark, almost black soil which would have been artificially enriched with humus to provide high levels of nourishment for the plants grown in them. They were 1.1m deep, sloped slightly from the edge and the bases contained large quantities of limestone rubble for drainage, packed in clay. Throughout the planting bed was a relatively large quantity of broken flower pot; its presence here may represent either deliberate addition for additional drainage along with some casual loss from crocking whereby smaller fragments may have become incorporated into the soil when plants were transplanted from pots into the main bed.

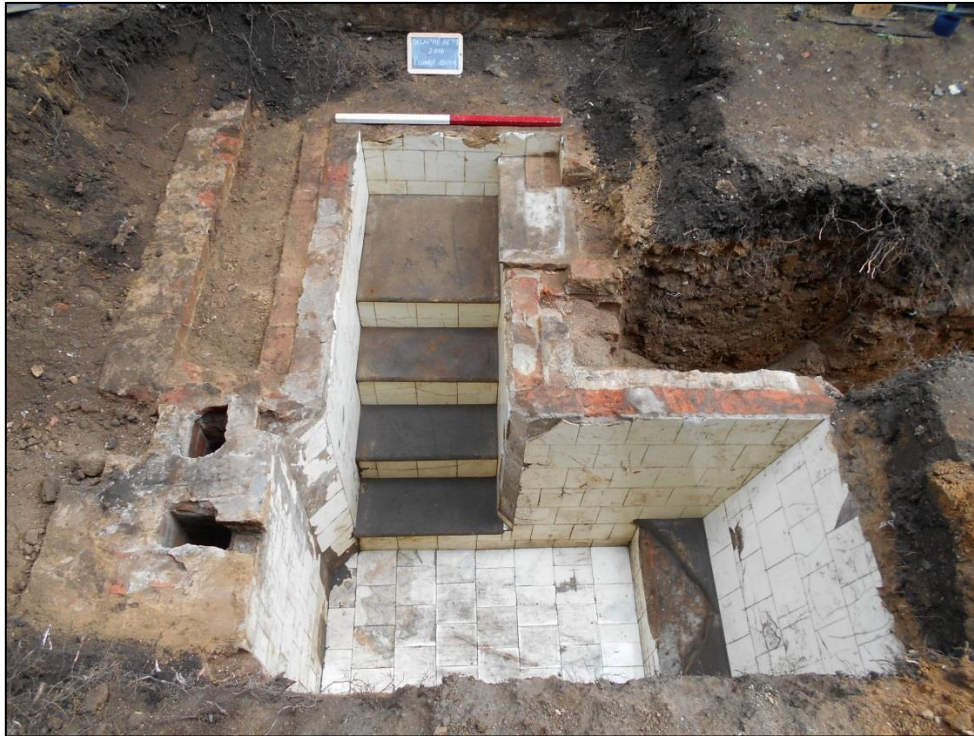
Fig 29: The plunge bath, looking south. Abbey north range to top; 1m scale.

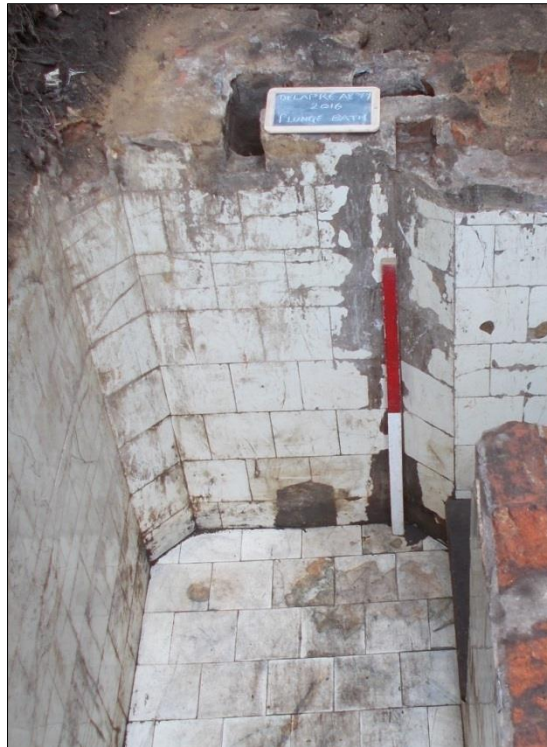
Fig 30: The former tap and drain locations in the east wall of the bath, looking east, 1m scale.

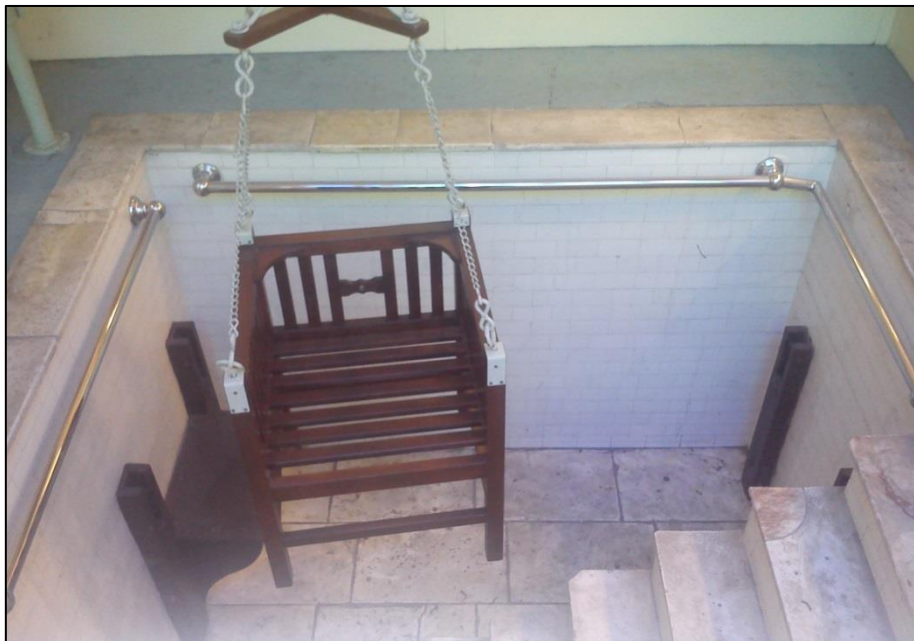
Fig 31: A comparative plunge bath conserved amongst Victorian public examples at Buxton Pool Rooms, Derbyshire. Here an invalid chair is lowered in as an aide for the sick to derive benefit from the waters.

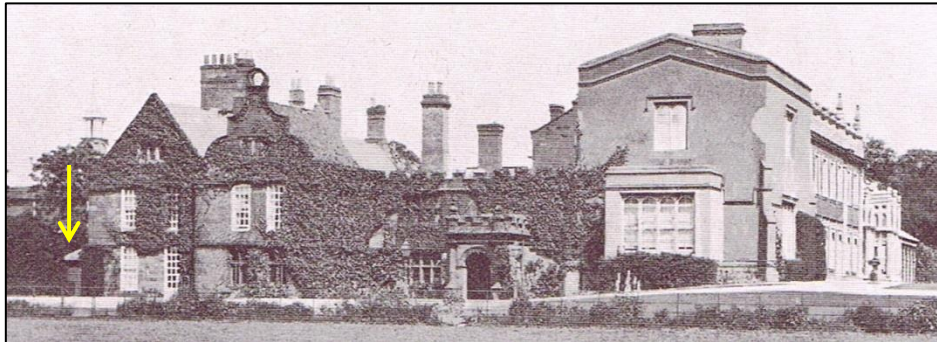
Fig 32: A photograph, from before 1901, shows the plunge bath building (arrowed). Note also the Conservatory at far right.

The principal evidence for the form of the building above the Delapr  plunge pool survives in the form of map evidence. The date of the construction of the bath house is uncertain although the 1885 Ordnance Survey map (sheet XLV. SW, surveyed 1883-84) shows a small building present against the north wall of the north range. By the publication of the 1901 Edition that building is gone indicating that it had been demolished and totally removed between 1885 and 1901. It is shown, although to no great effect, on a photograph (above), which also shows the contemporary conservatory.

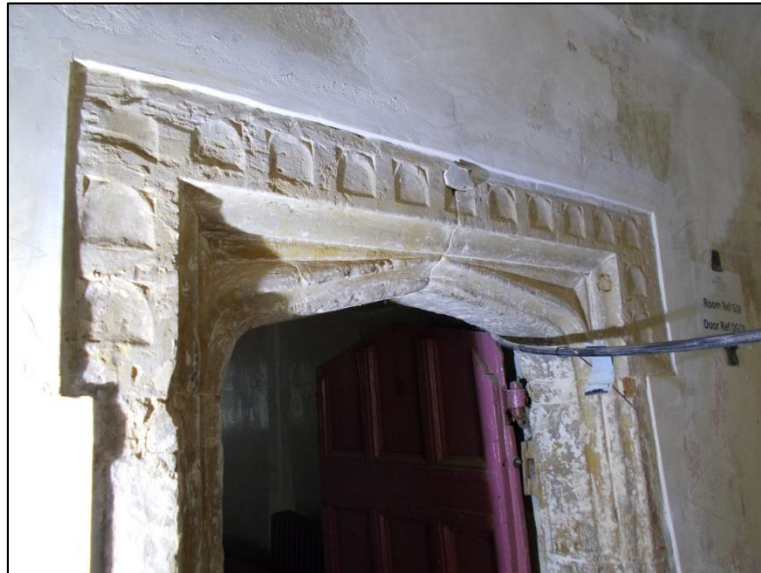
Fig 40: Fifteen tiny blind arches - stone detailing exposed for the first time for many generations in the north 'cloister'. Now believed to be possibly a monastic doorway.

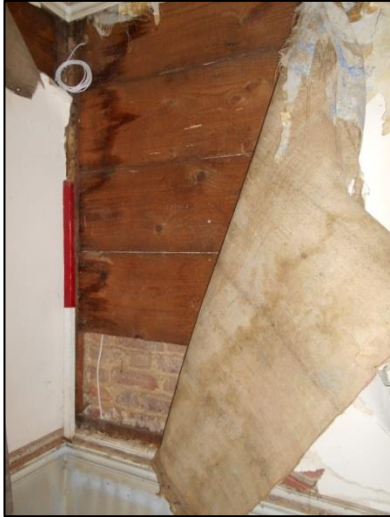
Fig 42: F3 The full sequence, hessian peeled back;
Scale 1m

The walls of F3 were originally panelled throughout, but of which only a few rails and muntins survived. Between these vestiges had been erected vertical softwood planking, with a hessian-type fabric stretched over it. Over this fabric had been stretched wallpapers. A white marble and wooden fireplace in the east wall is distinctively 18th-19th-century in origin with egg and dart decoration and an overmantel for a picture, an assembly which in plan notably does not respect the framing of the floor. A chair rail, a picture rail and skirting board, all of which match the fireplace, respect the planking. It is likely therefore that the room-sequence for F3 is:

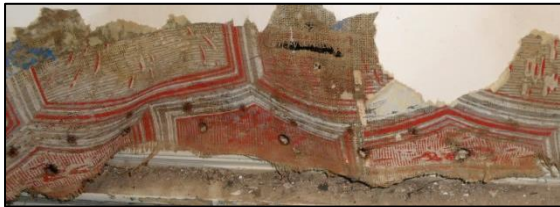
Fig 44: F3 – 19th-century wallpaper on hessian

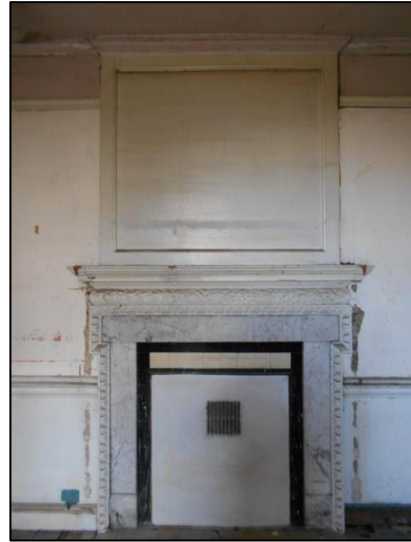
Fig 45: F3 The full sequence complete.

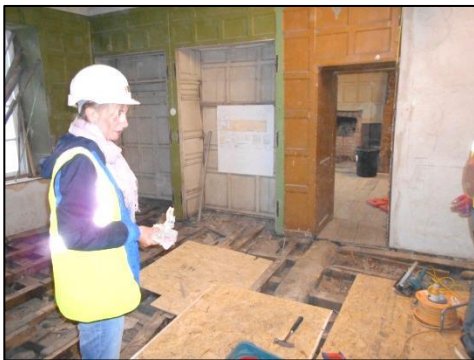
Fig 47: Room F9 looking east into F10. Note the cobbled-together panelling infilling a former fireplace left of centre

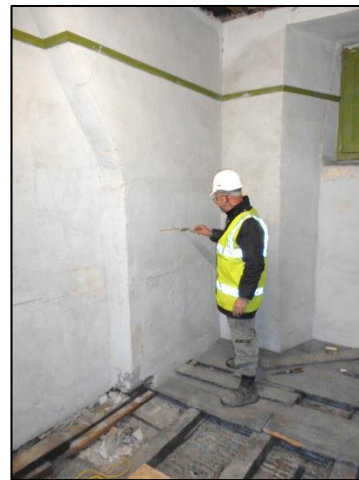
Fig 48: Room F9, discovering a hidden fireplace in the south east corner of the room; note the angled flue to top left

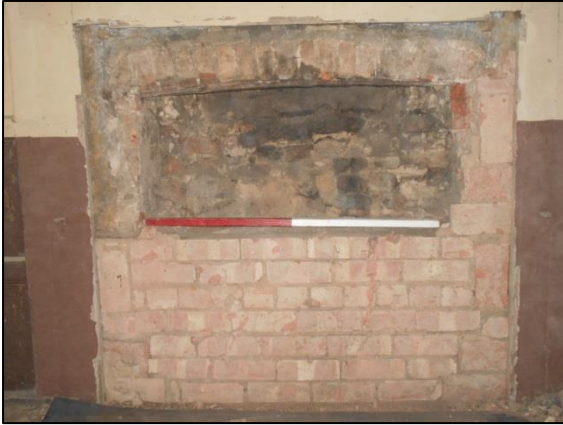
Fig 49: The reduced and blocked 17th-century fireplace in the east wall of F10; scale 1m

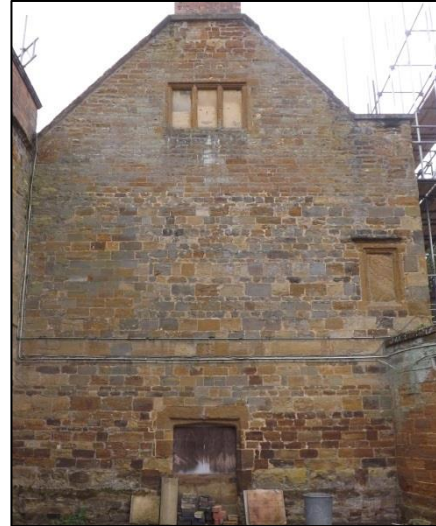
Fig 50: East end of the north range. Note at right the small blocked window which once opened into F10 next to the fireplace

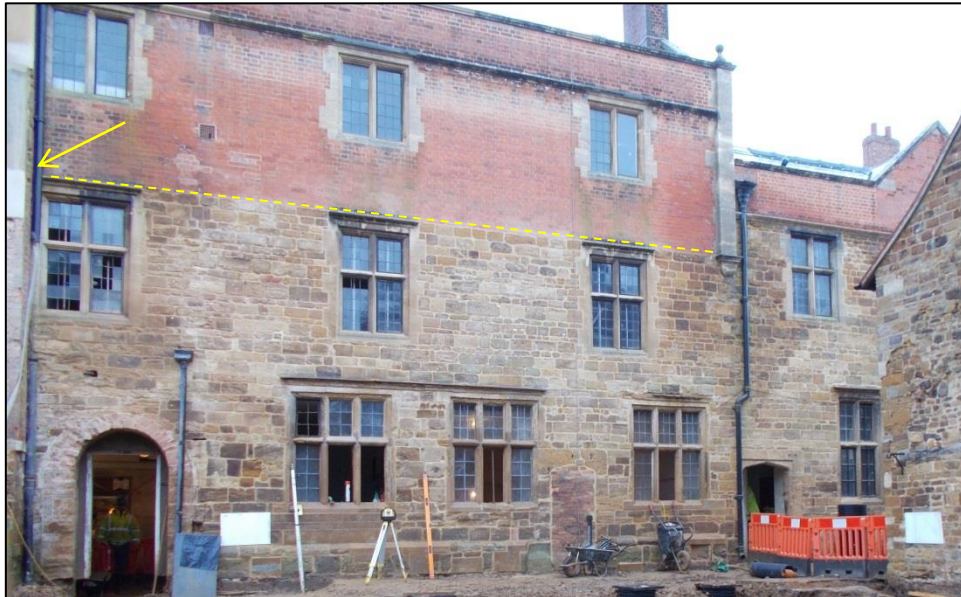
Fig 51: The majority of the East Range's east face, in a view briefly opened up by the archaeological excavations and then only possible after the scaffold cradle had been taken down. Note the added top floor in brick. The interior location of a gable kneeler (illustrated below) is arrowed. Supposed medieval doorway below.

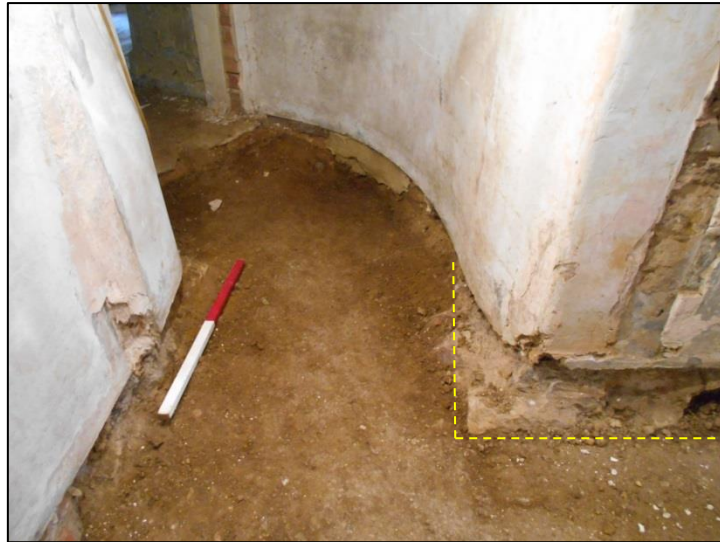
Fig 52: Floor reduction in G5; the curved corridor (looking north) shown to be an adaptation of a more angular access, linking G5 through G6 and into G7, the changes covered by render; scale 1m

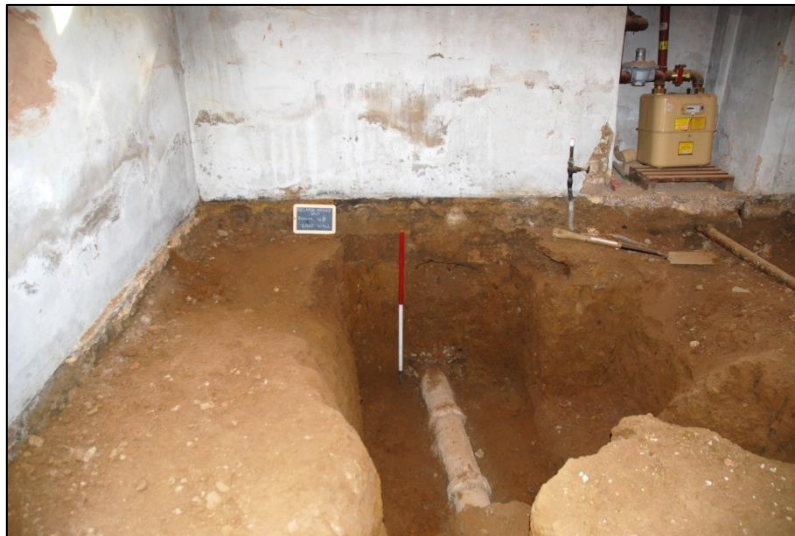
Fig 53: Floor reduction to natural geology and old services in Room G7, looking east to the outer wall. No earlier levels had survived; scale 1m

This work exposed natural geology almost straight away and showed that no archaeological deposits were present.

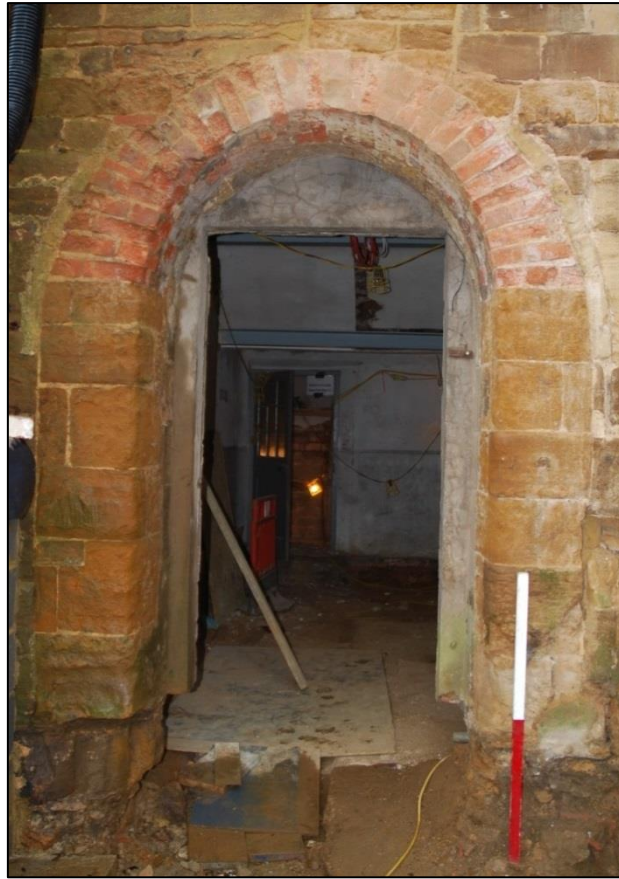
Fig 55: Supposedly medieval in origin, no new evidence was uncovered to support assertions as to the east doorway's 12th-13th-century monastic origin; scale 1m
