Iain Soden Heritage Services Ltd

**Archaeological monitoring, excavation, building
recording and analysis at Delapré Abbey,
Northampton 2014-19**

Archaeological monitoring, excavation, building recording and analysis at Delapré Abbey, Northampton 2014-19

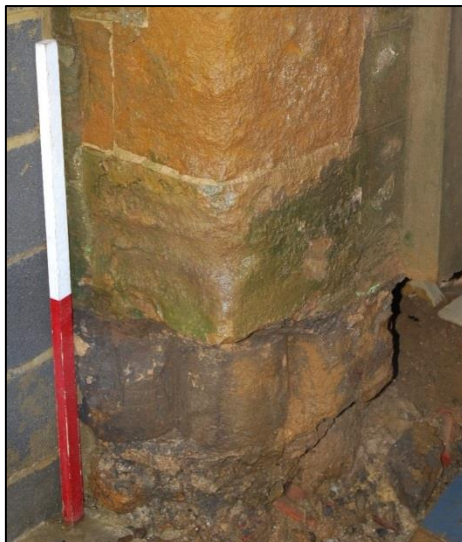
Fig 56: Base of the southern jamb to the eastern doorway, with medieval roll-moulding. This is the best evidence for a late Romanesque/Early English origin. No counterpart survived on the north side; Scale 1m

While most of this doorway is in fact a later, plain approximation within a distinctively round-headed Romanesque-style arch (with possible stone drip-moulding faced off), the new work uncovered the base of both jambs for the first time. One was decayed, but the southern example contained an *in-situ* clustered roll-moulding indicative of a 12th-13th century date. Although it has long been the best candidate for (upstanding) earlier medieval stonework, it is not certain that it is entirely *in situ*.

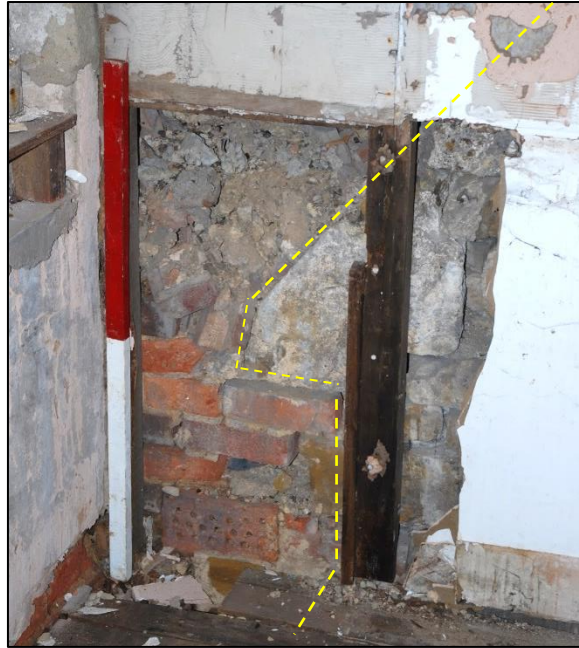
Fig 57: In-situ kneeler low in the east corner of the south wall of room S9; scale 1m. Its presence shows that the original junction of lower (first floor) eaves in the east and south ranges in the early 17th century onwards must have been configured in a separate gable. The addition of a second floor in brick covered this up.

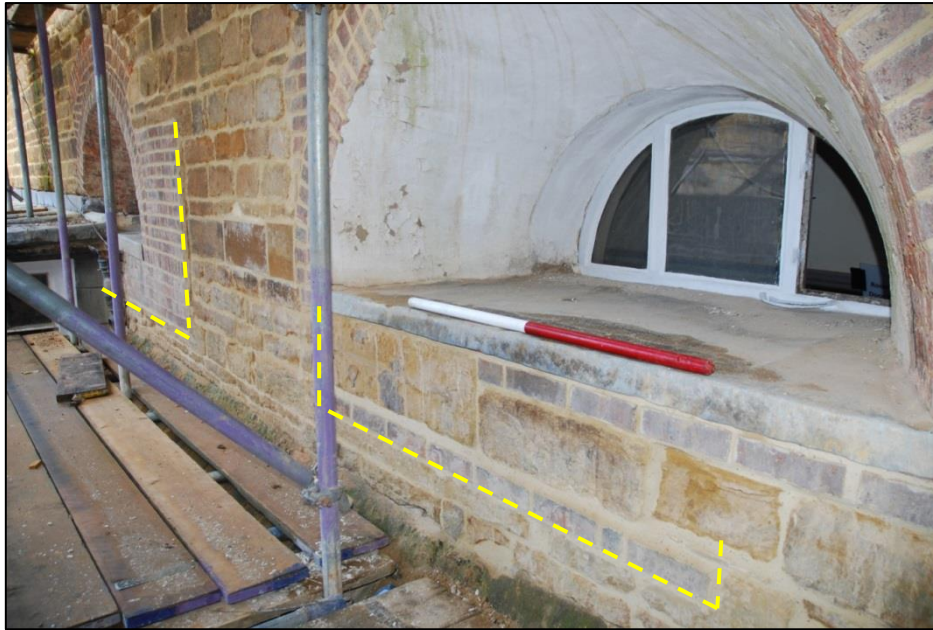
Fig 58: Two courtyard-facing lunettes replaced earlier stone-mullioned windows (dashed), view looking north-east; Scale 1m

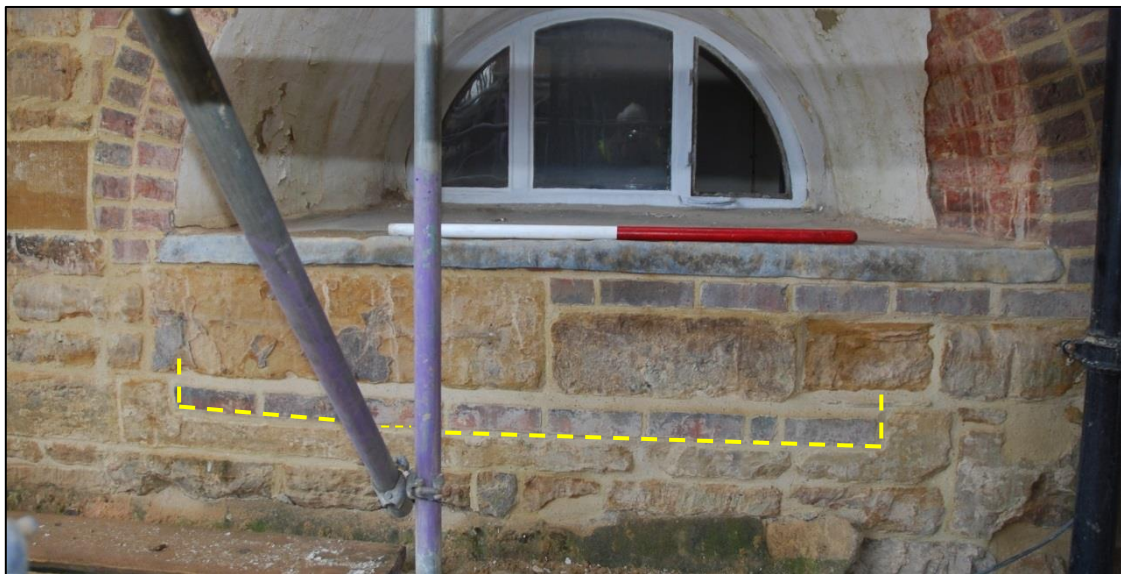
Fig 59: Another, more oblique view of the more southerly of the two lost window locations (dashed), view looking east; scale 1m

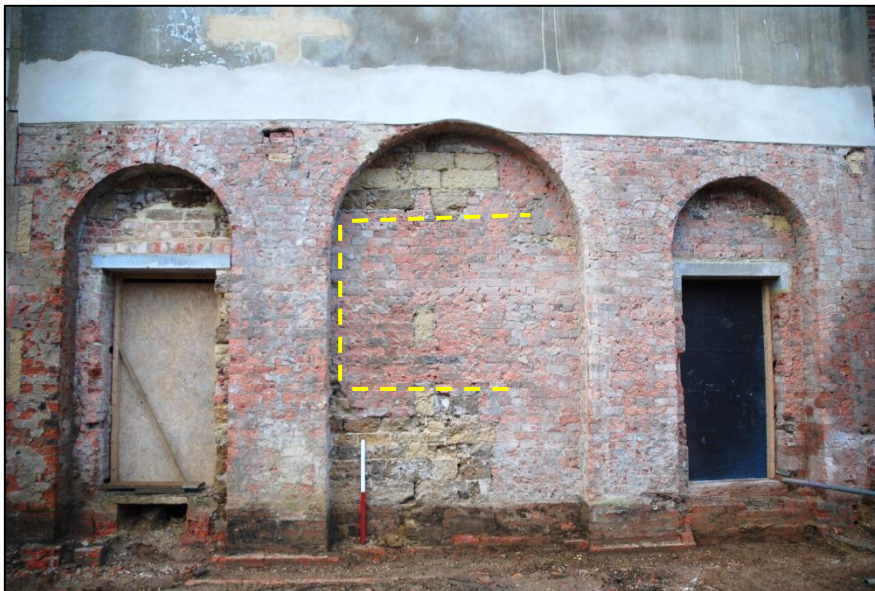
Fig 60: Looking west, applied brick buttressing used to add solidity to the old 17th-century gable end when it was increased in height in the 18th century. With 1.6m+ of unstable build-up on this (east) side, and a basement on the far (west) side, stability was paramount. Some remnants of the former stone gable were left where they could be, where build-changes suggest a former window location (dashed); scale 1m.

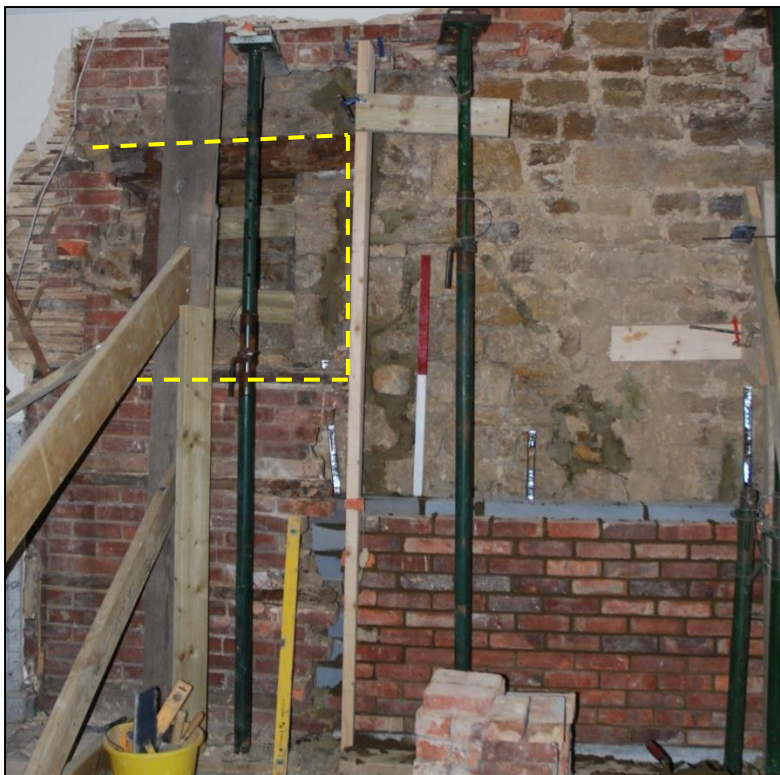
Fig 61: East wall of Room F30, with the old stone fabric and window (yellow) made good in brick with lacing timber courses. Hastily opened up and propped in 2016, the collapsing wall was substantially rebuilt from the inside; scale 1m.

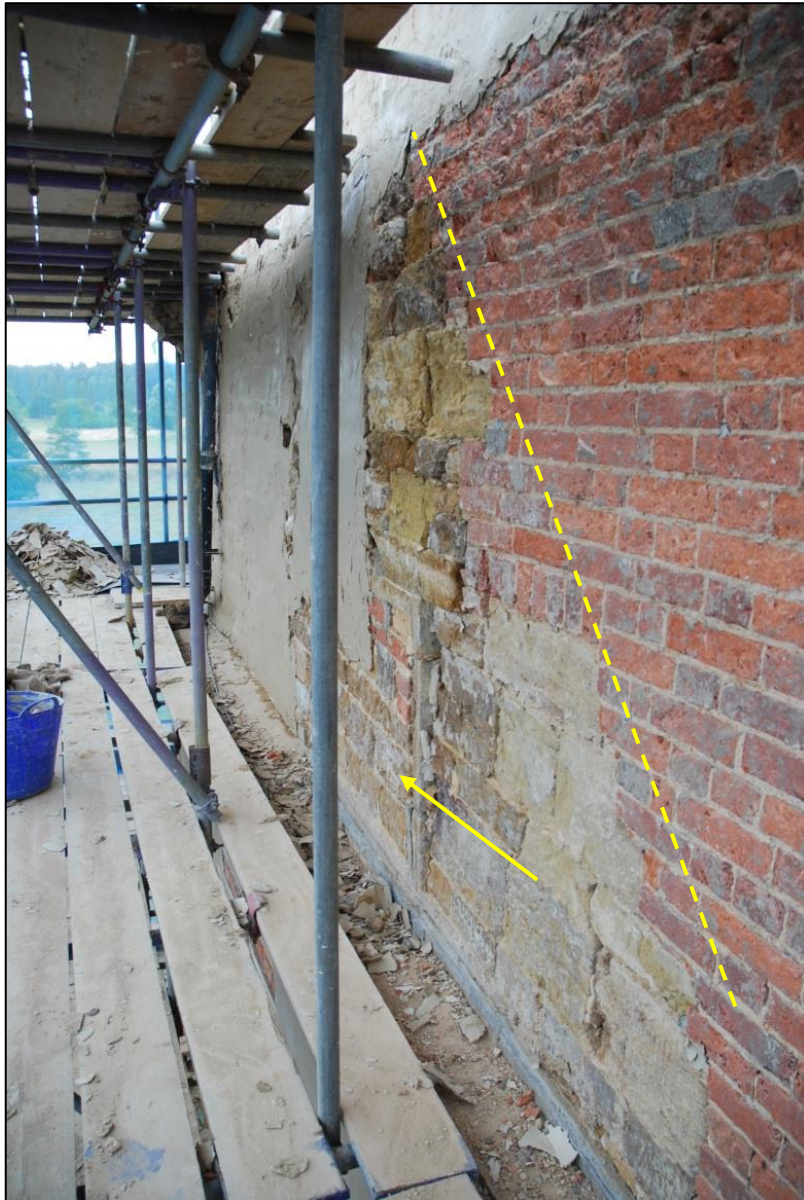
Fig 62: First floor blocked stone-mullioned window (arrowed) formerly looking east from Room F30. It looked out over the open site which would become the Victorian conservatory. Note the angle of the 17th-century stone gable.

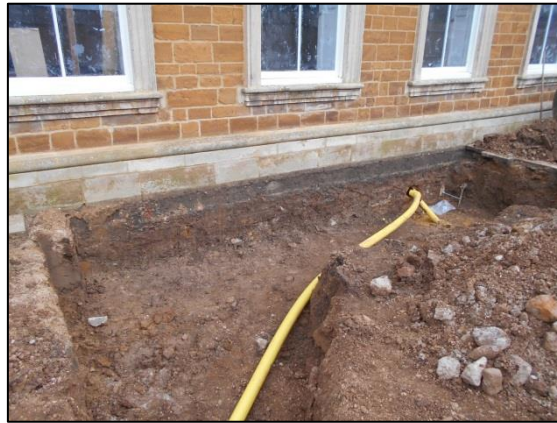
Fig 63: New services entering high in the basement wall of B5. Here Test pit G2 in 2014 noted 18th century destruction material (17th century fragments) at 1.2-1.5m below the modern ground surface (Soden 2014). Natural ground is 1.8m below the current ground surface.

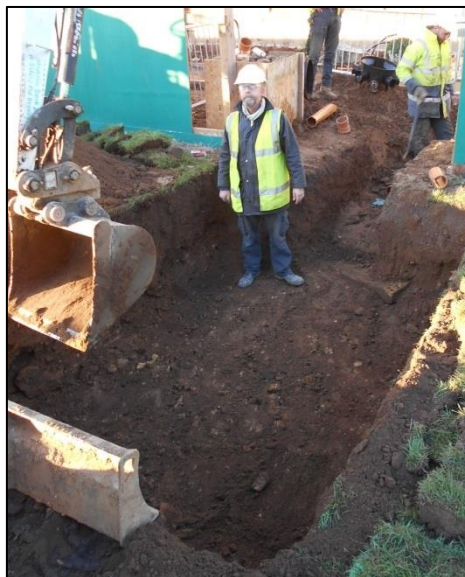
Fig 64: Digging the South Front soakaway. 1m down and still in 19th-century material, some 5m away from the South Range. Scattered medieval architectural fragments occurred at 1.4m down.

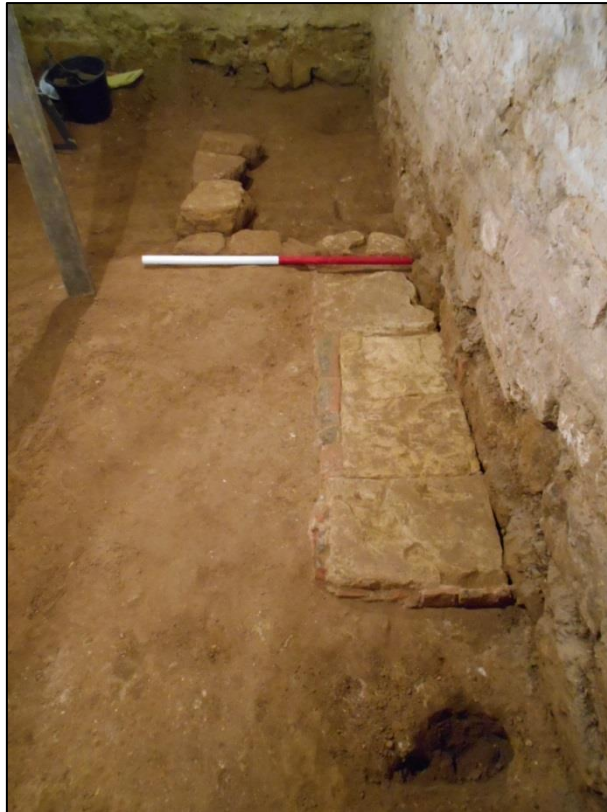
Fig 66: B6 excavated. View looking east in B6 showing the neat, carefully-edged tile arrangement (bottom step of the stair) under the 1750s spine wall, a dwarf wall of ironstone beyond, and, in the foreground an animal burrow which contained a clay tobacco pipe bowl of c1680-1700; scale 1m

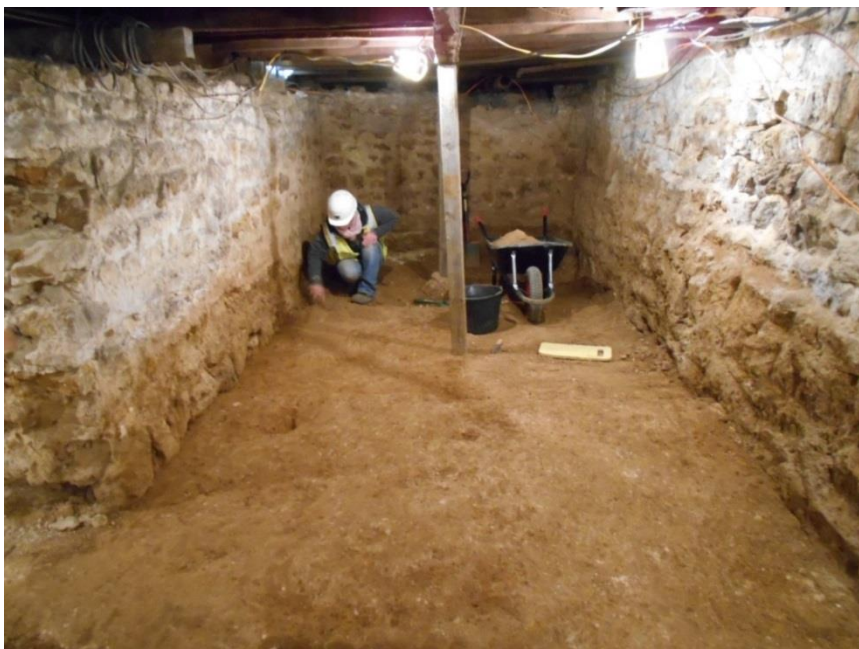
Fig 67: B5 excavated. View looking east within the emptied B5, during cleaning of the natural ground surface; the spine wall, broken through to link B5 and B6, is to the left. This level was then further reduced by a metre to create the new Plant Room. Sand-staining part-way up the walls marks the former height of removed debris.

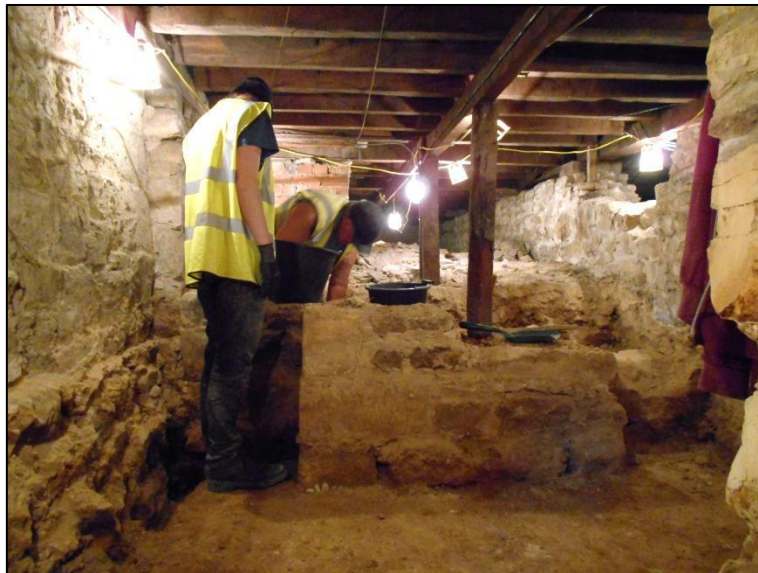
Fig 68: View east in B6, Danny and Will during evaluation of the thick debris-layer, here visible in the background. Buttressed 17th-century wall in the foreground.

First seen in Test Pits in 2014, and strewn liberally over all areas of these basements was a dense layer, up to 800mm thick, of finely-comminuted and dry debris which had been allowed to accumulate at a time (or times) when the ground floor, and possibly floors above that, had been temporarily absent. Thus it had accumulated when there had been building work, maintenance work, demolition work (and the likes) above. It contained no soils whatsoever, but was composed of a dense but un-bound matrix of sand, dust, mortar, plaster, wood chips, brick and tile fragments, Collyweston-type stone tiles, and ironstone fragments.

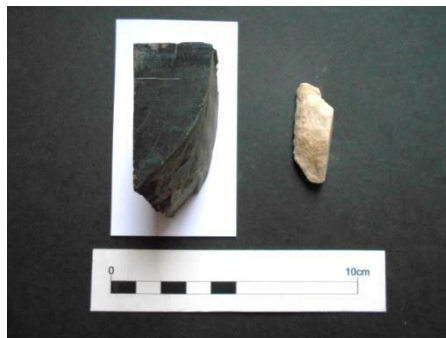
Fig 69: Fragments of marble; scale 10cm

7. Plain medieval floor tile fragment (B5)
8. Two small fragments of window glass (B6); five further fragments from (B5)
9. Fragment of black marble (B5) and fragment of white statuary marble (illustrated below)

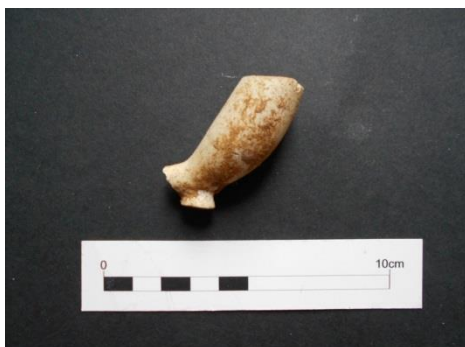
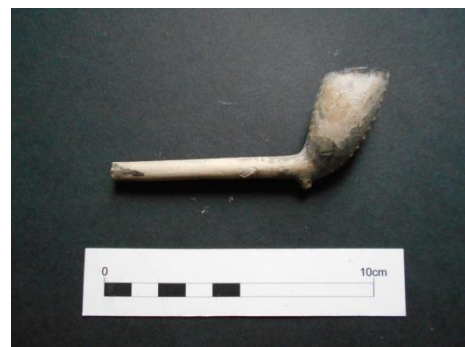
Fig 70 : Two clay tobacco-pipe bowls of late 17th-century / early 18th-century form from basement B5; scales 10cm

10. Two complete bowls and ten stem fragments of clay tobacco-pipes of 18th-century form (B6); a further four stem fragments and two bowl fragments from (B5) (illustrated below); a broken clay-tobacco pipe bowl from an animal burrow in (B5).

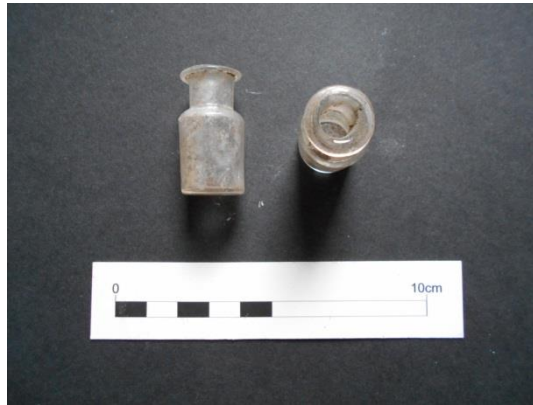
Fig 71: Glass phials from basement B6, possibly for pigments; scale 10cm

11. Two small complete glass phials (B6) (illustrated below)

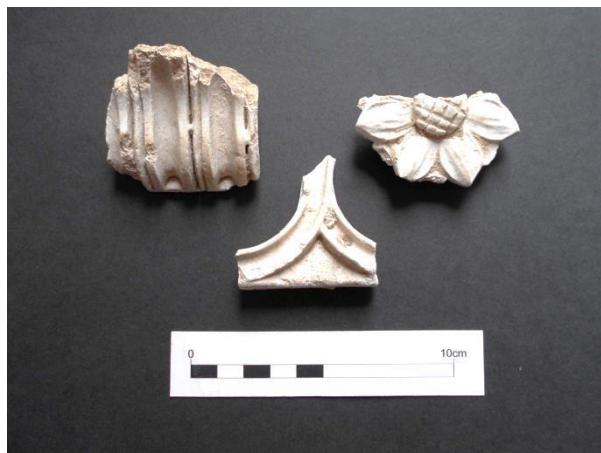
Fig 72: Decorative plasterwork from basement B5; scale 10cm

12. Rodent-chewed hazelnut and plum-stone (B6)
13. Base of a shaft-and globe bottle, 18th century (B6)
14. Eight fragments of broken but possibly unused plaster cornice fragments (all B5), comprising:
- One fragment of unidentified fragment of a fluted order on an ogee-profile, perhaps bordering a larger panel or as part of a cornice
 - One fragment consisting of half a flower with six petals
 - One fragment of border with raised repeated dots
 - Five fragments of guilloche

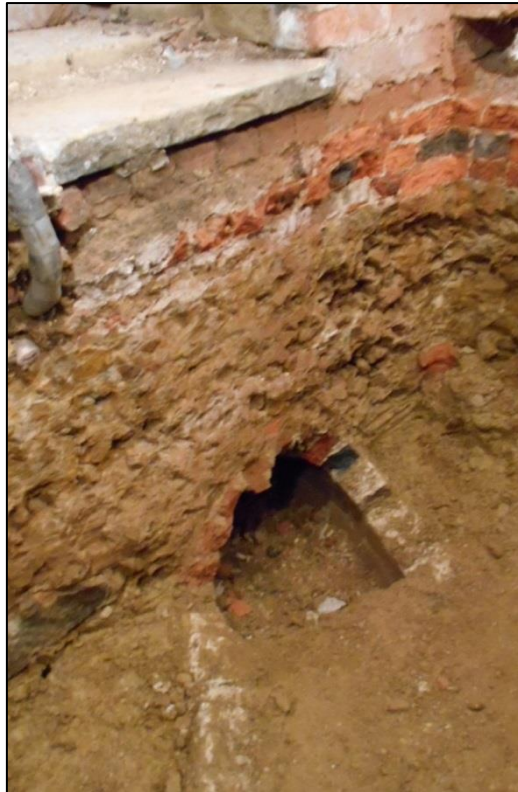
Fig 73: The library conduit where it entered from the courtyard's south-west corner, 1m below courtyard level.

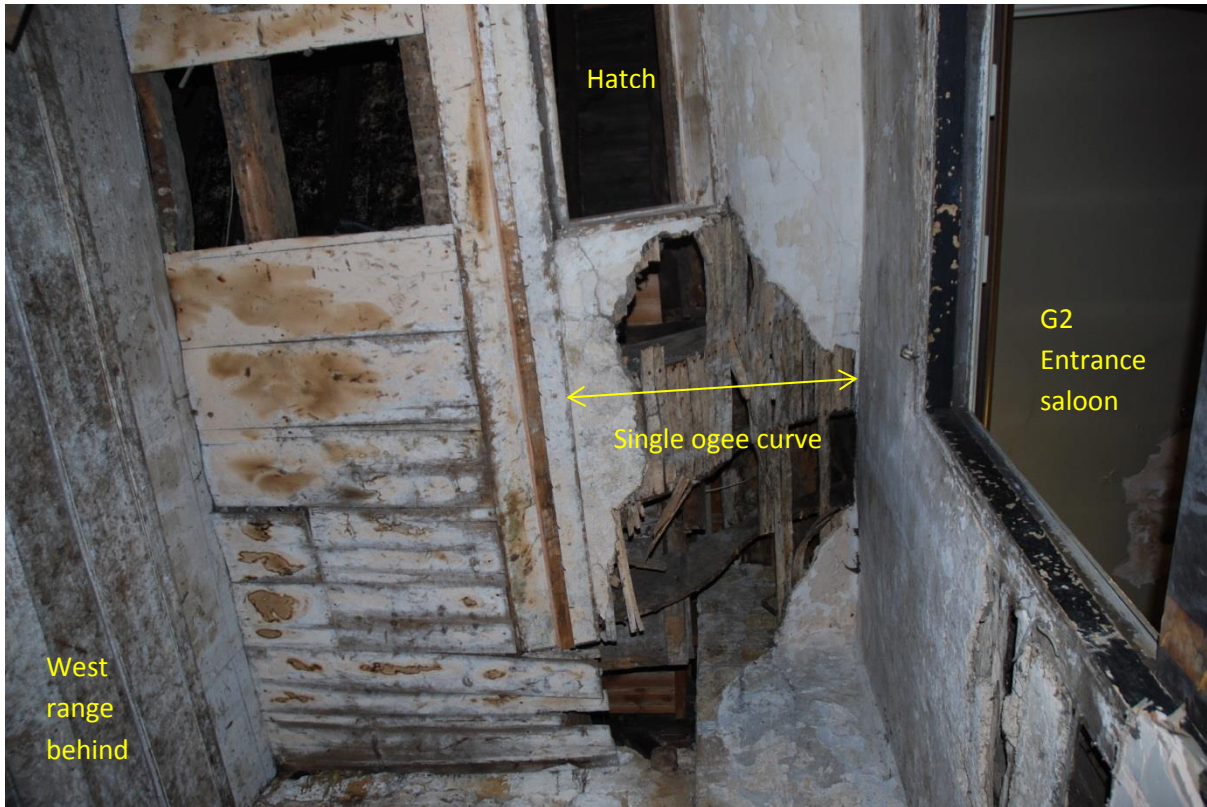
Fig 74: View directly up within G14, showing the underside of the former grand stair into the 1750s South Range when built.

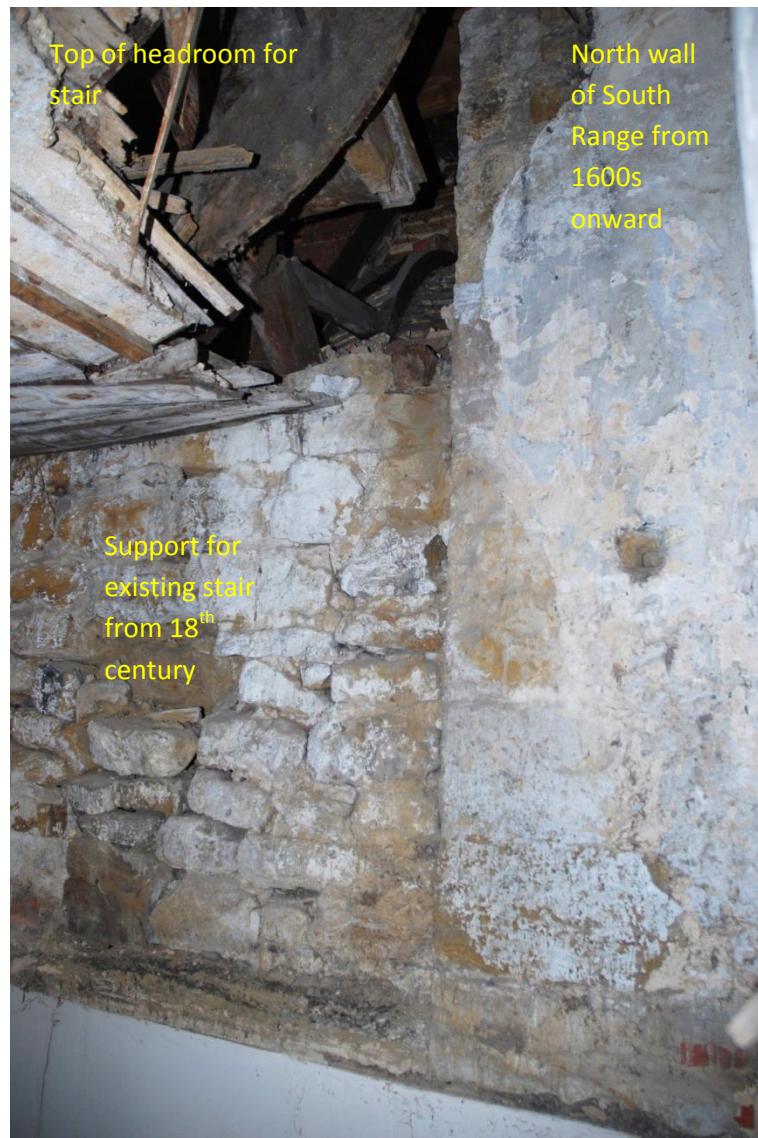
Fig 75: Phases present in G14; note the vertical butt-joint and the curved wooden former creating half an ogee

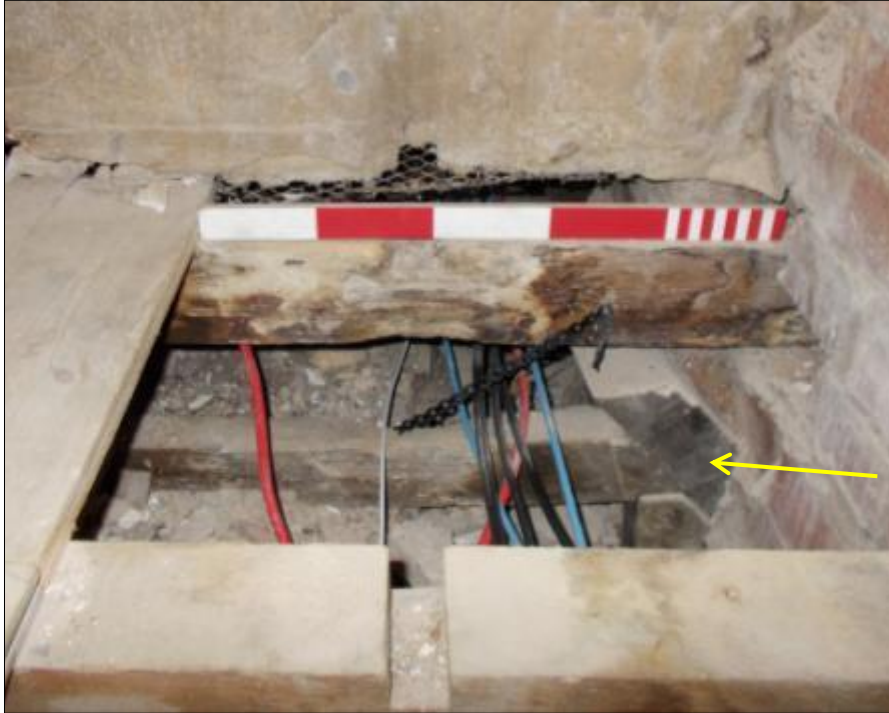
Fig 78: Sawn off rafter beneath the floor of F23 (arrowed); scale 50cm

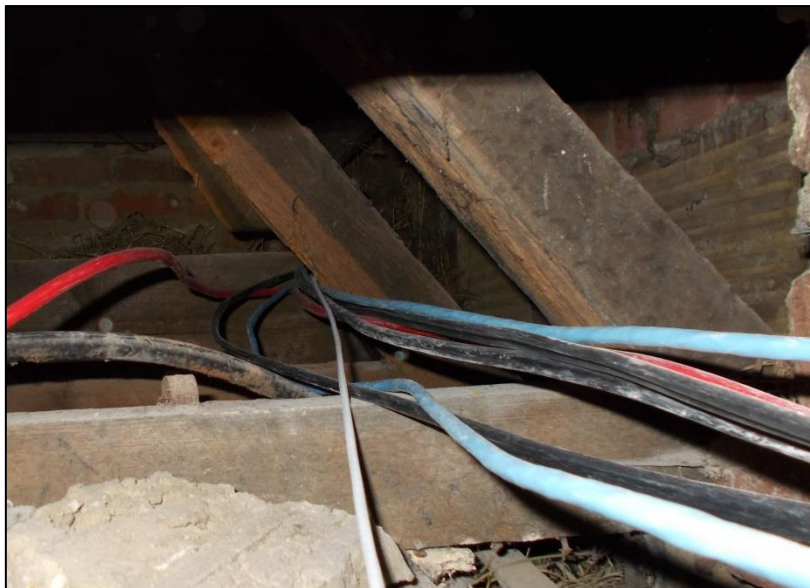
Fig 79: Glimpsed row of truncated rafters of a former, probably seventeenth-century, oak roof structure beneath the floor of rooms F23 and F24, looking west under floorboards.

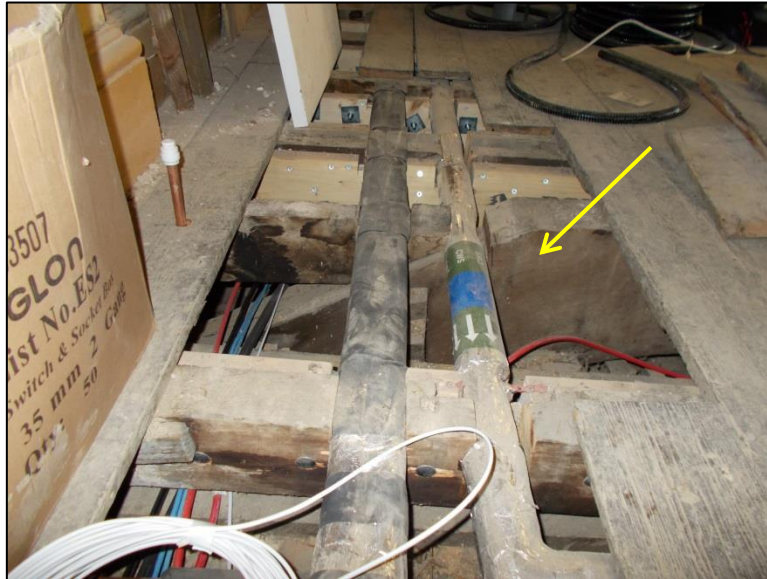
Fig 80: North end of a tie beam hidden below the floor of F23 (arrowed). Its camber (centre-left) matches the angle of the sawn-off rafters.

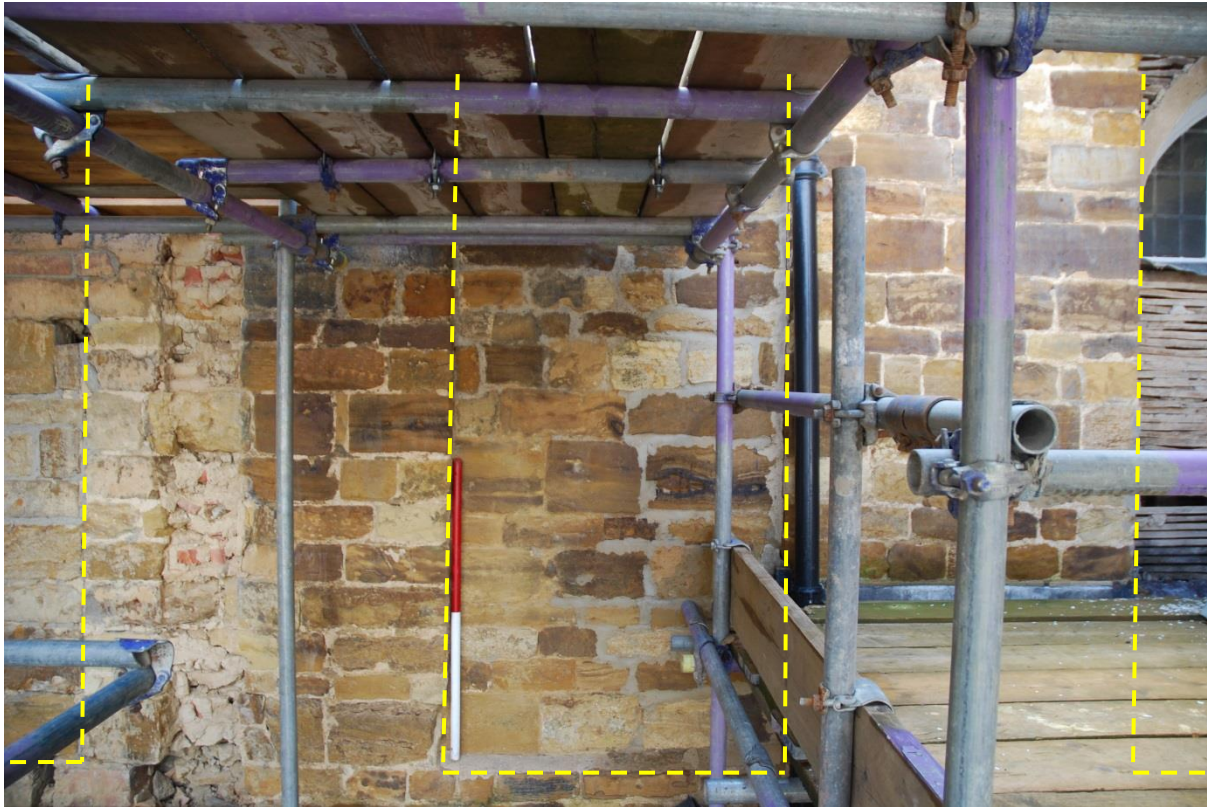
Fig 81: Behind the scaffold cradle lies a row of three former (probably) sash window locations (marked). There is a single replacement lunette (right); scale 1m.

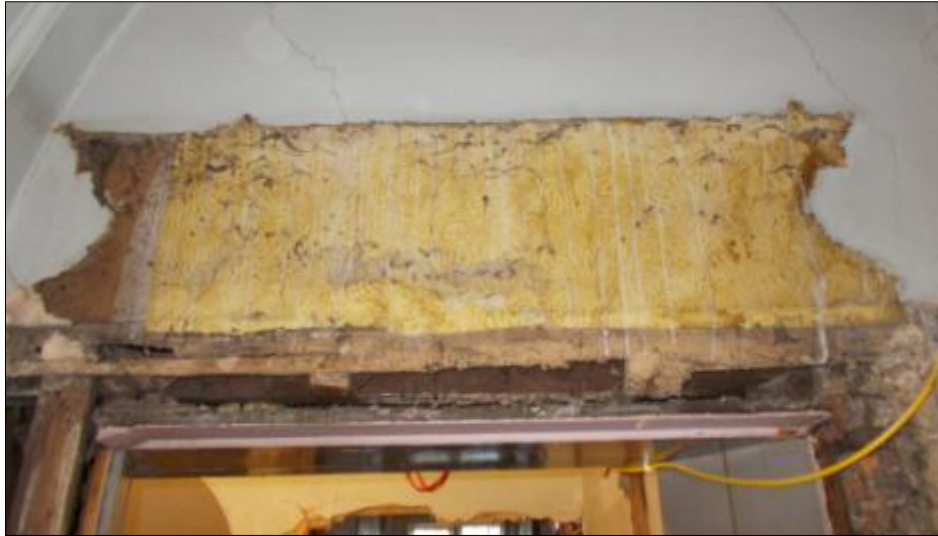
Fig 82: Nineteenth-century wallpaper behind later timber pediment. Room F27, looking east.

During the removal for repair of a late nineteenth-century over-door pine pediment a fragment of nineteenth-century wallpaper was observed. The paper retained a pattern in shades of yellow of a floral design.

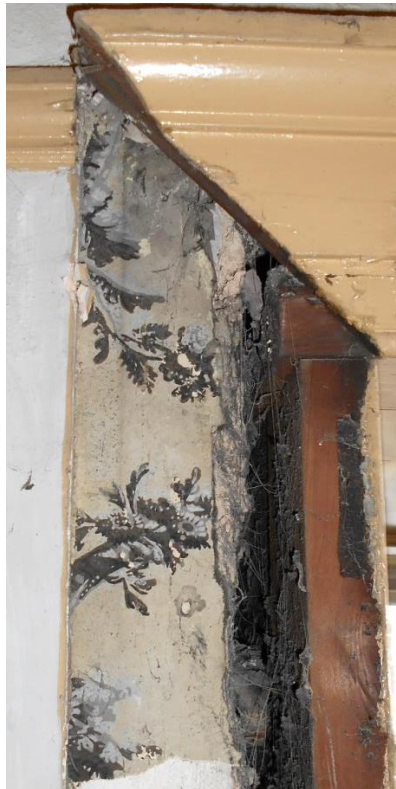
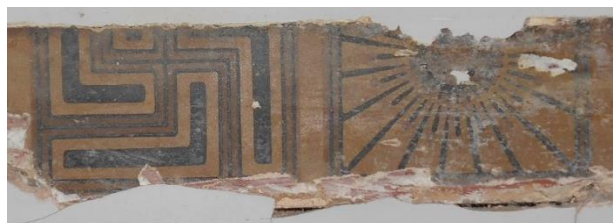
Fig 83: Two wallpaper fragments found under door architraves and photographed before loss.

Similar 19th-century wallpaper fragments were located and photographed in F3 of the North Range (see above). Also slivers of paper, either later 19th century or early 20th century, were found preserved under architraves which were removed.
