Archaeological Building Recording on a former farm barn at Twywell, Northamptonshire

Joe Prentice

Former barn at High Street, Twywell

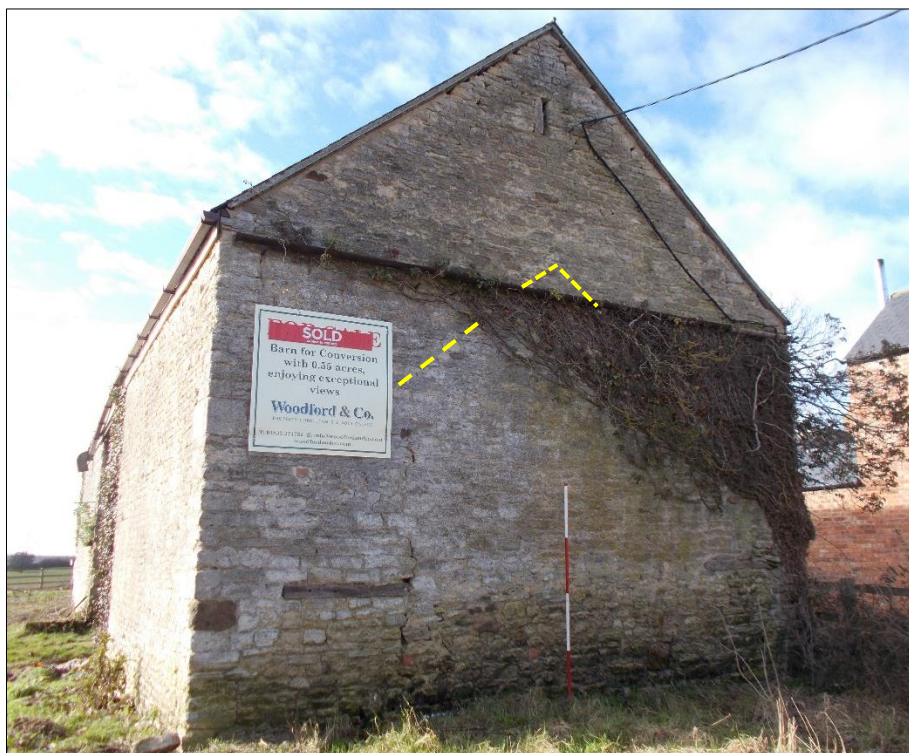
This elevation lies parallel to the High Street and it was against this end of the building that other structures are shown on the nineteenth-century Ordnance Survey maps (see Fig 3). No indications can be observed of those former structures in the current ground surface, but a faint flaunching scar indicates that the building attached to the gable was of a single storey with a pitched roof (Fig 5).

Fig 5: The north gable showing the flaunching scar (dashed yellow line). Looking south. 2m scale.

Recent ivy growth obscures much of the west side of the elevation so the remainder of the former roof line cannot be observed on that side. On the east side the lower limit of the former roof line is weathered away and can similarly not be seen. There is no indication that the former building was bonded into the present barn since there are no scars of stones being keyed into the gable wall. This suggests that the single-storey structure was a secondary addition.

In the apex of the present gable a narrow slit is present. It appears that this was intended just for air circulation and not as an owl-hole since the latter are usually larger, often triangular or square.

The only other structural elements visible in the elevation are two horizontal timbers, apparently bonding timbers, both of oak. Each is present approximately 1.1m above the present ground level; similar timbers are visible within the barn (see below).

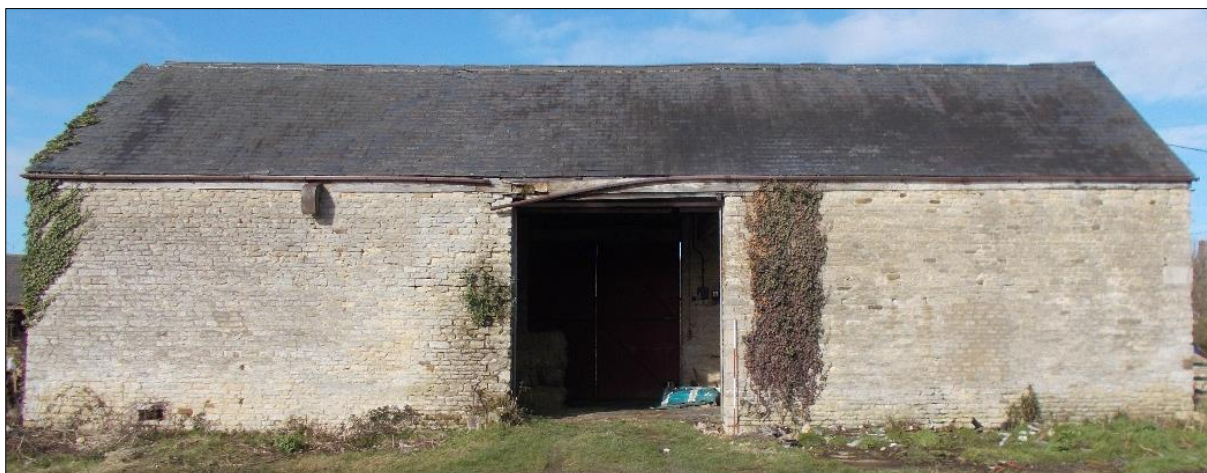
One of the two long sides of the barn, this elevation is constructed of the same materials as the remainder of the building (Fig 6).

Fig 6: The east elevation, looking west. 2m scale.

Comprising two plain walls with a central full-height cart door the elevation is remarkably plain. There is no obvious indication of the narrow range of buildings extending from the south-east corner which is depicted on the 1899 Ordnance Survey map.

Apart from variable cement patching to the mortar courses, a small modern (twentieth-century) opening close to the ground level near the south-east corner and an iron sheet-metal vent beneath the eaves, the two wall surfaces are plain. It is presumed that originally the full-height door would have been fitted with hinged doors though nothing of the framework remains. There is evidence that the opening was subsequently fitted with a sliding door system since a metal channel remains within the door sill although nothing of the top rail survives.

The present roof is covered with blue slate and the rainwater goods are of modern plastic.

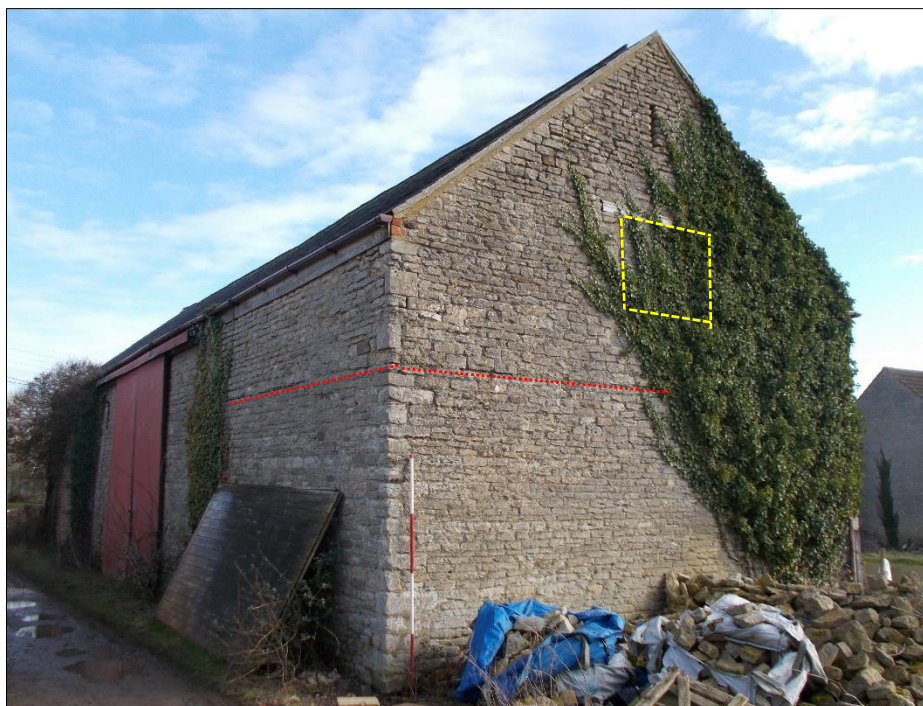
The south gable wall is constructed in the same way and of the same materials as the remainder of the building but originally had a high-level opening, currently now mostly obscured by ivy on the exterior (Fig 7).

Fig 7: The south gable and west wall, looking north-east. Infilled opening highlighted with yellow dashed lines. Level of iron sheet indicated by red dotted line. 2m scale.

The former opening, now infilled with modern blockwork, appears to have been most likely a hayloft door or window, allowing fodder to be deposited into the barn from the outside from the level of the cart, drawn alongside the gable, during the summer months. The opening retains its external timber lintel, visible from the interior and identifiable as a re-used railway sleeper. This re-use probably indicates a later replacement. Above, in the apex of the gable is a narrow ventilation slit.

Visible along that part of the gable not covered with ivy (and also seen on the east and west walls) is a curious horizontal sheet of thin iron sheet which extends around the whole building (see Figs 7 and 8). Where it is present the mortar has often eroded slightly more than elsewhere. At first thought to represent a line of flashing, perhaps for lean-to extensions, this sheet can be seen in the jambs of the cart doors and also in places within the barn interior. Thus, it is clear that this sheet extends through the whole thickness of the wall around its whole circuit. Its purpose is unknown; the author has not seen its like before, either on other farm buildings or domestic properties. It is too high, and too early in date, to have been inserted as a form of damp-proof course and if used as a temporary covering during building (perhaps reflecting a seasonal break in construction) there seems no reason why it was not removed when building re-commenced.

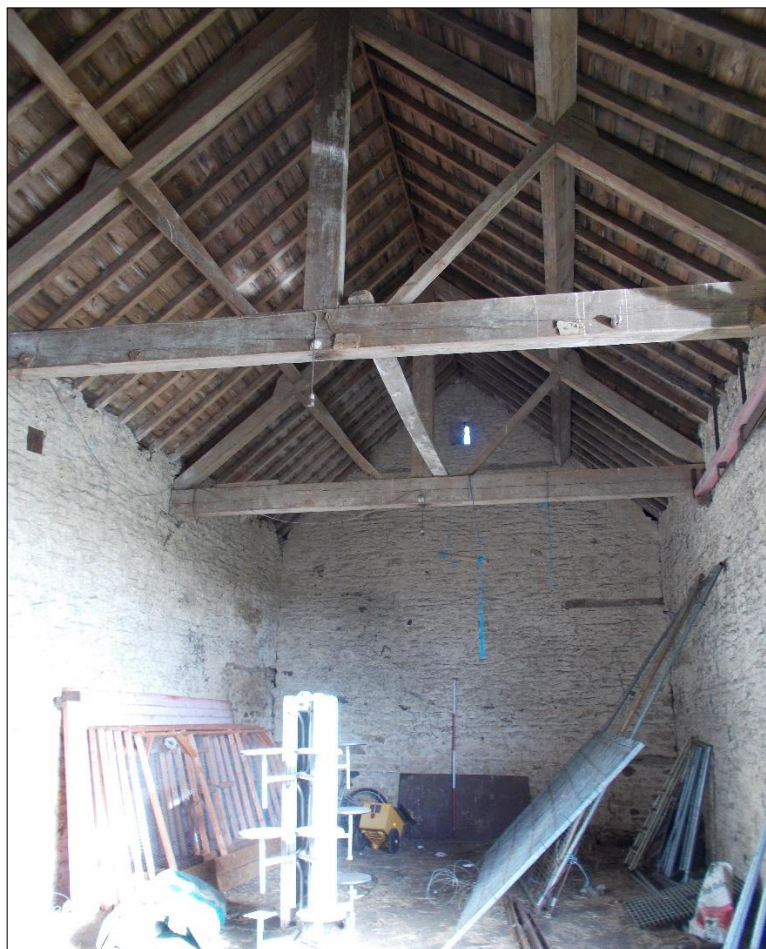
Fig 9: The interior, looking north. 2m scale.

The present floor appears to be a form of bitumen or pitch and there was no visible indication of any earlier surface. It may be that the floor was originally simply packed earth, although other materials could have been used depending on intended use.

The walls are composed of coursed limestone rubble with buttered joints, and there is no evidence that the surfaces were lime-washed. This is usually present when livestock was housed within such buildings as it has a mildly antiseptic property as well as increasing reflected light at a time when the only form of illumination was daylight or lamplight. There is also no lamp niche present inside either of the door openings. Occasional timbers are set within the wall planes adjacent to internal corners as ties; all appear to be of oak.

The roof is supported on four king-post tie-beam trusses of identical form (Figs 4 and 9, Cordingley 1961, fig 11 Vb, 3a). The bottom of an iron bolt can be observed beneath the king-post on the underside of the tie beam indicating that it is secured with that fixing, though it may also be pegged, as may other joints. Each tie beam is set into the east and west side walls as are the bases of the principal rafters. These support a single purlin on each side, set above a cleat. Whilst the principal trusses do not lie exactly perpendicular to the side walls (see Fig 4), the secondary rafters do and are covered either with sarking boards or modern roofing felt where the former has been removed, presumably following deterioration. There is a simple ridge plank at approximately 6.80m above

present floor level. All timberwork appears to be of pine, some retain striations from circular (mechanical) saw blades.

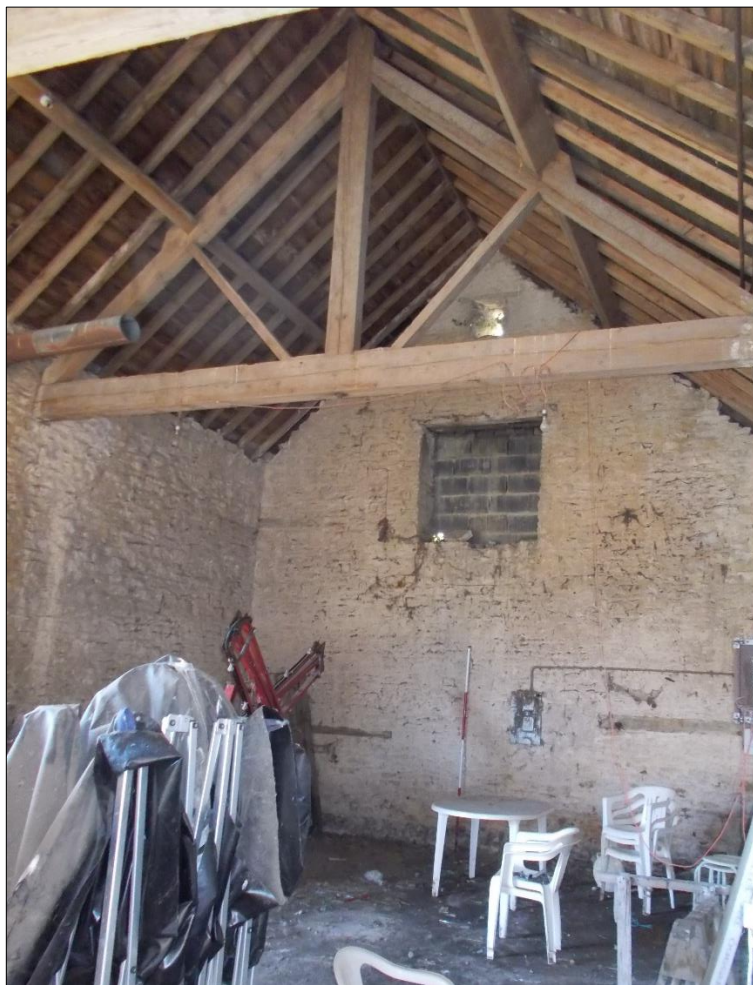
In the south gable the interior dimensions and location of the hayloft door or window can be seen (Fig 10). Its sill is located approximately 3.3m above present floor level and the opening is approximately 1.4m high.

Fig 10: The south gable with hayloft door or window. 2m scale.

As previously noted, that opening is currently infilled with modern blockwork. The internal lintel remains and appears to be of oak. There are no side jambs of timber which might indicate the former presence of a door or window frame, though this may have been removed when infilled.

The ventilation slit is splayed and here the opening is spanned by a timber lintel.

Apart from modern fixtures for electricity and the internal end of the metal duct (see Fig 10, left side at eaves level) there are no other internal features or fixtures apart from occasional bonding timbers within the walls.
