An archaeological evaluation at the former Amalgamated Tyres site, St John's Street, Northampton

Former Amalgamated Tyres Site, Northampton

Iain Soden BA MCIfA

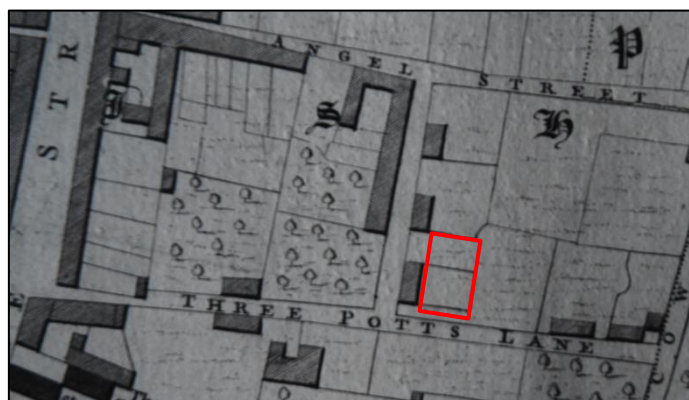
Fig 1: The site (approximate) on Noble and Butlin's map of 1746. Fetter Street was formerly much narrower and its historic frontage was lost when the street was widened eastwards

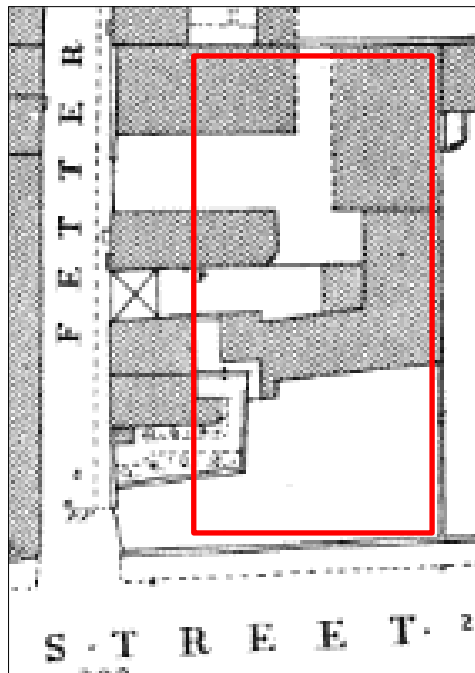
Fig 2: Fetter Street/St John's Street corner surveyed at 1:500 scale by the Ordnance Survey, 1885. The approximate site is outlined. Even at this date there is no cellar (or building above) on the St Johns Street frontage, such as was found in evaluation.

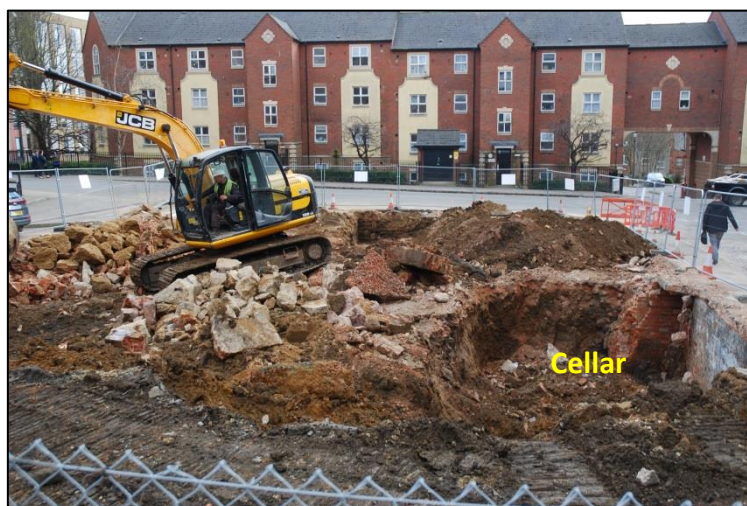
Fig 3: The site during breaking-out of floors and sub-surface impediments, looking south.

The work was carried out in fine weather and in good ground conditions. However, even this trenching exercise discovered garage-related disturbance not previously suspected, such as a buried oxygen cylinder and an inspection chamber. An undefined further brick-and-concrete chamber filled with broken roof tiles lay at the north end of the trench at its terminal.

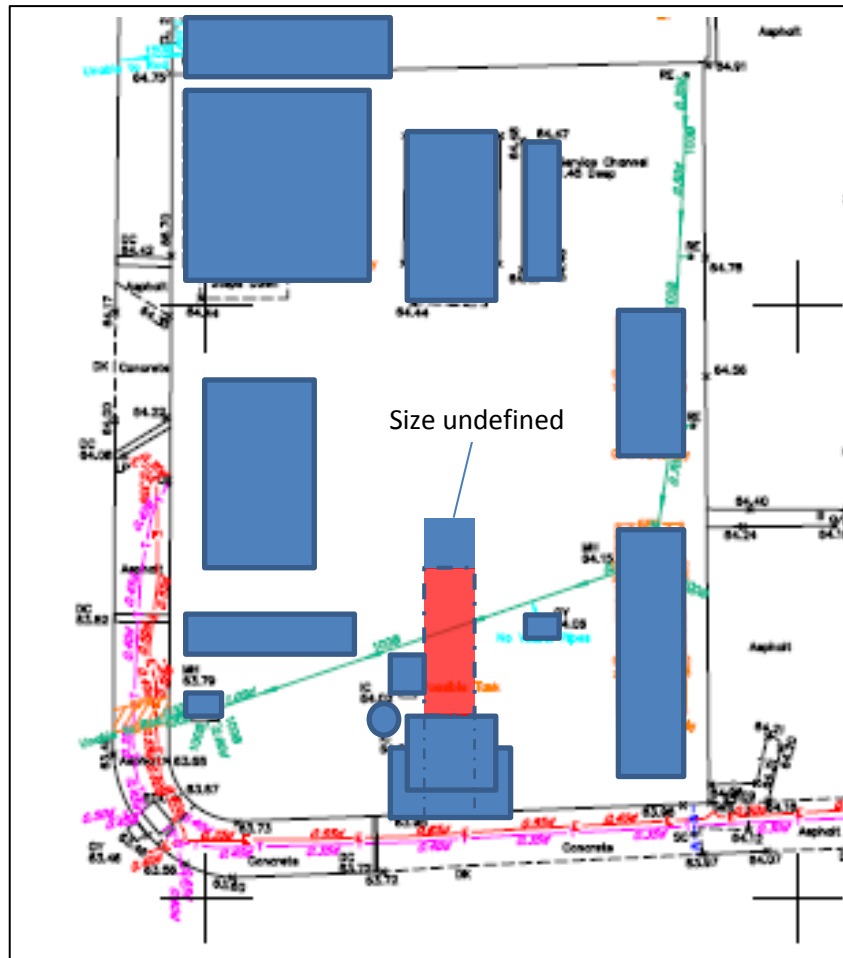
Fig 4: The Amalgamated Tyres plot with principal areas of garage truncation in blue. The un-truncated part of the evaluation trench is shown red. A ceramic drain-pipe, shown in turquoise here, was the only garage feature to lie above the natural geology. This plan shows nothing of the 19th and early 20th-century house foundations mapped in Fig 2. Note the unanticipated cellar at the foot of the figure, itself disturbed by a tank. A disturbance at the north end of the trench was not further defined and its extent is unknown.

1 cellar c1900, 1 cellar 1930s, 4 fuel tanks, 1 oxygen tank, 2 inspection chambers, 2 vehicle inspection pits, 1 rolling road. Anything with a depth of over 1m had penetrated into the natural geology (Fig 5).

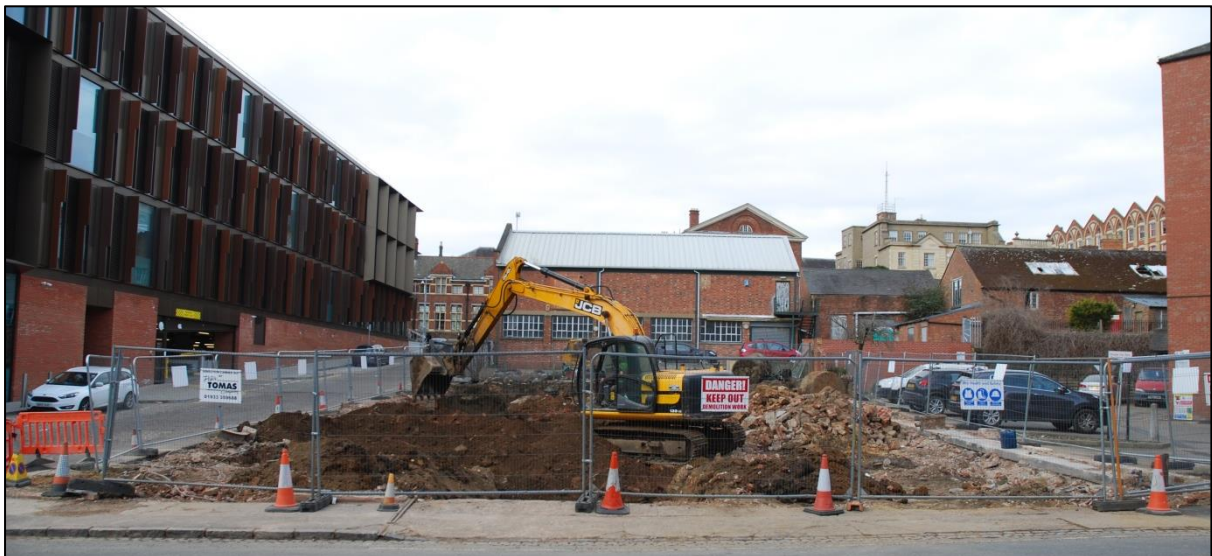
Fig 5: The site during trench backfilling. The trench lay directly between the camera and the machine.

By agreement, a single archaeological trench was machine-dug under archaeological control in an area thought to be relatively free from garage-related disturbance, up the mid-line of the site (Fig 5). The machine was a 20-ton tracked excavator fitted with a 2m-wide toothless ditching bucket, already on site for the last of the garage demolition works (*Thanks to Peter Tomas for its use*). The trench measured 12m long x 2m wide, although it was found that cellar- and tank-disturbance had destroyed the archaeological sequence at the south end. Only 8m x 2m of the trench remained unaffected.

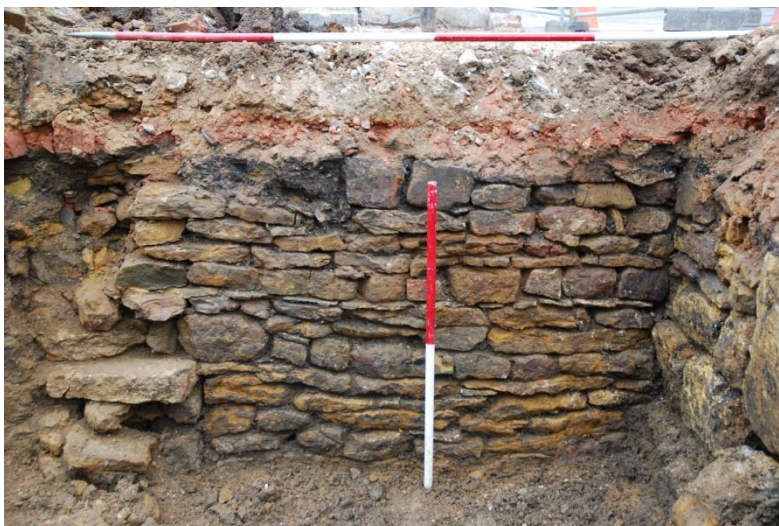
Fig 6: The cellar, looking east along St John's Street. The back (north) wall broken open by insertion and removal of a fuel tank. Scales - 2m horizontal and 1m vertical.

Machining from south to north the trench first of all encountered an ironstone and brick cellar adjacent to the St John's Street pavement, which had itself been broken open by the burial and placement of a large steel fuel tank which the demolition contract removed. The cellar post-dates the first edition Ordnance Survey of 1885, but must have gone out of use when the garage was built. It was thus perhaps in use for a mere 30 years or so. There was 19th-20th century willow-pattern china protruding from its lowest course (not removed). The cellar was otherwise emptied (since its backfill was falling in), cleaned and its extant sides photographed (Fig 6).

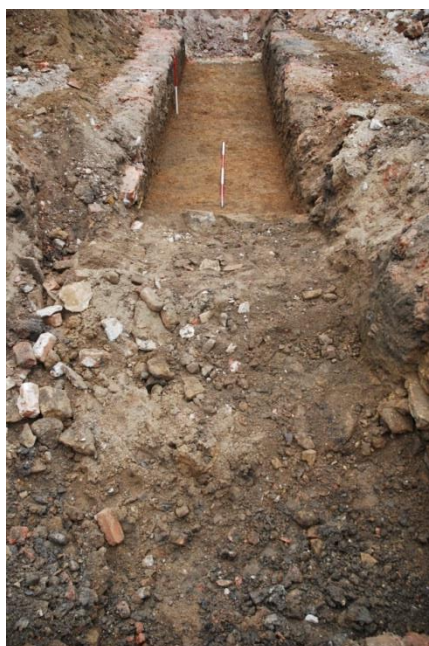
Fig 7: The trench looking north. The area in the foreground is all backfill from the cellar and fuel-tank. Together these reduced the natural geology in the southernmost 4m of the trench. Scales 2m (horizontal) and 1m (vertical)

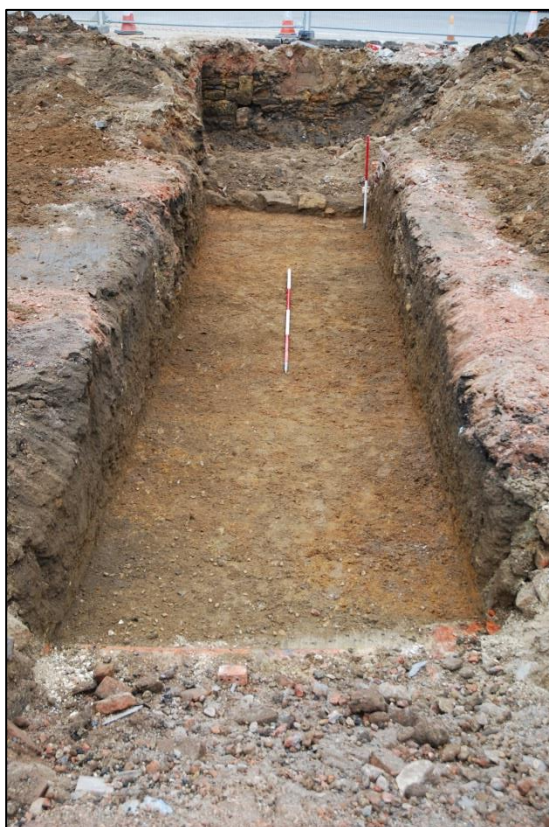
Fig 8: The trench looking south. Two discoloured semicircles of pits 9 and 11 can just be made out either side of the 2m horizontal scale. The vertical scale is 1m.

Cut into the natural geology, and sealed by the homogenous dark brown garden soils, were two sub-circular pits [9 and 11], each extending under opposite sections. At about 1m diameter, neither had been dug purposefully and was about 300-400mm deep and the soil fills (10 and 12, respectively), almost indistinguishable from the homogenous garden soil (4) above them, contained a few sherds of medieval pottery, but no more. There was no suggestion of industry present.

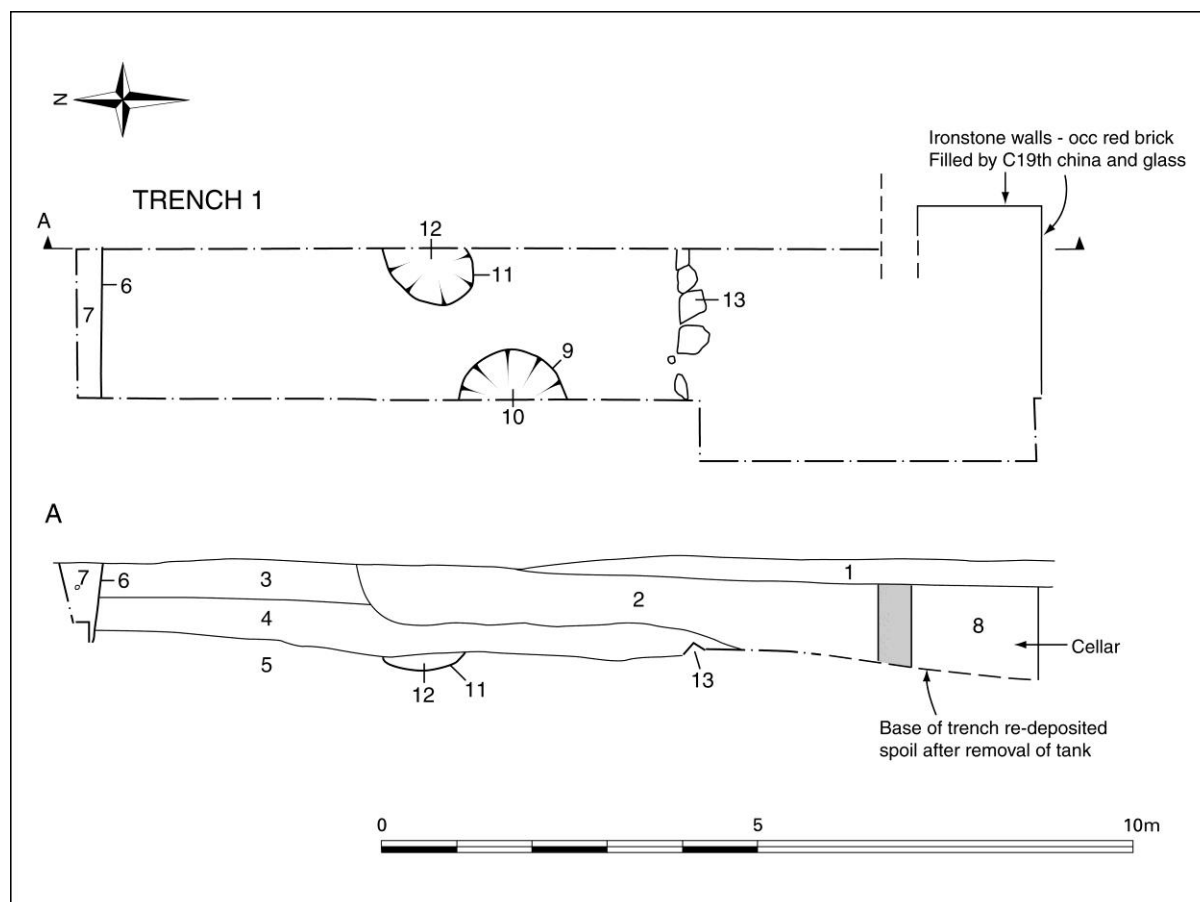
Fig 9: Plan of the evaluation trench and its west-facing section (Andy Isham)

The residue of demolition (1) overlay an area of densely-packed former disturbance, probably in the construction of, or alterations to the garage (2). Further north lay the upper of two barely-distinguishable and homogenous garden soils (3, and the lower one 4); each was some 400mm thick and both contained 19th-20th-century china as well as occasional residual medieval potsherds. Below these soils lay the natural Northampton Sand with Ironstone geology (5).

While the south end of the trench was disturbed by the ironstone-and-brick cellar [8] and inserted modern fuel tank (subsequently removed), the north end of the trench terminated in a modern brick wall edging a cement-screeded chamber [7]. This is a sub-surface feature of unknown extent (to east, west and north); what was seen of it was filled with roof tiles, including pan-tiles. Its base appears to be just below the level of the natural geology and it was set in through all later layers as indicated by its construction trench [6].

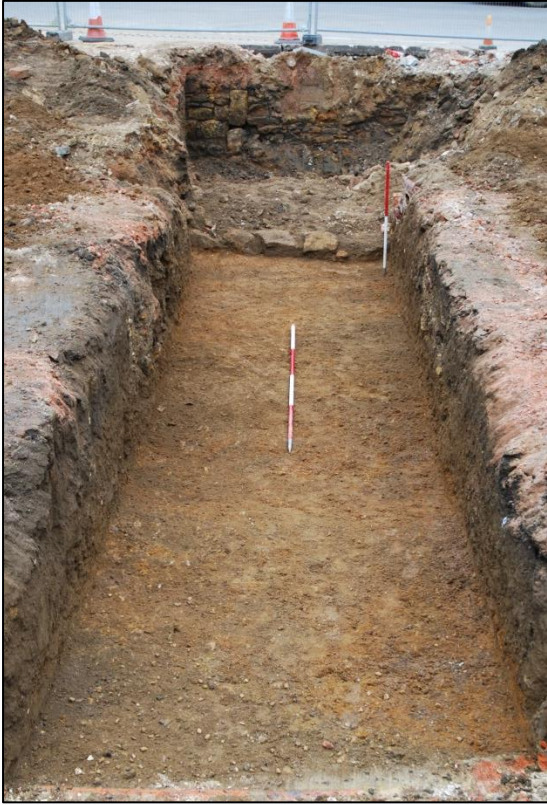
Fig 10: Evaluation trench shows a narrow swathe of undisturbed natural geology and a few cut features lie at c900mm depth

This scenario has proved to be so. Only a small area has any potential to retain medieval archaeological features cut into the natural geology at a depth of c900mm, at 62.5m aOD at the south and climbing gently at a gradient of 1 in 20. There is evidence of homogenous garden soils above this but no evidence for early structures or a significant stratigraphic sequence have been found. It is therefore likely that this area comprises medieval back-plots or gardens, whether related to Swan Street to the east or St John's Street to the south is unclear. Widespread garage-related disturbance is to be expected, over and above that already known.

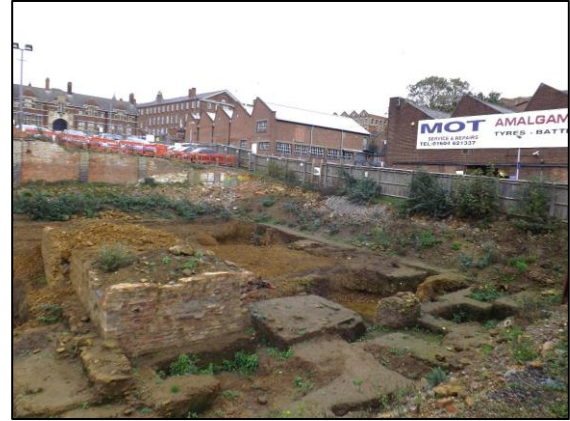
Fig11: Project Angel depths for comparison -1.5-2m depth and a terrace into the hillside. Note the former garage building across Fetter Street.

Comparing Amalgamated Tyres and Project Angel is a useful and pertinent exercise. It shows that even back to the late medieval period, the creation of Fetter Street part way along St John's Street had physically separated the plots to west and east and introduced separate planning-stories for the plots. While that to the west acquired a deeply terraced frontage and rear yards given over in part to brewing, that to the east was comparatively little-used and, more importantly, never terraced, leaving what little medieval and post-medieval archaeology it had acquired riding high and very vulnerable to both Victorian development and the construction of the 20th-century garage with its range of buried equipment and fuel storage.
