**An archaeological watching brief on groundworks for
an extension to 3-5 Court Lane, Stevington,
Bedfordshire**

Joe Prentice

Summary

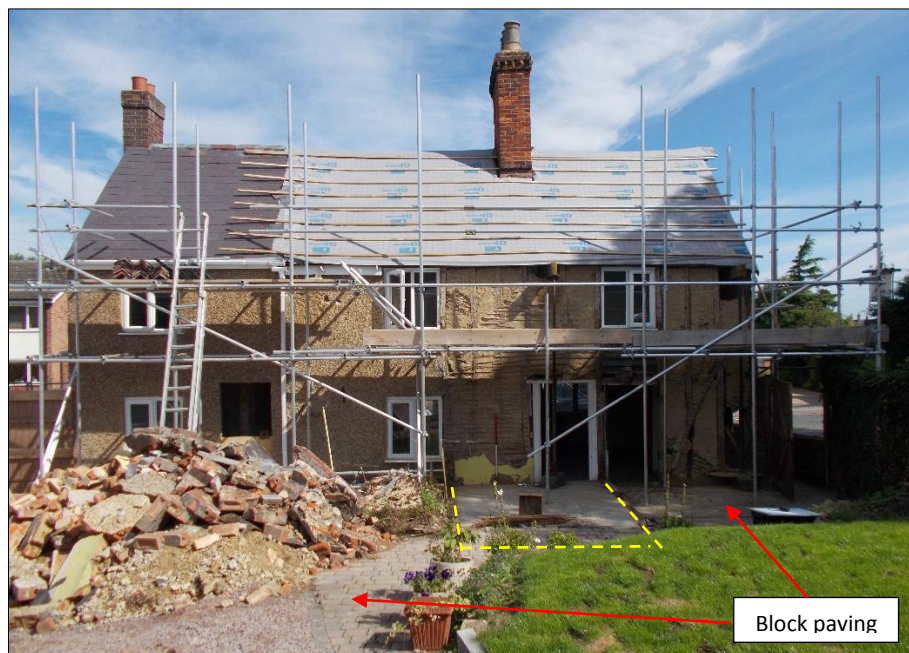
Fig 2: The site prior to the current works showing footprint of previous extension (yellow dashed line) and paved area, looking north.

Much altered by previous occupants, and formerly having rear (south) kitchen extensions added which provided additional space, the timber structure of the building was in a poor condition due to being covered by a non-permeable cement render. In addition to the west gable extension which was entirely of post-World War II brick, also rendered, there were small detached structures set within a large area of either concrete or modern block paving at the rear of the property. These were separated from the main garden area by a stone retaining wall (Fig 2).

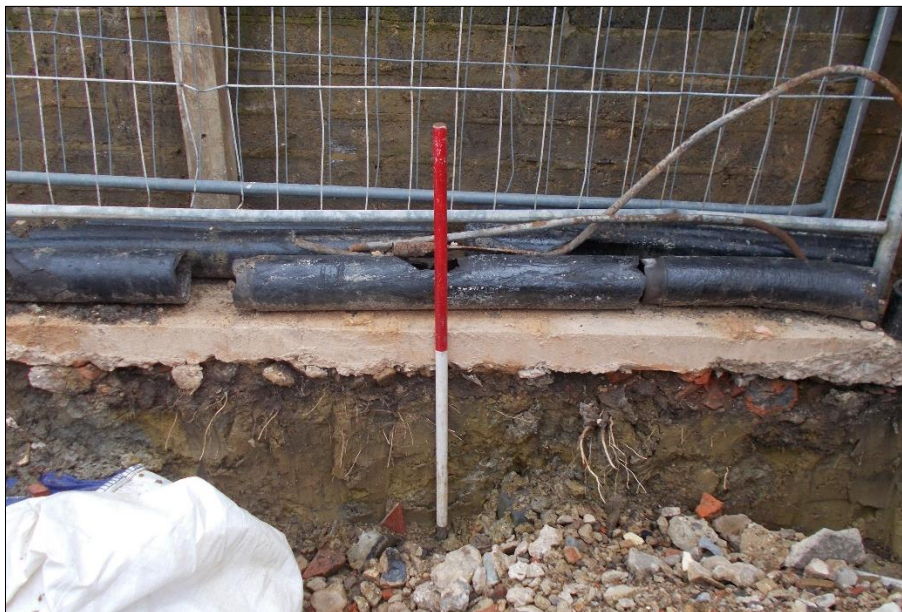
The whole area to the rear of the cottages had been thoroughly truncated by previous works which had reduced the area to slightly below the level of the brick sleeper wall on which the timber superstructure of the cottages was built. Due to the slight natural slope to the south of the former field in which the cottages were built, this reduction had removed a considerable layer of natural topsoil and also subsoil so that as a consequence the whole rear area close to the cottages was cut up to 0.5m into natural geology.

Fig 6: A remnant of the previous concrete surface and hardcore lying directly on top of the natural clay geology, looking south. 1m scale.
