Archaeological monitoring of BT Fibre-optic cable trenching at Lyveden Old Build, May-June 2018

WAN Enhancement Programme –Lyveden Old Build

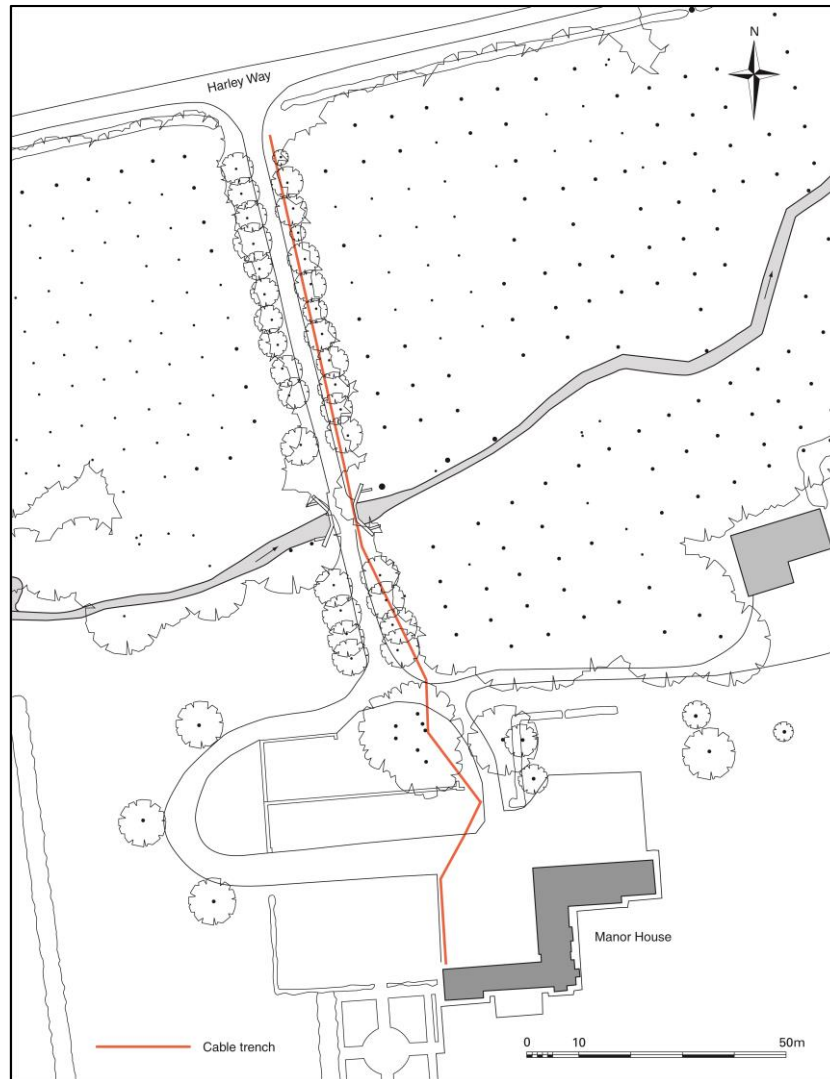
Fig 1: The site with course of cable trench (Andy Isham, after NT survey)

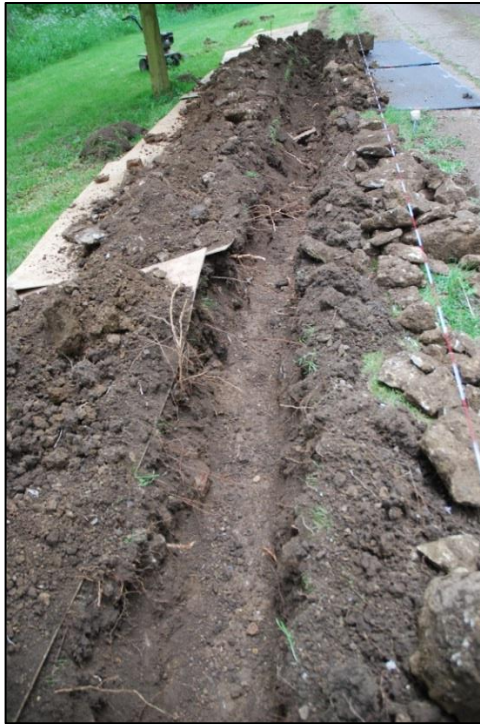
In this section the majority of the trench was hand-dug due to the presence of poplar roots, resulting in a trench some 300mm deep and only 200mm wide. Beneath the turf and rather thin topsoil lay masses of limestone rubble with occasional brick fragments, concrete pieces and water-worn cobbles. So much rubble was present that it seems probable that the existing concreted access track

has a much wider rubble sub-base and was once an un-made haul-road, probably during the demolition of the farm buildings in the mid-1970s or during the upgrading of the Old Build c2000. There were no finds from this section of trench.

Fig 2: Harley way to the stream. The first 15m was especially full of stone.

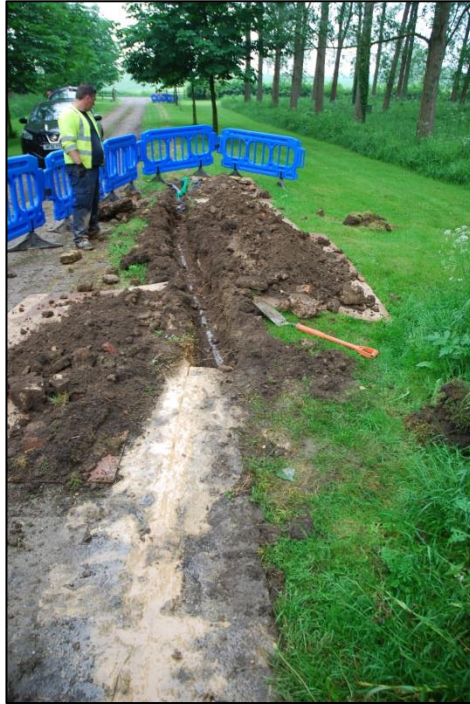
The grey plastic cable ducting was laid, the trench backfilled and the turf replaced before moving on to the next section. Close to the stream the trench coincided with that which already existed for the BT telephone cable, so for some 5-10m no fresh ground was disturbed. Above the stream the new duct was laid into the existing concrete of the bridge span.

Fig 3: Approaching the bridge from the north, for c10m the new trench shares its line with an existing BT duct.
Note the large poplars to the right whose root systems are extensive.

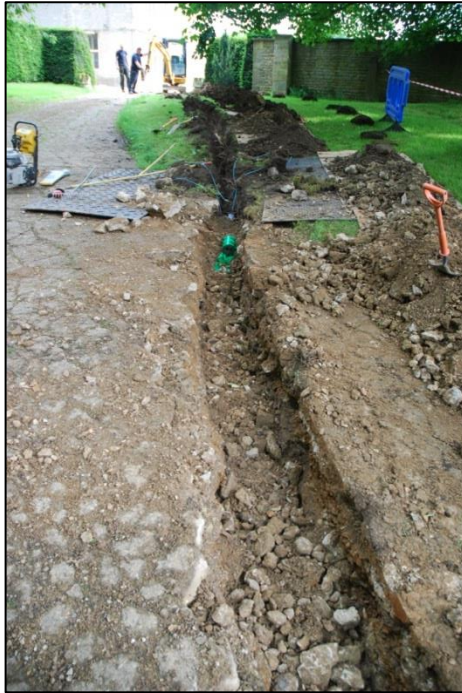
The hardstanding of the trackway proved to be all modern concrete and hardcore down to natural clay. This was, however, rammed solid and no archaeology was apparent. Here the machine was used to dig the trench, 400mm wide and 400mm deep, which would have been impossible by hand.

Fig 4: Traversing the trackway, south towards the manor yard

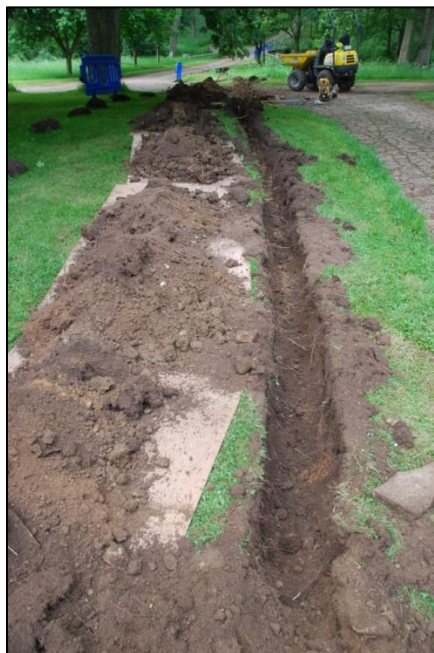
Once back into turf, hand-digging resumed due to the proximity of tree roots. Thus the trench again narrowed and shallowed. Here the topsoil overlay redeposited clods of natural clay in a topsoil matrix suggesting the bank is at least partly man-made. Numerous limestone pieces were present, but not in the density found north of the stream. From the topsoil in this section derived two sherds of 18th-century Midland Black pottery (not retained). Near the top of the bank it became possible once more to use the machine, fitted with a 200mm-wide bucket and cutting a trench down to c350-400mm.

Fig 5: Looking back north from the entrance to the manor yard

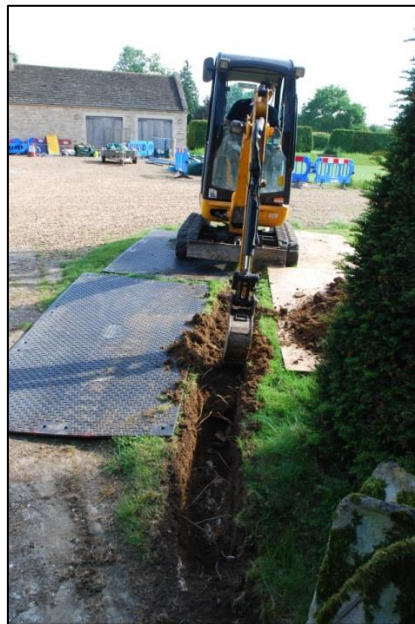
The section of trench across a lawn within the manor yard (Fig 6) found the overburden to be well-prepared and stone-free topsoil. Once into the gravel of the manor yard, the gravel overlay hardcore to a depth of c400mm, which was unbroken all the way to the manor garages. No archaeological levels were exposed.

Fig 6: Machine trenching across the manor yard; garages in the background
