**An archaeological watching brief on a new path to
the town War Memorial, Uppingham Parish Church**

Uppingham Churchyard and War Memorial

An archaeological watching brief on a new path to the town War Memorial, Uppingham Parish Church

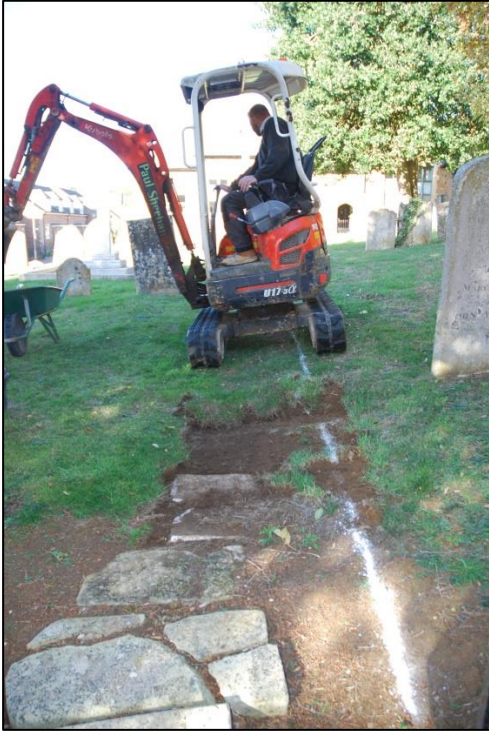
Fig 4: Removing the turf; note the re-used foot-stones being uncovered. At the bottom edge of this view is the top step serving the earlier path

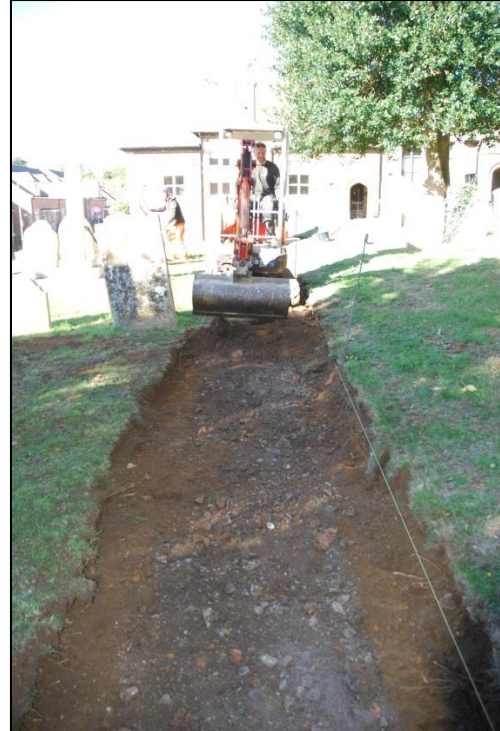
Fig 5: The final machining to a depth of about 250mm. Note the clinker sub-base of the old path down the centre

A small 2-tonne tracked excavator fitted with a toothless ditching bucket was used to strip the course of the new path, first of its mat of turf and topsoil (about 100mm thickness) and then of the underlying material (about a further 200mm thickness). The underlying layer comprised a mixture of an imported layer of clinker, ash, brick pieces and broken gravestone fragments with grave-kerb pieces and almost-complete grave markers/footstones; these had formed the sub-base of a previous path. Along the edges of this material was the graveyard subsoil (or possibly grave-earth) which was a mid-brown/orange sandy clay with stone chips. About 2m from the War Memorial was a dump of 20th-century pottery and glass (see below), virtually inseparable from the former path sub-base.

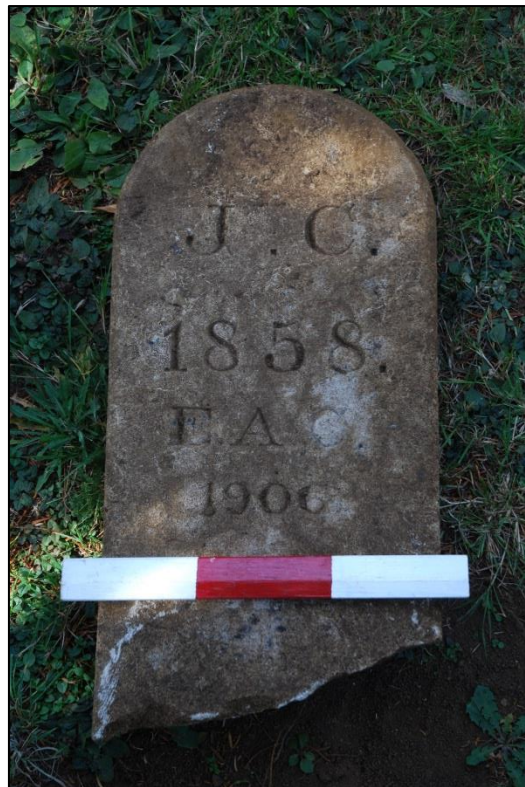
Fig 6: One of the foot-stones/grave markers; scale 30cm

JC 1858 & EAC 1906 (pictured)

Already previously disturbed, and therefore of no further archaeological interest, these were re-incorporated into the new works, face-down as a foil to frost-damage and separated from the new concrete by a builders' membrane. Some had been used previously to line the up-slope cut-out formed by the erection of the vertical War Memorial into the steep churchyard slope, and these were set aside for re-use exactly in that way.

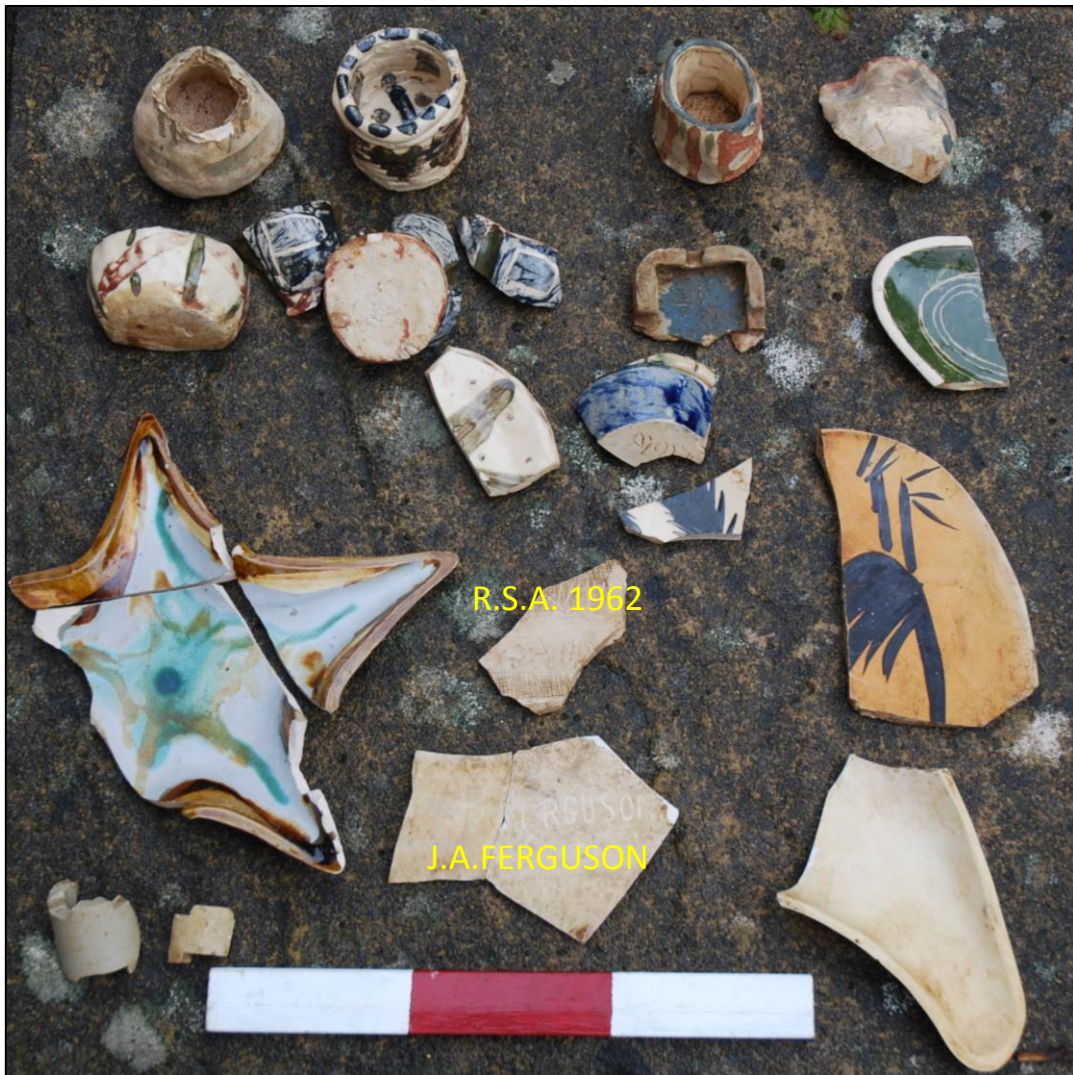
A dump of art-class pottery was disturbed about 2m from the memorial itself (location marked on Fig 3). Much of this comprised complete, but subsequently broken pots, mostly painted and glazed, and all using the washed, pre-prepared commercial white-firing clays used in 20th-century kilns. It included hugely artistic and competent (if not actually professional) art-pieces alongside beginners' coil-pots and children's finger-pots, as if a variety of ceramics classes were represented. None were apparently kiln-wasters, perhaps tending to militate against them being just rejects from a firing. Two were signed on the base – one J.A.FERGUSON and the other R.S.A. 1962, providing an earliest possible (and likely) date for the deposit. There were a number of commercially-made kiln-bobs or spacers too, which may indicate that the wares were stacked at the site. Also present were at least six small, unbroken screw-top glass jars containing paint -one at least was a re-used Vaseline jar, together with four complete, but empty wine / spirits bottles.

Fig 7: Art class pottery and bottle from sub-base of the former path - note the signed pieces; kiln-spacers at bottom left; scale 30cm

While they may have been brought in amongst earlier path aggregate –and were buried as oversupply, and were simply unclaimed or unwanted pieces from an art-school pottery, it remains just possible that they briefly constituted a poignant local act of homage to the fallen, since so much appears to have been brought in complete and spacers suggest some stacking on site. That the spirits bottles and the jars were all unbroken is notable. However, the evidence is equivocal. None of these modern finds has been retained.

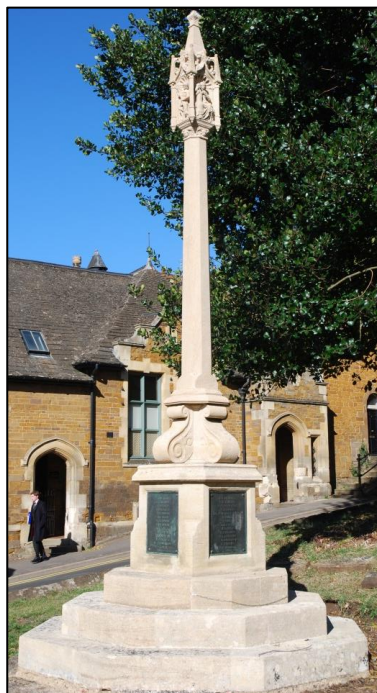
Fig 8: The War Memorial during works on 1 October 2018.
