**A programme of geotechnical boreholes at Canons Ashby House,
December 2018, with depth-data key to land management
around the house.**

SMC S00191165; OASIS 336635

Canons Ashby House – 2018 boreholes and other depth data

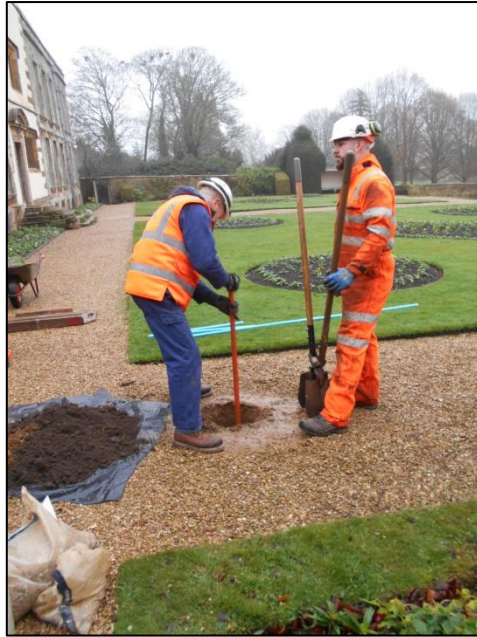
- **WS2** *Path in principal garden south of the great cedar of Lebanon canopy*

0-500mm Washed gravel top and pebbles in sandy matrix, sub-base to current garden path

500mm-1.0m Black, loamy topsoil with few inclusions (long-lived growing medium –old topsoil)

1.0m – 1.2m Pebbles and gravel in grey sandy matrix (drainage layer to create garden)

1.2m Natural geology (clay)

Fig 3: The Window Samples were hand-dug to a depth of 1.2m. Here WS2 is shown.

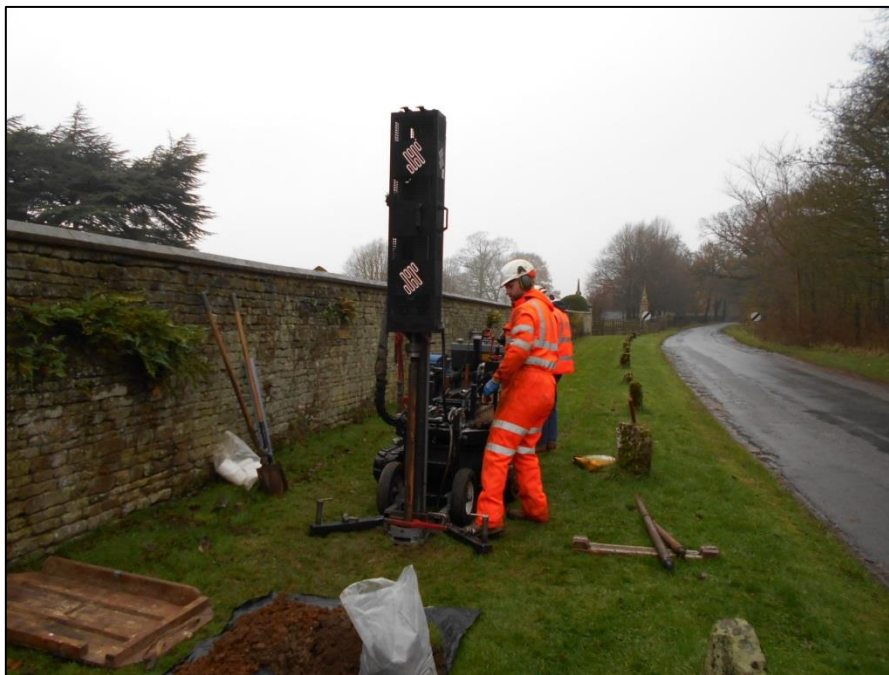
- **WS1** *In grass verge of Preston Capes Road, adjacent to East corner of house*

0-500mm Turf and Topsoil

500mm-1.35m Ironstone rich layer with pieces of tile (possibly old road-sub-base or builder's material close to the house)

1.35m Natural geology (clay)

Fig 4: Mechanical coring of the Window samples, the core retained in a removeable plastic sleeve from 1.2m downwards. Here WS1 is shown.
