Archaeological recording on Catesby Tunnel and other Great Central Railway features at Charwelton, Northamptonshire, 2018

Iain Soden and Joe Prentice

The redundant Great Central Railway Catesby Tunnel of 1897 was recorded in accordance with an Historic England Level 2 record, while a nearby related road-bridge due for demolition was recorded to Level 1 equivalent. An archaeological trench uncovered remains of a goods-yard building and the former mainline track-bed with the foundations of the station platform. A former 1897 signal box layout was also excavated.

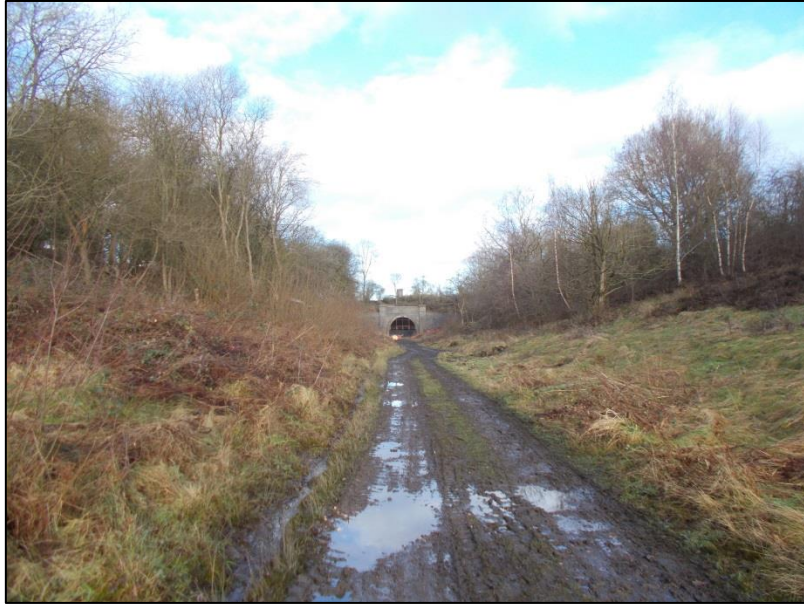
Fig 2: The abandoned railway cutting looking towards the Charwelton-end tunnel entrance

bushes grew liberally across the site, and some mature hedgerow trees. The cutting towards each tunnel mouth was overgrown and bore signs of recent vehicle access, for tunnel inspections, farming access and initial development-led survey and investigations (Figs 2, 3).

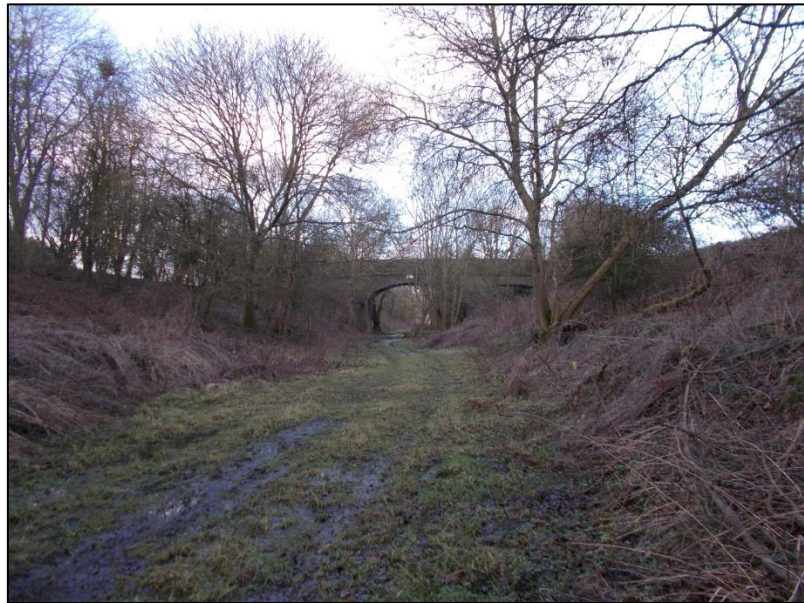
Fig 3: The abandoned cutting at the Catesby end, looking away from the tunnel mouth

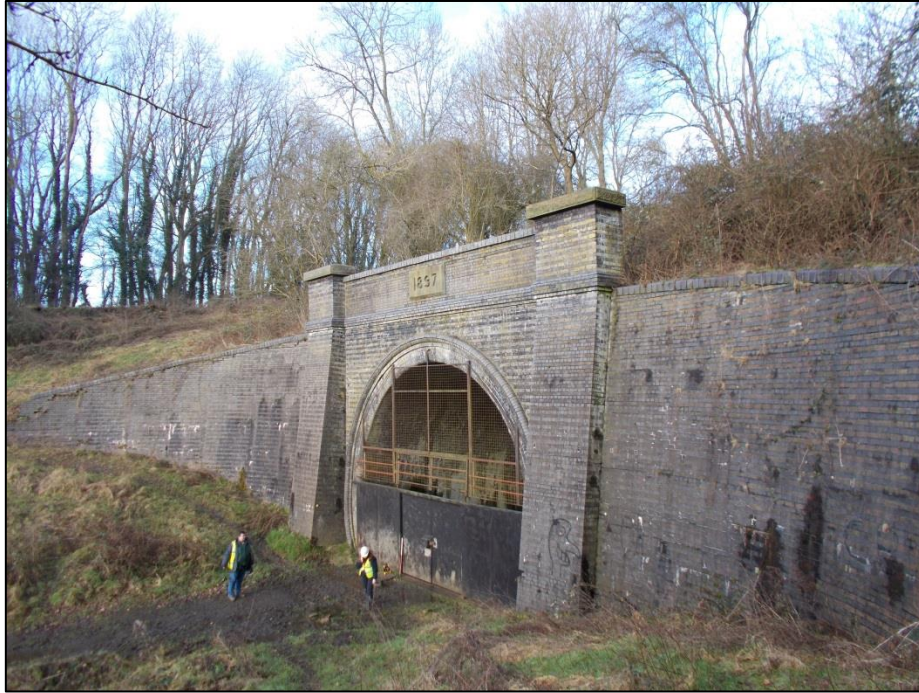
Fig 4: The southern, Charwelton-end mouth of the tunnel, with date-stone 1897.

The tunnel mouths or portals stand between brick buttresses and the junction made with the surrounding land as it ends in a cutting is finished in the ubiquitous Staffordshire blue engineering brick. Parapets are finished off either in stone (millstone grit?) or in engineering bricks moulded to form cappings. The tunnel itself, where it visibly meets a series of three rest cabins, appears to be some seven bricks thick (7 brick bed-widths/c31.5 inches/78.6cm). Naturally 99.99% of the tunnel is not available for such a measurement so it is unknown whether this is a consistent measurement or a localised design at these occasional entrances.

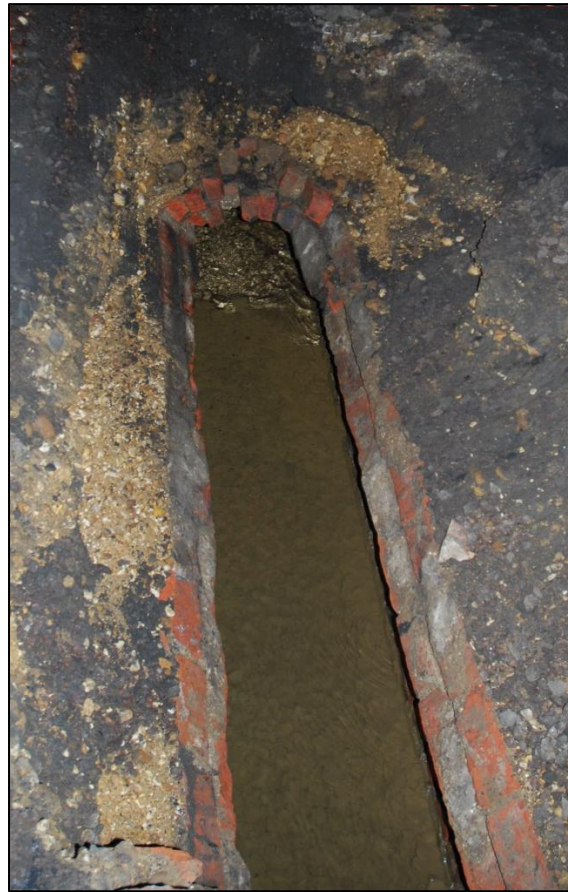
Fig 5: a short section of the tubular brick drainage culvert exposed, its vault opened for inspection

culvert which is present positioned down the centre of the entire length of the tunnel for water drainage. This can also be seen both beyond the north and south portals in open ground and can be seen in section on the original engineer's drawing (Fig 6).

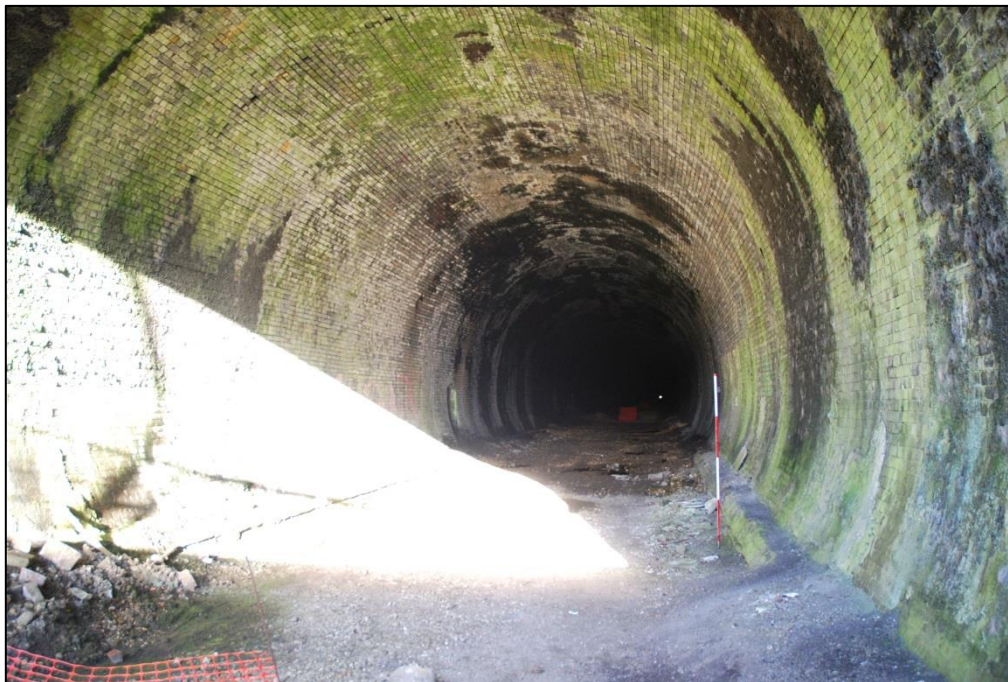
Fig 7: View along the tunnel from the southern, Charwelton end; 2m scale. A miniscule pinprick of light marks the opposite end, 3000 yards away.

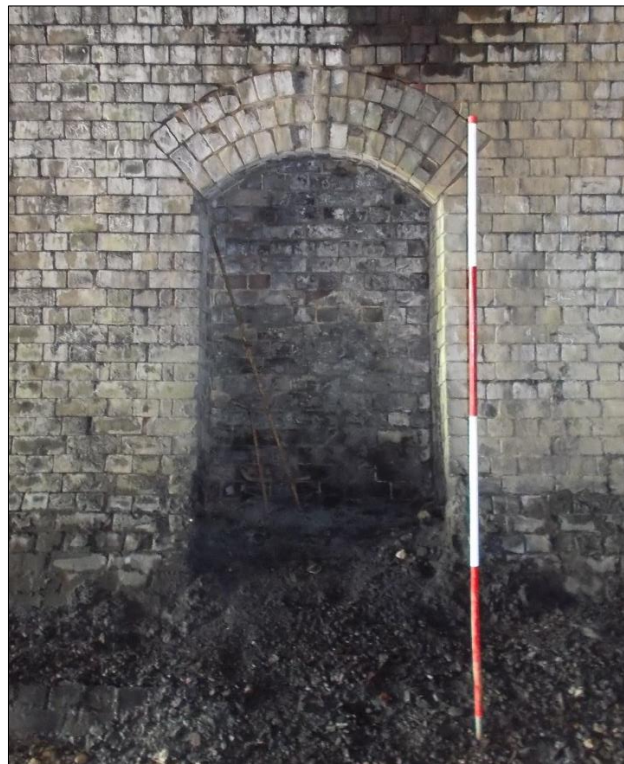
Fig 8: One of the arched refuge niches on the west side of the tunnel. Hard-packed gravel is 'splashed' over its base. 2m scale.

Once completed, track-workers were relatively well served with regular refuges provided on both sides within the entire length of the tunnel; they are all identical in size and shape (Fig 8). The base of these refuges, ending in a running ledge, indicates the former level of the track bed, now significantly lower than when the tunnel was in use. Each refuge has enough space for one, or two at a squeeze, track-workers to shelter in whilst a train was passing. There are also three rest cabins built into the Up-Side (eastern) wall (Fig 9). The central one is located directly opposite a tablet that marks the 'half way' point. During the tunnel's many decades in operation, both lines were inspected by the local ganger twice a day, so refuges and cabins must have had a great deal of use.

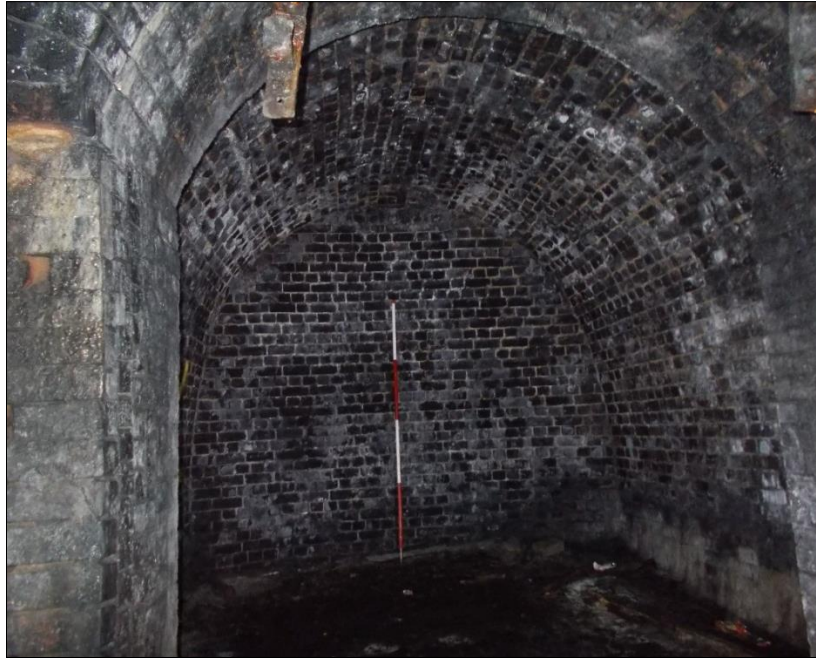
Fig 9: One of the three rest cabins on the east (Up) side of the tunnel, looking east. Here the thickness of the tunnel brickwork can be gauged. 2m scale.

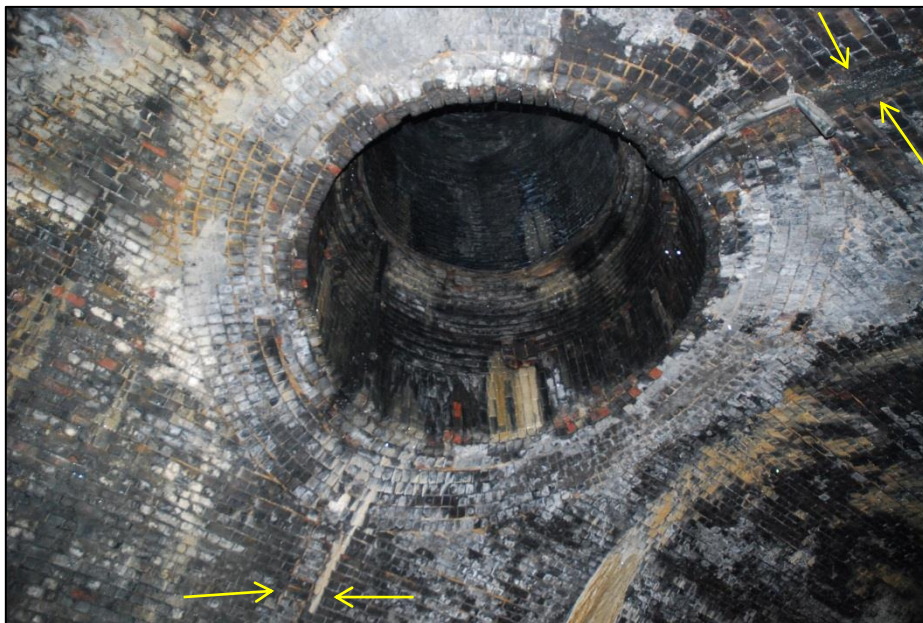
Fig 10: One of the ten-foot wide ventilation shafts; note the elaborate tumbling-in of brickwork to marry up the two different-sized brick cylinders involved. Built-in drainpipes run off each side (arrowed)

Ventilation along the length of the tunnel was provided by five shafts (Fig 10). Four of these are 10 feet in diameter but the northernmost is 15 feet wide to provide greater air flow. These shafts are indicated, along with the entire route of the tunnel, on Ordnance Survey 25-inch series maps which date from 1899/1900 onwards, and remain as cylindrical brick towers in the landscape in their own right. The length of the tunnel means that three sheets cover the entire length of the tunnel; XLII.12, XLII.16 and XLIX.4. The last sheet also shows the station and its associated buildings close to the village of Charwelton, south from the southern portal.

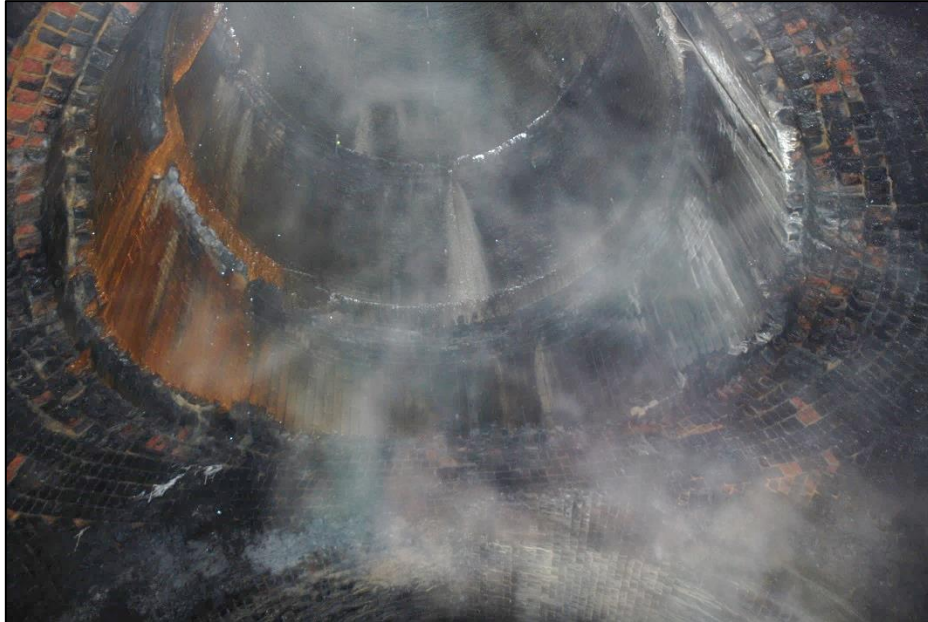
Fig 11: The mist-filled mouth of the larger, 15-foot wide, ventilator shaft

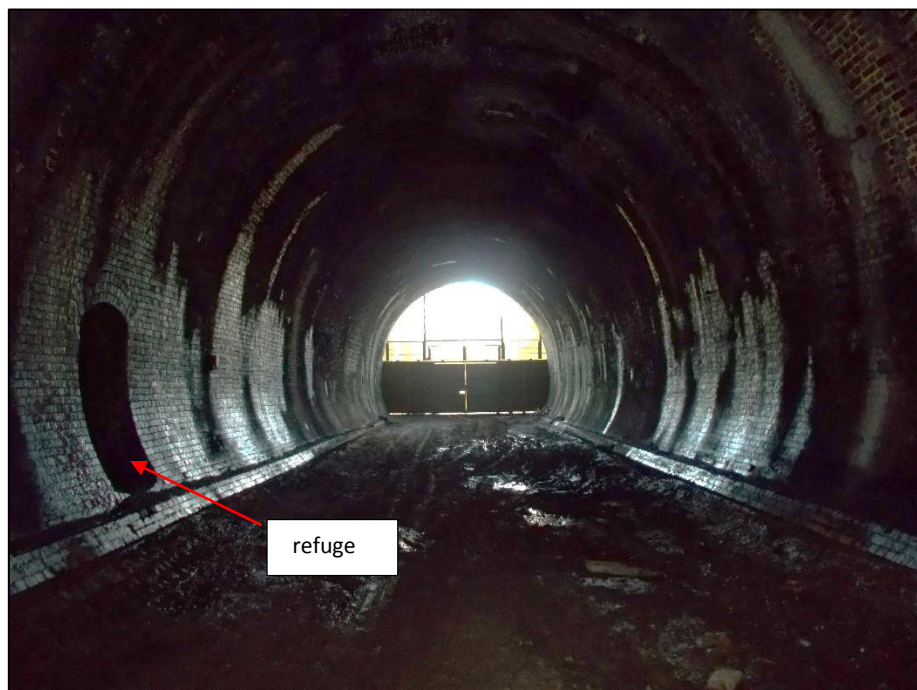
Fig 12: The northern (Catesby) end of the tunnel, looking north. Note arched refuge to the left and built-in opposed ledges which elsewhere are mostly covered in gravel.

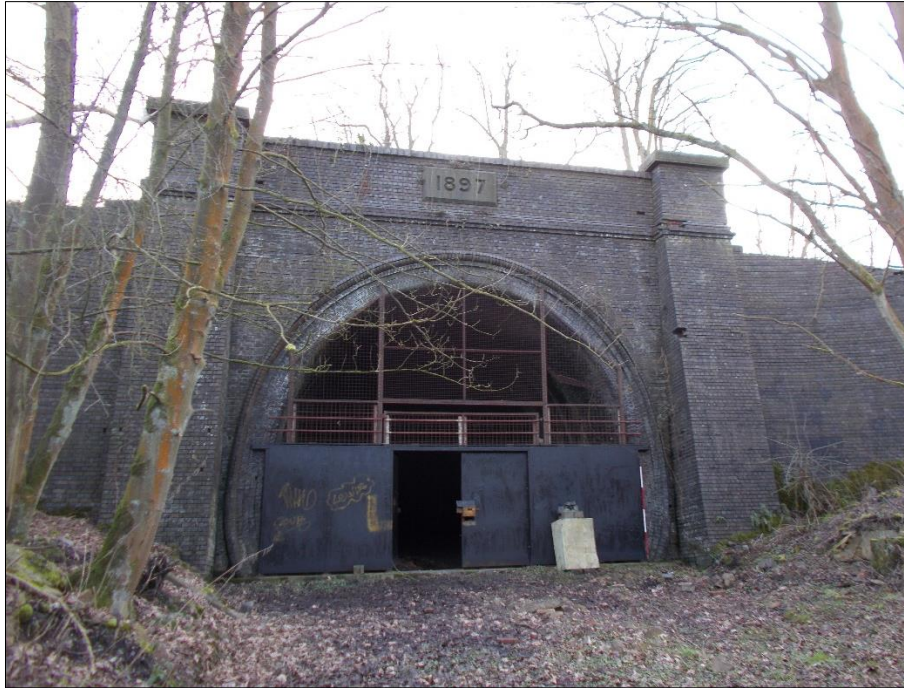
Fig 13: The northern (Catesby end) mouth of the tunnel, with date-stone 1897, looking south. 2m scale.

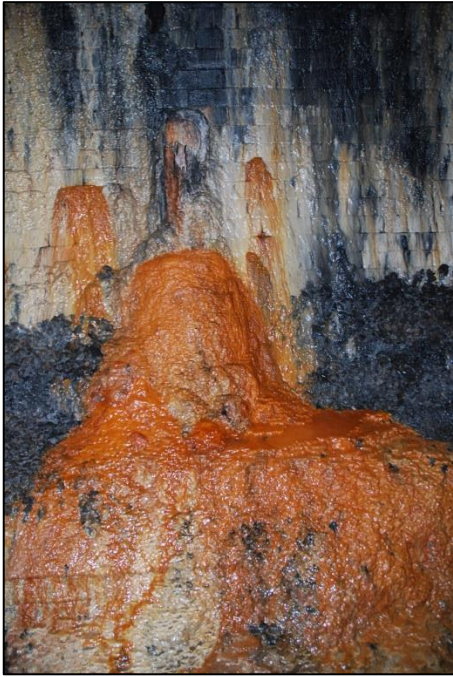
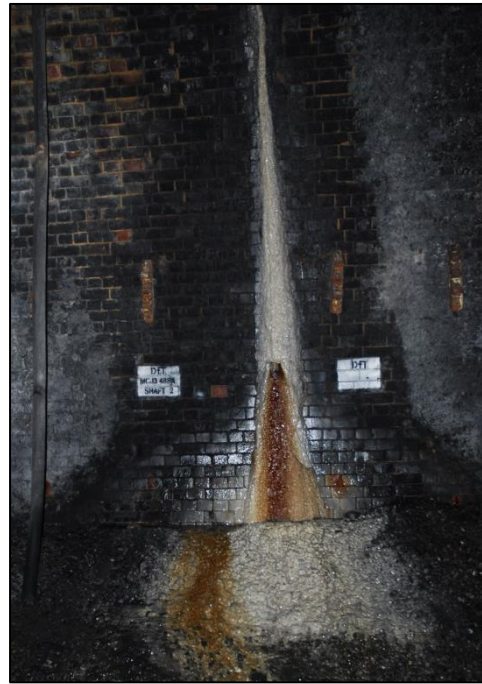
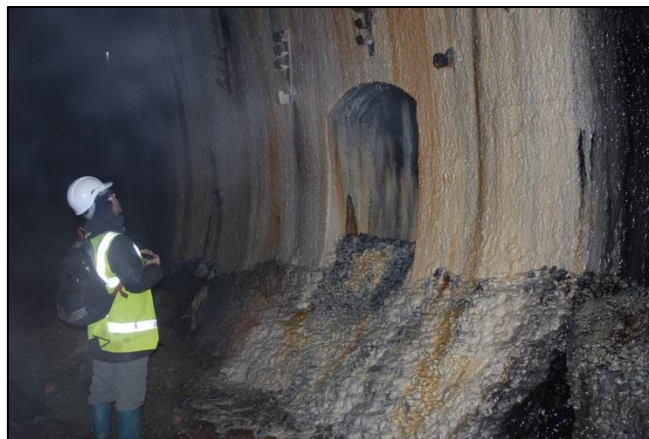
Fig 14a-c: Some of the mineralogical deposits formed in the abandoned tunnel, a by-product of water ingress

At various points along the tunnel, where there was either a concentrated or extensive water ingress over a prolonged period, and sometimes both, there was a cave-like environment, in which the natural salts in the ground, in the bricks and the mortar binding them, had leached through into the tunnel, building up and mineralising as they went, as if they were man-made stalagmites on the floor (Fig 14). The curve of the tunnel promoted a run-down of the salts in suspension and generally militated against the formation of stalagmites as such on the roof, but the deposits down the sides were thick and even had formed the characteristic folds of 'drapery' seen in true cave environments. Iron impurities stained some a garish orange. While these presumably began to form soon after the tunnel's completion in 1897, they would during the life of the tunnel have been prevented from thick build-ups, but they have been unchecked since disuse of the tunnel.

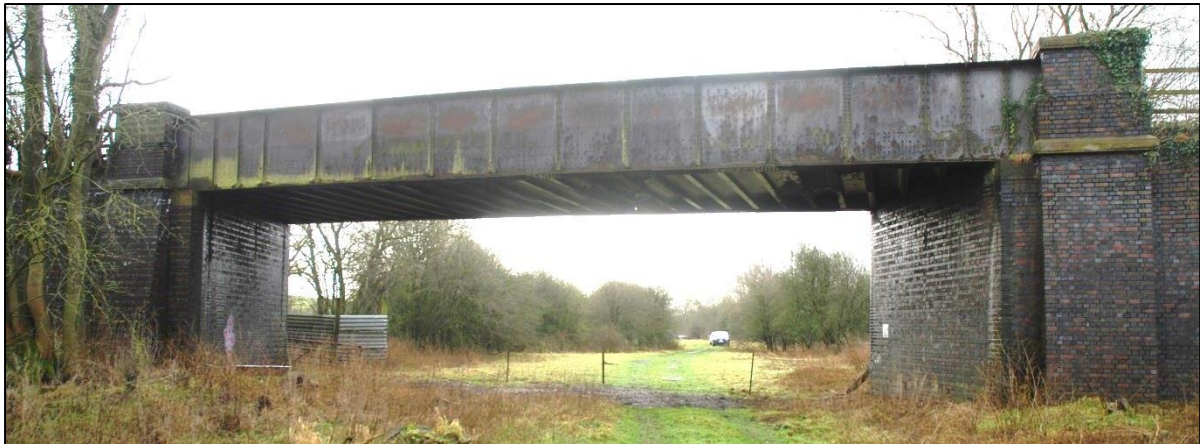
Fig 15: The Hellidon road bridge, looking towards Charwelton from the Catesby Tunnel side

The Hellidon road bridge, shown on Fig 1, is of simple riveted plate-girder construction and joins two raised sections of a small road linking Hellidon to the A361 in a single span. It spans the space taken by the up-line and down-line of the former Great Central Railway and has until recently continued to take modern road traffic.

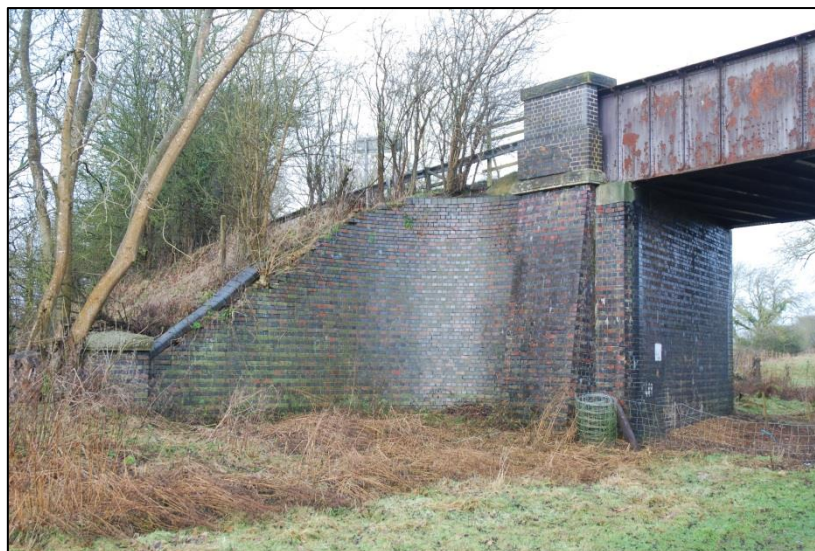
Fig 16: Staffordshire blue engineering brick bridge abutment, looking north-west. Note the principal girder-bearer in stone, matched by the finishing details.

The bridge abutments which tidy the bridge-embankment junction are formed in a manner identical to the portals of the nearby Catesby Tunnel, using Staffordshire Blue engineering brick, the girder-bearers, buttresses and finishing piers formed or capped in millstone grit and the walls capped in Staffordshire blue capping bricks. The brick at the outer surface is laid in alternate courses of headers and stretchers, although this may not be mirrored behind the visible face.

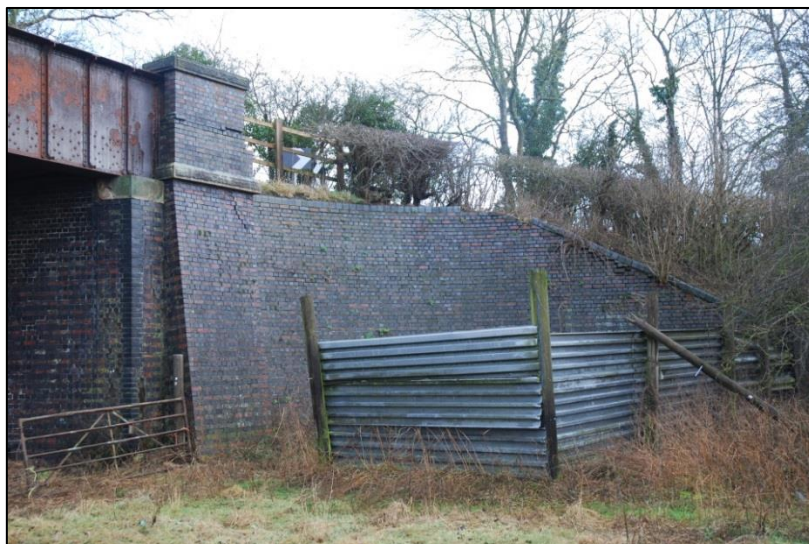
Fig 17: Staffordshire blue engineering brick bridge abutment, looking north-east

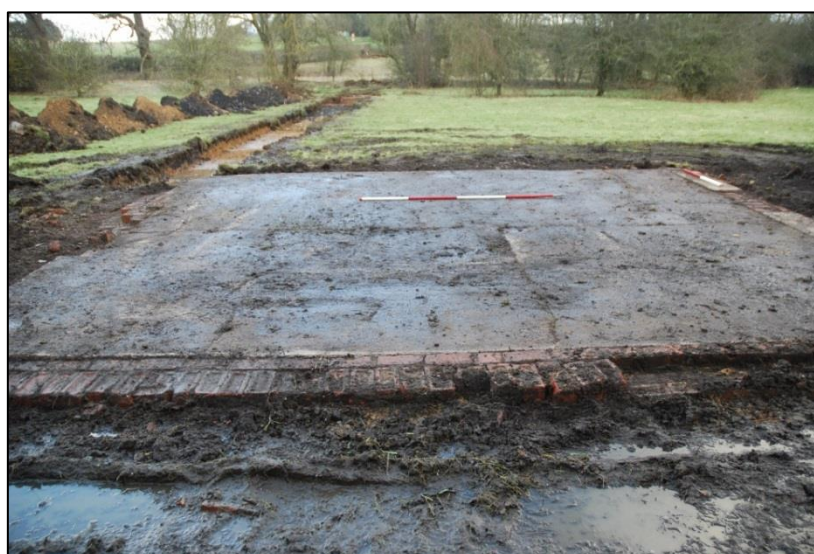
Fig 18: The concrete floor and frogged brick foundations of a small railway building which stood in the Charwelton goods-yard. It is seen in the historic photograph at fig 12 of Walker (2015). Scales 2m and 1m, the latter at a doorway in the south wall

Ground clearance at the start of works uncovered a simple concrete floor surrounded by 1.5-brick wide foundations in red frogged bricks (each 225mm x 110mm x 75mm), relating to a small building which stood in the former goods yard of Charwelton station (Fig 18). The former building, which measured 7m x 6m externally, had a double doorway with small wheel-ramps (and the hinge-fixings in the threshold stone) on the south side and a pedestrian doorway alongside, with (probably) one or two windows in its north wall, for which an iron sash-weight was found nearby (not retained). The building had no interior features and its use is unknown, but its size means it could have been both for storage (hence double doors) and office use (a single door and sash-windows). It appears to have been unheated.

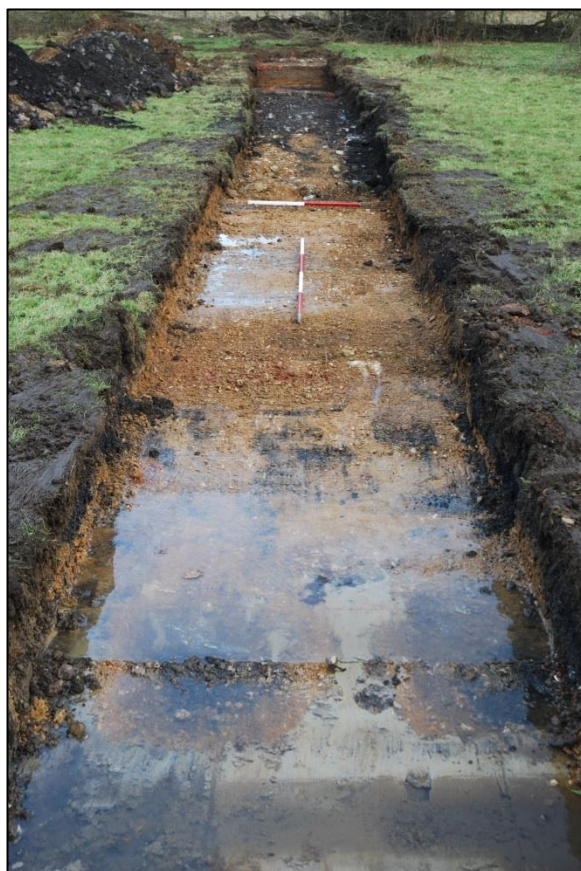
Fig 19: Trench with gravelled goods yard in foreground, partly under groundwater. Lias clay lies beneath. Looking north-east towards former platform foundations. Scales 2m and 1m

A single trench was dug north-east from this building, measuring 27m long x 1.8m wide, using a 5-ton tracked mechanical excavator, which was fitted with a wide, toothless ditching bucket and working under archaeological control.

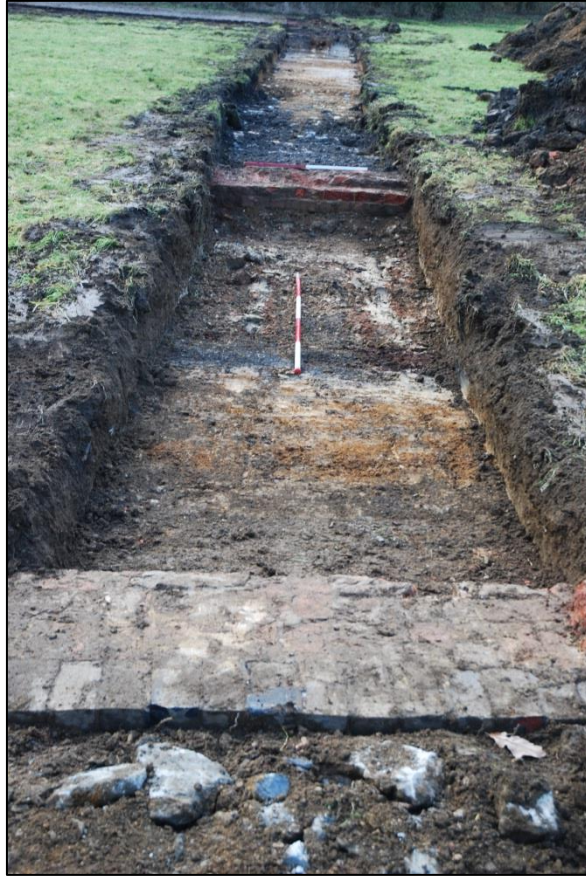
Fig 20: The trench looking from the platform foundations (x 2, one on either side). In front and beyond lies the heavy ballast which characterises the sub-base of the track bed to both the up- and down-lines. Scales 2m and 1m.

Within the trench lay the brick foundations of both sides of the former Charwelton Station platform, 6-bricks thick in a mixture of Staffordshire blue engineering brick (outer edges) and red brick elsewhere, both types being featureless, and measuring on average 230mm x 115mm x 85mm. The platform had been 7.7m wide, across the exterior edges of the foundations.

On either side of the platform lay the rubble stone ballast of the track-bed sub-base, which was deeply impressed into the underlying natural clay by many hundreds of tons of trains passing regularly. Further west, between track and the excavated building, lay an area of gravelling, the former goods yard visible in Walker (2015, fig 12). No elements of the station superstructure had survived, even as rubble. Only a few photographs survive of the layout (such as Walker 2015, fig 11), but a 1930s plan shows the former layout, which included ticket office, separate waiting room, separate toilets, all in brick with Welsh slate roofs (Fig 20, below).

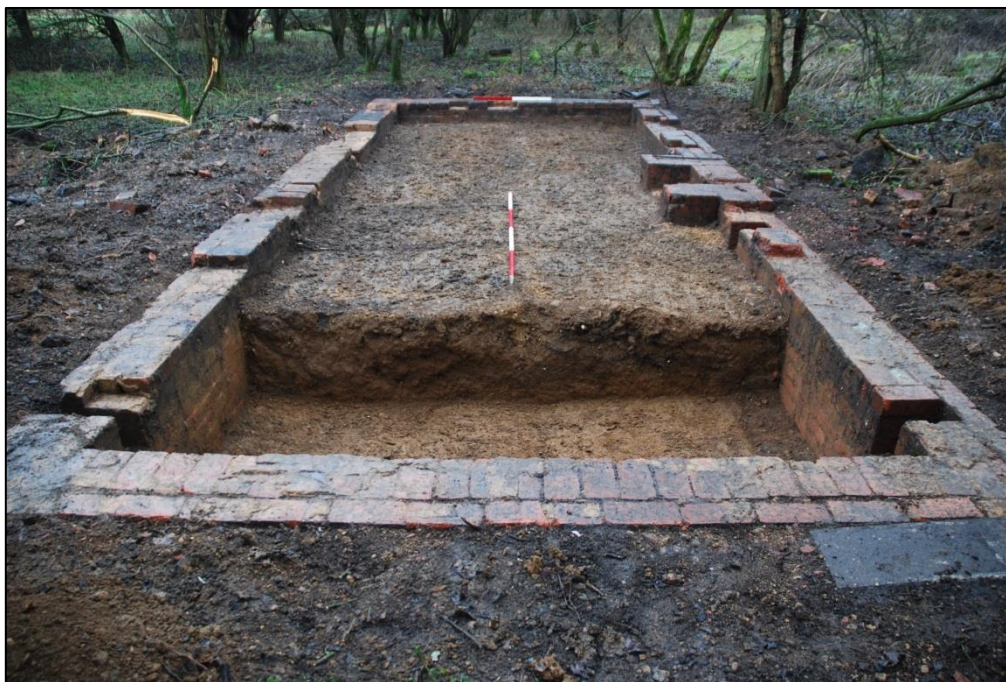
Fig 24: The brick base of the signal box, cleared and cleaned; Scales 2m and 1m

The signal box was built of plain red brick, and measured 8.6m x 3.7m externally, the foundation walls laid three-bricks thick and where visible appeared to be five courses of stretchers to one of headers. The bricks measured in general 225mm x 116mm x 76mm, and included a few frogged examples with the stamp GIBBS BROS LOUGHBOROUGH. Slots in the long walls showed where former joists had supported the principal joists of the ground floor timber floor; vestiges of joist remained, although much-rotted.

Partial excavation of the signal box interior showed that the material inside was builder's infilling, using redeposited natural clay. At its base, below eight courses of foundation walling, lay a clear construction trench in the natural clay for the building of the brick walls (visible in Fig 24, and shown on Fig 26).

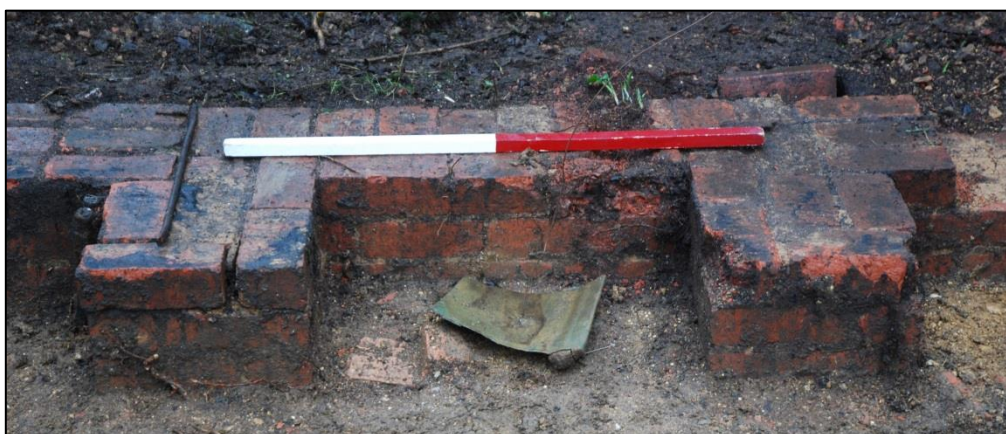
Fig 25: The brick piers and probable earth-plate; note disconnected armoured cable ends at left. Scale 1m

At the mid-point of the east wall lay two brick piers or projections into the room (Fig 25). In a purely domestic context these might have been interpreted as a hearth. Here, however, in the ground-floor signalling equipment-room, no such hearth would be needed -they probably ran all the way up the wall and supported a hearth in the first floor room above. Between them lay a large sheet of copper, with a wire through it. This was probably the ground-plate of the electrical earth which the signal box enjoyed. Just to one side of one of the brick piers were four armoured cables of the former electricity supply, truncated at demolition just above where the timber floor would have been.
