Archaeological monitoring of a new drainage outfall at Delapré Abbey, Northampton, 2018-19

Joe Prentice and Iain Soden

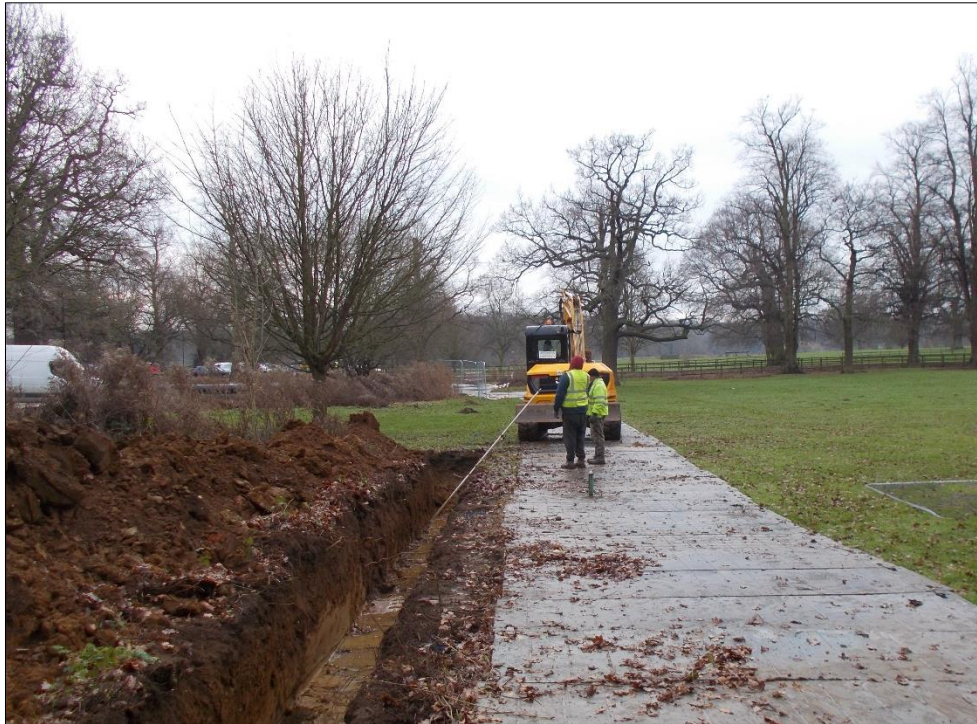
The entire length of the new trench was excavated by a tracked mechanical excavator which operated from a continuous temporary trackway of protective interlinked decking laid to minimise soil rutting and disturbance, which would otherwise be made worse by winter ground conditions

Fig 3: The trenching underway showing the temporary trackway laid to prevent rutting, looking south.

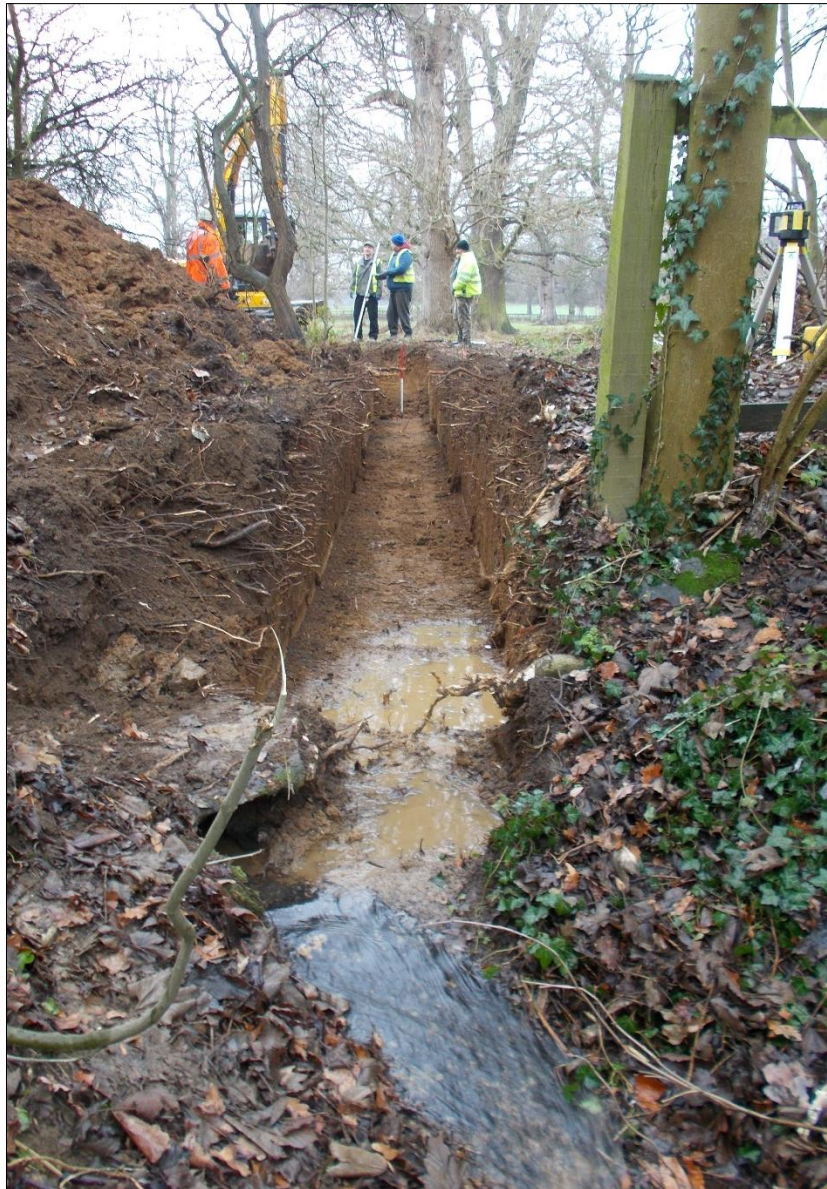
The trench commenced adjacent to the outlet of the old, stone, culvert which at the time of the observations was still functioning, although not fully (Fig 4).

Fig 4: The north end of the new drain run trench (right) and the old stone culvert outlet (left), looking south-west. 1m scale bar.

The depth of the trench at this point was approximately 1m and comprised a shallow topsoil which must represent imported soil since much of the layer beneath contained quantities of late nineteenth- or early twentieth-century machine-made red brick such as had been observed previously during 2015-16 excavations at the Abbey. Mixed into this modern deposit was an almost complete Aucissa copper alloy brooch (found by metal detecting of up-cast spoil) dating to the 1st century AD (see below, Finds). This brick-laced rubble layer extended south for approximately 22m from the stream (see Fig 2).

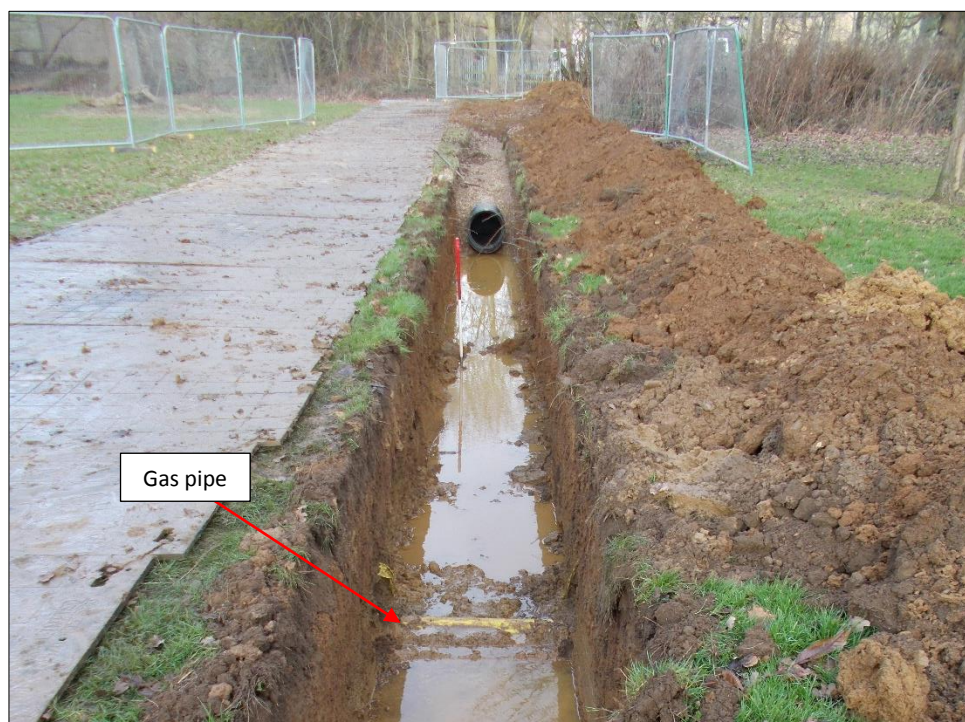
Due to the wetness of the soil, sections of new trench were excavated daily and then the new drainage pipe laid within it to prevent the likelihood of overnight trench collapse. As can be seen from the accompanying photographs, within a short period after excavation, each section of new trench began to fill with ground water (see Fig 5). Thus, each day a relatively short section was observed and recorded with all up-cast spoil being metal detected.

Fig 5: The new trench with installed new water pipe and backfilled section, looking north. 1m scale bar.

The soil profile changed little along the entire length of the pipe trench, a relatively thin topsoil (c.0mm-300mm) lay above alluvium (c.300mm-1.2m) which in turn overlay river terrace gravels (> 1.2m). A recently-laid gas supply pipe was observed within the bottom of the trench, its route having been previously observed in 2016. Further to the south a defunct metal gas pipe was observed and further south still, a newly laid electricity supply comprising two parallel cables set beneath warning boards, their installation route having also been previously observed.

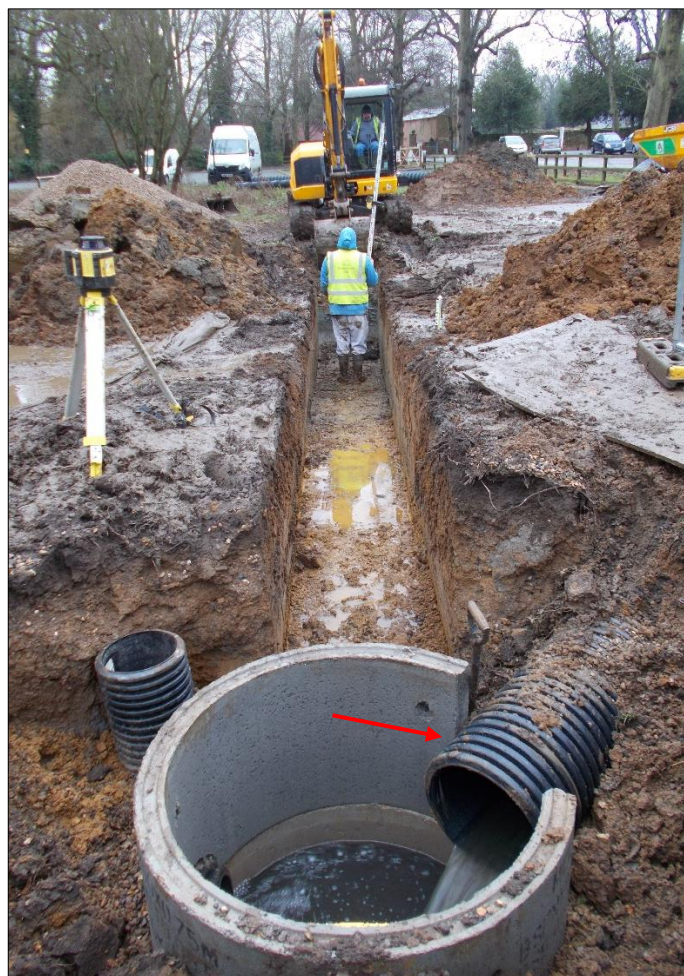
Towards the southern limit of the new water pipe trench an inspection pit comprising pre-cast concrete rings was installed in order that a short section of pipe aligned south-east could be connected to an existing manhole serving the stone culvert (Figs 2 and 6).

Fig 6: The inspection pit at the south end of the primary north-south new water pipe run, looking east. The short south-east section (arrowed) has been fitted which connects with an existing stone culvert manhole. Looking east.

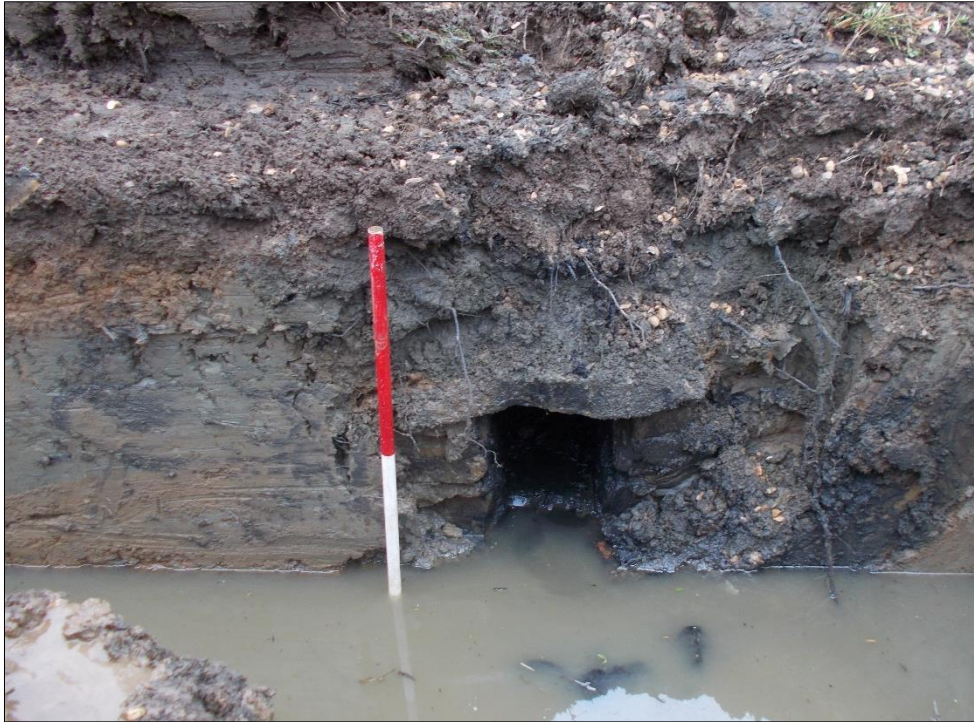
After the installation of the inspection pit, a second east-west aligned length was dug from the east side (see Fig 6). That, too, revealed no archaeological features until reaching the point where the new trench cut across the line of the existing stone culvert (see Figs 2 and 7). The stone culvert was revealed to be entirely blocked by silts and debris and comprised two parallel ironstone walls capped by narrow slabs of the same stone (Fig 7).

Fig 7: The stone culvert, looking north. 1m scale bar.

As in other sections of the new trench, as soon as it was excavated, the base filled with water indicating the high water-table and poor drainage. A further inspection pit was added at this point with new drainage pipes inserted into the ends of the stone culvert on either side.

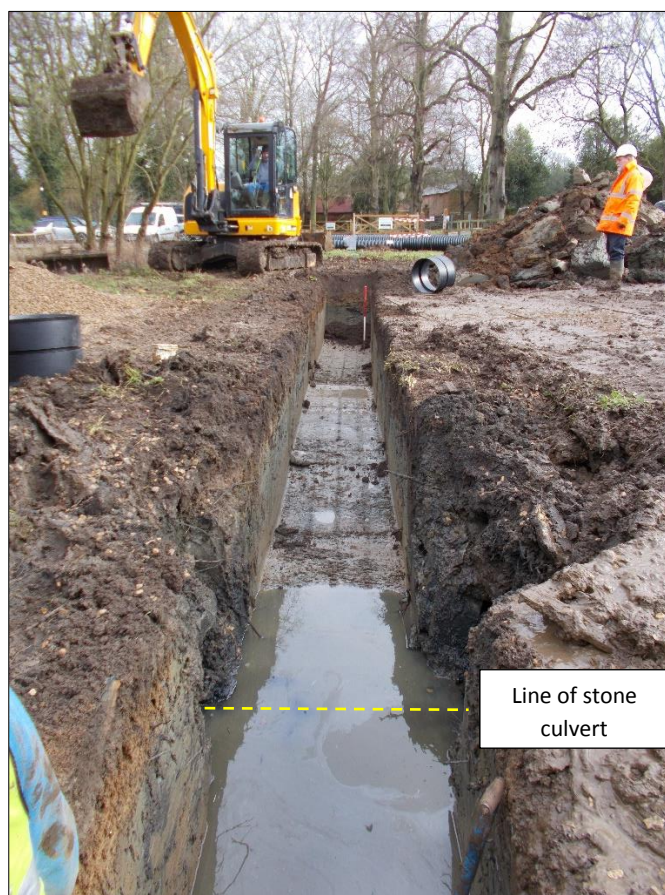
The east-west section of trench continued to its eastern termination to the east of the line of the stone culvert before returning in a south-westerly direction for a connection with another inspection pit before turning south-west to connect with an existing section of another culvert (see Figs 2 and 8).

Fig 8: The eastern end of the east-west section of new pipe trench, looking east. 1m scale bar.

Much of the south-west aligned section had been previously affected by groundworks and the upper levels were much disturbed.

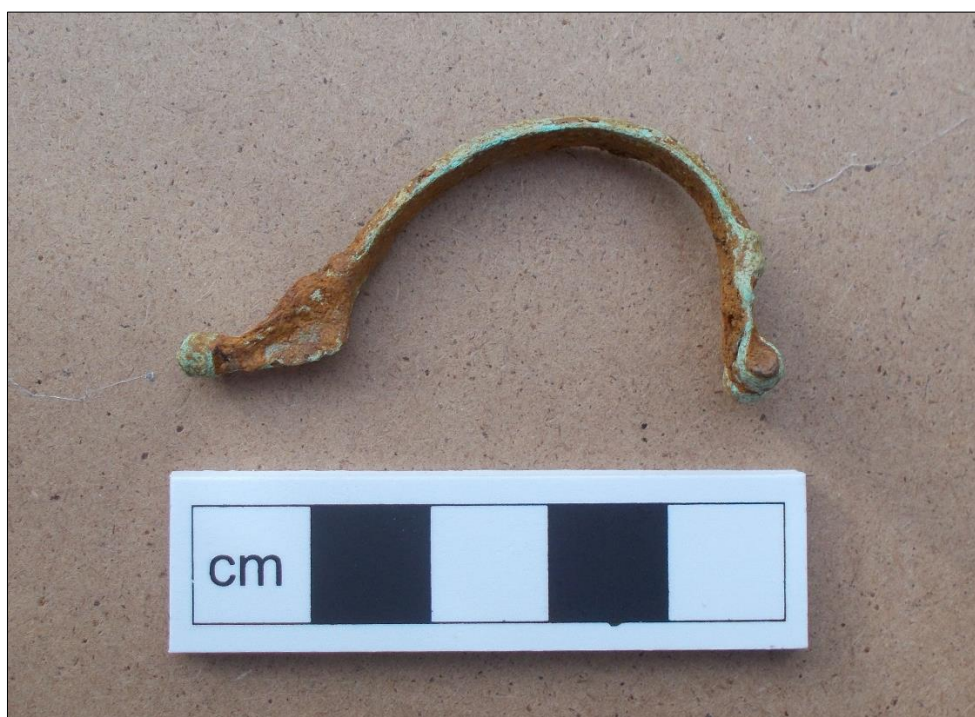
The Romano-British bow brooch was residual in a modern, disturbed layer (Fig 9). Complete, apart from the catch-pin and spring, the brooch retains traces of rows of dot-decoration along the raised spine of the bow and a tiny knob terminal to the catch plate. The two loops which would have held the spring of the pin remain intact, although the pin itself has been lost.

Fig 9: The Aucissa-type Romano-British bow brooch. Scale in cms.

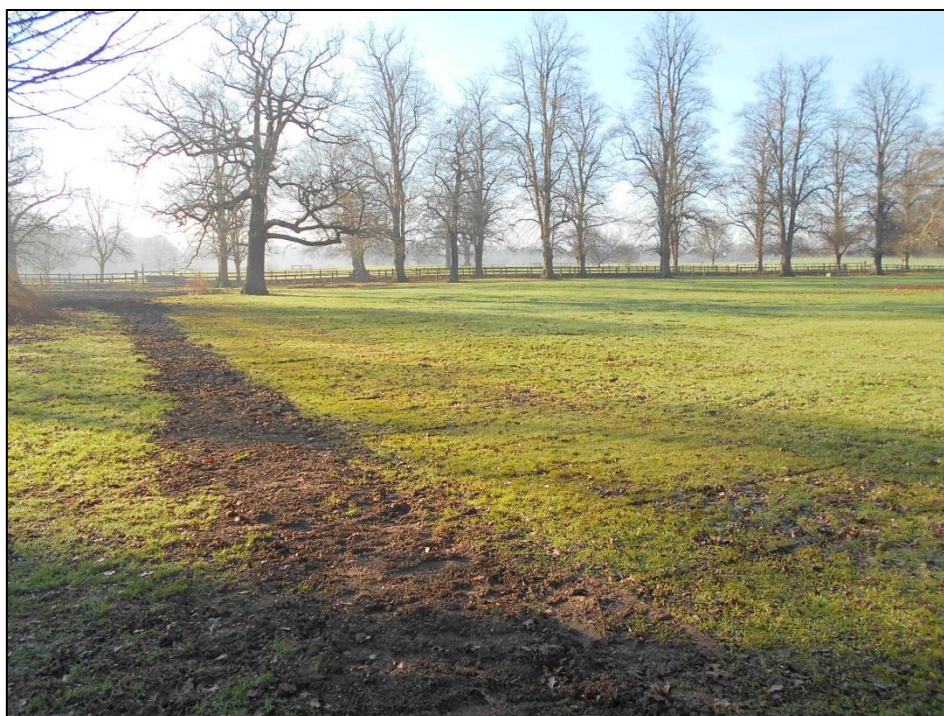
Owing to the sensitivity of the site as part of a registered battlefield equal care was required of the pipeline contractors in restoring the site after their works were completed. A final visit verified the neatness of their operation in backfilling the trench and making-good the excavation works.

Fig 10: A final visit verified the neatness of the site made-good; within days of removing the protective tracking, the grass was already recovering its colour. Looking south.
