**Ongoing conservation works at the former Vulcan Works,
34-36 Guildhall Road, Northampton**

**Site preparation and groundworks for development on
Angel Street, 2019**

Vulcan Works (Angel Street development)

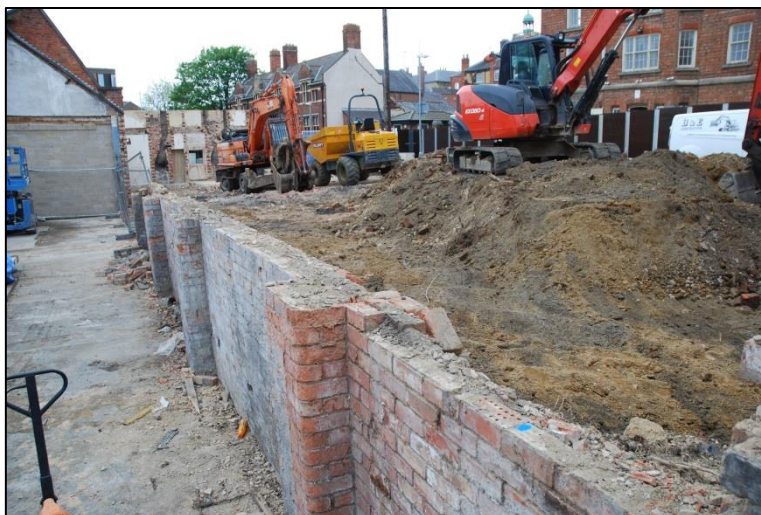
Fig 2: Reducing the modern (Angel Street) level; at left the Vulcan Works floor level (Block A, bays 5-11). View looking west from Block A, bay 5.

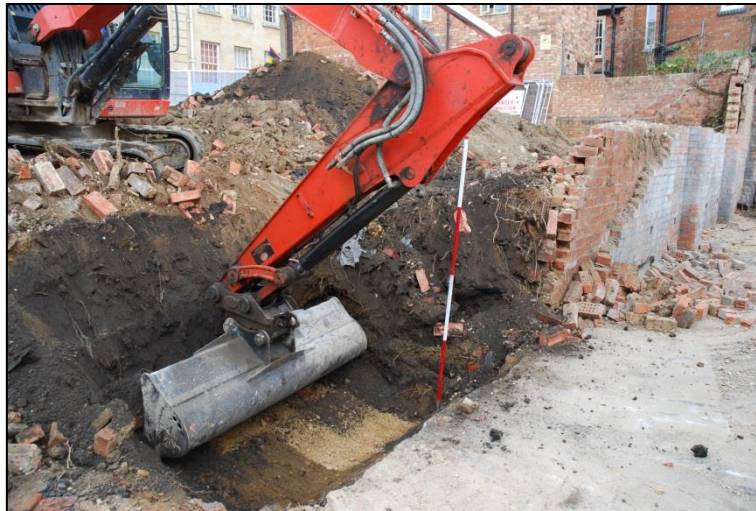
Fig 3: A machined test pit failed to expose natural ironstone geology even 300mm below the Vulcan Works (adjacent Block A, bay 9) concrete floor, c2.5m below the modern (Angel Street) ground surface; scale 2m

When the desired level was reached for the import of the piling mat a simple test pit was machine-dug to assess what thickness of overburden still lay above the natural ironstone geology and any potential medieval archaeology. This was seen to be at least 2.5m thick below the modern ground surface and in excess of 0.3m below the concrete floor of the Vulcan works Block A (Block A as set out in Soden and walker 2016). Mixed horticultural soil deposits were exposed at c2.5m depth but natural geology was not reached. This indicated that in excess of 1.5m of medieval and later horticultural together with post-medieval industrial waste deposits have accumulated over natural geology, until the ironstone foundry was erected on the site in the later 19th century.

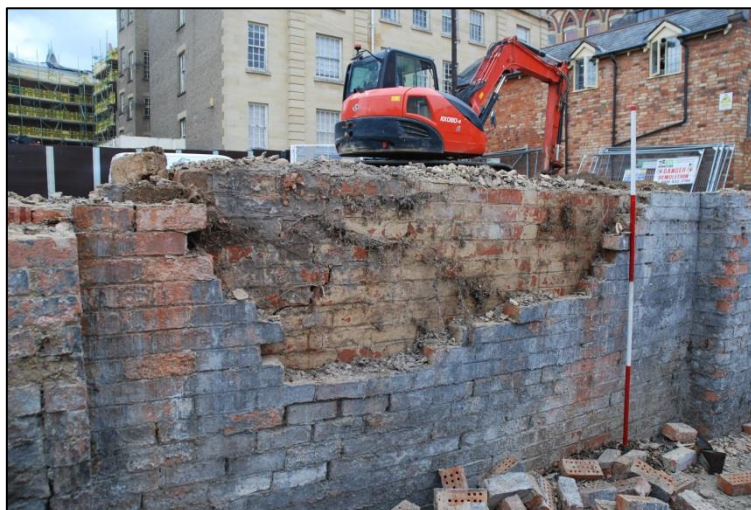
Dismantling of the north wall of the Vulcan Works Block A was necessary since the wall was buckling under the weight of its own roof. The exercise quickly showed that this had happened because the wall was only one brick thick, being only a 4.5-inch skin which had been built up against an earlier terrace wall on its north which appears to have surrounded and delineated the foundry on Angel Street. This earlier wall's exterior was clearly on show before Vulcan Works building was erected and had been neatly pointed up and had been lime-washed, of which large areas survived.

Fig 4: The 4 ½ inch-thin Vulcan works (Block A, bay 9) north wall-skin, built up against the outer face of earlier foundry boundary retaining wall, still with its pale lime-wash. View looking north; scale 2m

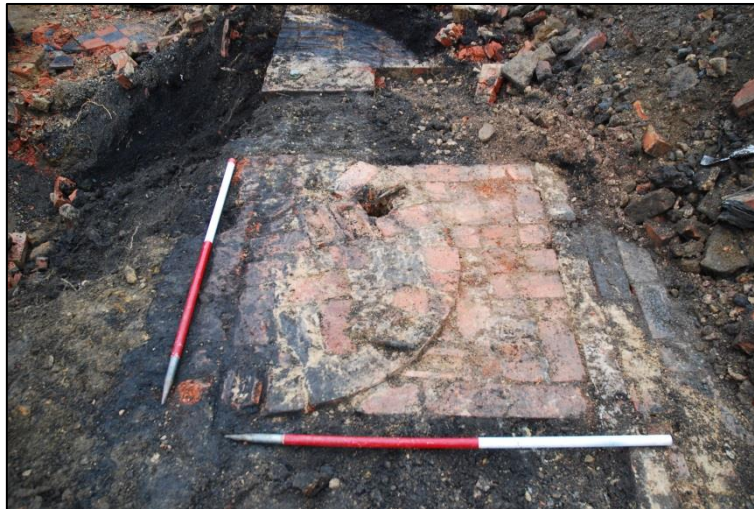
Directly adjacent to this was a brick base which described within it the arc of part of a circle. Although it looked a little like a well on first inspection, it was found to be solid mass throughout, and included some iron reinforcement rods deep into the structure. Two of these protruded upwards and probably fixed to two (of originally four) cupola legs. This is interpreted as the base of the iron-smelting cupola attested on the 1899 Goad Insurance map. It had been truncated on its south side by a 10-inch salt-glazed drain which turned and angled between cupola and chimney. The reader is referred to the following datasheet by the Historical Metallurgy Society which explains the remains and their purpose in the context of the ferrous metalworking industry.

Fig 6: The truncated brick base of the steel-making cupola, view looking west with chimney base in background; scales 1m

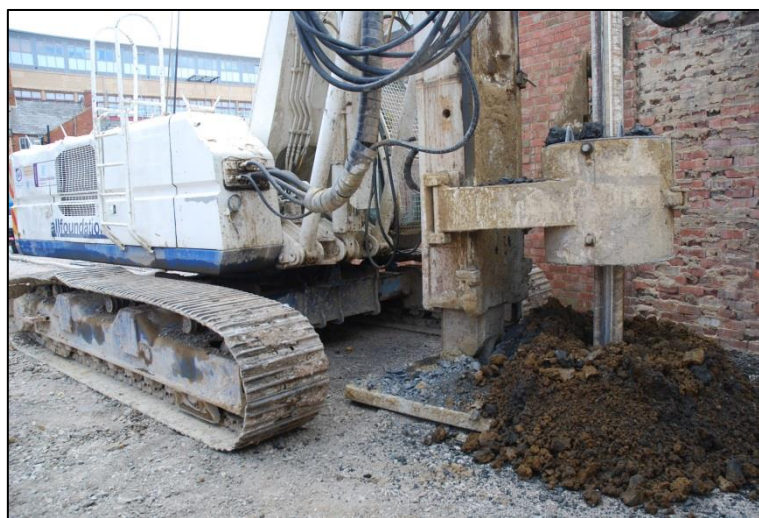
Piling took place from the stability of the imported piling mat. Two piles were monitored to verify the efficacy of the operation and the subsequent effects they had had on anthropogenic layers. While the up-cast of the augered holes was very mixed up, with no finds apparent, a view was later possible of the set concrete of four piles prepared to receive a ring beam. The concrete, neatly contained within the hole (not pressed outward by the concrete pump), had actually taken on the form of the Archimedes Screw of the auger as it had been reversed back out of its pile hole. Thus the potential damage piles might cause was minimal and restricted to the volume of the pile where it passes through anthropogenic layers, with no zone of liquefaction and no wider deformation of stratified deposits.

Fig 7: CFA piling in progress in angle between retained portion of Weights and Measures building and Vulcan Works inter-war shed 1. View looking south-east.

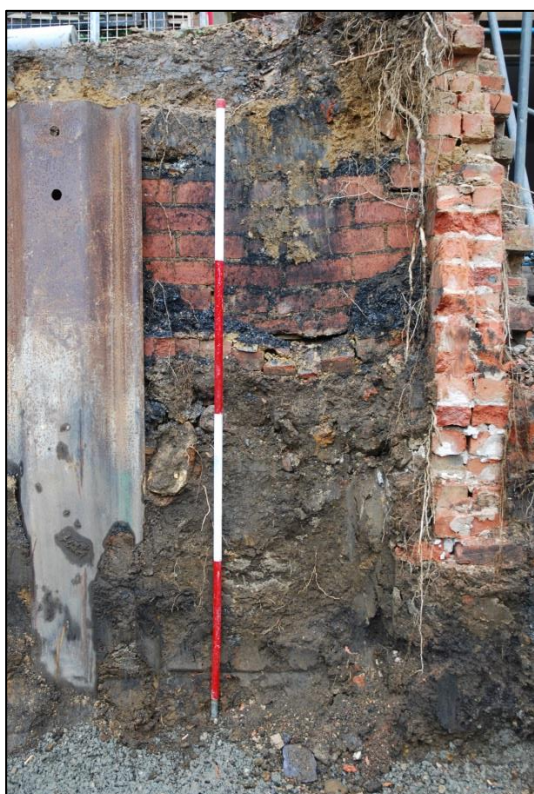
Fig 8: c3m of fill below the modern ground surface at the south-east corner of the site; scale 2m

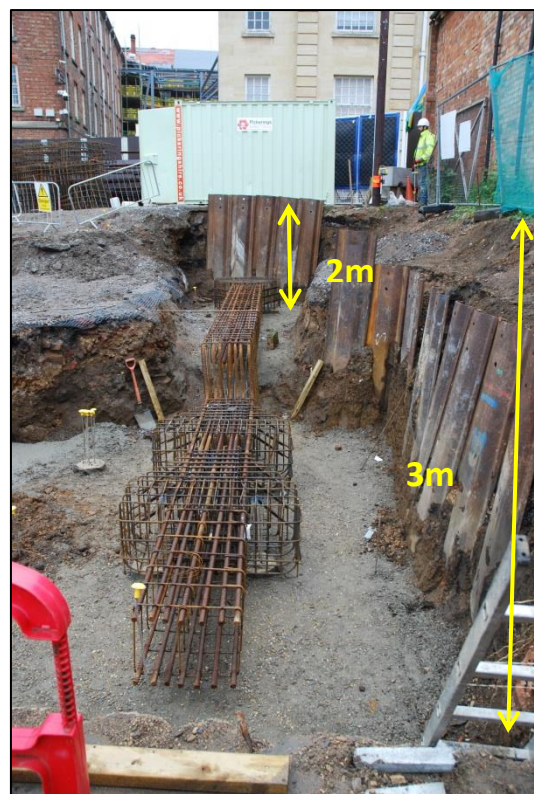
A large tracked excavator was used to remove the imported piling mat and to dig the pile caps and linking trenches into which the ring beam foundation will lie. The foundations are in two stepped blocks, each occupying about half of the site. The northern half has the soffit of its ring beam set at about 2m below the modern (Angel Street) ground surface; the southern half has its ring beam soffit set at 3m below the same level.

Fig 9: Ring beams linking the pile groups. Note the depths.

Monitoring during excavation of the ring-beam trenches shows that the thickness of the late post-medieval and modern overburden is quite sufficient to leave any medieval cut features or remaining stratification below the formation level.

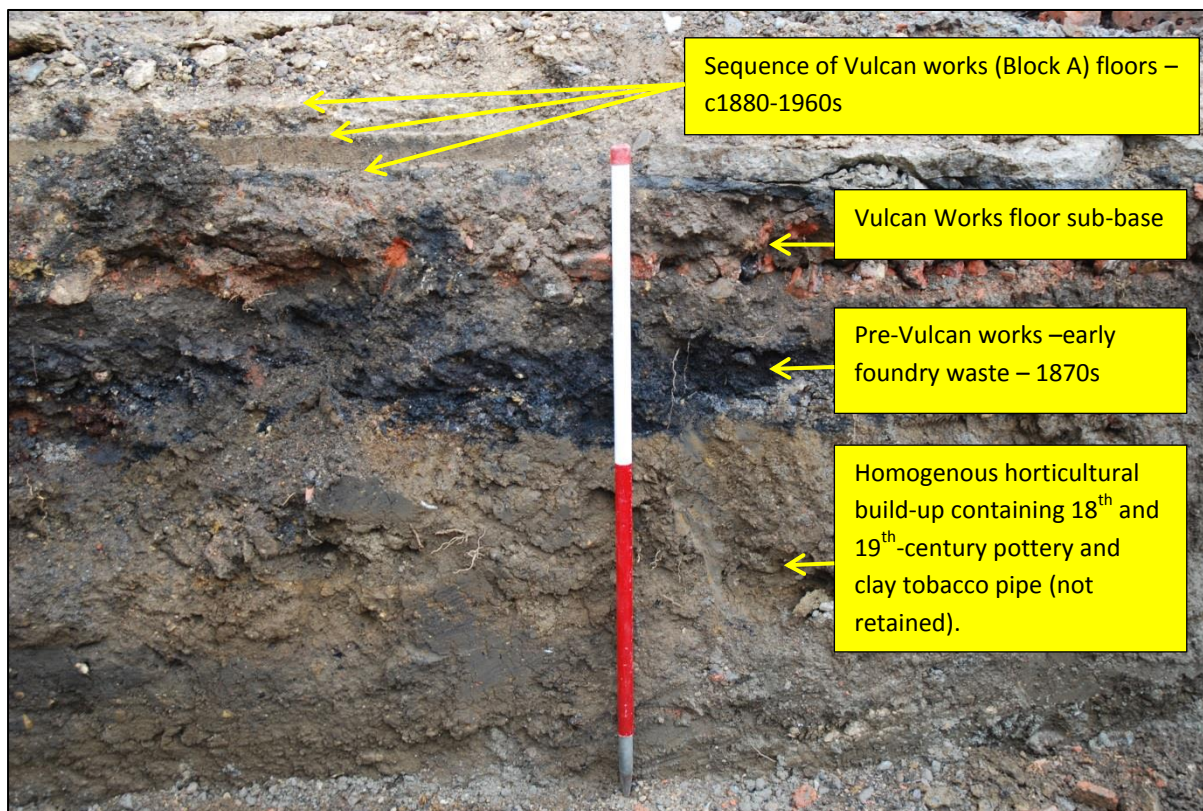
Fig 10: North facing section under the floor of Block A, along bays 7-9 of the Vulcan Works (its north wall removed). The Vulcan Works Block A floors are marked. In excess of 1m of post-medieval fill lies below them.

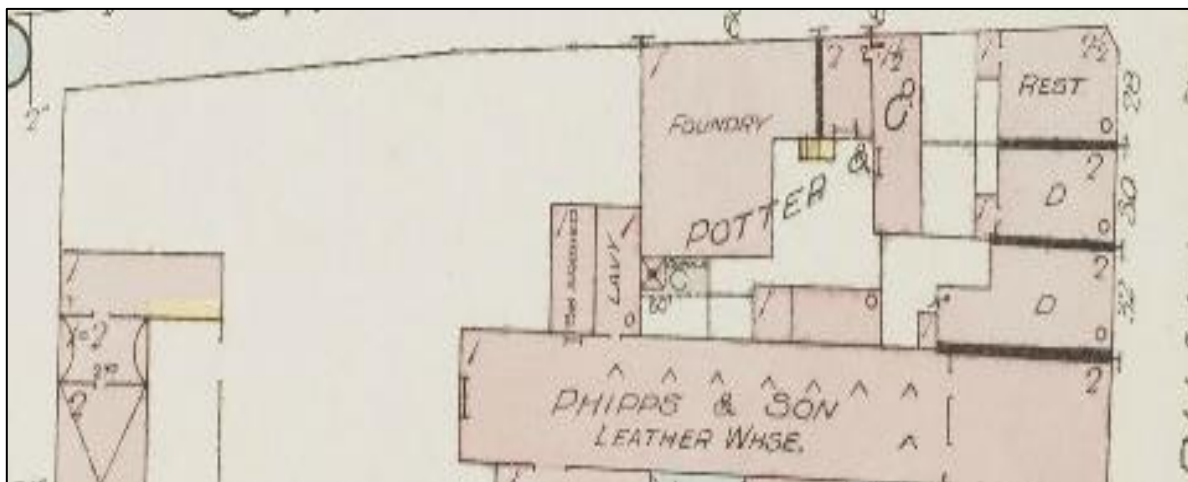
Fig 12: Goad Insurance plan 1899, showing the foundry with cupola and 50-foot chimney both to the south

owned by Potter and the ironworking cupola is shown to the rear of the main foundry building. Its base is that found in excavation (above). Instone (ibid) reports that it was then operated by one Mr Haymer.

The Goad Maps, drawn for many decades to a universal key, show that the building was of a single storey and was surmounted by a slate roof. It had a skylight of between 20 and 50 square feet. Adjacent to it along the frontage was a building of two storeys, from which it was separated by a fire-wall. Neither building now stands.

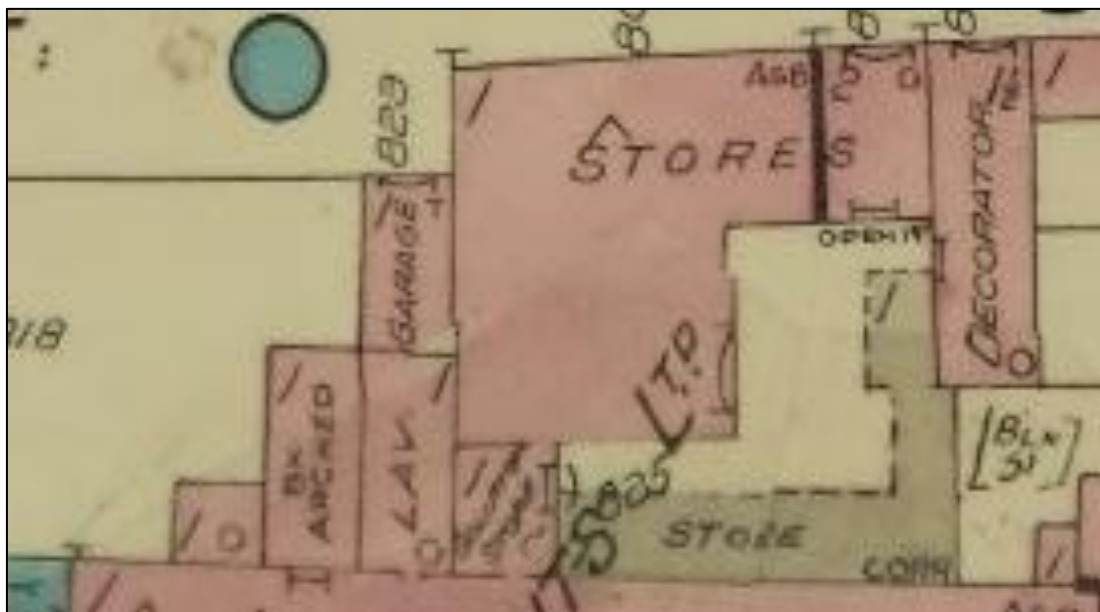
Fig 13: The last days of the old foundry building, 1956. Note how the frontage extended across what is now the Angel Street footway, aligned on the same frontage as surviving buildings to the east, such as that marked 'Decorator' (now a coffee shop in 2019). This alignment accounts for the ironstone basement which was found being part under the recent pavement.
