**A programme of fieldwork at (Lower) Benefield Castle,
East Northamptonshire, 2018**

(SM 1015535)

A programme of fieldwork at (Lower) Benefield Castle, East Northamptonshire, 2018

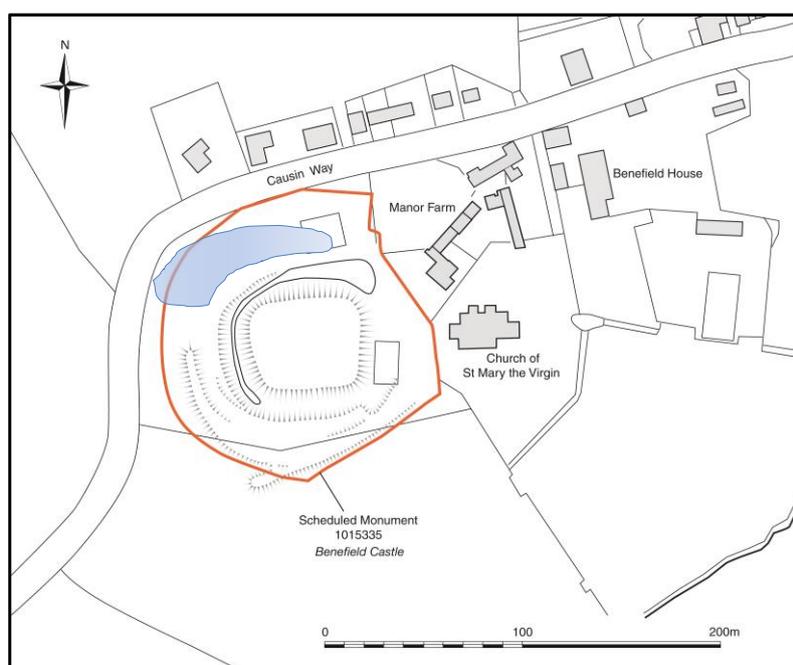
Fig 1: The Scheduled Monument of Benefield Castle. Earthworks as surveyed by the former Royal Commission (RCHME 1975, 18; fig 29). Drawing by Andy Isham. The area specifically addressed in this report is toned blue.

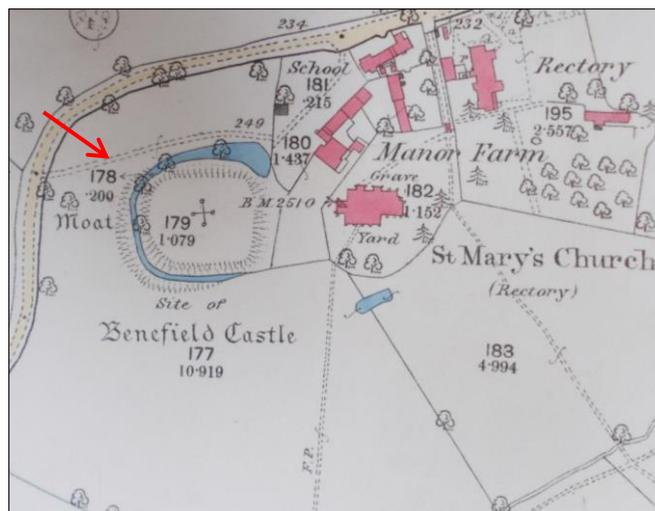
Fig 4: The castle moat, earthworks and part of the village, mapped for the Ordnance Survey 1st edition, 1886. A northern trackway from Causin Way is shown for the first time (here arrowed), and thereafter repeatedly depicted.

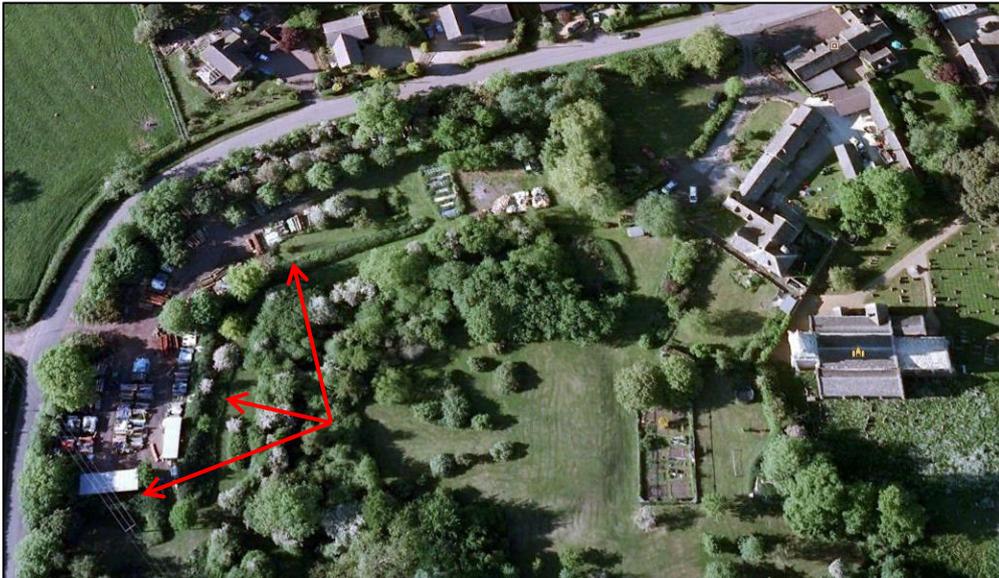
Fig 5: The castle as depicted on a satellite view of 2005, the first year the bund (arrowed) was in existence (it is not present on a 2004 satellite view). Note the density of buildings and vehicles to its north and west. With acknowledgement to Google Earth timeline

The test pits showed that a considerable area had been previously stripped of its soils and hard-core had been introduced in places, spread directly onto the natural geology. This was not largely old hard-core related to the former (late 19th-century) trackway, but modern builders' rubble, probably related to the former recent uses to which that part of the site was put. This is believed to have included a saw-mill and wood-yard with related extensive hard-standing (see Figs 5 and 6 for former extent).

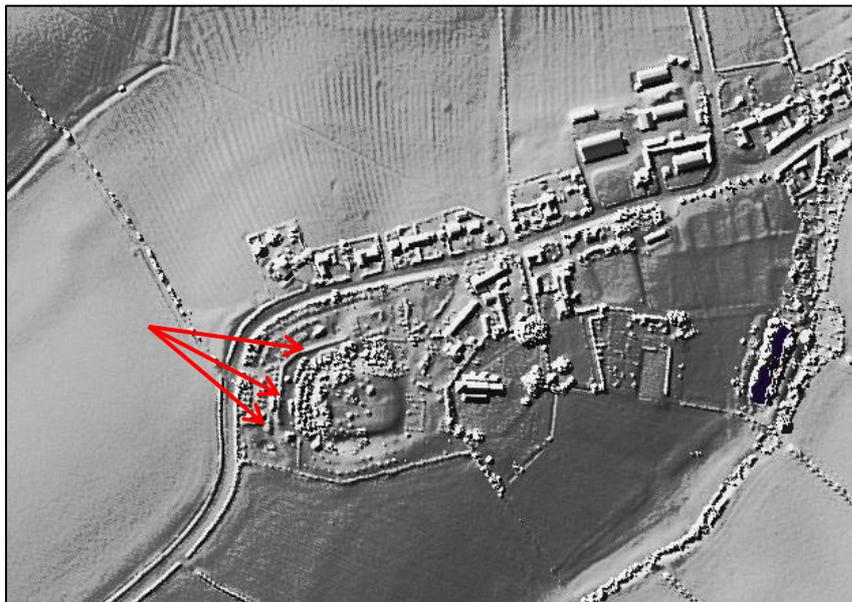
Fig 6: A Lidar image of the castle which shows the 2004/5 bund (arrowed) removed (spread flat and compacted) as part of the current works. Thanks to Bryn Gethin, Archaeology Warwickshire, with acknowledgement to <https://houseprices.io/lab/lidar/map>

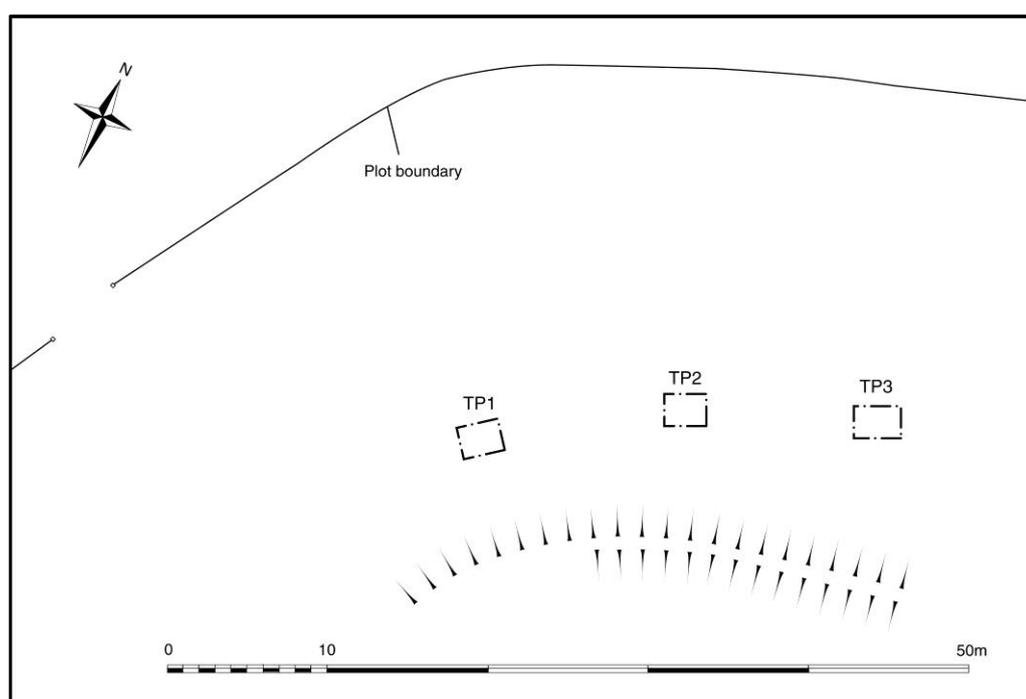
Each of the three test pits measured c2.5m x c1.6m in plan at the surface and was a maximum of 600mm deep. Their eventual locations were chosen to best reflect the course of the former trackway and to assess where possible the proposed course of the new one, all subject to on-site impediments and the potential soil modification which was thought to have taken place in the creation of the adjacent bund. None of the test pits targeted a known medieval castle-related feature.

The location of the test pits was measured into the site by means of a manual taped offset which also took in the northern plot boundary adjacent to Causin Way and the curving bund earthwork on the south, to be removed shortly after.

Fig 7: The test pits relative to the gateway (mapped repeatedly since 1886), the Causin Way roadside plot boundary and the bund which was removed shortly after. Reduced from 1:100 field measurements. Drawing by Andy Isham.

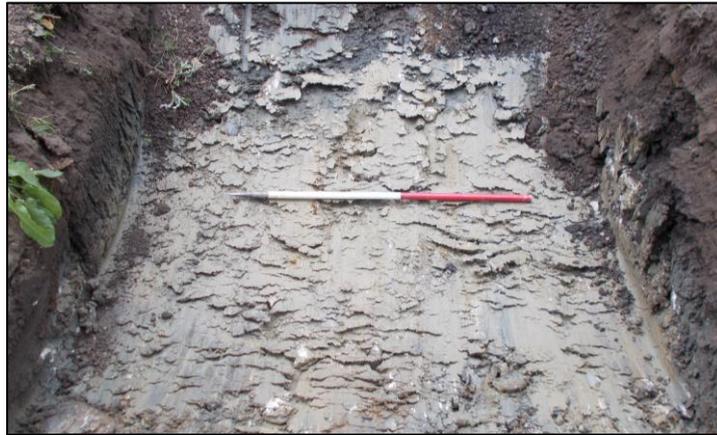
- *Test Pit 1* measured 2.5m x 1.6m at the surface and was 600mm deep.

- 0-400mm Modern rubble and road-planings/scalpings
- 400-500/600mm Compressed topsoil with much rubble
- 500/600mm Natural grey-buff clay with water-worn cobbles

Fig 8: Test Pit 1 looking north west; scale 1m

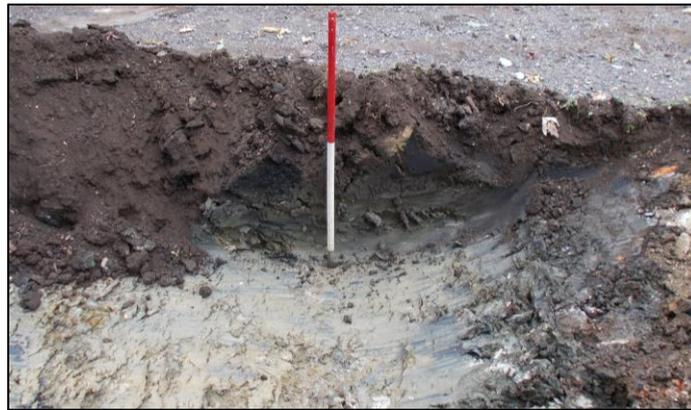
- *Test Pit 2* measured 2.5m x 1.6m at the surface and was 500mm deep.

- 0-100mm Dark brown topsoil and edge of scalplings/road planings
- 100-450/500mm Rubble including tarmac pieces, kerbstone, brick, limestone
- 450/500mm Natural grey-buff clay

Fig 9: Test Pit 2, looking north, note former hardstanding behind; Scale 1m.

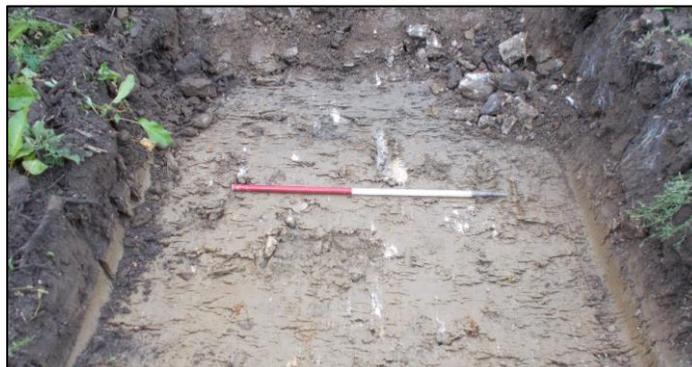
- *Test Pit 3* measured 2.5m x 1.6m at the surface and was 400mm deep.

- 0-400mm Dark brown topsoil with occasional modern rubble, rutted and rammed into clay below
- 400mm Natural grey-buff clay with limestone flecks.

Fig 10: Test Pit 3, looking west; scale 1m

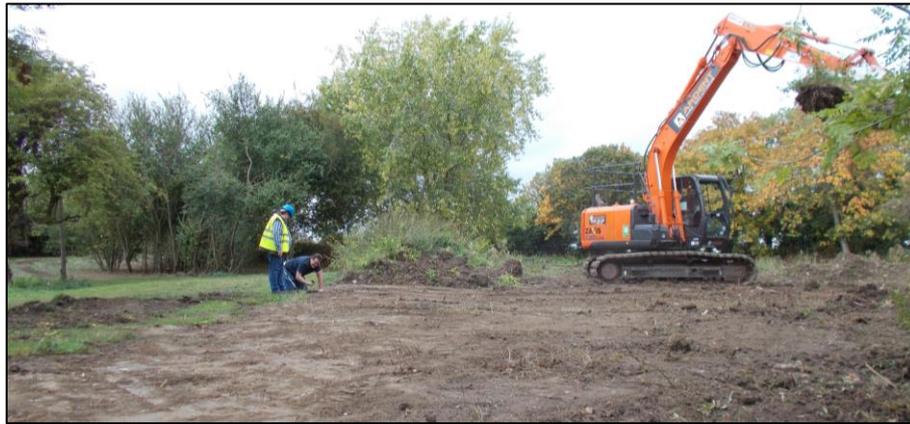
Although thought originally to be a topsoil bund, the earthwork was found to contain considerable quantities of builders' rubble, from limestone and brick, to concrete kerbstones, breeze-block, timber off-cuts, plastic piping, guttering, concrete, land-drains, ceramic pipes etc. It resembled the dumping of a former builders' compound material or direct tipping of construction waste. Topsoil had been used to seal the waste and provide a growing medium over it.

Fig 11: Spreading the bund, here about 1.2m high. Note the newly-reunified ground levels to either side.

Following machine-backfilling of the test pits, the 14-ton machine was deployed to spread the bund, which in places was up to 2m high, across the former hardstanding and disturbed areas on its north and west sides. The work continued to be archaeologically monitored.

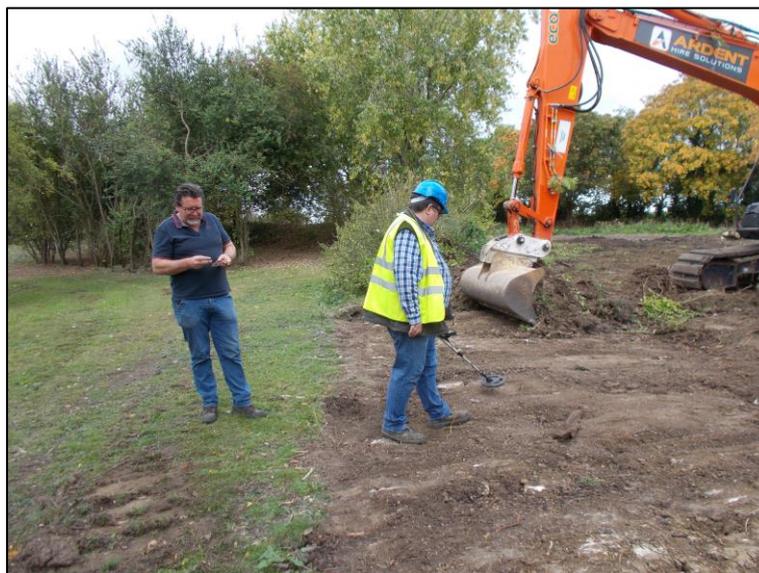
A metal-detector was deployed to scan the newly re-spread former bund to look for any non-ferrous metallic finds in the previously disturbed up-cast. The detector was set to discriminate against the many iron-based objects which are usually present in a former farmyard. In the event there were few non-ferrous signals present, although copper, lead and probable cupric alloys (such as heating pipe-fittings, washers and a paraffin lamp grille and wick-holder) were present amongst modern builders' waste; these were not retained. There were no pre-modern finds.

Fig 12: Metal-detecting across the base of the bund
