Iain Soden Heritage Services Ltd

**Lyveden Reconnected: a programme of archaeological
monitoring to accompany the unification of the
New and Old Builds at Lyveden
by The National Trust 2019-20**

**Planning refs: (East Northants) 18/01818/FUL (works to and around
the manor), and 19/01734/FUL (pipeline)**

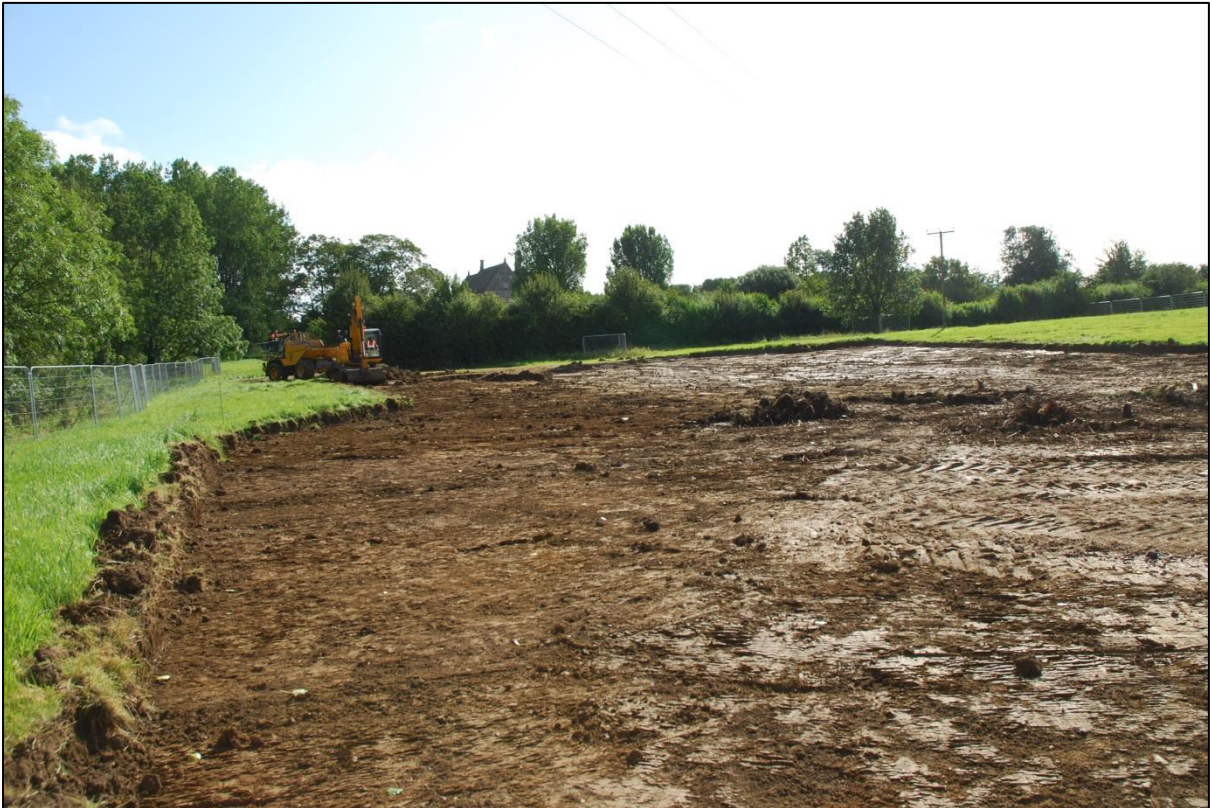
Fig 3: New Car Park area, stripped of topsoil and subsoil, looking east. Manor House in the distance.

The topsoil and thin subsoil were removed by two 13-ton tracked excavators and spoil moved to another part of the site in a relay of large articulated dumpers. A varying total of 300-450mm thickness was stripped off mechanically, with a wide toothless ditching bucket being used throughout (Fig 3).

No archaeological features were present anywhere in the stripped area. Strawn evenly across the area, and handpicked from the base of the ploughsoil (it had not been ploughed for many years) was an assemblage of mainly medieval (occasional 19th-century) abraded and water-damaged domestic pottery. None was stratified except for its presence in the vestiges of the plough-soil after machining. It was retained, by agreement unprocessed, for future educational use by The National Trust at the site. The pottery was entirely of the local Lyveden/Stanion unglazed A ware (CTS 319), with some green-glazed B ware (CTS 320), and dates between c1150 and c1400 (McCarthy and Brooks 1988, 285-9, 430-1). The vessels from which the sherds derive were probably made in the

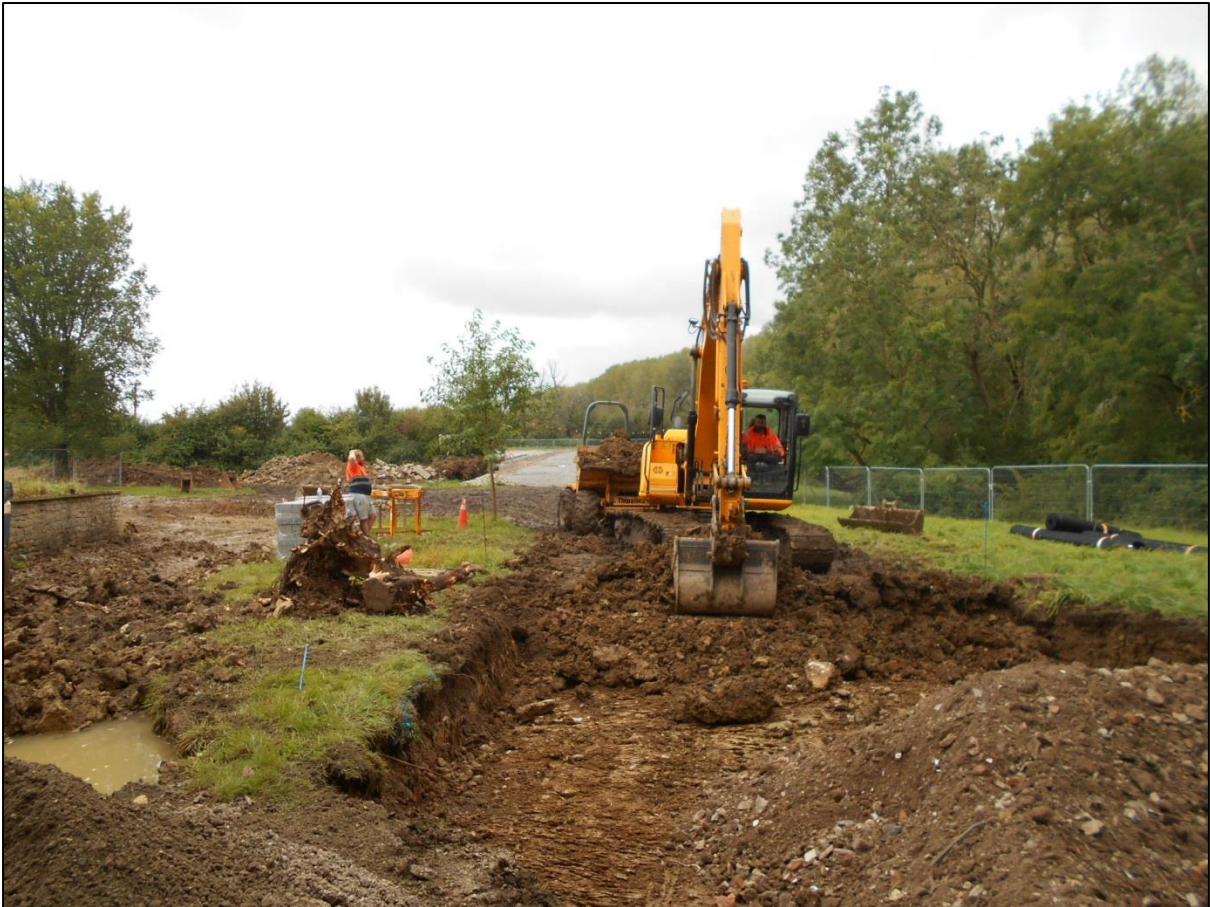
Fig 4: Digging out and stoning-up the access road to the car park, looking west

A new service road was then dug out to connect the site access of Harley Way to the new car park. This entailed removing the turf, topsoil and underlying material to a depth of up to 1m to provide the required thickness of inert, weight-bearing stony fill (Fig 4).

The material removed here, below the modern topsoil and turf was all modern (20th-century) demolition-material intermingled with lumps of natural clay and unworked limestone. Natural clay geology was locally exposed in places but also the demolition material was seen to extend deeper than the 1m necessary for the formation-level. It is believed to date to around the mid-1970s when the site was extensively landscaped and the adjacent stand of poplars planted.

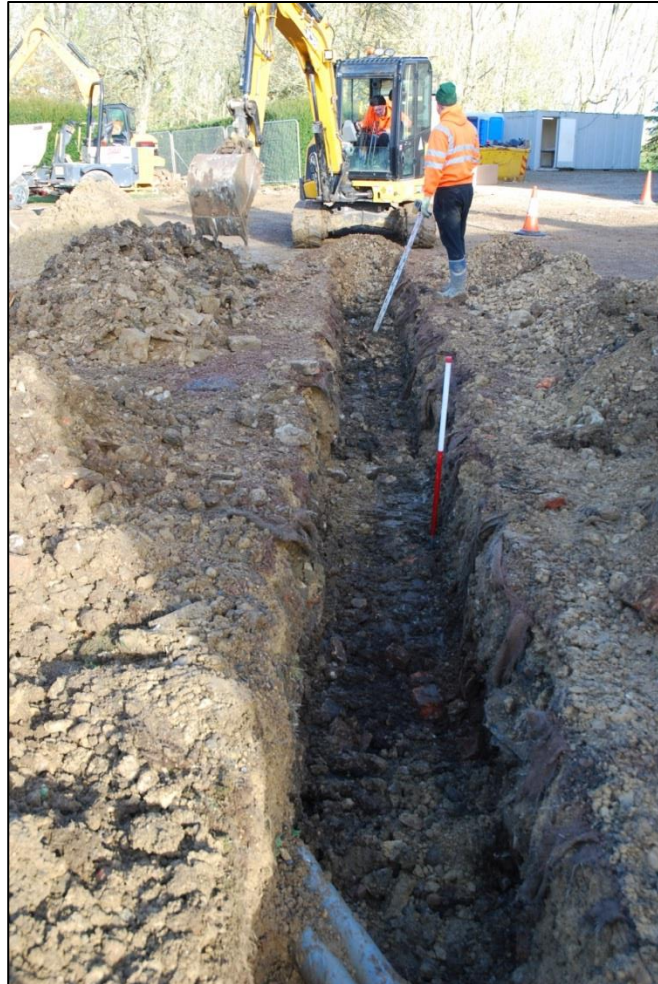
Fig 5: View along the courtyard service trench (southern third), looking north-east; scale 1m. The light grey plastic ducts in the foreground were laid for BT -WAN enhancement in 2018 (see Soden 2018)

The southern third, 800mm deep, cut through the surface gravel and a rubble base. At the base of the trench lay thick, dark grey, noisome clay with rubble in it, which comprise a thick layer or infilling of modern farm debris. This was at least 200mm thick. This deposit was noted in 2018 when the BT cable ducting was laid into the top of it.

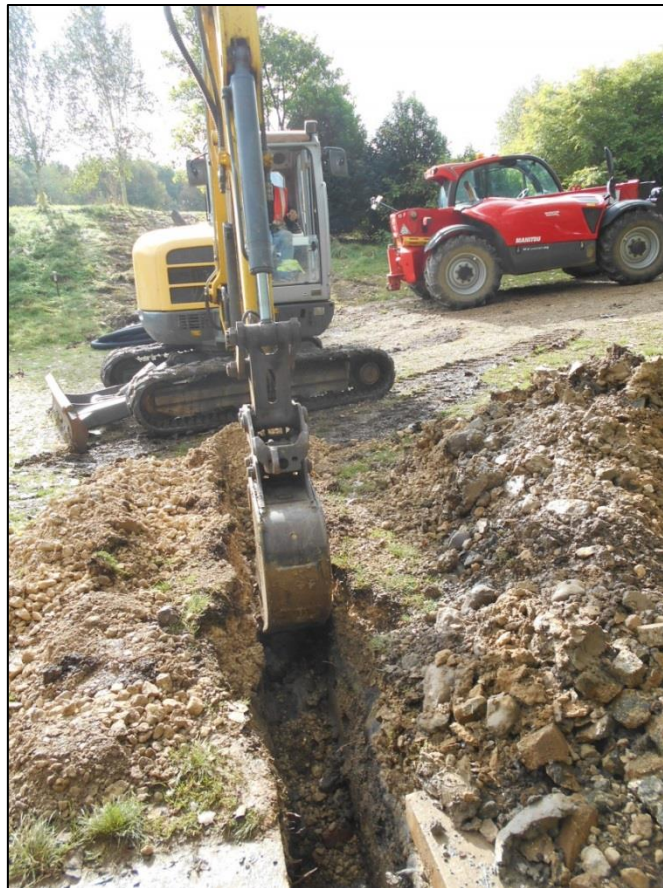
Fig 6: Commencement of the pipeline at the manor service shed, looking north. In the background the escarpment which marks the north edge of the cricket field.

The route began where it left the National Trust service shed which lies north-east of the manor house (Fig 6). At this point it was cut through the gravelled hardstanding directly into natural clay geology; there were no intervening layers, showing that the shed and service road here stand on a modern terrace created for the service area. It then climbed the escarpment of the existing cricket field, a modern earthwork.

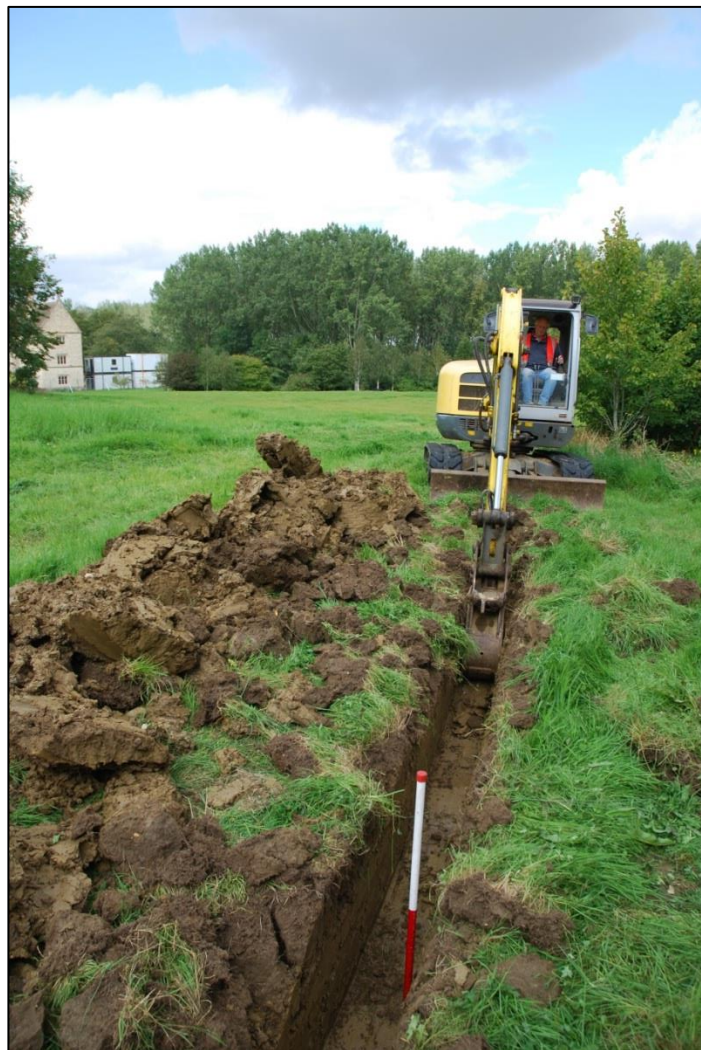
Fig 7: Machining south of the cricket field and swinging out around trees, looking north-west with manor in the background; Scale 1m

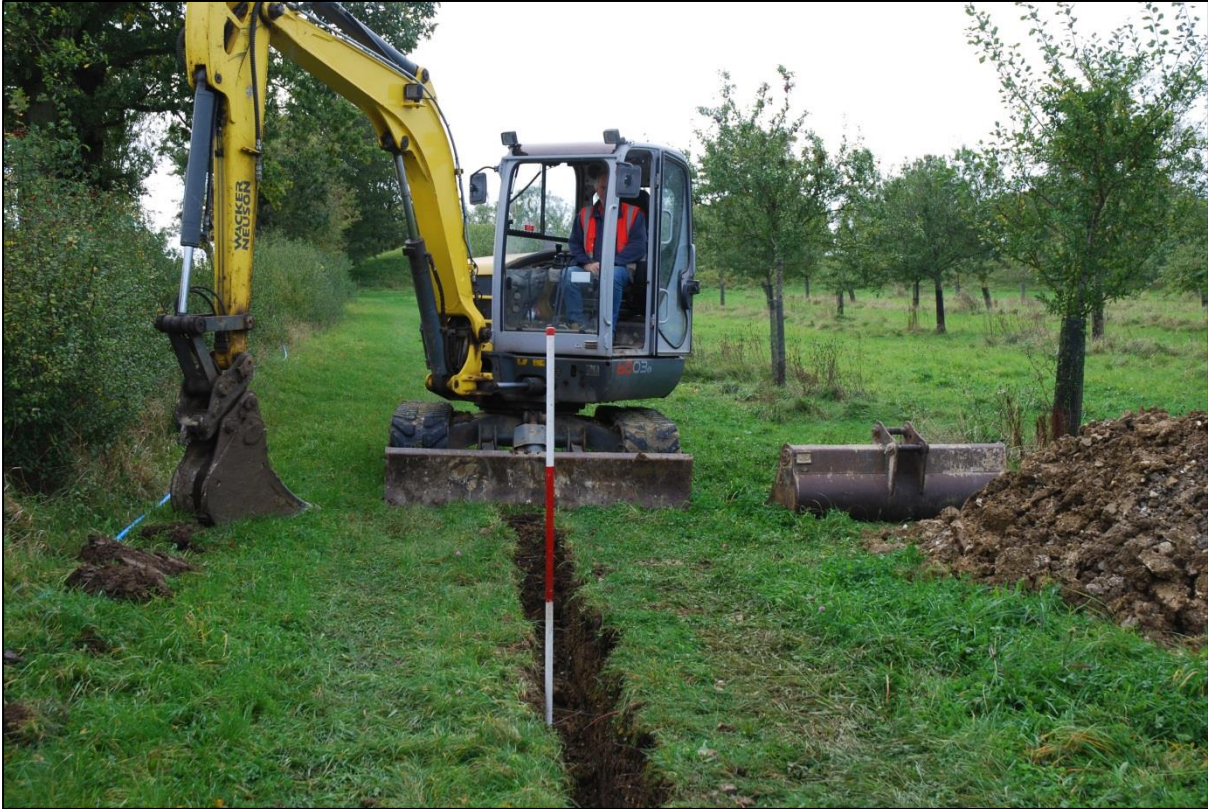
The trench remained a uniform c2m distance from the eastern plot-edge, from which a constant mat of hedgerow roots were noted growing through its eastern side. A greater distance was maintained to the easternmost row of orchard trees to ensure that their roots were unaffected. Here the trench was deepened to c1m (Fig 9). Much of the material through which the machine dug was flecked with chalk or lime, presumably from successive dressings of the land to aid its productivity. At about 1m depth it repeatedly encountered natural limestone, often broken up. There continued to be occasional finds of abraded medieval pottery, but mixed with 19th century material and some 20th century plastics. No tree planting pits were observed.

Fig 9: Machining along the orchard's eastern boundary, looking south. The trench here was about 1.1m deep.
Scale 2m in 0.5m graduations.

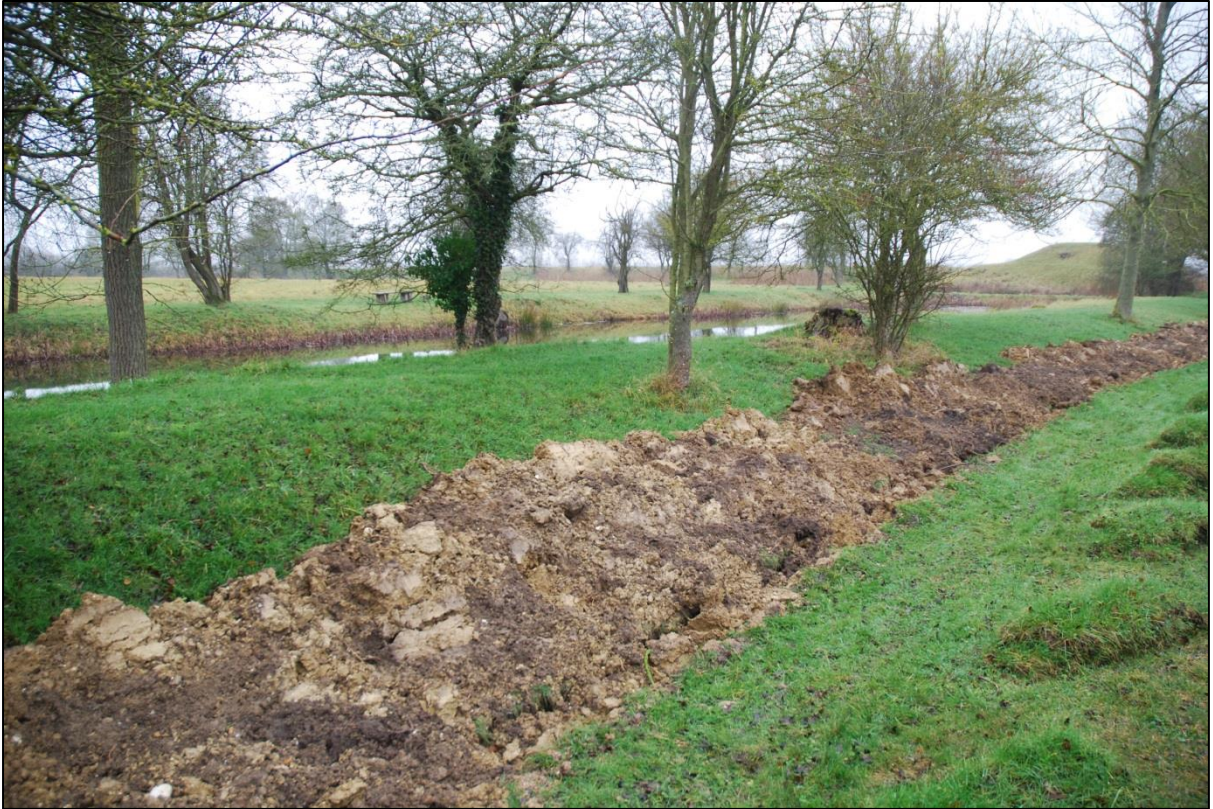
Continuing at the same width and depth it soon became apparent that the winter water-table, as indicated by the adjacent garden moat, was very high. The pipe trench quickly flooded and the sides were in danger of falling in. The pipe was therefore laid straightaway and the trench quickly backfilled to preserve its integrity (Figs 8 and 10).

Fig 10: Alongside the moat. Here the trench flooded so it was quickly backfilled.

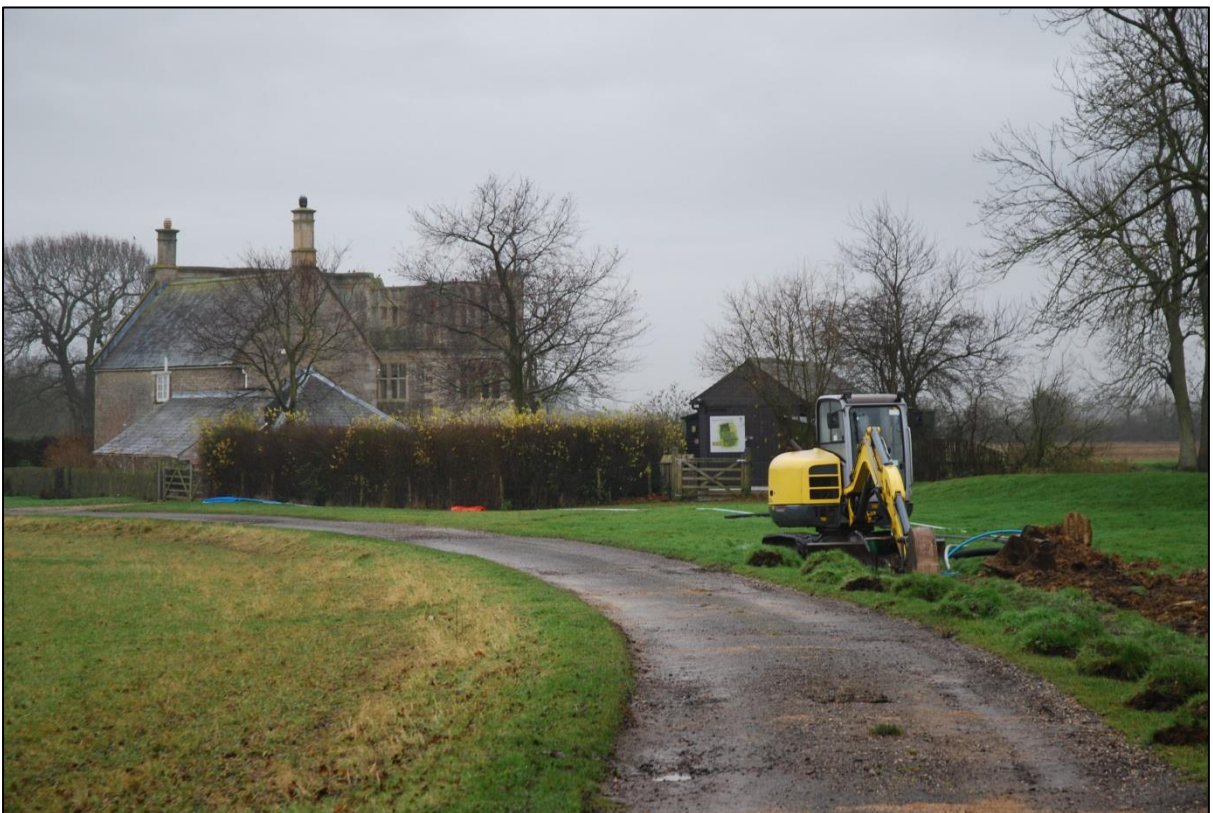
The flooding subsided further from the moat and the trench continued parallel with the access track to the custodian's cottage/tea rooms without further issue (Fig 11).

Fig 11: Approaching the cottage, 'Lyveden New Build' is glimpsed directly behind.
