Building Recording at Noborough Farm, Norton, Northamptonshire

Summary

Noborough Farm comprises the remaining three stone ranges of disused farm buildings, two of which date from the eighteenth century and one from the nineteenth. A number of other former buildings have been lost during the twentieth century. The whole complex is well mapped back to 1812 and it had reached its maximum size and complexity by 1884. One surviving range, containing a former stable, contains three *in situ* Upper Cruck first-floor/roof trusses in good condition.

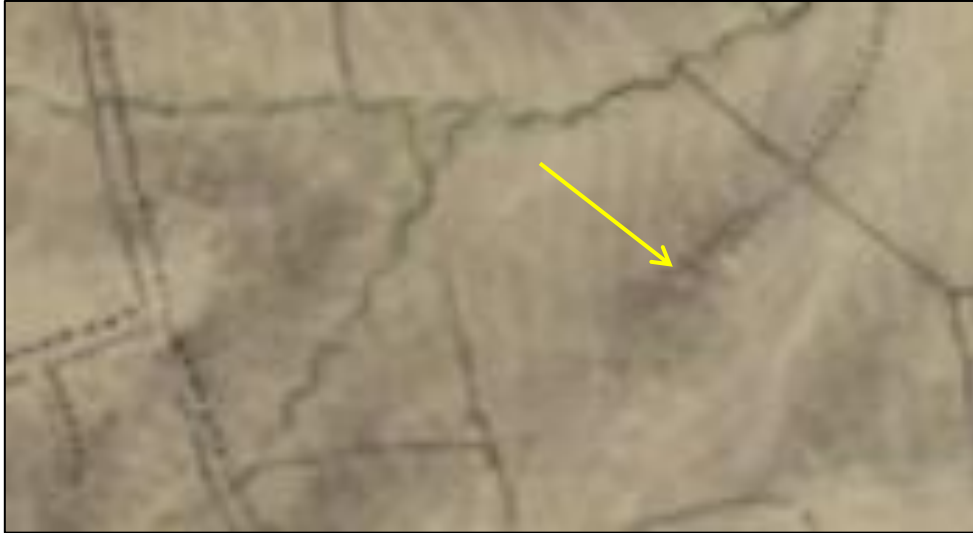
Fig 2: 1812 Ordnance Surveyors edition, Towcester sheet (228), detail. Noborough Farm arrowed.
North to top left (approximately).

The site first appears on the 1812 Ordnance Survey Surveyor's map (Towcester sheet - 228), which shows the east and south ranges, which both survive today. Neither range is wholly distinct but their presence is confirmed. The site does appear to be enclosed on the remaining two sides, probably by a wall or other boundary.

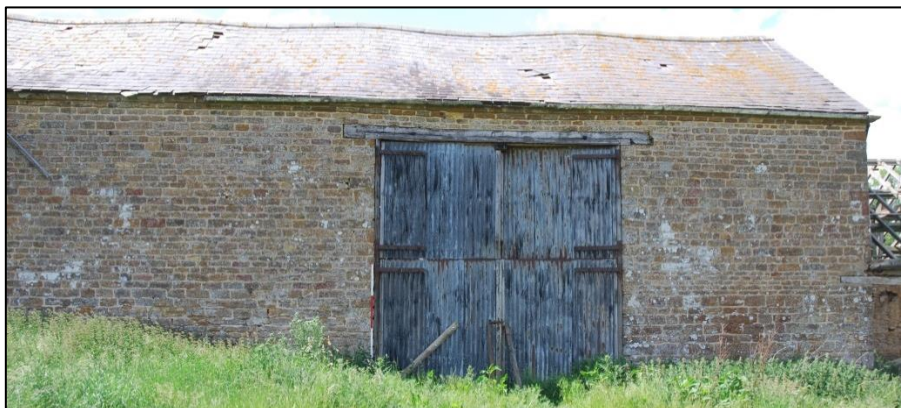
On the basis of the historic mapping, the barn was already standing prior to 1812. It comprises a single stone-built structure c15m x c5m in plan, with opposed high double doors for threshing purposes. Inside, a later brick wall has divided off the eastern end, while a timber hayloft has been created in the remainder of that east end, supported upon stout timbers. The queen-post type trusses are later nineteenth-century replacements and support two pairs of purlins under a slate roof with a blue engineering-tile ridge. The floor is of a mix of patches from cobbles, through brick, to concrete.

Fig 5: North side of the barn, looking south-west; scale 2m

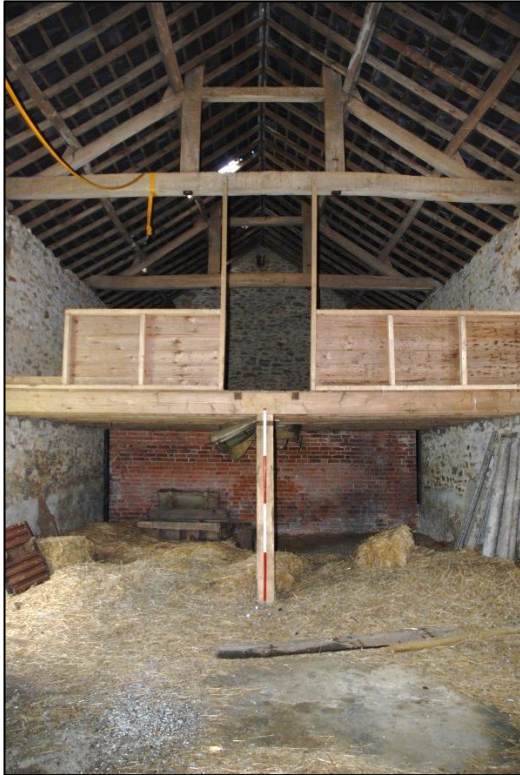
Fig 6: Barn interior with east end hayloft; scale 2m

The lower half of the far eastern end of the barn has been separated off from the main portion of the barn by way of a substantial brick wall, probably in the latter half of the nineteenth century, and which helps carry the weight of the hayloft above. The resultant room is linked to the farmyard by way of a pedestrian door and a similar one up a short flight stairs to the corner room of the north and east blocks. This room is little bigger than a short corridor and is unlit. It is likely that its use was ancillary to the barn and the other room to which it connected. It may have been merely for storage.

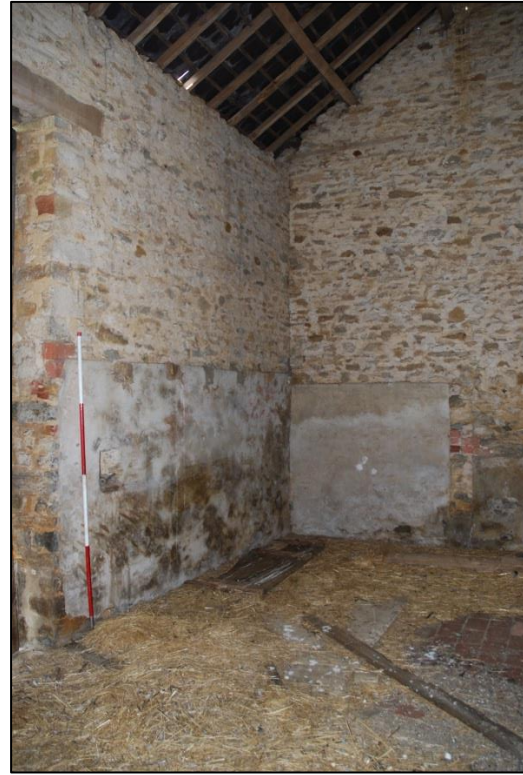
There are the remains of a small brick-built room in the south western corner of the barn, which also once created a useful mezzanine floor on top. This brick box may once have been for a shepherd or cowman to sleep in when livestock needed attention, such as in spring during lambing etc. It neatly encompassed about a third of the western end of the barn and included within it an original lamp niche which is located just inside the western leaf of the southern barn door.

Fig 7: Barn interior with scars of shepherd's hut and lamp niche; scale 2m

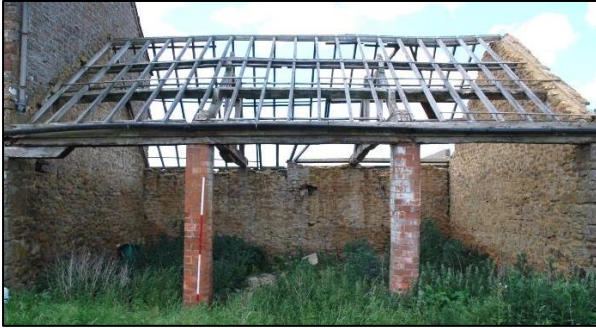
Adjacent to the barn on its western end is an outward (north-) facing cart hovel of three bays. Also of the original build (there are no joins in the stonework), it is open-fronted, and while it would formerly have had the eaves of the open front supported upon timber posts, these were replaced no earlier than the third quarter of the nineteenth century, by a pair of brick piers made from bull-nosed red brick. The building would have provided garaging for up to three carts, wagons or other wheeled vehicles, (as usual) facing north so that no direct sun dried out and split the iron-rimmed wheels and their component parts (Joe Prentice, pers comm). A pair of surviving, angled timbers in the south face of the (very dilapidated) slate roof indicates the location of the former pitched roof of the lost west range (which stood pre1884-1958/64).

Fig 8: Cart hovel outer (front) face; scale 2m

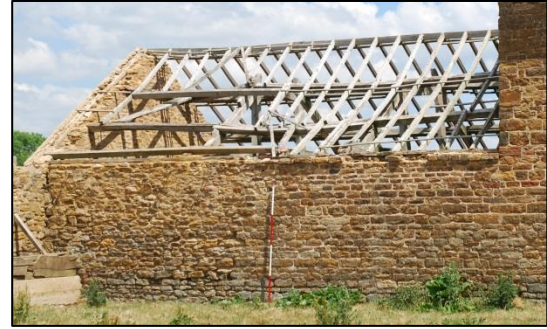
Fig 9: Rear (farmyard) face of cart hovel; Note the angled timbers of west range roof; scale 2m

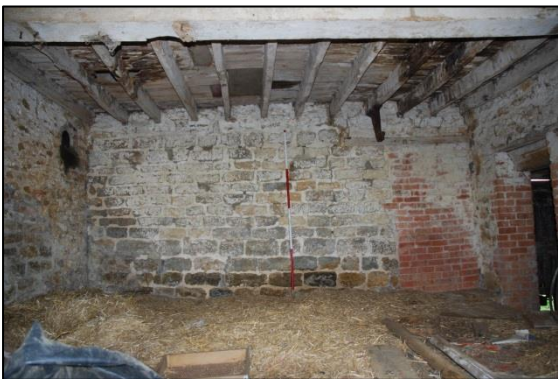
The corner rooms, one above the other comprise: on the ground floor a single room accessed by a pedestrian door in the north wall leading to a plain room with a brick-blocked door in its far wall, and an inserted doorway in its west wall, which leads down a short flight of stairs into the unlit 'corridor' room within the barn space. A boxed-in flight of timber stairs stands against the west wall, while along the south side of the room are the mountings for a drive-shaft (bearing in the east wall, stirrup affixed to a ceiling joist) which would have been attached either to a traction engine (outside) for threshing around the end of the nineteenth-century, or a small stationary steam engine for powering a hoist to lift produce/fodder/hay/straw into the upper room, - or possibly both as the need arose.

Fig 10: South wall of the corner room with bearing at left and hanging stirrup visible. Note blocked door and secondary doorway to the right. Scale 2m

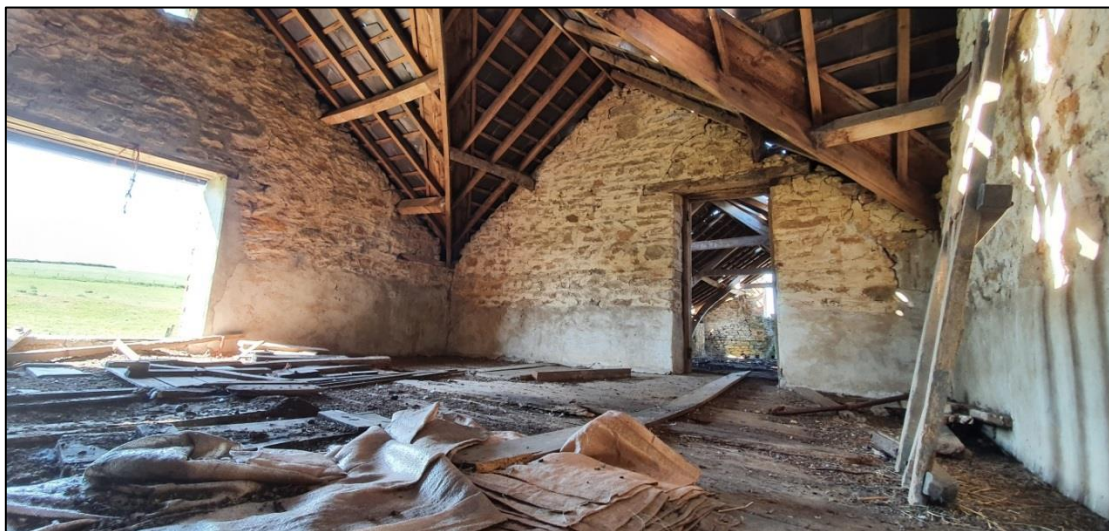
Fig 13: The first floor corner room connecting with the floor over the stable, looking south from the stairs. Note how the walls are plastered to about 70cm high. Unusually, the photo was taken from the stairs with extreme wide angle on a phone-camera for coverage and to avoid treading across the floor.

The c6m x c5m corner room at first floor level is a simple floored space open to the roof, with a pitching door in the east wall (Fig 13). It does not connect with the barn but does connect with the first floor of the stables in the east range. The walls at this high level are plastered or rendered from the floor to a height of about 70cm. In first-floor granaries this is to defray damp in the storage of crops and is noted as such as a peculiarity in other counties (Grundy 2004, 26-7).

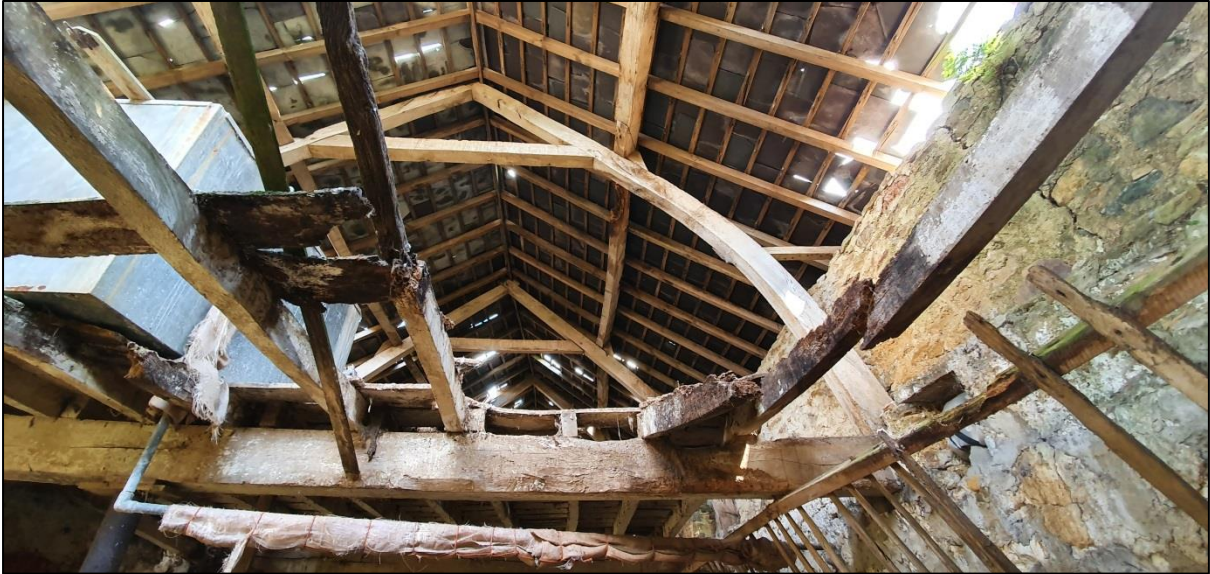
The range is divided into four equal bays by three distinctive 'Upper Crucks' (Alcock et al 1989, 26 [type C]). Cordingley calls them 'Through-purlin Open Cruck Trusses' (Cordingley 1961, 93 [fig 14, type VIe]- thanks to Joe Prentice for drawing my attention to this definitive work and the correct classification). Three pairs of cruck trusses are equally jointed into the floor beams of the first floor and sunk into the thickness of the stone side walls at the same level. This is a distinctive feature of some of the last of the tradition of cruck-construction and is likely to be of the second half of the eighteenth century (Harvey 1984, 98 and 114-116). They have been recorded in Worcestershire, Herefordshire and Staffordshire, with a very late example from Shropshire (Grundy 2004 27-8 & n25). The use of crucks in this way provides exceptionally good headroom (and storage) at first floor level. To obviate the need for a restrictive low tie beam across the first floor space, sling-braces have been added to the cruck blades where they curve out from the wall-tops, lending them additional stability (Fig 14).

Due to the very degraded first floor joists and floorboards the first floor was not accessible, so a number of photographs were taken where gaps in the ceiling permitted. An opening and a trimmer joist in the northernmost bay indicate where a stair had lain, but this has been lost. Meanwhile a huge metal water tank above the southernmost bay makes up to some extent for the apparent absence of a well in the farmyard (Fig 14). The south-west corner of the building had once been rebuilt, possibly to get this tank into position. A pitching door lies in the outward (east) facing long wall, while a second one in the south gable, had been reduced in size and converted to a (brick-edged) high window when a later cow-house was put up against the gable (by 1884), obscuring its lower half and preventing access. The floor was not visible beneath detritus.

Fig 14: View of the southernmost Upper Cruck truss from the south end of the stable. Note the water tank and a sling-brace visible just above the wall. Unusually, the photo was taken with extreme wide angle on a phone-camera for coverage given the inaccessibility of the subject and to maximise the view of the crucks.

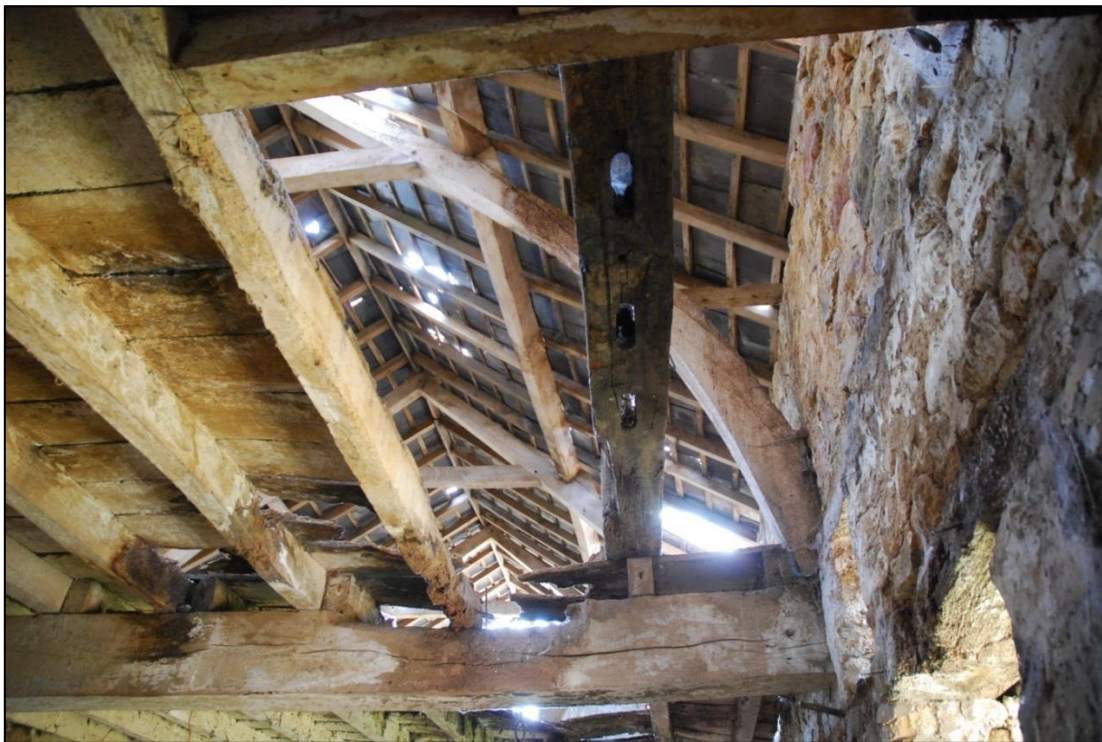
Fig 15: Looking south at the northernmost Cruck Truss, collar and sling-brace, through the redundant stair aperture. The morticed timber lies there loose by chance.

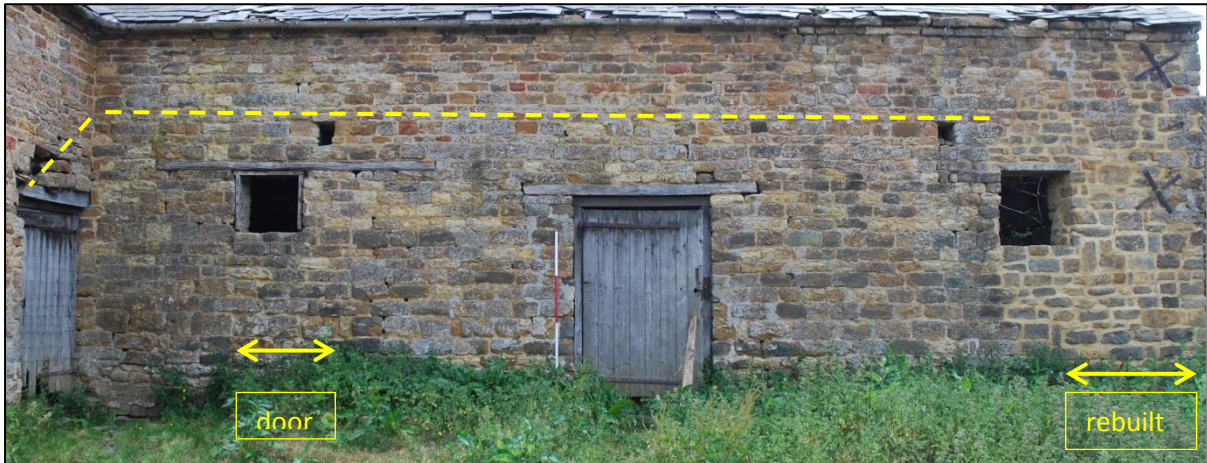
The farmyard-facing elevation of the stable is perhaps the most interesting since it includes elements of the early building and of additional elements. The central doorway is original, but to one side was formerly another door, subsequently blocked. Of the two windows, one is original, while the other was configured within the door-blocking. The two square ventilation holes mark the approximate height of the first floor, while a row of blocked former joist sockets and stone damage against the adjacent barn indicates where a former pentice once ran the length of the range to

prevent the farmer getting wet while working between the barn and stable/cowhouse (Fig 16). It may have run all the way to the end of the range, but the rebuilding of the south-west corner has removed the evidence.

Fig 16: The farmyard elevation of the stable/cowhouse. The original door blocking and row of blocked joist sockets indicated; scale 2m

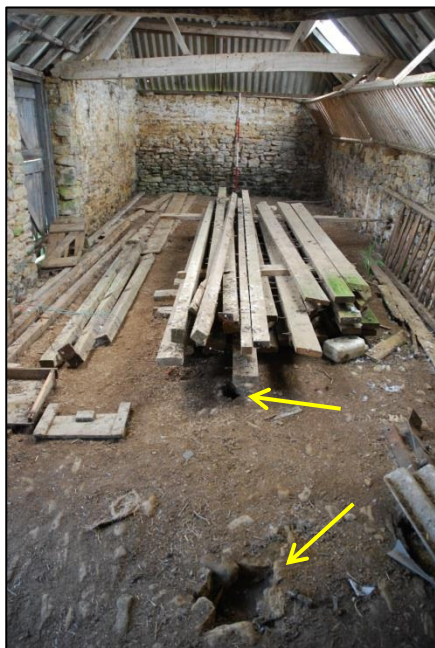
With its construction dated by historic maps between 1812 and 1884 this single-storey stone building under a modern replacement asbestos roof contains the smallest spaces in the farm. However it is unusual as the original floor of pitched stone survives, still with a row of empty post-holes along its centre-line where the stalls would have been seated.

Fig 17: Cow house, looking east, post-holes arrowed; scale 2m

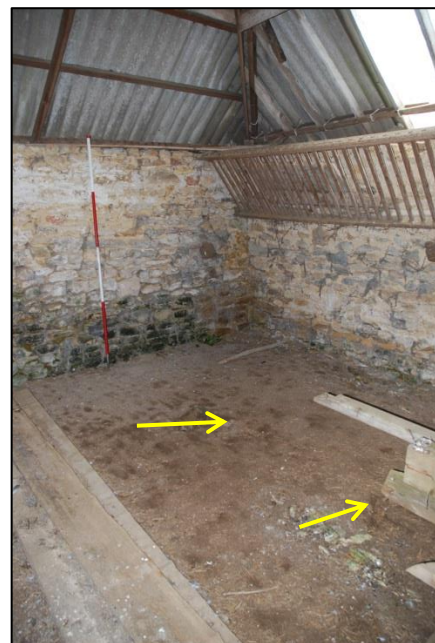
Fig 18: Cow house, looking south-east, post-holes arrowed; scale 2m

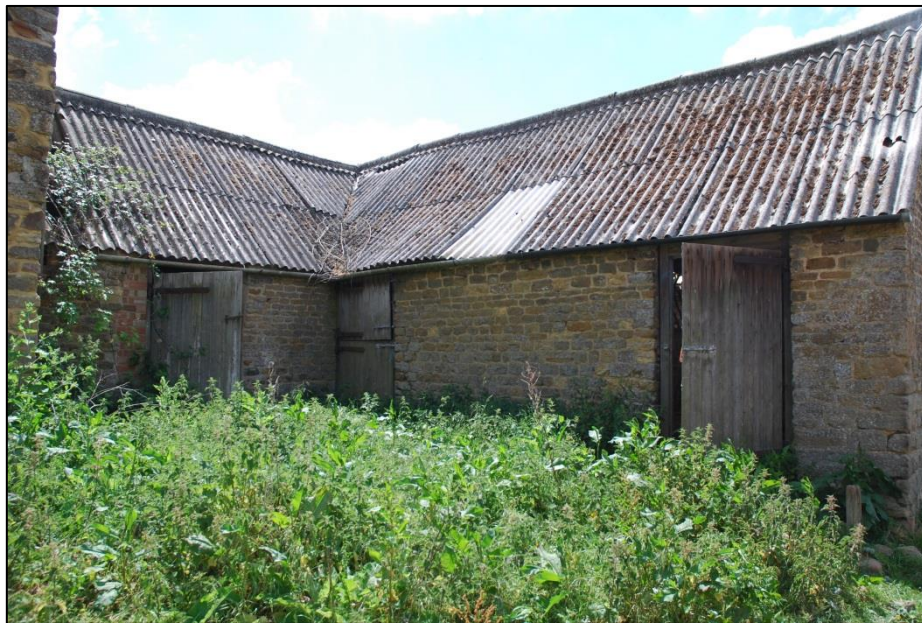
The building has no windows and is simply-constructed of coursed ironstone rubble. Only the principal trusses survive of its original roof. Its construction has made a pitching door in the south gable of the bigger stable/cow house redundant, which has been part-blocked and reduced to a high window.

Fig 19: The cow house from the farmyard

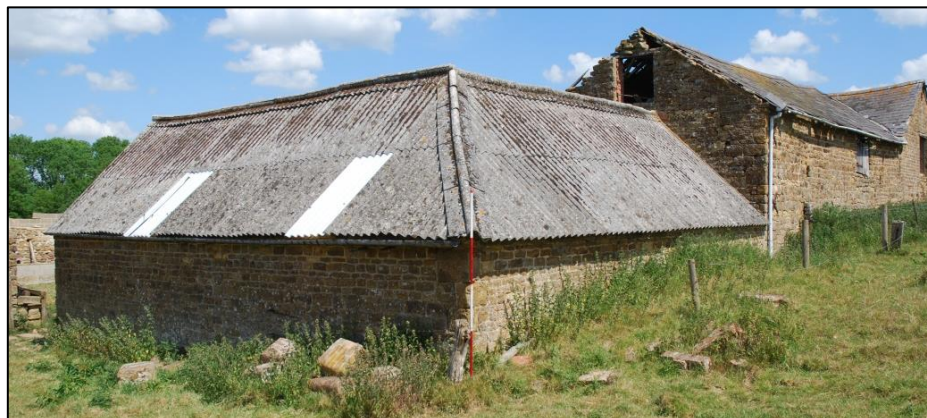
Fig 20: The cow-house exterior. Note the original pitching door above the stable which was made into a window when it became inaccessible; scale 2m

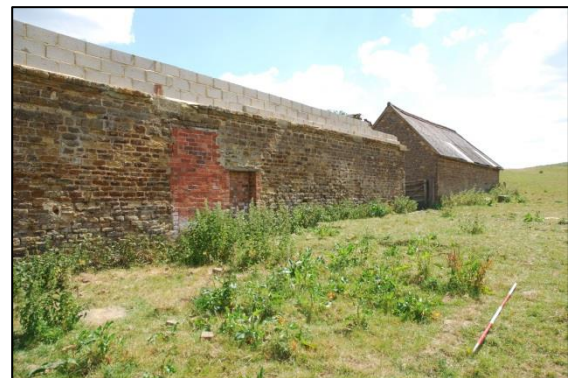
Additionally, historic maps also indicate that a building was erected against the south wall before 1884, which was demolished around 1958. The brick foundations can still be seen in the turf, although an absence of any scars in the adjacent standing stone wall suggests that the superstructure may have been of timber. Its purpose is unknown, but its deliberate location outside the farmyard may suggest it was not directly related to animal husbandry. Similarly the same OS map (Fig 4) shows that a small structure was once built up against the west wall of the farmyard on the outside, but no sign of this now exists. It may have been a timber lean-to.

Fig 22: The south wall exterior. The two blocked door-heights probably relate to the original and a heightened wall. The 2m scale lies along surviving brick foundations of a demolished building.

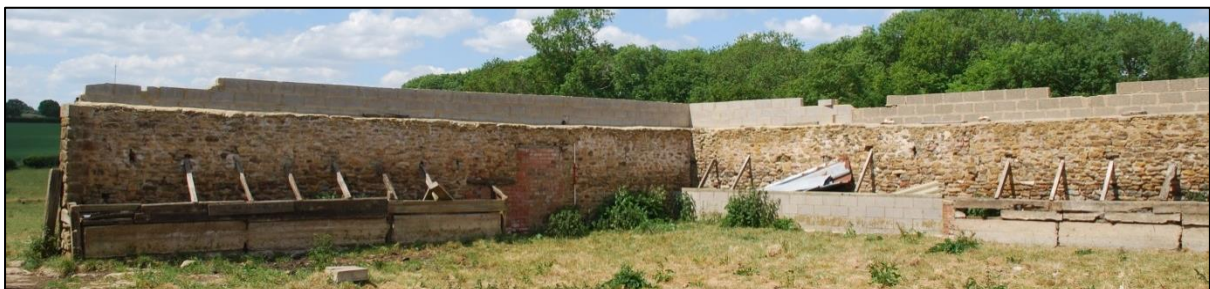
These ranges were lost (on mapping grounds) between 1958 and 1964, when a large Atcost-type livestock shed was constructed across both former ranges. This too was demolished in recent years but appears on the most recent aerial coverage of *Google-earth*.

Fig 23: Vestiges of the missing west and south ranges. The uppermost blockwork and interior troughs were entirely related to the modern At-cost type shed; scale 2m
