**Archaeological monitoring of new house foundations
at 15 Lumber Lane, Paulerspury, Northamptonshire**

Summary

A programme of monitoring on new house foundations at 15 Lumber Lane, Paulerspury uncovered a single large pit, truncated by the foundations of a previous dwelling. The pit produced no finds of any description and is thus undated and its former purpose is unknown.

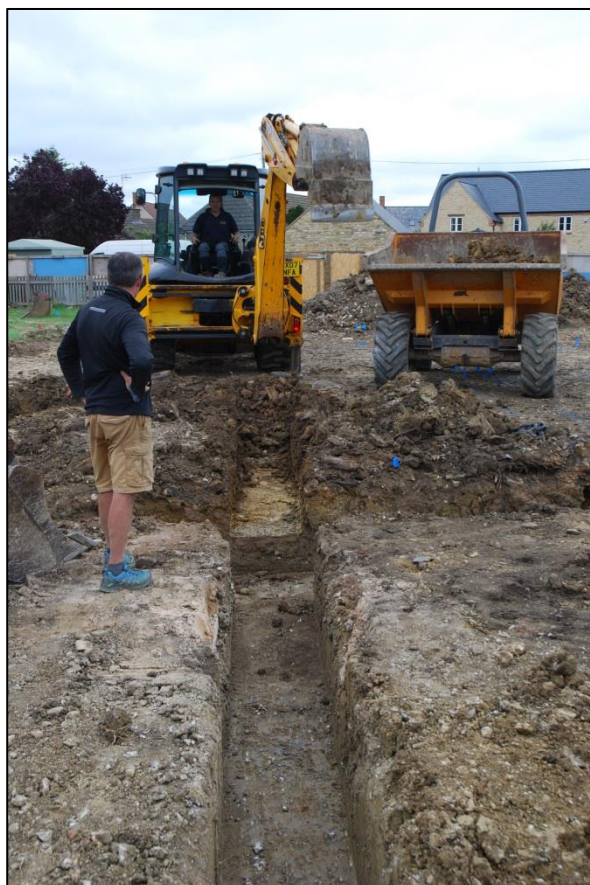
Fig 3: View of the foundation-digging looking east, uncovering a concrete foundation slab at depth

Throughout the process it was clear that the previous building, the so-called Kingston's Bungalow (located on Fig 2a), although it had comprised only a single storey and was predominantly timber-framed, benefitted from concrete strip-foundations which were of greater mass than either had been anticipated or might have been required for such an apparently insubstantial structure. Most of its walls had rested upon concrete-filled hollow blockwork which in turn stood on 500mm-wide concrete strips, each being c100-150mm thick, and which were set 500mm deep in the ground, within ragged former machine-dug trenches (probably once dug with a toothed bucket). The largest was a 2m x 2m square slab of c150- to 200mm-thick concrete on which had stood the brick footing of the former bungalow chimney (being uncovered in Fig 3).

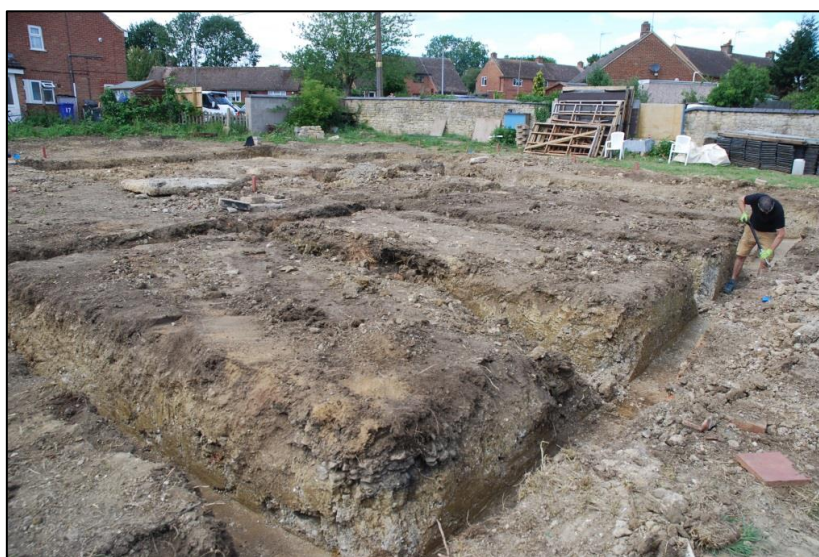
Fig 4: The site at the end of fieldwork, looking north-west. Extensive disturbance left many corners collapsing.

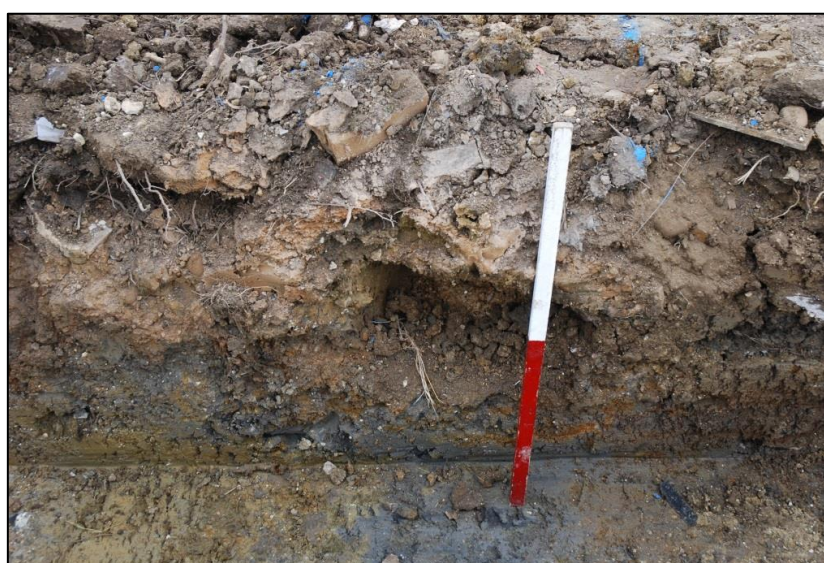
The pit fill (Fig 5) comprised grey-brown silty clay, mottled in the manner of soils which are periodically and seasonally wet, then dry out, graduating to black at the base where it was probably anaerobic. The sides, where they could be observed, were moderately gently-sloping. There were no finds of any description.

Fig 5: Truncated pit fill at the base of a west-facing section; Scale 1m

Observations recorded a single archaeological feature – an undated pit some 1m across, lying at the junction of two foundation trenches (Fig 2b). Only its lower 300mm had survived since its location coincided with one of the bungalow concrete strips and the trench in which it lay.

Constructing the former bungalow had been strikingly destructive of its footprint, such that the only pit found had lost some 500mm of its upper portion (leaving only the 500mm of the basal fills untouched). Across the area a similar level of disturbance indicates that any potential archaeological feature of less than 500mm depth would have been lost when the bungalow was constructed.
