**Archaeological observation and recording on
land adjacent to**

11 Egerton Close, Brackley

Iain Soden

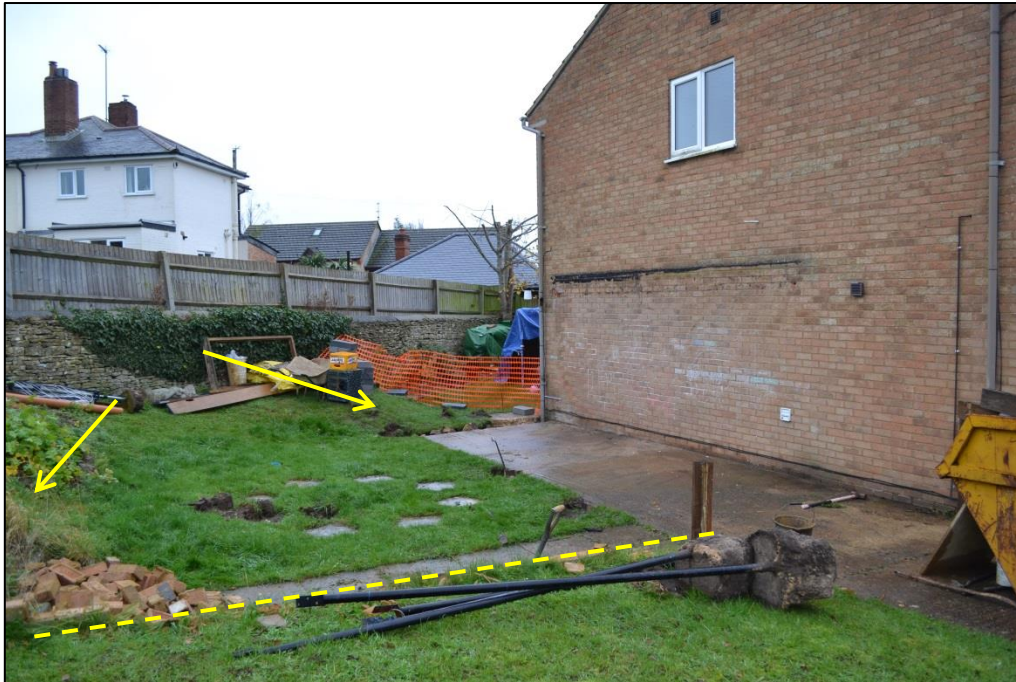
Fig 3: The site, looking north with car-port base still *in situ*. Note the two drops in garden level indicating modern terraces (arrowed). A sudden drop is also present along the dashed line. The houses to the north are built from a higher level, the plots separated from those of Egerton Close by a low stone retaining wall.

The site is sandwiched between existing housing (Fig 2) and at the time of fieldwork was a garden which was terraced in an arc to the west of the house and surrounded an attached, secondary carport. This indicated that the ground of the garden fell about 1m from the adjacent houses at the north and west down to the floor level of the existing 11 Egerton Close (Fig 3). This it seems to have done in either one or probably two drops, according to the space available.

It was clear that the terrace seen on the grassed garden surface (Figs 3 and 4) was mirrored beneath by the base of the garden soil, underlying redeposited light grey clays and the hard buff clay and limestone of the undisturbed natural geology (Fig 5). This was probably machined flat and stepped in a previous construction-process, either when no 11 and its neighbours were built, or subsequently when the car-port to no 11 was put in. Some such work may have accompanied both construction regimes which would have been advisable to aid rainwater drainage at a distance from both the house and car port and aid the practicalities of garden-use.

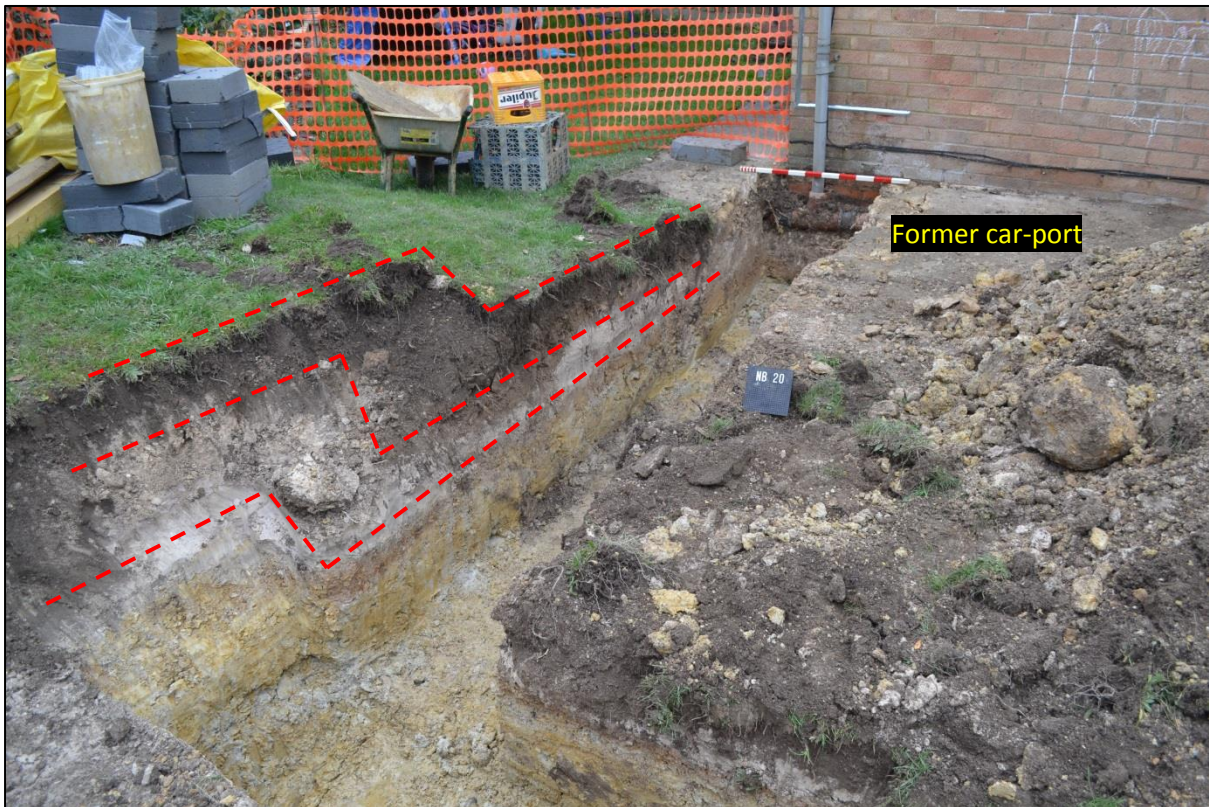
Fig 5: View of the northernmost foundation trench, showing the deliberate garden make-up above the terracing to the natural geology (dashed line). A slightly higher terrace lies to the west out of the picture at left as the plot narrows; Scale 1m

new property (Figs 4 and 5). They were dug through redeposited topsoil and light grey clays, into the natural stiff buff Jurassic clay and limestone beneath.
